ARBORICULTURAL IMPACT ASSESSMENT REPORT

BS 5837:2012 'Trees in relation to design, demolition and construction. Recommendations'

Land surrounding Snowman and Casterbridge House,
Belsize Road, Camden, NW6 4DP

DATE: 19 May 2020

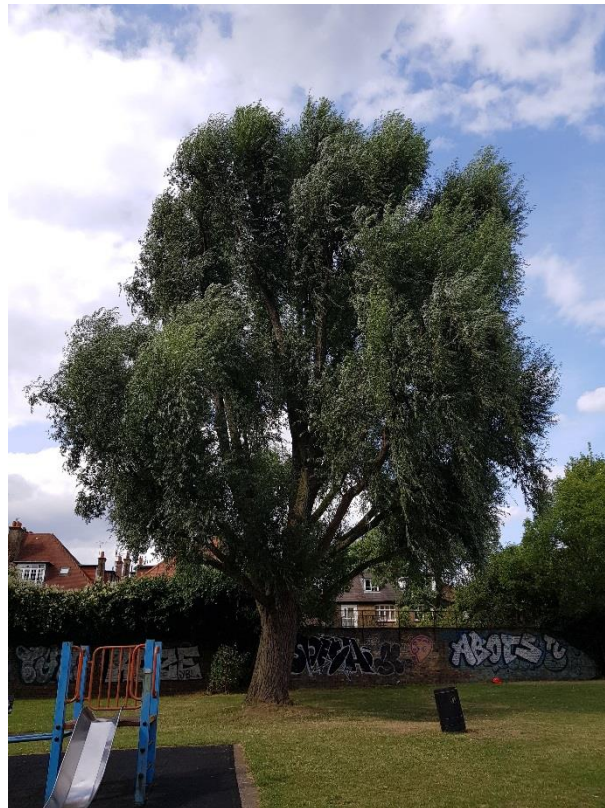
T4 and T5 are 9-metre-high Norway maples growing on the edge of the car park and both have structural and physiological defects, although they are not hazardous trees. T34 willow is the most prominent tree within the site and has been managed by regular crown reductions. It has large surface roots but otherwise appears to be in reasonable form and condition.

Photo 1 of T34 looking north

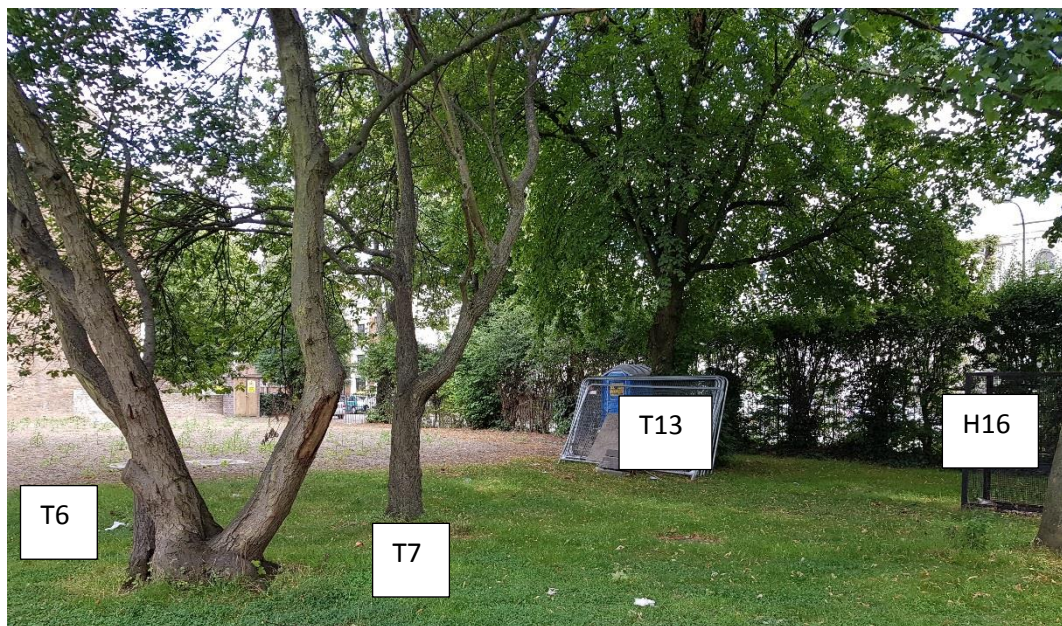
T6 and T7 goat willow has a poor structural form, with T6 being potentially hazardous. T8 sycamore is in reasonable form but with more dead wood than is typical, with a tight fork where the tree becomes co-dominant at 3m.

Photo 2 of T6, T7 and T13 looking south-east

The following trees might be removed due to their condition and/or unsustainable location next to the wall: T6, G23, T26, T27, T29 and T31 and G28. Please note that trees recommended for removal by the arboriculturist are currently under review as part of the scope of this project, final confirmation of this is to be secured by way of planning condition.

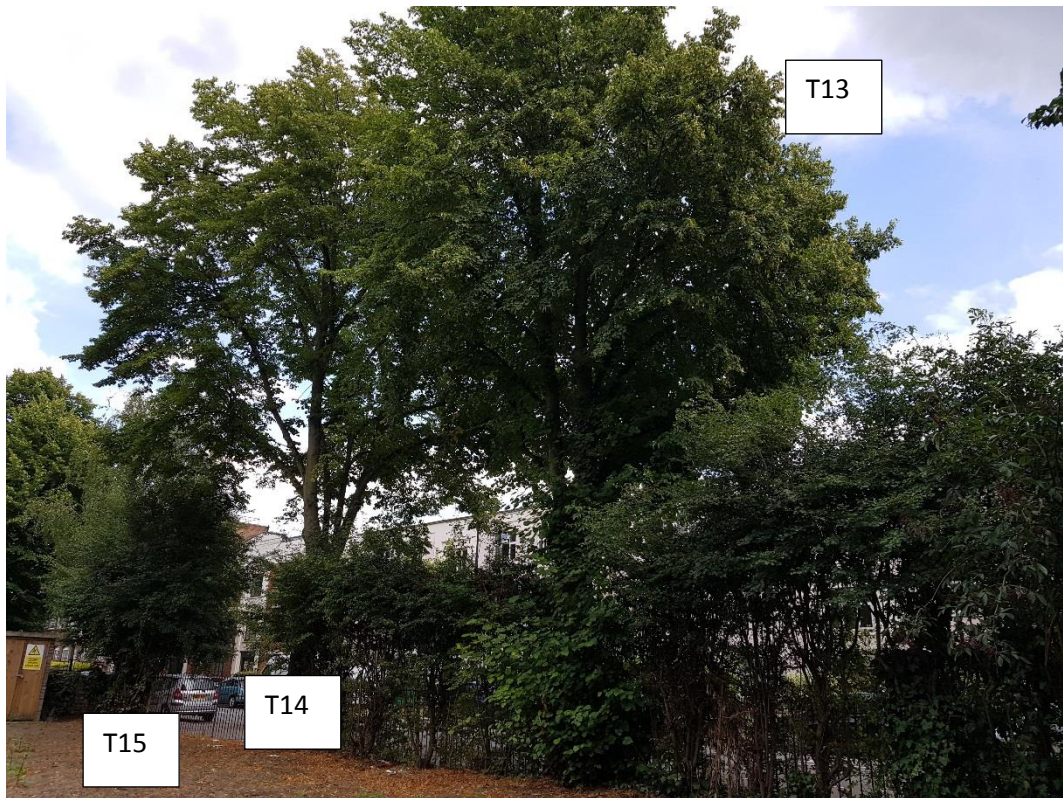
Photo 3 of T13, T14, T15 and H16 looking south-east

The lime trees T9, T10, T11, T13 and T14 are all managed as pollards and provide a high level of visual amenity to Belsize Abbey Road and Abbey Road. T12 sycamore is also prominent. T15 hawthorn is a small scrubby tree slightly to the east of a neat 3m high hawthorn hedge along the road frontage, behind the railings.

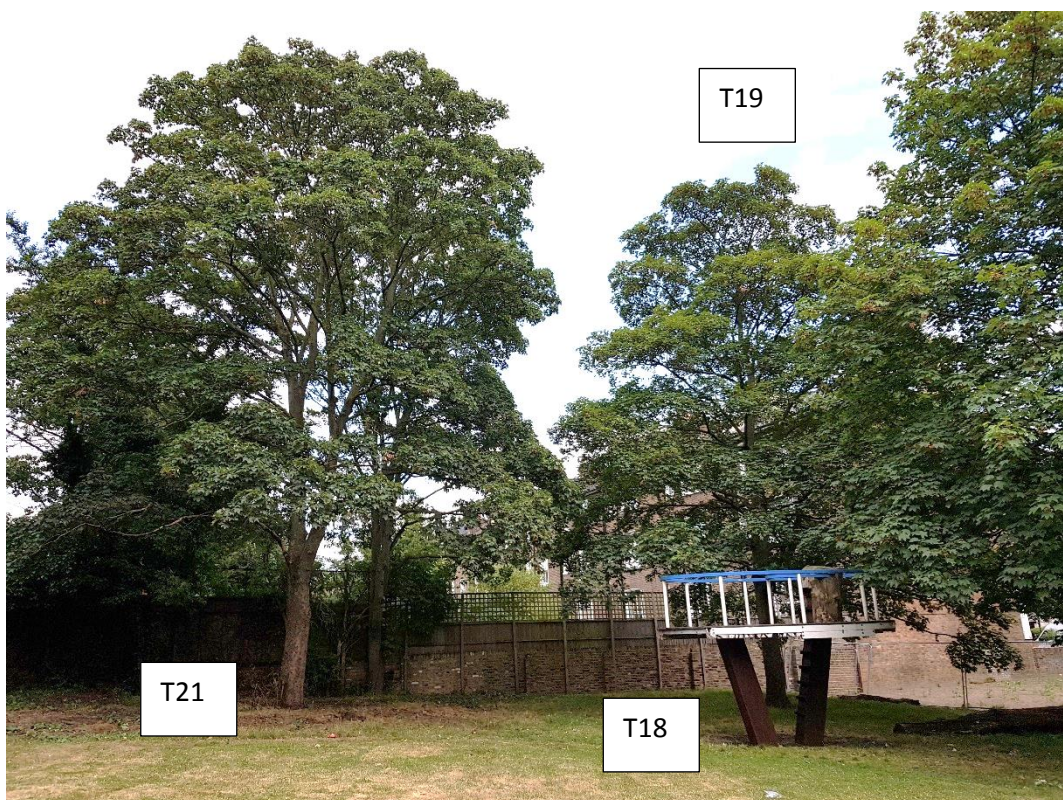
Photo 4 of T18 – T21 looking north-east

Set back from the road are a group of trees comprising T17 a semi mature ash with a tight fork between the main stems, T18, T19 and T21 sycamores in reasonable form and condition (but with some dead wood in the crowns). T20 is growing right next to the boundary wall which will be acting as a root barrier, at least to the depth of its foundations. Given the height of the wall, the foundations are likely to be substantial. The crown overhangs the neighbouring property. The remainder of the trees are all semi-mature self sown trees growing right up next to the boundary walls in an unsustainable location. The exception to this is T32 sycamore which are offsite and the wall acts as a root barrier into the site.

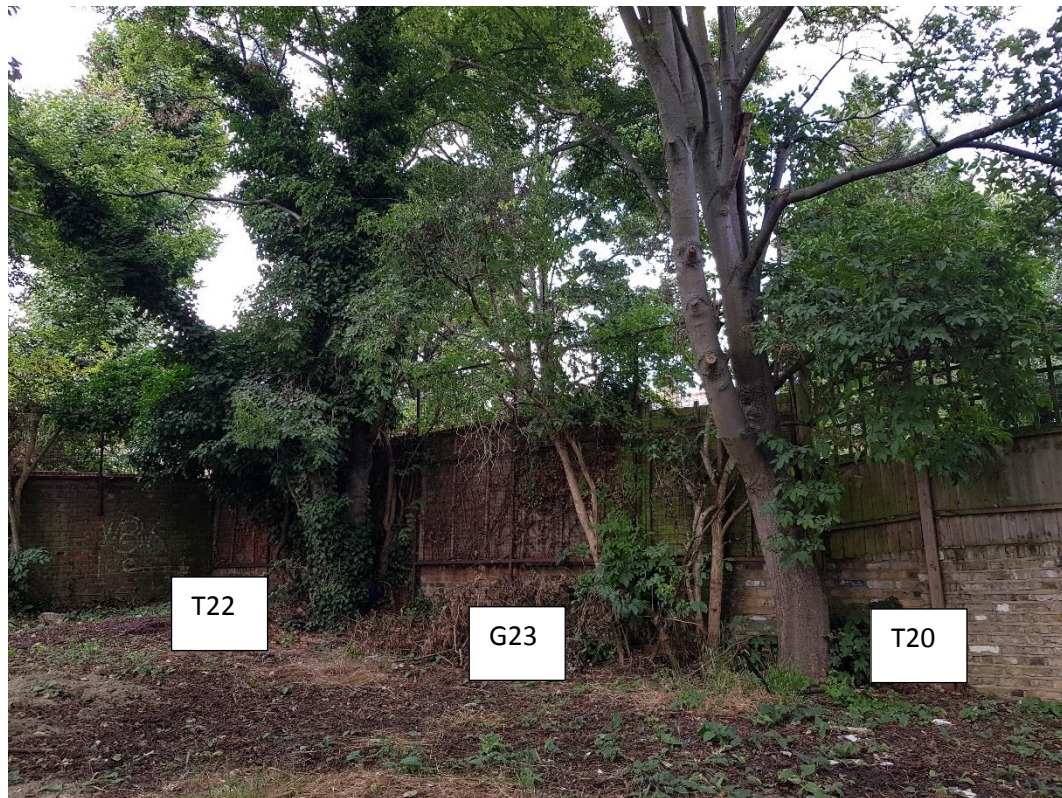
Photo 5 showing close proximity to the wall

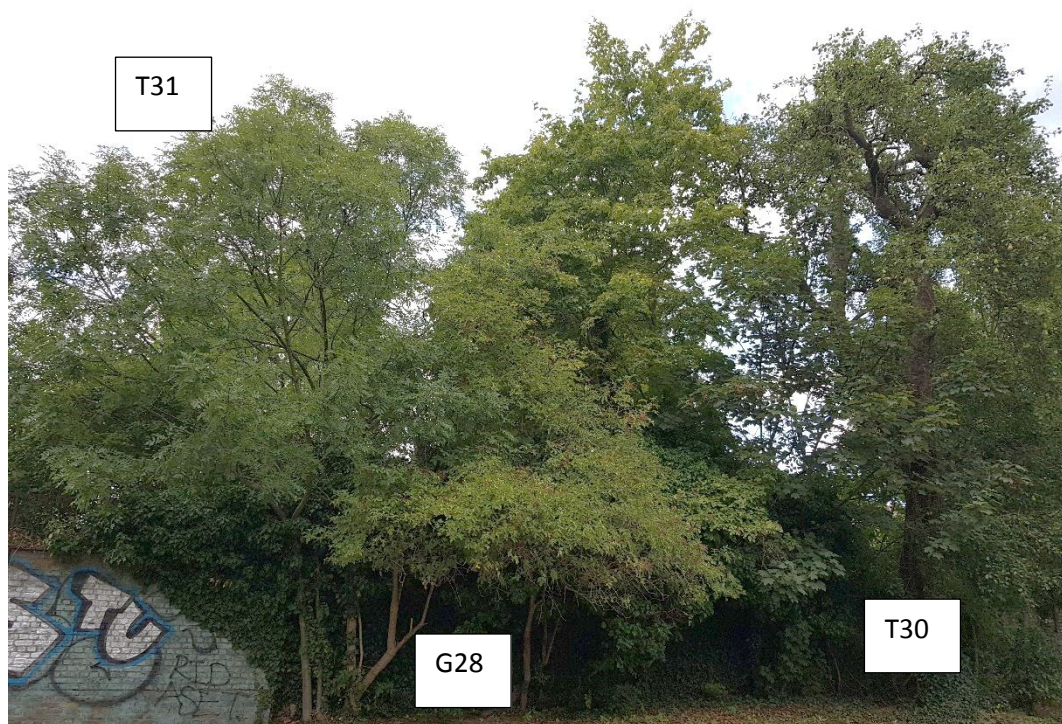
Photo 6 of G28 – T32 looking north

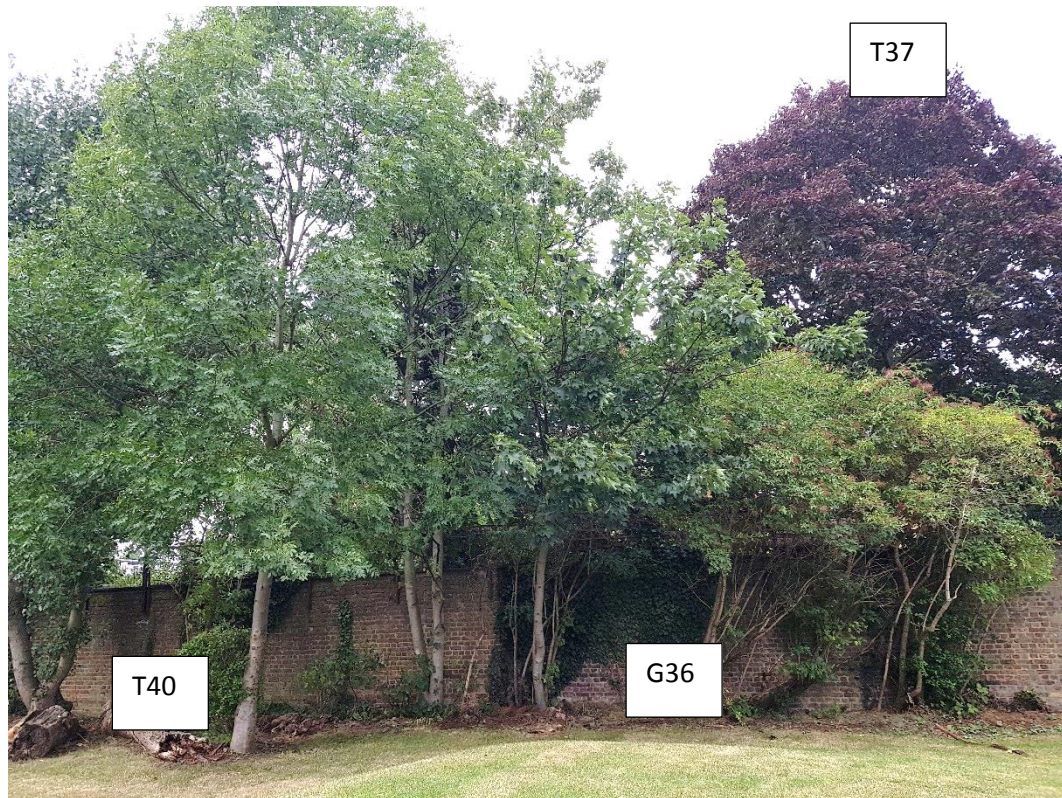
Photo 7 of G36 – T40 looking north

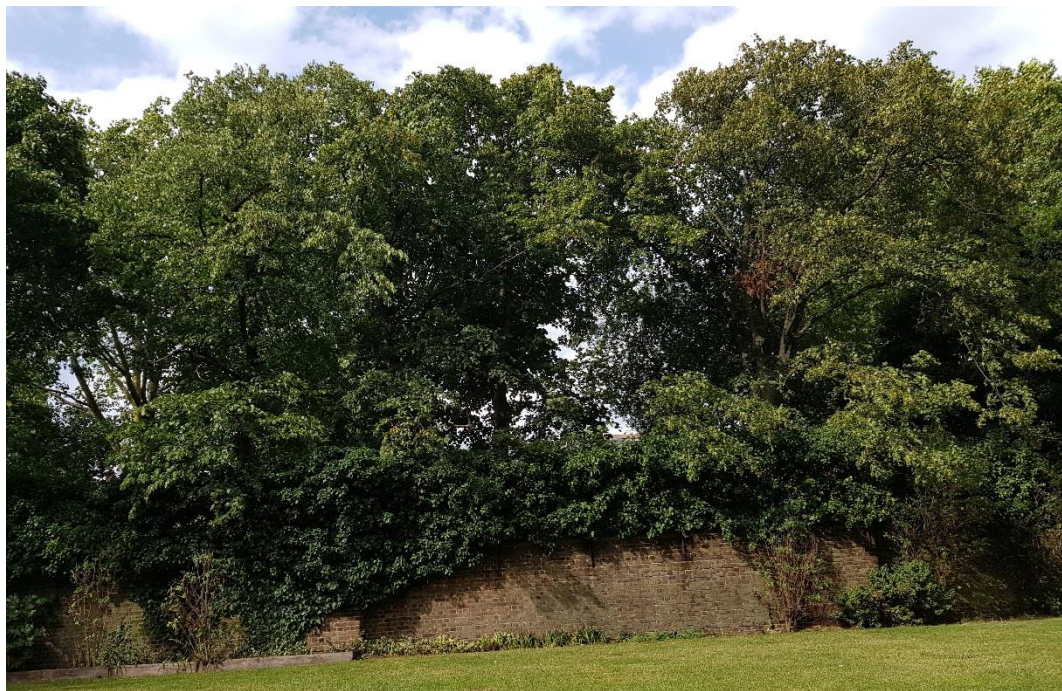
The line of offsite trees which are T35, T37, T47, T48, G49, T50 and T51 provide a pleasant backdrop and collective screening. The tall wall acts as a root barrier to the depth of its foundations. The on site trees are low quality, reasonably small and leaning due to overcrowding. The category U trees will be removed as a matter of good practice.

Photo 8 of offsite trees T48 and G49

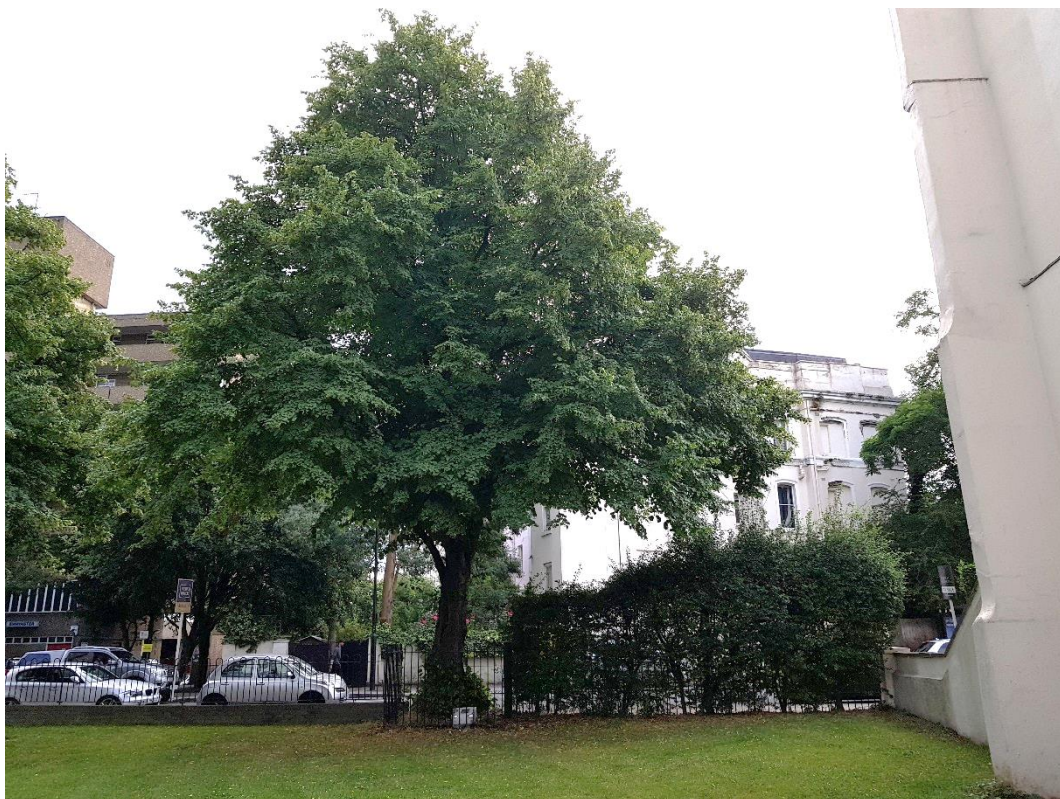
The high and moderate lime trees, T53, T59, T60, T62, T64 and T65 form a collective high quality amenity to the site and the neighbouring area. T55 lime has a fungus which is likely to cause tree failure. This has been reported to Camden Council to take necessary action with regards to the tree removal. The two whitebeams, T56 and T57 are in a reasonable form and condition and form a pair fronting Snowman House. Many of the trees have been planted in narrow low planting beds, which is a poor design for tree planting. The levels and walls have to remain as the tree roots will be growing up to the walls and using them as support.

Photo 9 of T53 and H54 looking south

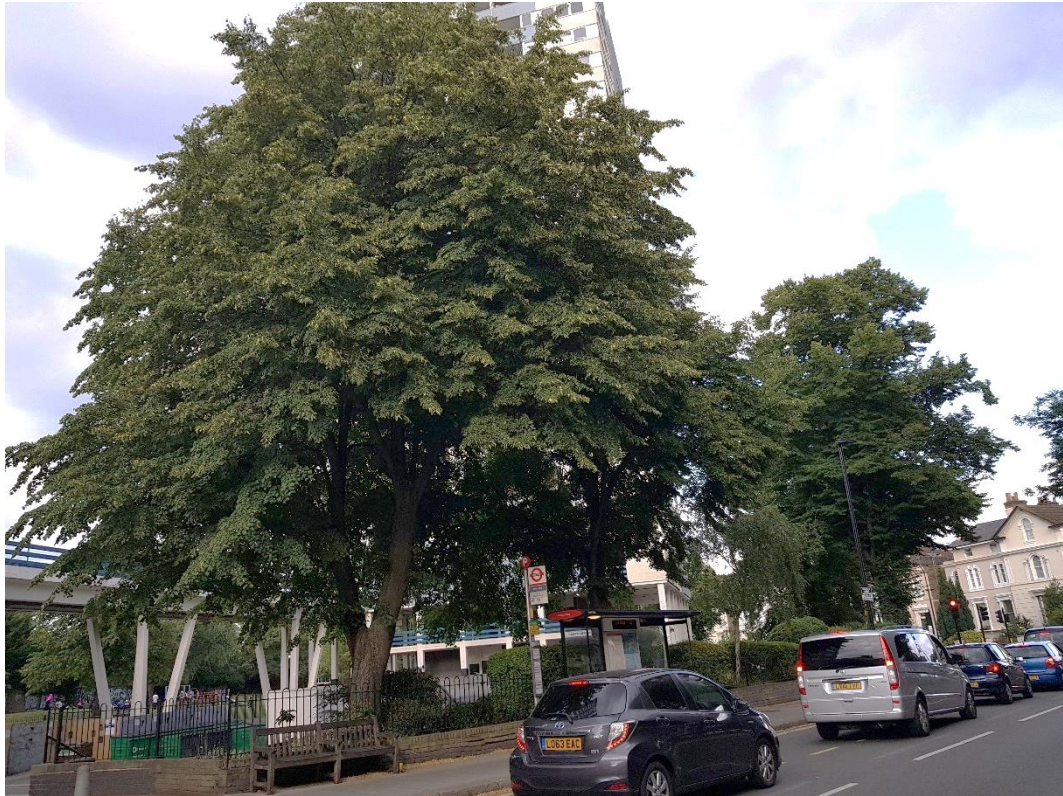
Photo 10 of T62 looking along Abbey Road east

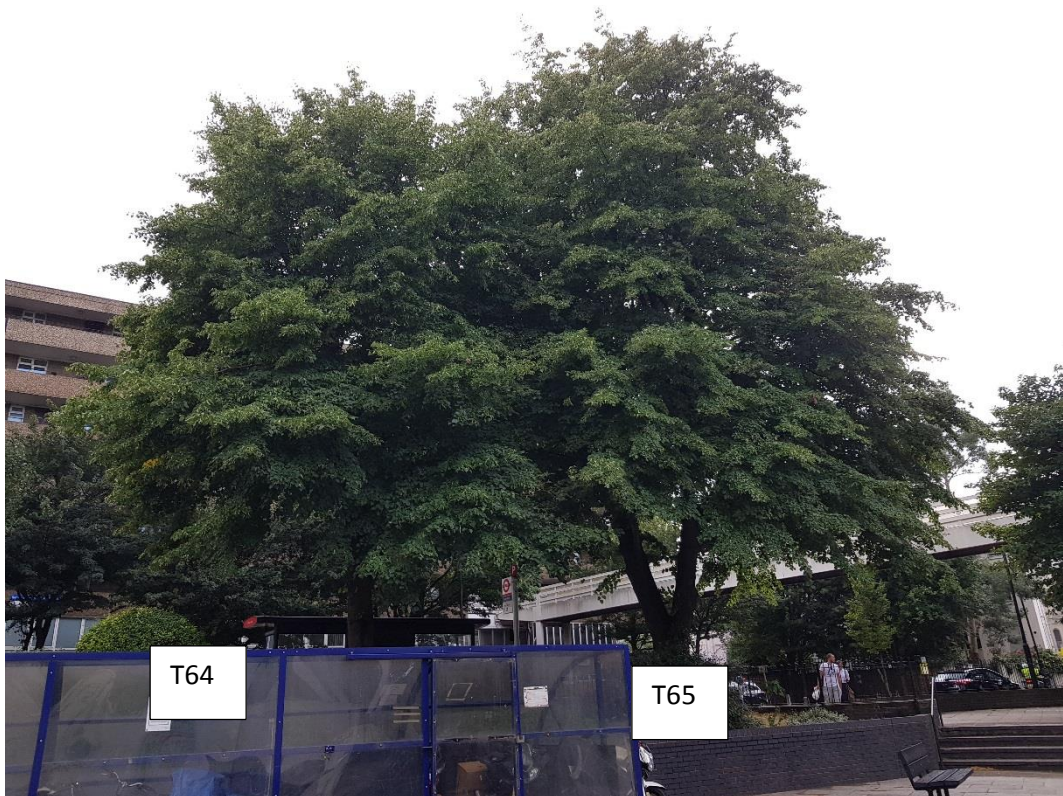
Photo 11 of T64 and T65 limes

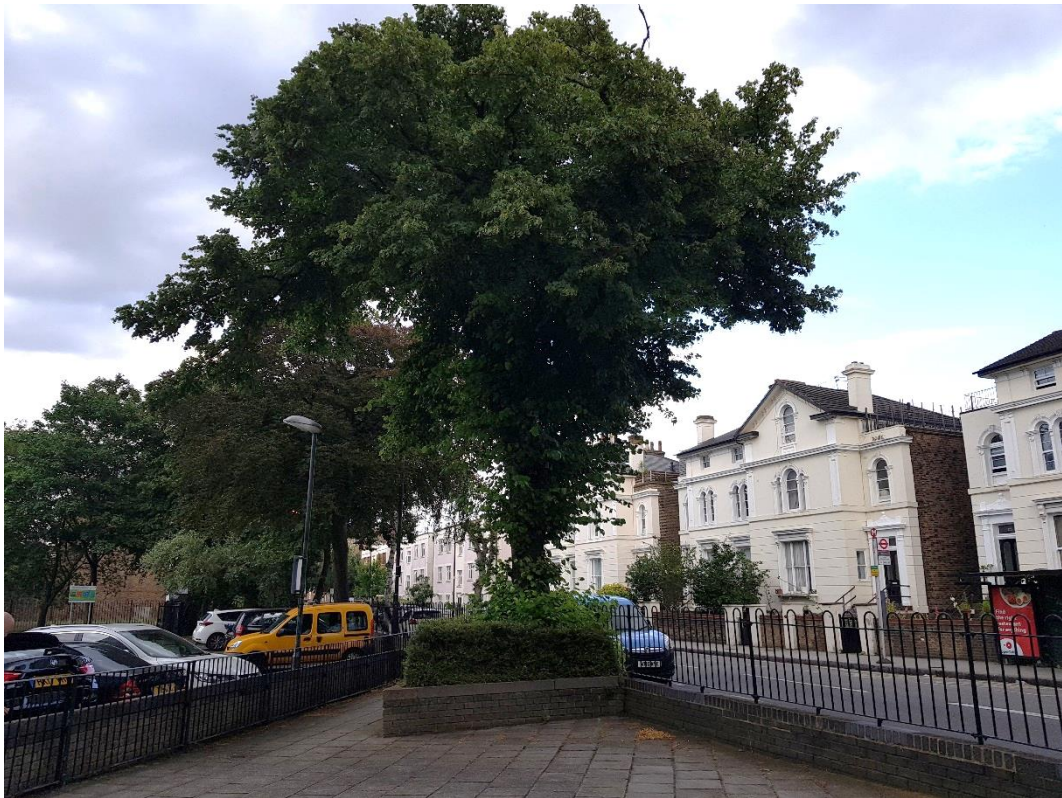
Photo 12 of T66 looking east

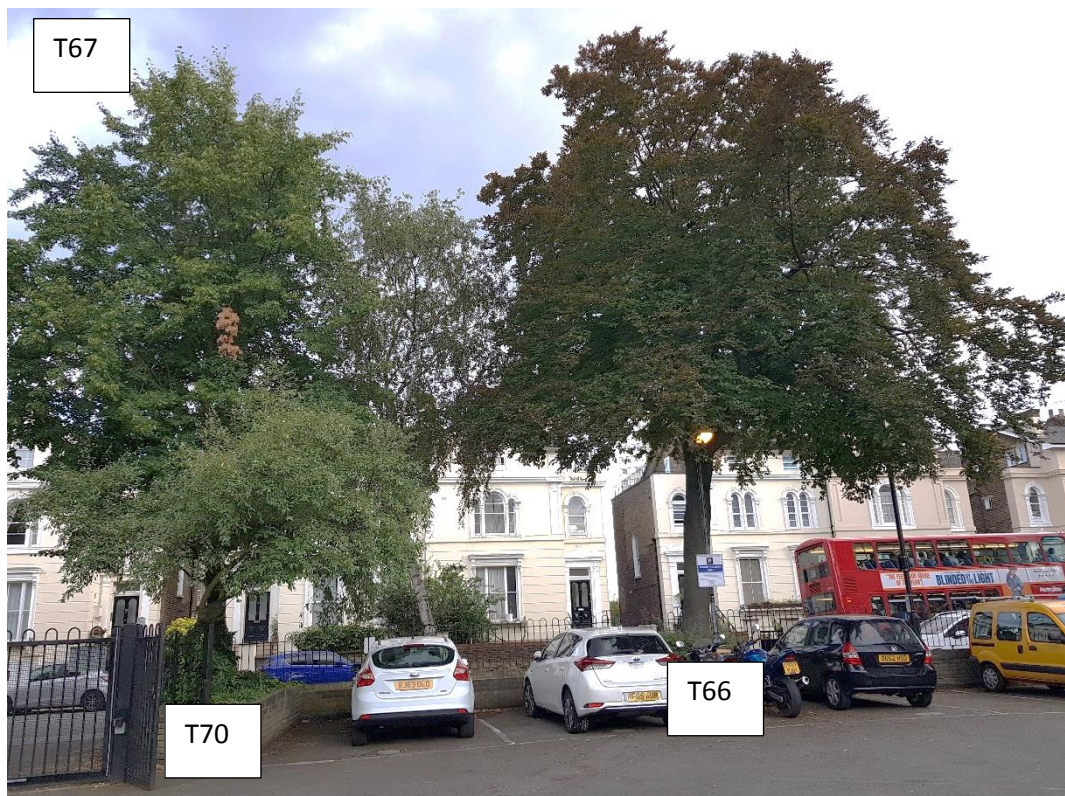
Photo 13 of T66 beech and T67 and T70 looking south
