HERITAGE STATEMENT FOR LISTED BUILDING CONSENT APPLICATION

**3, 4, 5 and 6 Oak Court
St Albans Villas
Highgate Road
London
NW5 1QU**

Nos. 3, 4, 5 and 6 Oak Court, St Albans Villas- Window Replacement and General External Repairs as well as Refurbishment of Internal Communal Circulation Areas including Fire Precautionary Upgrade Works

**Job No: 30914
Date: May 2020**

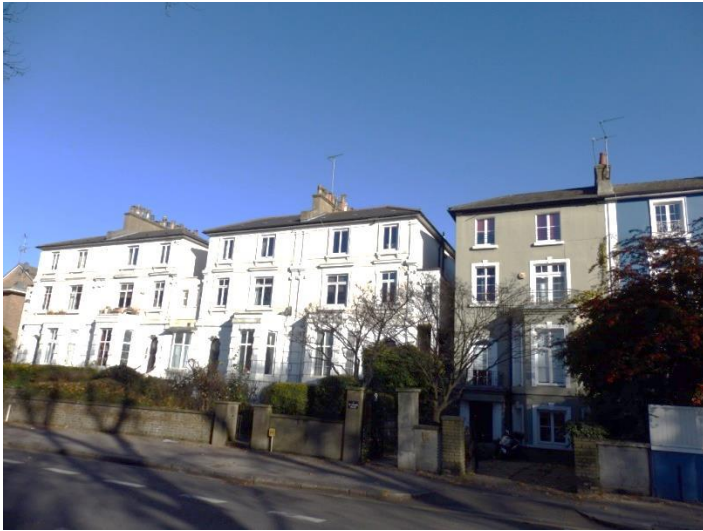
4.1.2 Historic England's description of the Site makes no reference to the fact that today all the front elevation windows are double glazed PVCu, therefore it can only be assumed that they were installed post Listing and possibly without planning permission or Listed Building Consent.

4.1.3 **The PVCu windows are not sympathetic to the age of the Site** and detract from the aesthetic tenets of classical architectural designed centred around the proportions of the Golden ratio or Golden rectangle as such, they could depreciate the market value of the Site. Given the above it is felt that the replacement of the PVCu windows for timber windows with Slimlite double glazing is justifiable.

Photo 1. Nos. 3-6 Oak Court (cream and white)

- 3.2.1 For the most part the proposed works relate to the replacement of all windows on the front elevation and a number of windows on the rear elevation, as indicated on the accompanying plans. All replacement windows are to be timber with Slimlite double glazing. The use of 14mm thick Slimlite sealed units keeps the overall thickness of the windows to a minimum whilst complying with the latest version of Approved Document L1B: Conservation of fuel and power in existing dwellings.

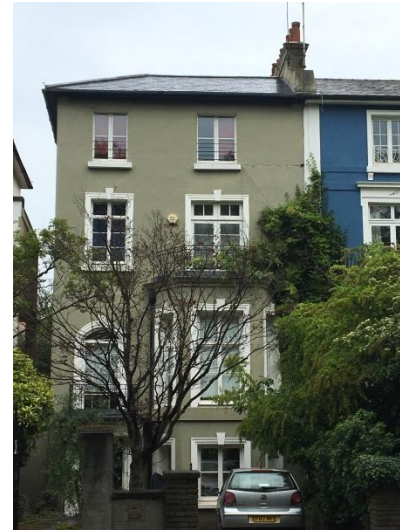
3.2.3 The use of multiple glazing bars is typical on period buildings and as such the fenestration of the proposed front elevation casement windows has been based on those of the neighbouring buildings Nos. 1 and 2 St Albans Villas (see photos) which have retained theirs in some form or other. The glazing bars are to be structural. The proposed windows are to be of redwood with oak cills.

Photo 2. No.2 St Albans Villas

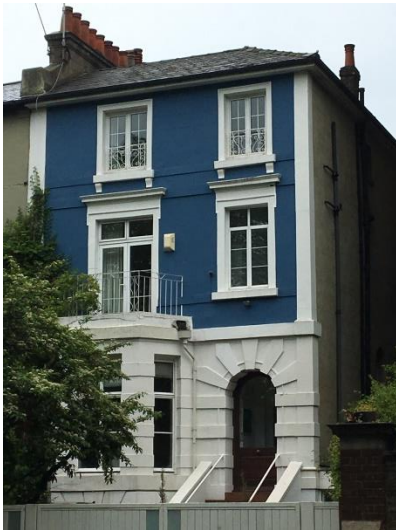
Photo 3. No. 1 St. Albans Villas

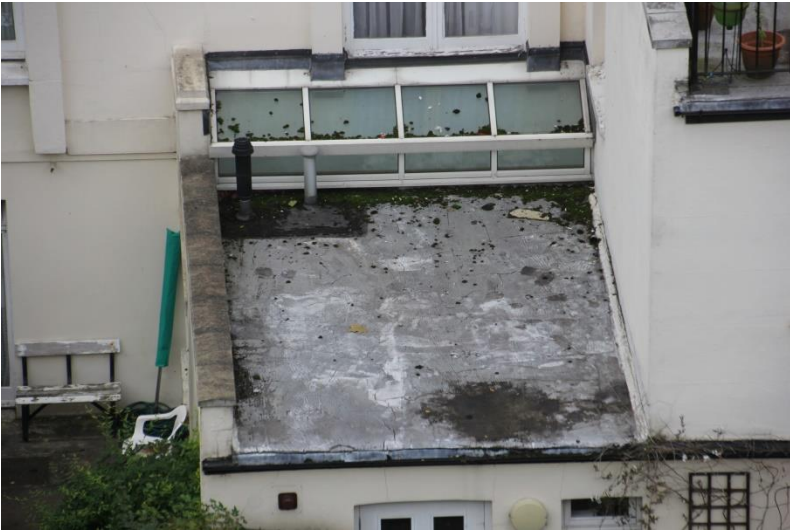
3.5.13 Aerial photos show the covering to lower height rear addition of No. 4 to be asphalt which is in fair condition. The intention is to carryout minor asphalt repairs and apply a brush applied solar reflective paint to prolong its serviceable life.

Photo 5. No. 4 Oak Court - lower flat roof

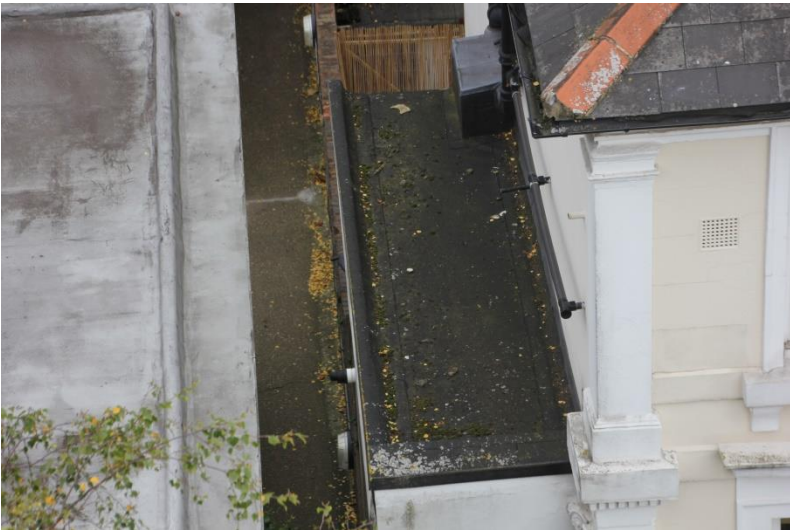
3.5.11 Aerial photos show the coverings to the two outer most flank roofs and the link roof to be bituminous felt with lead flashings again circa 10-20yrs old. As such they are assumed to be in a fair-good condition. The intention is to brush off any accumulated loose debris and re-point any loose sections of flashings.

Photo 7. No. 6 Oak Court - flank flat roof

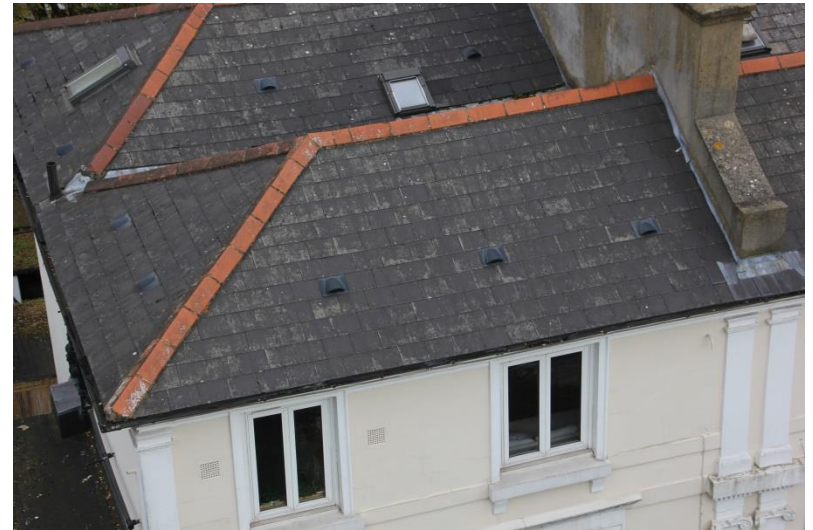
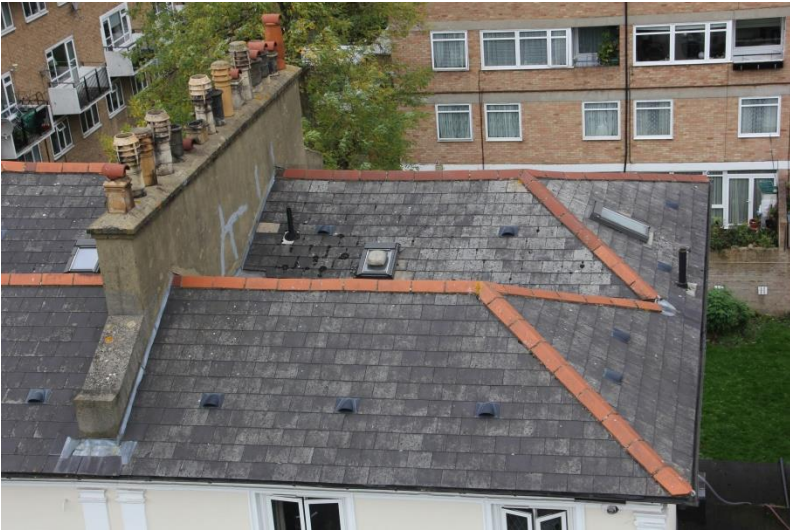
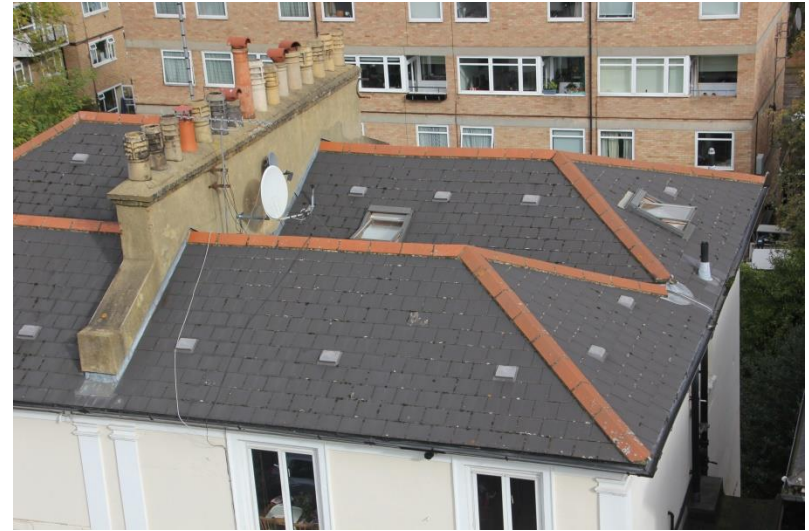
3.5.4 Aerial photos show the existing roof coverings to be of artificial slate with plastic vent tiles and clay ridge tiles. The coverings are considered to be circa 10-22yrs in age and as such are in fair to good condition with minor defects. The intention is to carefully brush off any moss growth and replace any broken or missing tiles on a 'like-for-like' basis.

Photo 8. No.6 Oak Court -main roof

Photo 9. No. 5 Oak Court - main roof

Photo 10. No.3 Oak Court - main roof

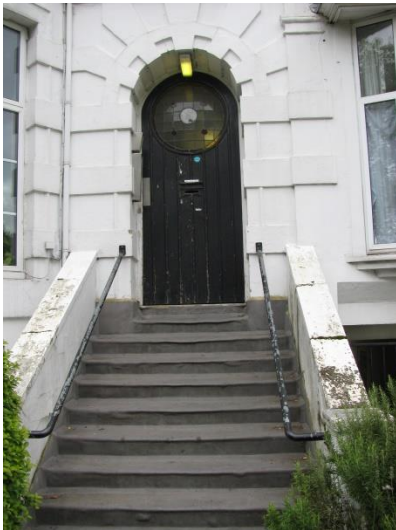
- 3.5.27 **Communal Front Entrance Steps**
- 3.5.28 The communal front entrance steps are of concrete and are in need of minor repair. The steps of No. 5 have an asphalt covering which has slumped down the risers and as such poses a hazard to the health and safety of both residents and visitors to the Site; the intention is to renew the asphalt.

Photo 11. No. 5 Oak Court - communal front entrance steps

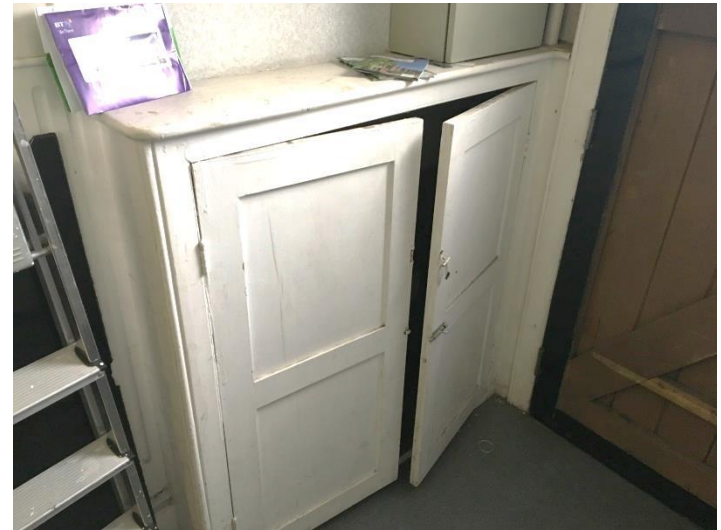
Photo 12. Electrical cupboard within communal entrance hall

3.5.52 Although not included in the FRA recommendations the Council's intention is to replace any non-complaint electrical cupboards within the common escape routes (see photo) for fire resistant cupboards. The intention is to replicate their appearance as best as possible and to consult with the conservation officer on their finished appearance.

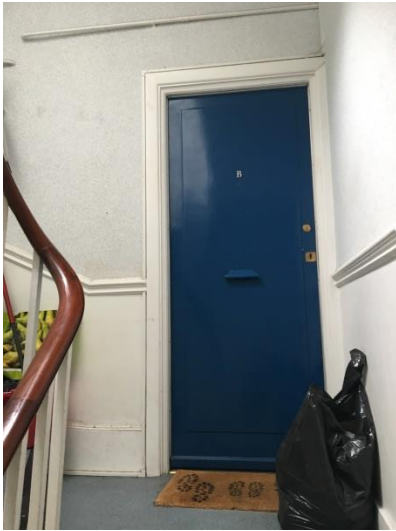
3.5.49 The majority of the existing doors and frames are assumed to be circa 1920/30s in age and are essentially flush faced in style with letter plates (see photo). The replacement door sets are factory produced and although available as flush faced will not be possible to replicate the profile of the letter plates.

Photo 13. Generic flat entrance door

3.5.48 Although not included in the FRA recommendations the Council's intention is to replace any non-complaint flat entrance doors and frames which open onto the common escape routes for compliant FD30s fire door sets.

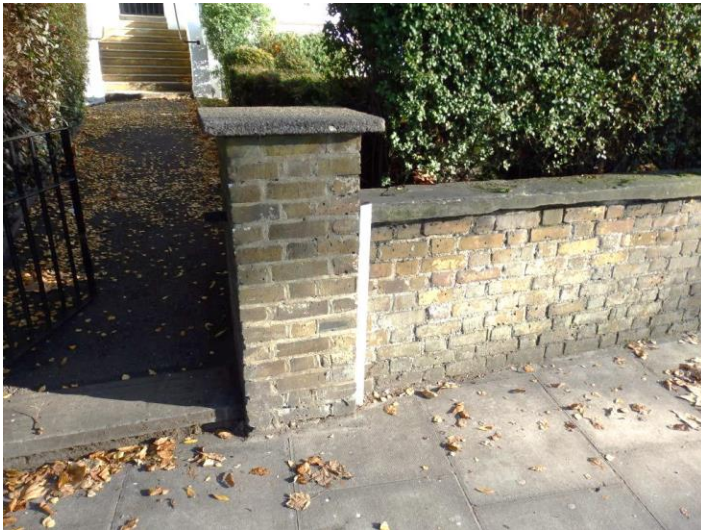
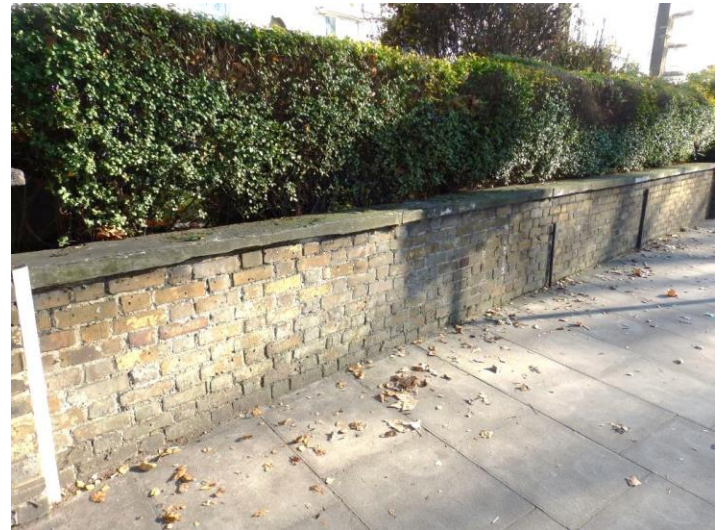
- 3.5.31 The rear boundary walls are considered to be in fair condition and as such will be sympathetically repaired.
- 3.5.32 The front boundary wall is of brick construction and is not original despite having stone copings. The wall requires some re-pointing and re-bedding of copings.

Photo 15. Oak Court - front boundary wall

Photo 16. Oak Court - front boundary wall
