Ref 2026 – 1c – 4b Hampstead Hill Gardens

Re: 4b Hampstead Hill Gardens

I have accessed the Camden Council Planning Portal to review the documents posted for the planning application to demolish and rebuild 4b Hampstead Hill Gardens, as instructed, to carry out a structural review of the proposal.

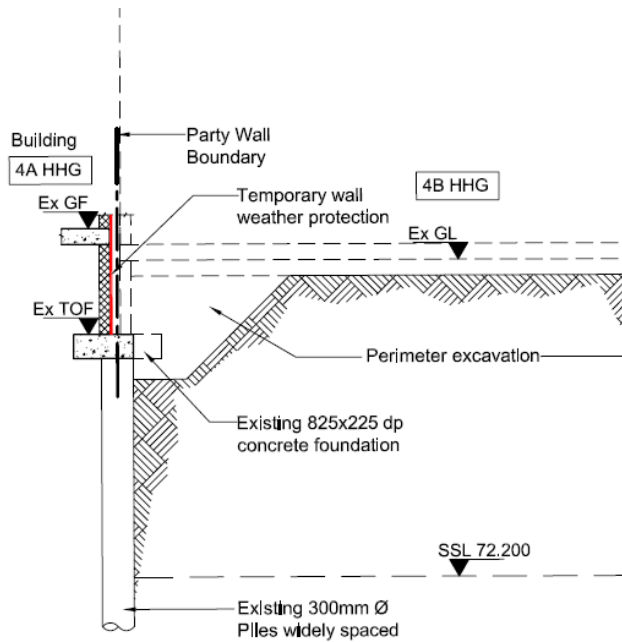
From the record drawings attached the existing property is founded on strip foundations 1ft 4" deep bearing on short bored 8 inch dia (200mm) piles located at strategic points. The drawing does not show if the strip footings are reinforced but mentions that the piles are doweled into the strip footing with 2 x ½" dowel bars 24 inches long with 2 horizontal ½" bars 48" long over each pile. The piles to extend 6'-0" below the formation of the strip footing so 9ft 6inches (2.9m) below ground level. The strip footing seems to have step across it to accommodate the layout and is referenced on the plan with dig levels varying from 3' 6" to 4' 6" with thickness of the footing varying from 1' 4" to 1'. This is not reflected in the Temporary Works proposals as below.

The current Temporary Works proposals show that the existing masonry walls built off the strip footings on the Party Wall line are to be retained but cut back to the Party wall line. As these walls retain the ground additional temporary works will be required to allow this to happen. In addition, the drawing incorrectly references the size of the piles (300mm) and thickness of foundation (225mm) The drawing also indicates that the piles extend significantly below the proposed Basement SSL which is not the case based

on the record drawings, which indicate a toe level at approximately 72.700, as described above.
