Ref 2026 - 1c - 4b Hampstead Hill Gardens

## **Re: 4b Hampstead Hill Gardens**

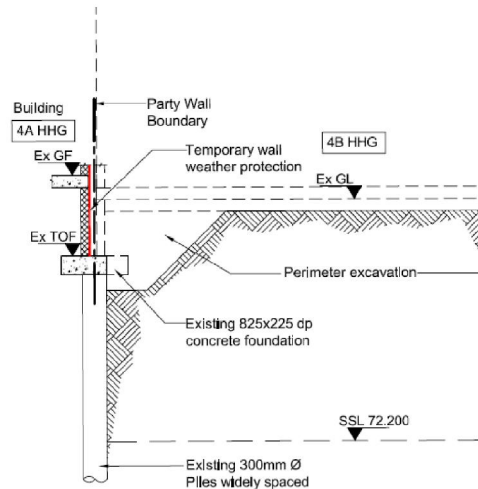
From the record drawings attached the existing property is founded on strip foundations 1ft 4½ deep bearing on short bored 8 inch dia (200mm) piles located at strategic points. The drawing does not show if the strip footings are reinforced but mentions that the piles are doweled into the strip footing with 2 x ½ inch dowel bars 24 inches long with 2 horizontal ½ inch bars 48 inches long over each pile. The piles extend 6½ feet below the formation of the strip footing so 9ft 6 inches (2.9m) below ground level. The strip footing seems to have step across it to accommodate the layout and is referenced on the plan with dig levels varying from 3½ feet to 4½ feet with thickness of the footing varying from 1½ feet to 1½ feet. This is not reflected in the Temporary Works proposals as below.

The current Temporary Works proposals show that the existing masonry walls built off the strip footings on the Party Wall line are to be retained but cut back to the Party wall line. As these walls retain the ground additional temporary works will be required to allow this to happen. In addition, the drawing incorrectly references the size of the piles (300mm) and thickness of foundation (225mm). The drawing also indicates that the piles extend significantly below the proposed Basement SSL which is not the case based

on the record drawings, which indicate a toe level at approximately 72.700, as described above.

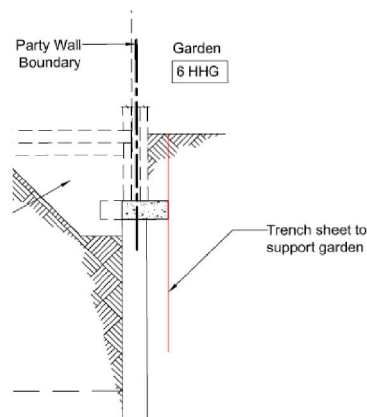
The cavity wall leaf is to be removed for the full height as noted in the stage drawing and waterproofing is to be provided. This will result in the remaining part of the cavity wall having to resist the wind loads that it has not been subjected to previously and where as one could expect a cavity wall to withstand the wind load on a floor by floor basis this is not the case in this situation. The condition of the wall is not known and nor is the adequacy of any tie in of the wall into the floors which is required to resist any wind load, so the assumption made that no damage will be caused is suspect. This is a major flaw in the planning of the work which will put 4a at risk both during the demolition phase when one leaf is removed but also in the longer term during construction under wind and stability loading for an unknown period of time or season. In addition the construction of the wall below DPC is shown on the record drawings as both cavity and solid construction. To reduce a solid wall thickness by half over a significant length will inevitably create damage to the retained portion of the party wall.
