Applications relating to 14 Monmouth Street, London WC2H 9HB – Revised Scheme.

Appendix 1 – Photos of flooring

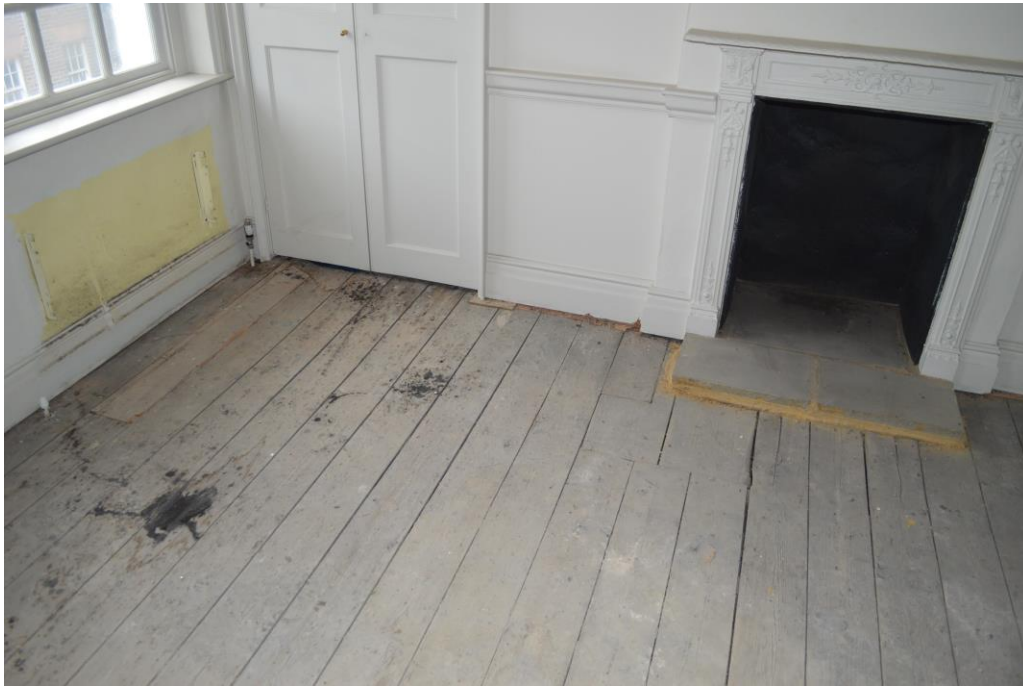
Third floor front room - 19th or 20th century narrow boards throughout

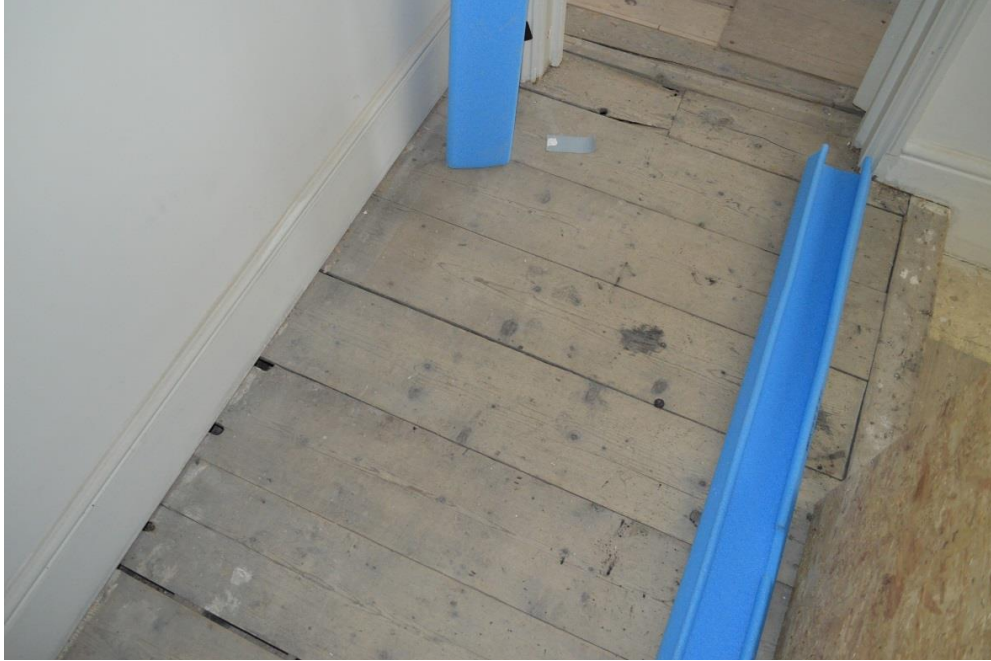
Third floor landing – 19th or 20th century narrow boards.

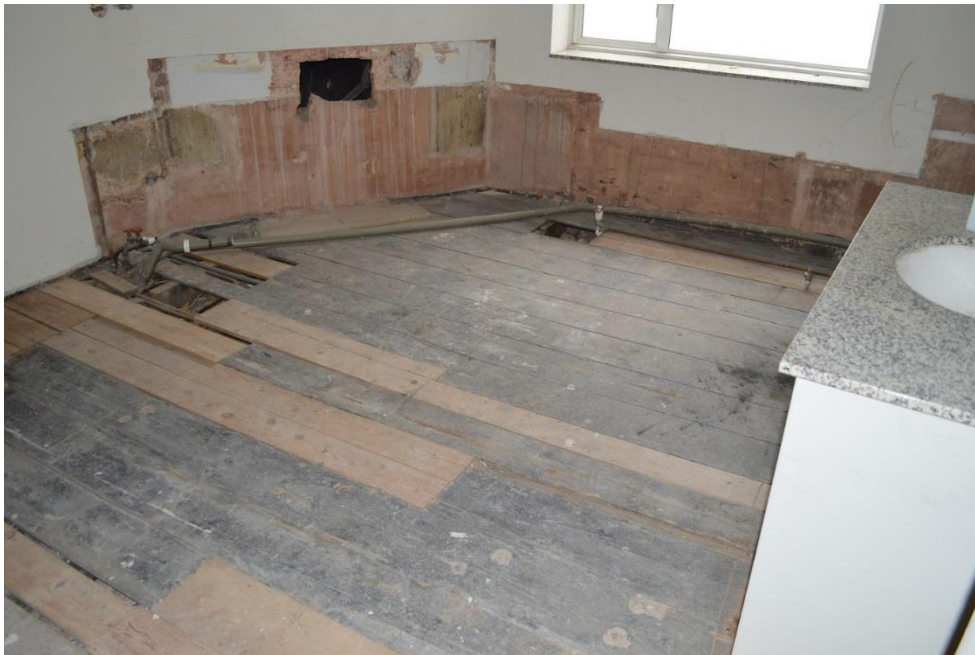
Third floor bathroom – a few possibly original boards but mixed with modern boards and 19th or 20th century boards.

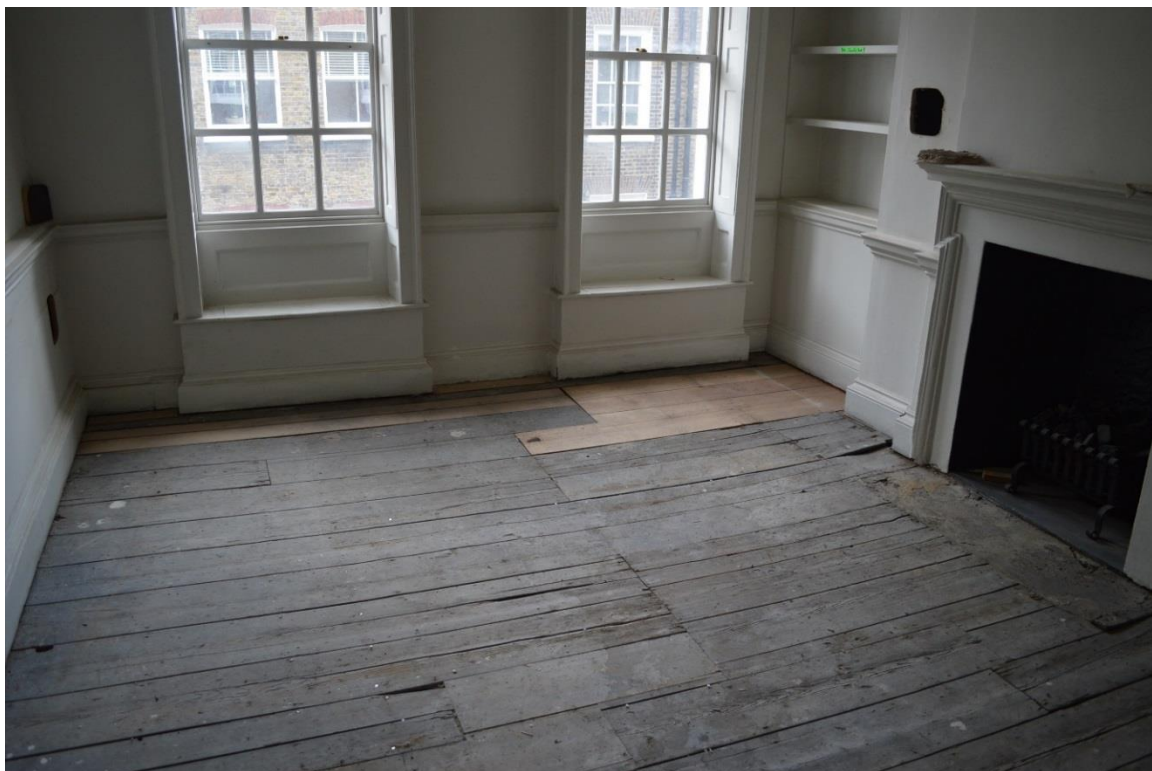
Second floor front room - possibly original Georgian boards but in poor condition. A small section of modern boards towards the windows on the front elevation.

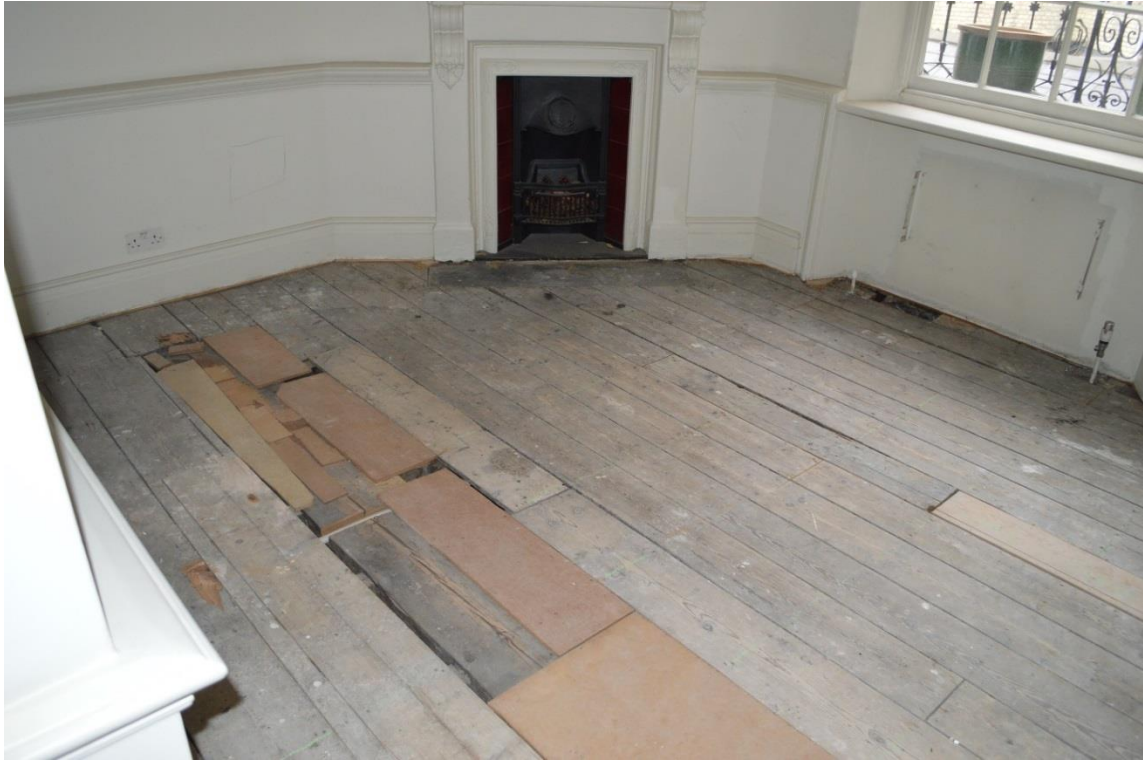
Second floor rear bedroom - narrow 19th / 20th century boards, a few wider, possibly Georgian boards at entrance to room, see below.

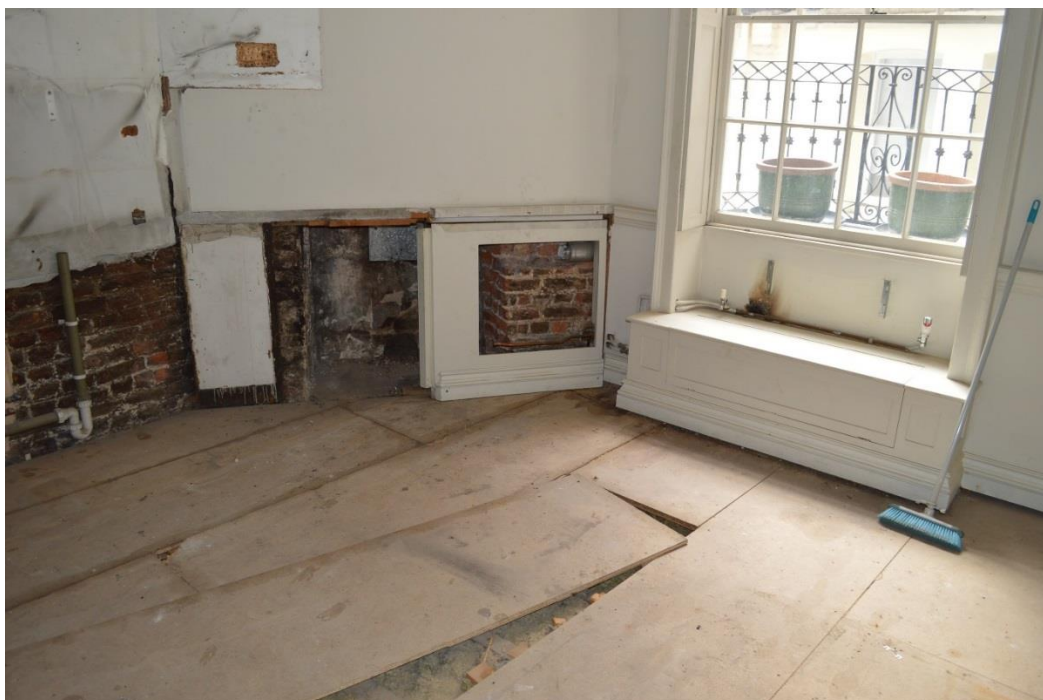
First floor kitchen – whole room is chipboard. No boards retained beneath.

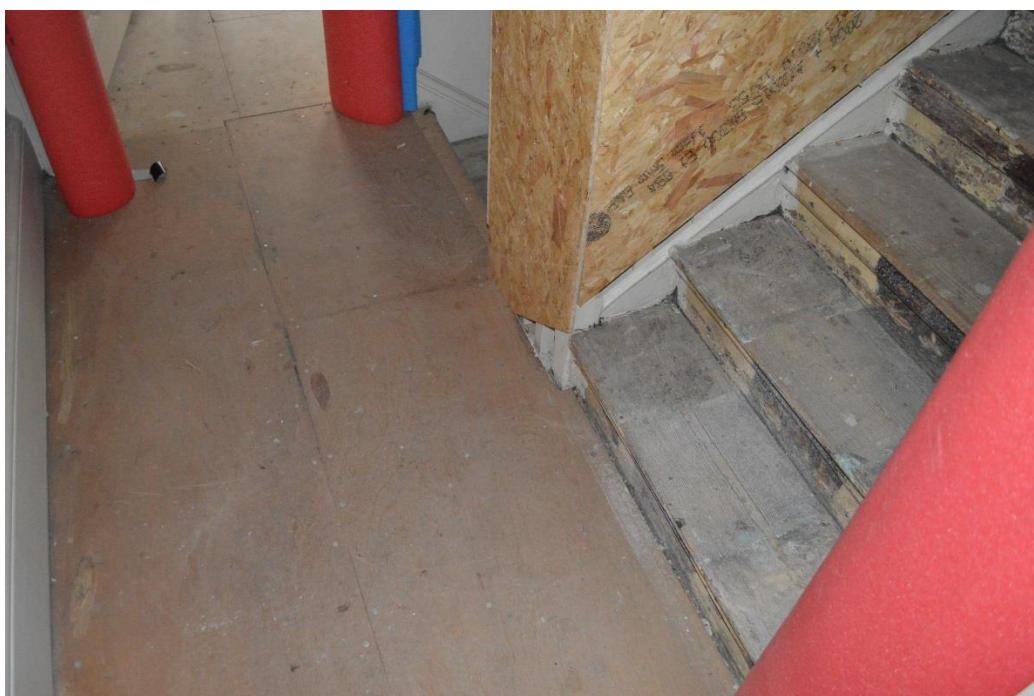
First floor hall - chipboard

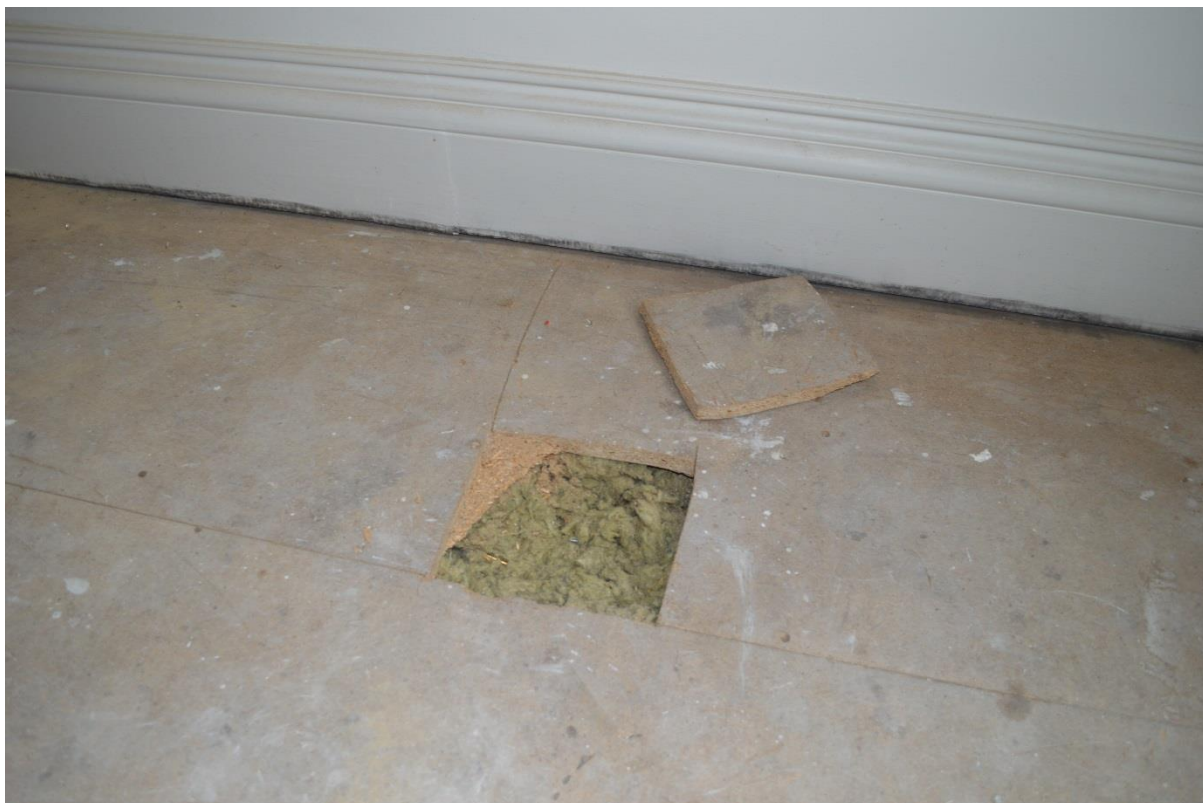
First floor front room- chipboard. No boards retained beneath.

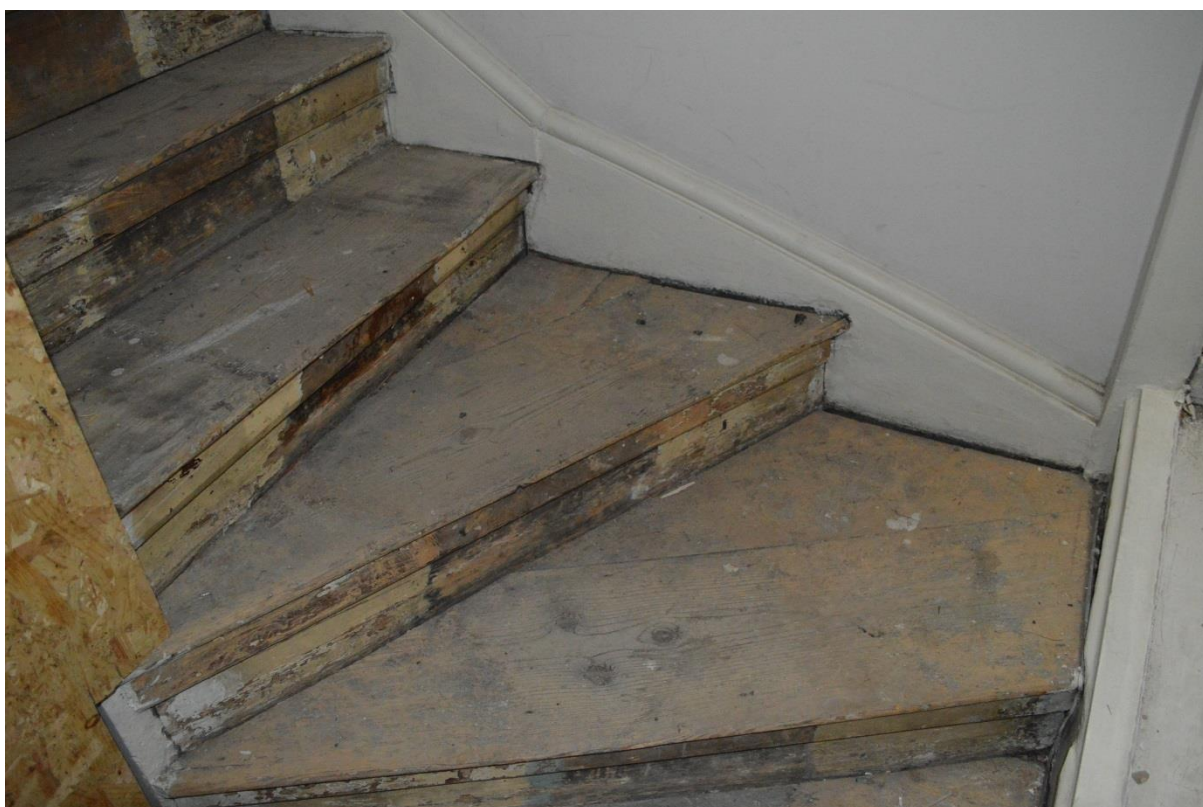
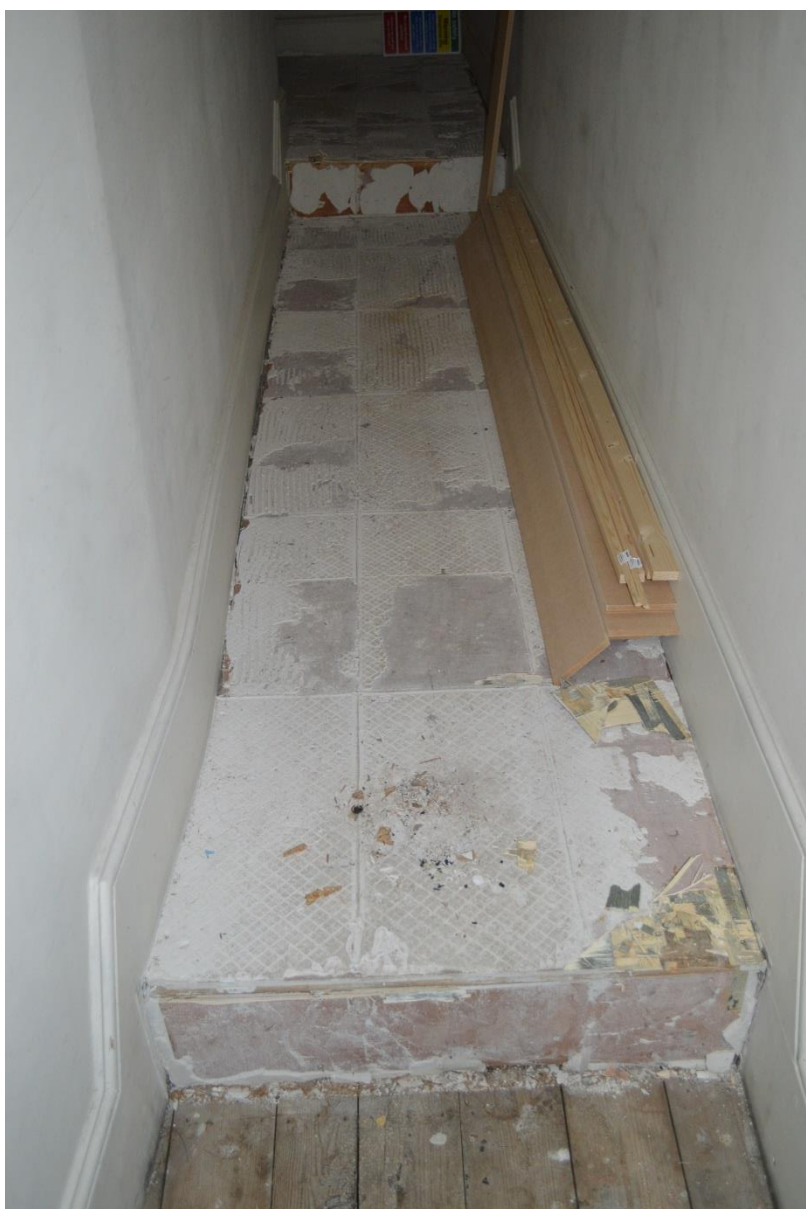
Entrance hall - modern narrow boards.
