PHOTOGRAPHS OF EXISTING CHAMBERS

(as of 09 September 2019)

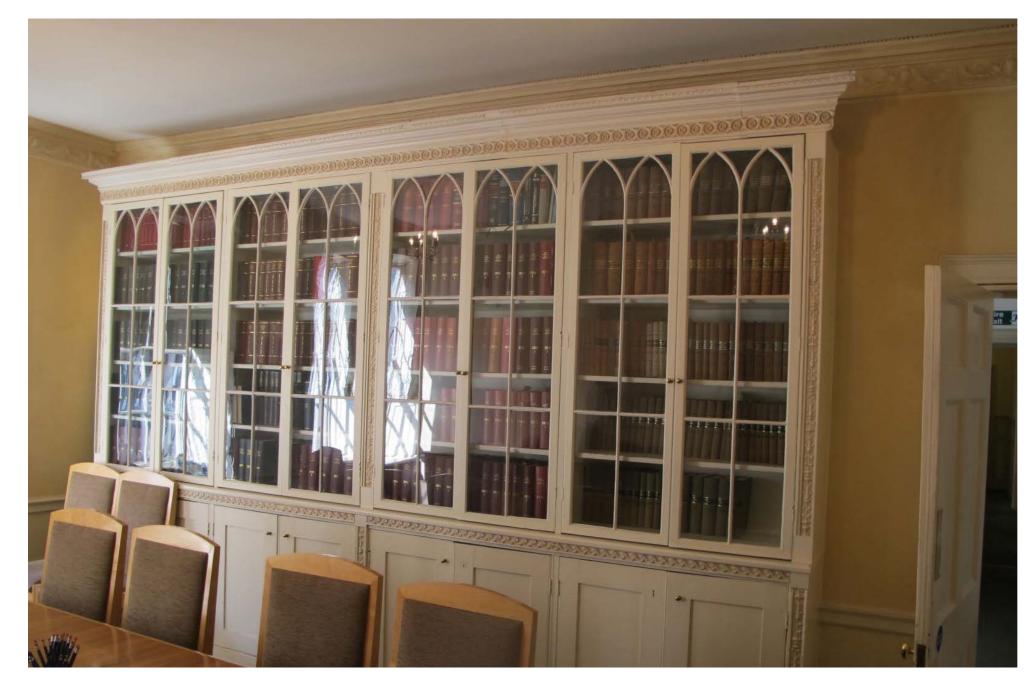
Fig. 1.1 Existing Bookshelf to be removed

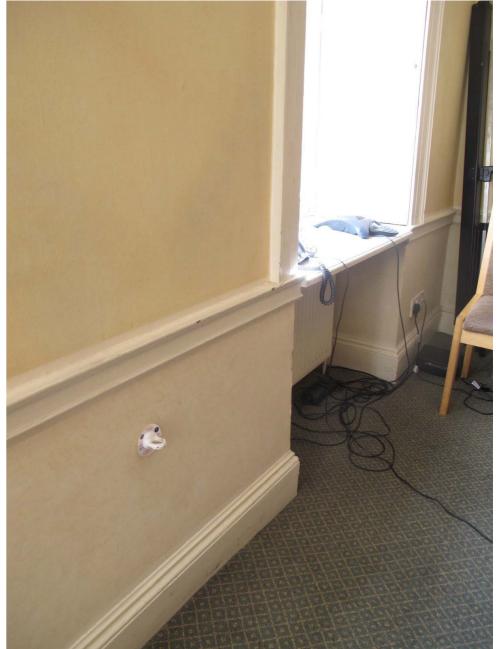
Fig. 1.2 Existing Dado and Skirting Board

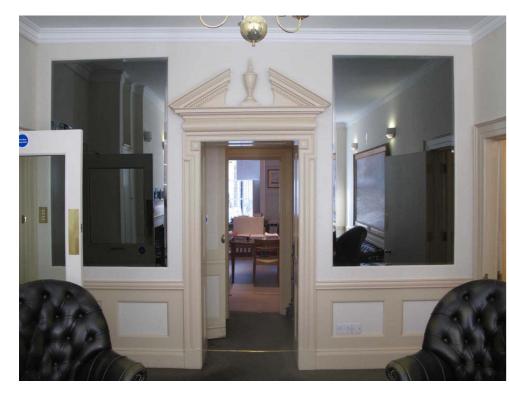
Fig. 2.1 Elevation 01 as existing

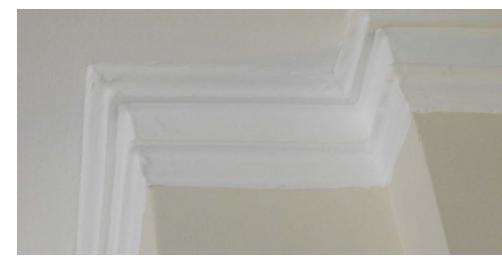
Fig. 2.2 Existing cornice moulding

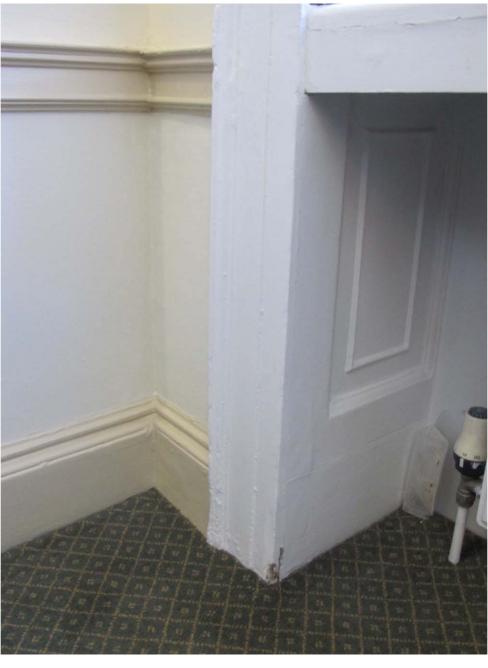
Fig. 2.3 Existing dado and skirting board

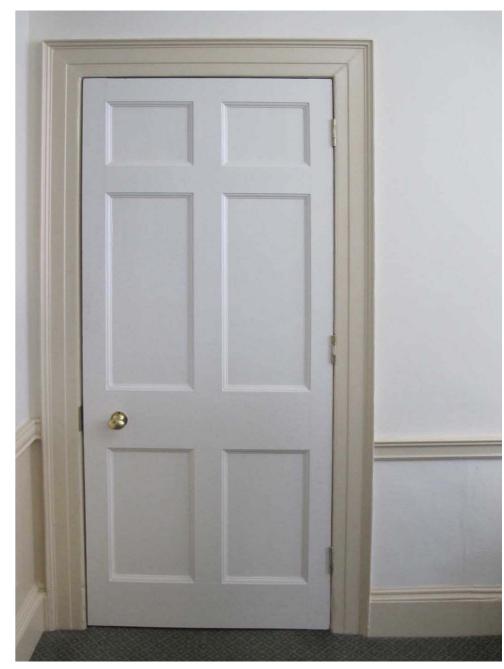
Fig. 2.4 Existing Door D02 with architrave

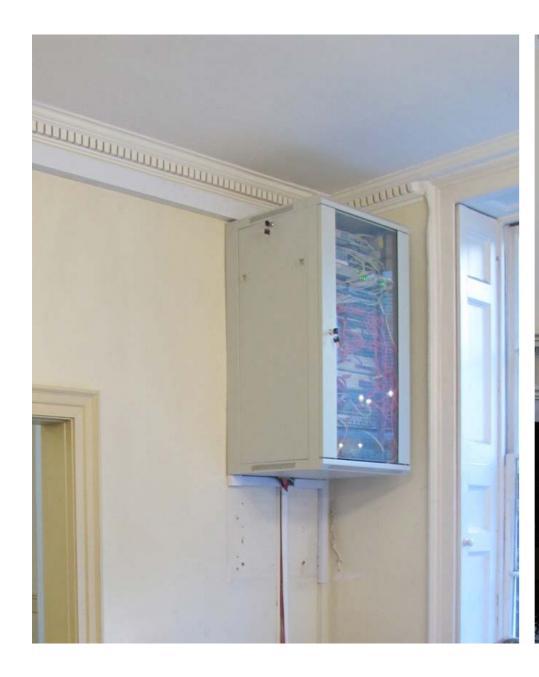
Fig. 4.1 Existing data box

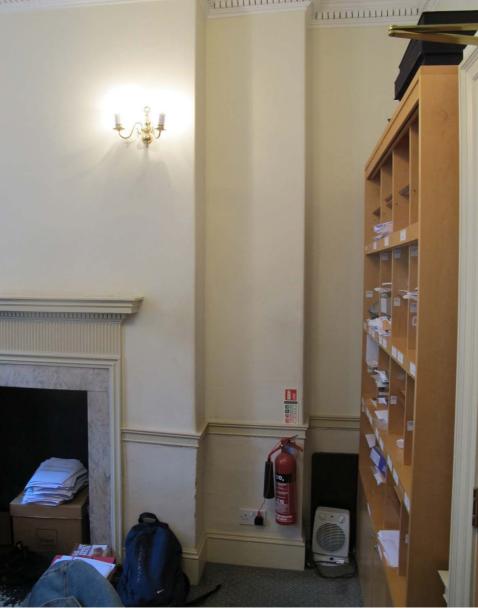
Fig. 4.2 Existing freestanding bookcase to be removed

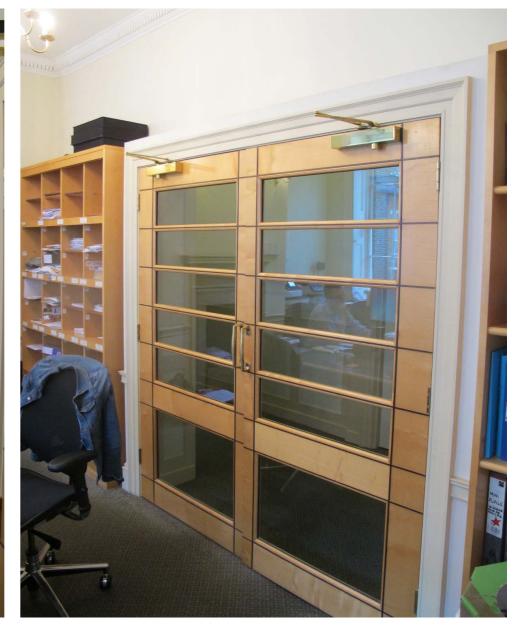
Fig. 4.3 Existing freestanding bookcase on far left to be removed

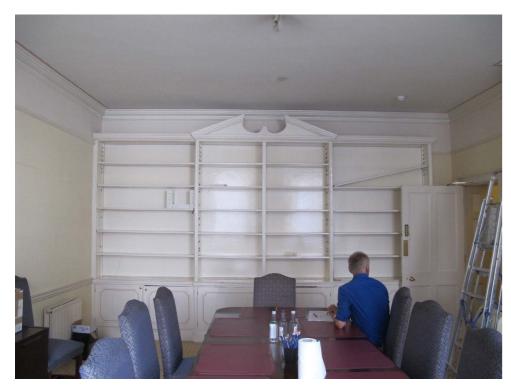
Fig. 5.1 Existing bookshelf

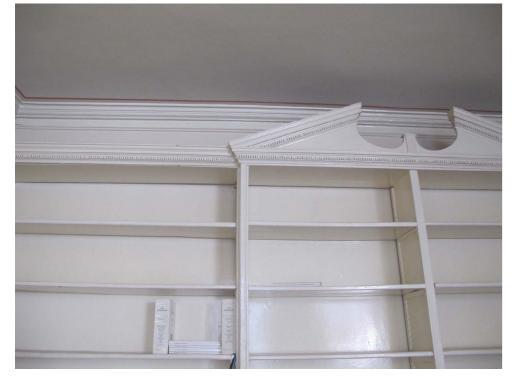
Fig. 5.2 Existing bookshelf detail

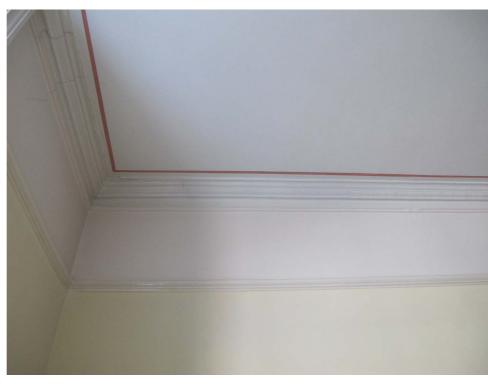
Fig. 5.3 Existing picture rail and cornice

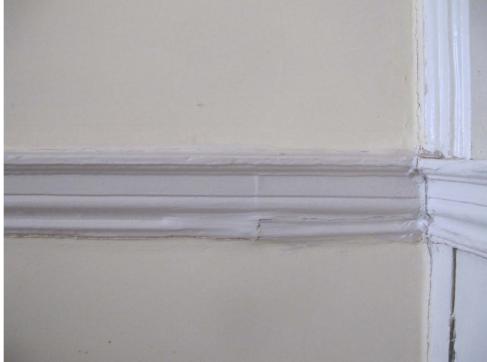
Fig. 5.4 Existing dado rail

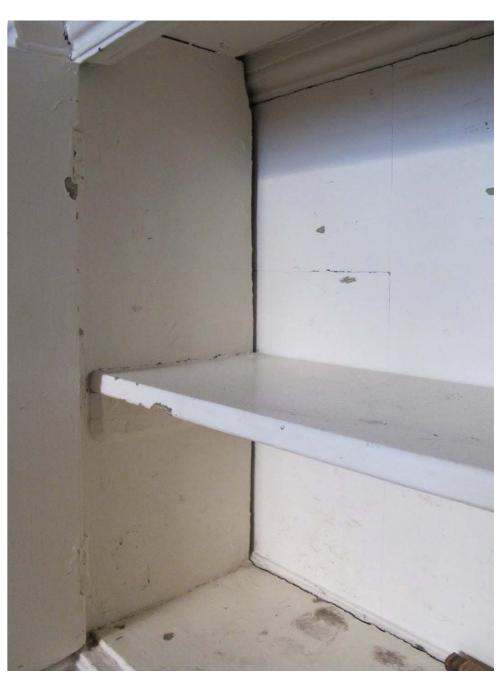
Fig. 5.5 Existing bookshelf showing retained dado rail

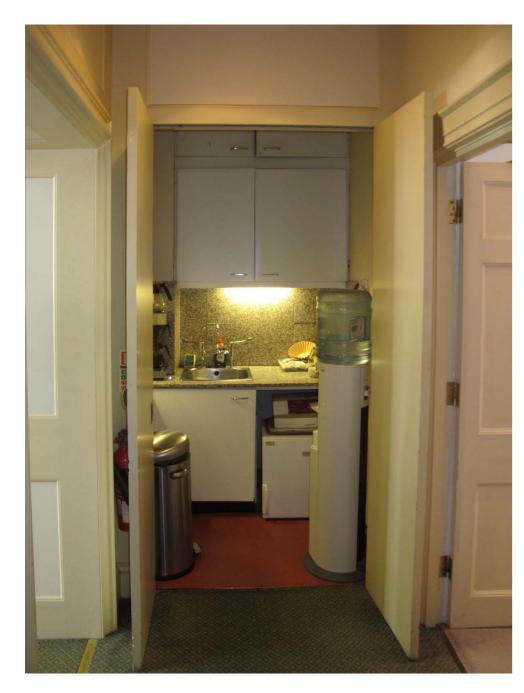
Fig. 8.1 Existing kitchenette

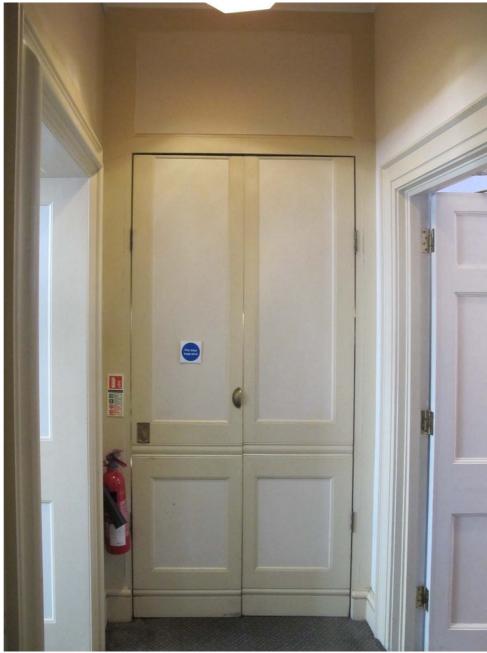
Fig. 8.2

Existing kitchenette doors

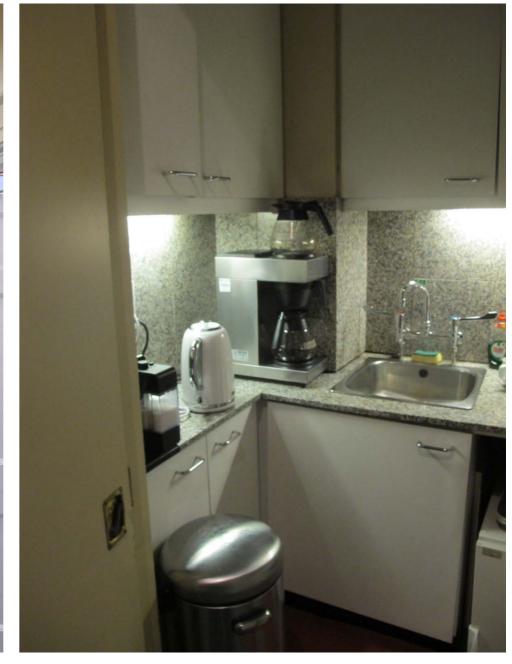
Fig. 8.3 Existing kitchenette cupboards

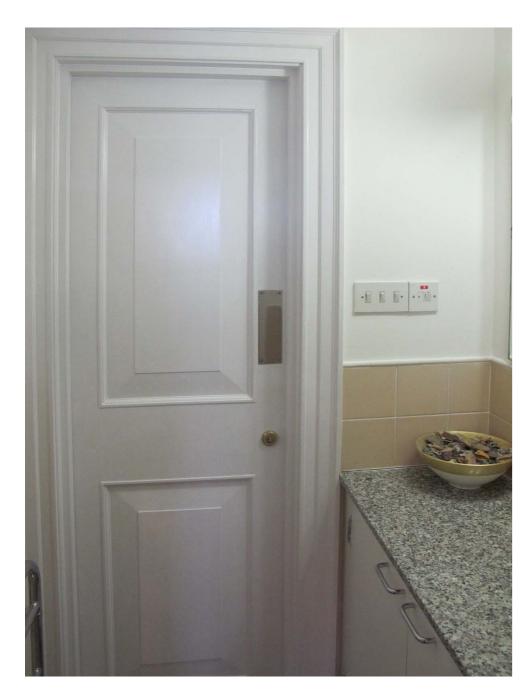
Fig. 10.1 Existing WC door

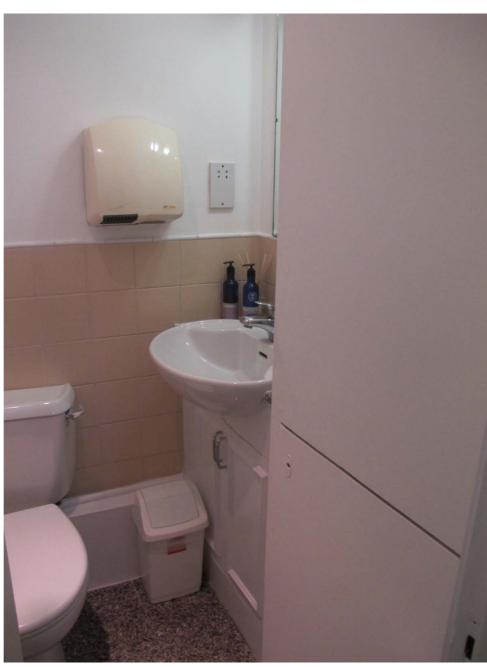
Fig. 10.2 Existing WC

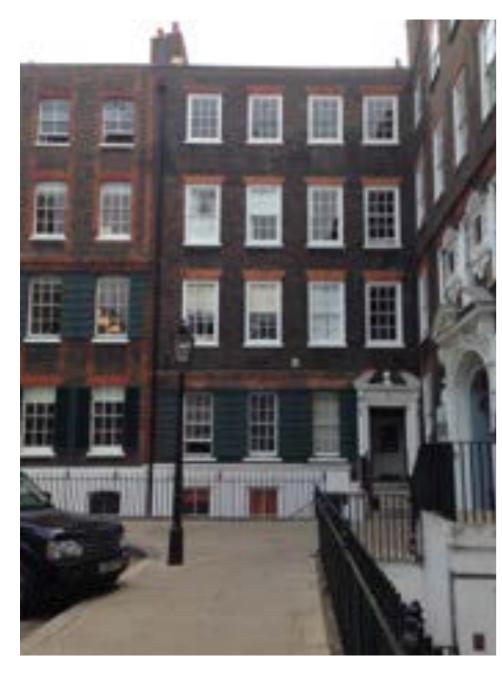
Fig. 11.1 External Elevation from New Square

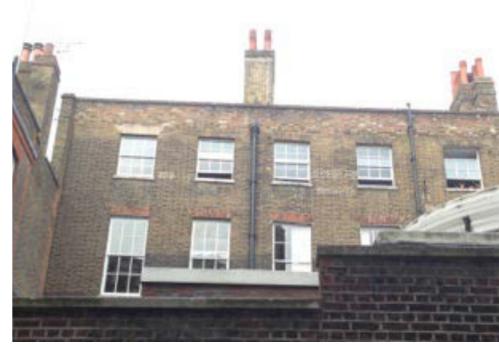
Fig. 11.2 External Elevation from Carey Street
