BS5837 Arboricultural Impact Assessment

3/3a Frognal Gardens, Hampstead, London, NW3 6UY

Client: Alexander Martin Architects

Job Reference: 03124Rv4

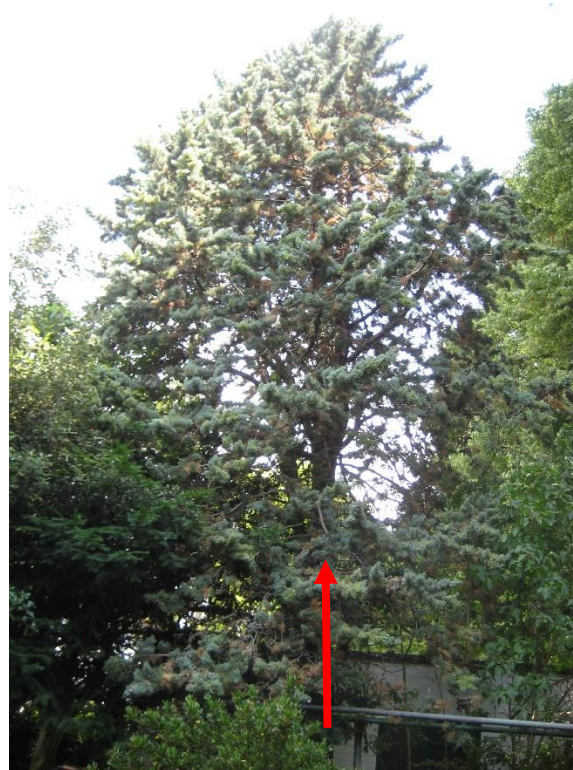
5.3.1 The proposal requires the removal of T5 (Cypress). The overall amenity of this tree is considered limited given its position and the retention of all other site trees. The density of the existing tree stock limits scope for replacement planting works. T12 (Plum) is also proposed for removal.

Fig 1 – T5 (Cypress) indicated above and shown on the plans at Appendix 4 & 5 will be removed.

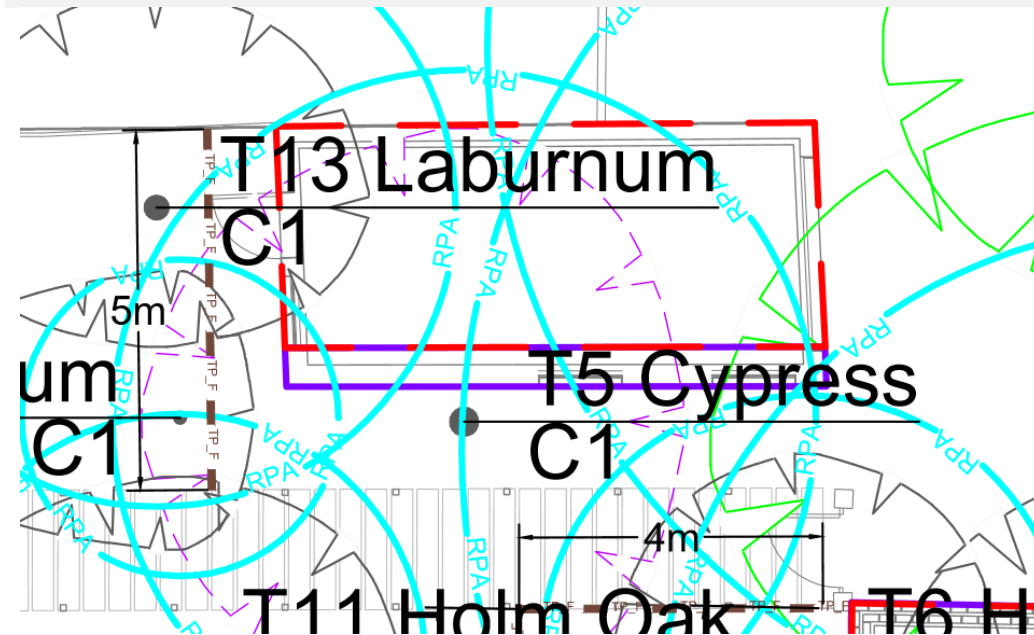
Foundations

- Existing footings of both buildings retained.
- Extended for Building A (left).
- All works within RPA's undertaken by hand.
- Any 'wet pour' areas to be lined prior to concrete pour to remove risk of root to concrete contact.

LOW/MEDIUM

5.4.4 The existing footings are retained and enhanced with careful hand digging where excavations are within the RPA.

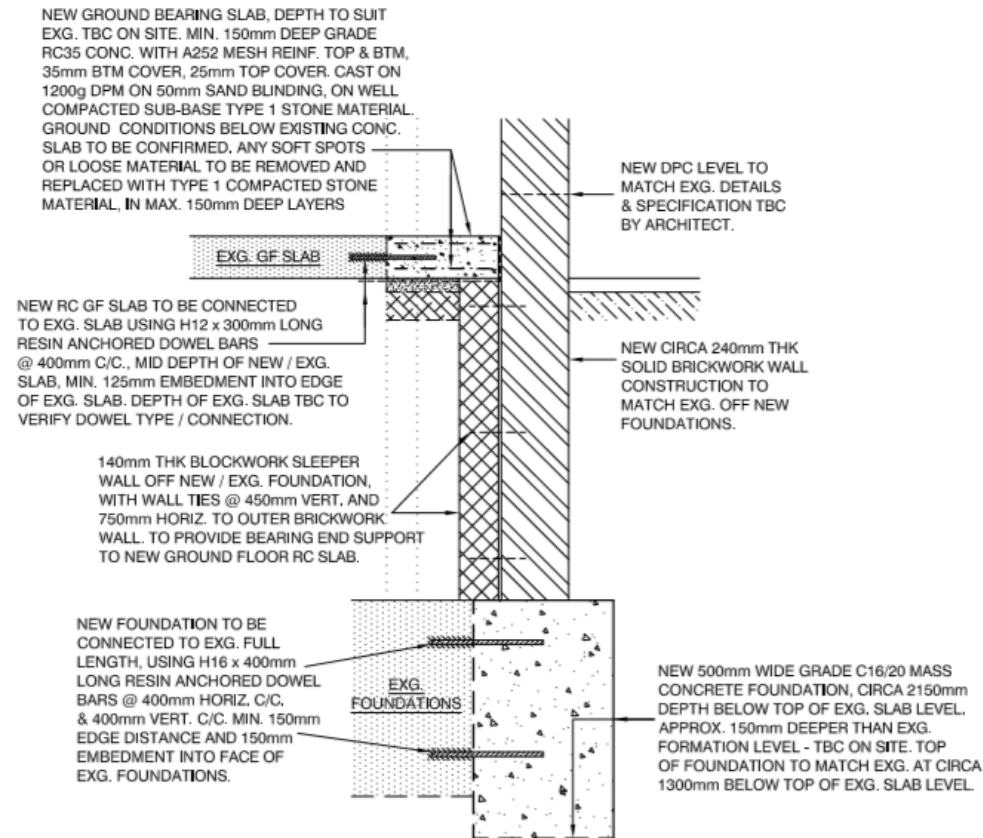
Fig 3 – The footings tie into the existing footing as indicated above. Any excavation work is completed by hand and all excavations are lined with non-permeable membrane prior to a concrete pour to remove the risk of root to concrete contact. Excavations to be subject to site inspection.

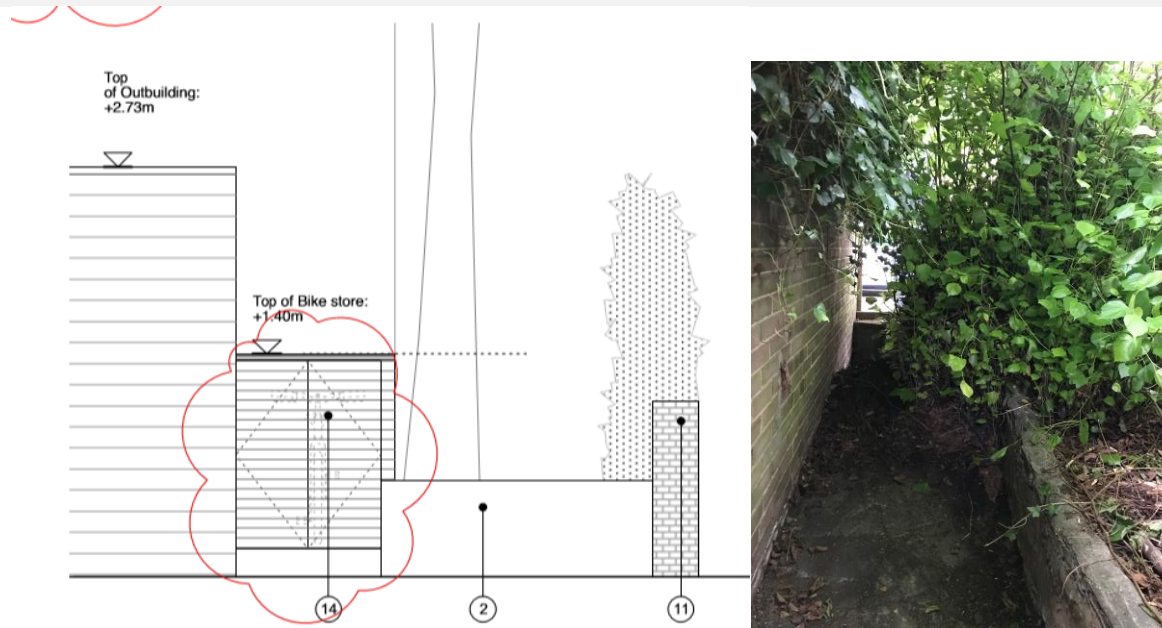
Bike Store / Foundations

- *Built on existing concrete base visible in image (left).*
- *Existing low wall retained.*
- *Timber construction.*
- *No ground excavation required.*

LOW

5.4.10 Further to representations from the local authority the bin store close to T2 has been removed completely and the bike store rotated. This means the bike store can now be accommodated on the existing hard surface in the area it is proposed and the low wall and ground levels close to T2 can be maintained.

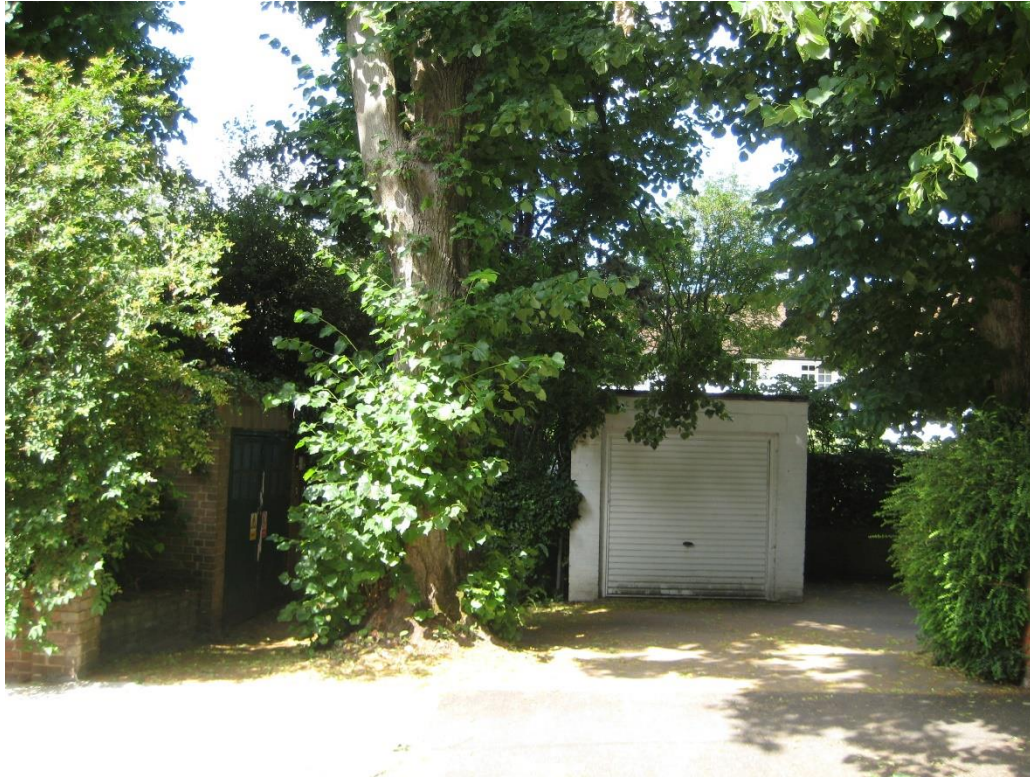
- *Existing hard surface access to the garage and garden room removes risk of adverse ground compression.*
- *Lower stem of T3 is visible and will be basally shuttered prior to any on site works.*
- *Removal of epicormic growth from lower 2m of stems on T2 & T3 proposed.*
- *Area suitable for material storage. No materials to be stored on soft 'open ground'.*

Fig 6 – Site access is already existing hard surface through the RPA of T2, T3 & T4

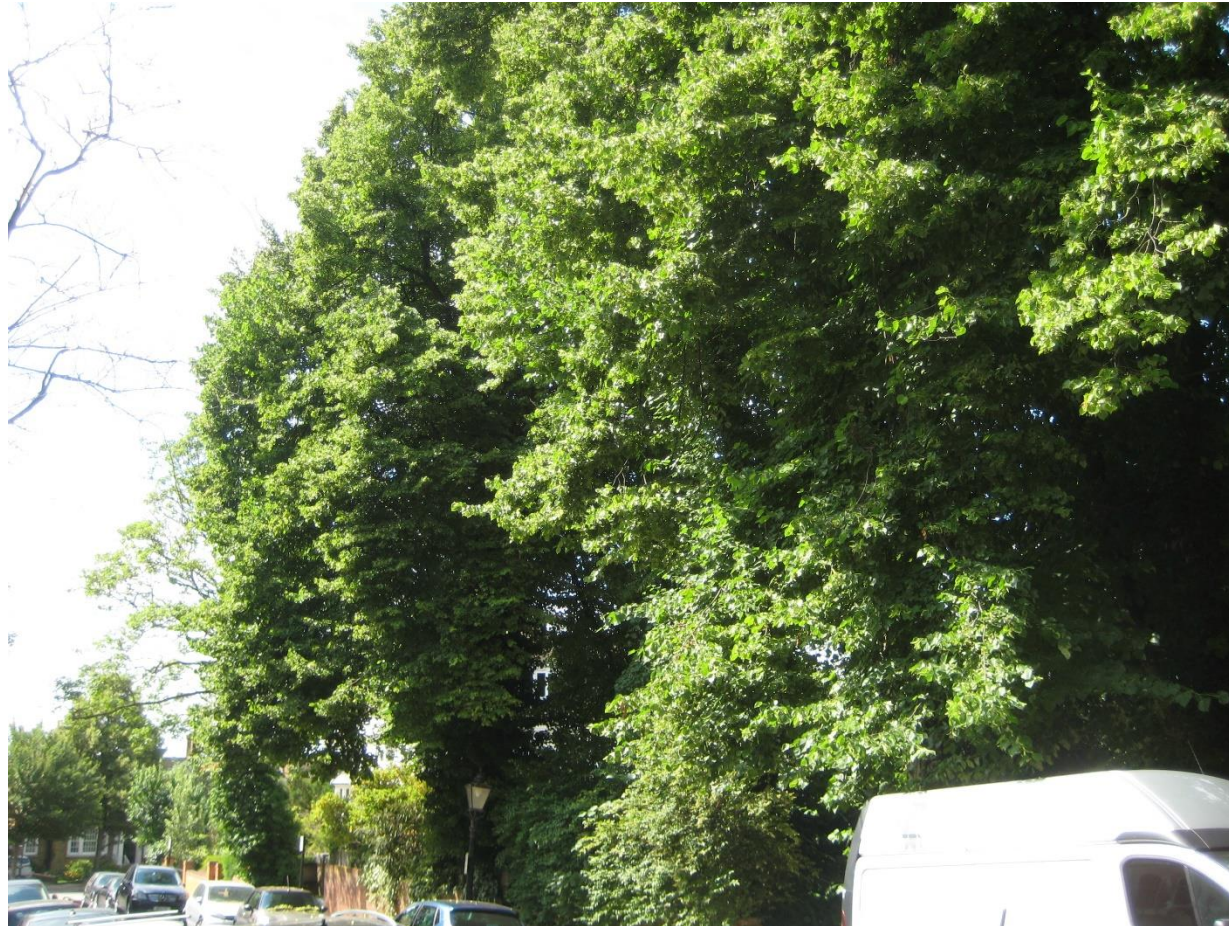
Image 1 – The Limes (T1, T3 & T4) offer amenity to Frogna Gardens

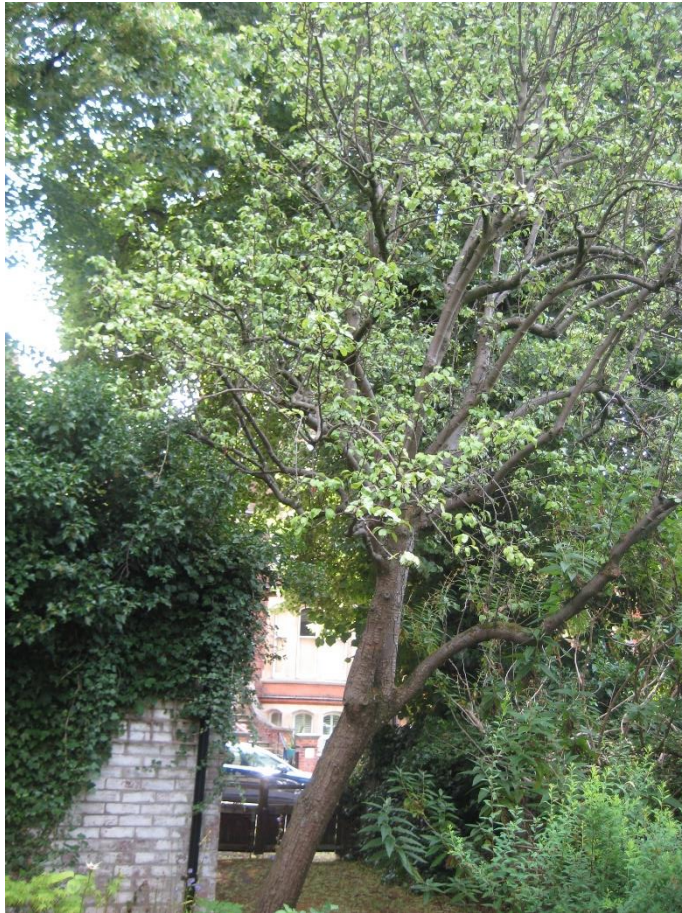
Image 2 – T7 Pear close to the Garden Room, the footing is retained as this tree may be ‘braced’ below it

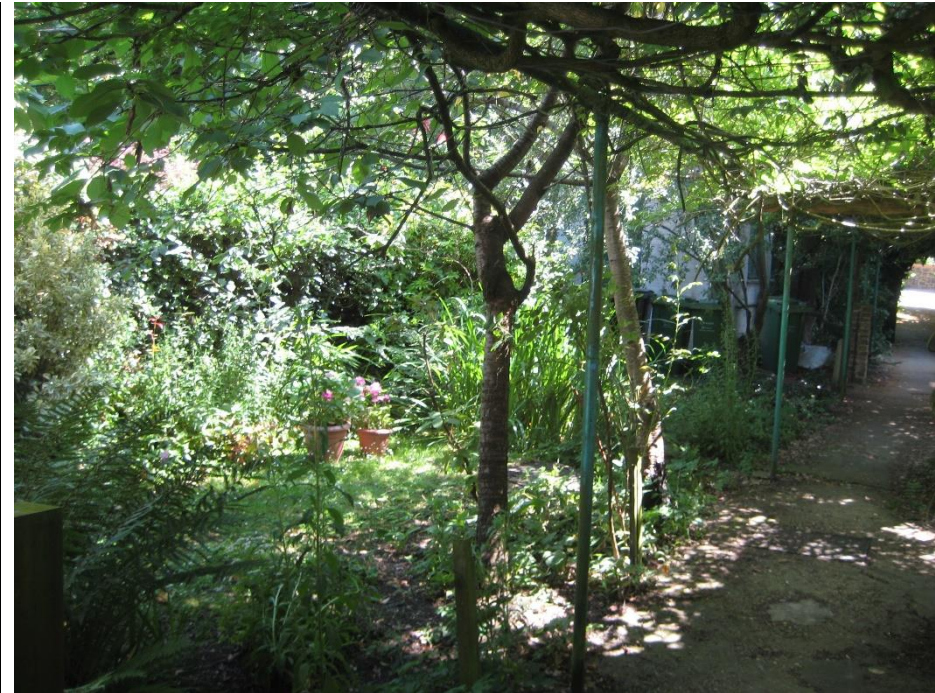
Looking east from the main property – the garden has many trees and shrubs present. Careful planning of material delivery/ storage is required.
