42 Bedford Square

*Proposed External Cleaning to
13 Bedford Avenue
August 2020*

Rev A 18th August 2020, Introduction updated

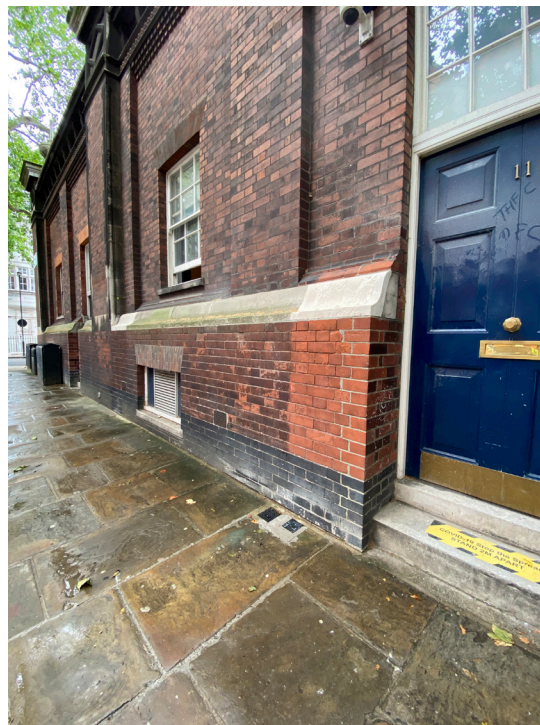
11 Bedford Avenue showing TORC/JOS cleaning system sample

The results indicate that the wet air-abrasion TORC/JOS cleaning sample is the most appropriate. Therefore this method is proposed. Nozzles and pressures to be as sample clean. Heavily soiled areas to be reviewed after initial clean to agree if further cleaning is required.

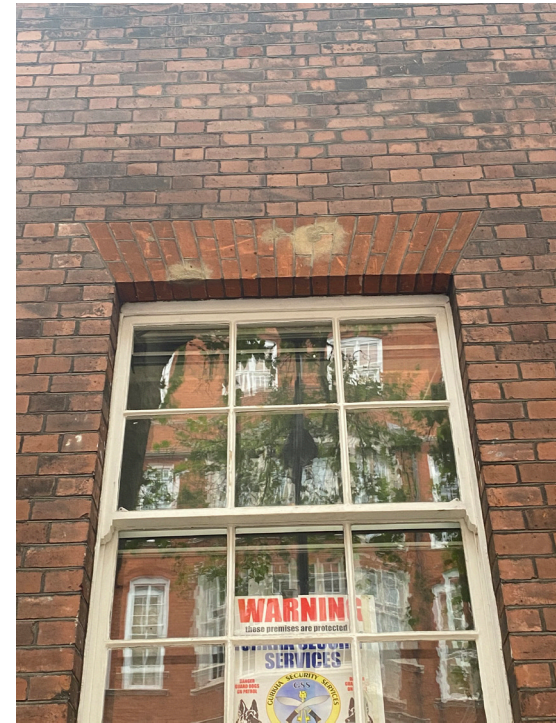
Ground Floor Window

Cement mortar to be removed to assess works required

Minor areas of defective brick are to be cut back on individual bricks and repaired with lime mortar coloured to match existing brick. Cement mortar to headers above ground floor window (far right image) is to be carefully removed for inspection, it may be necessary to cut out and replace individual red facing bricks to match existing bedded in lime mortar.
