# Arboricultural Appraisal Report

Impact Assessment & Method Statement to Inform Development

39 Maresfield Gardens  
London  
NW3 5SG

CLIENT:	Schneider Designers
MWA REF:	DEV200814-558
MWA CONSULTANT:	Mark Bisley <small>BSc Hons</small>
REPORT DATE:	04-09-2020

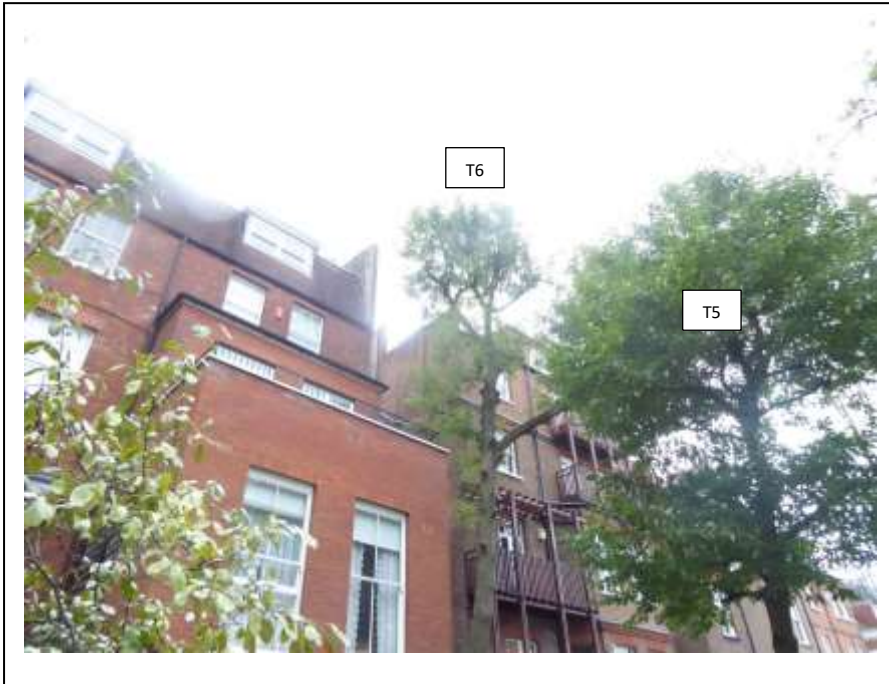
- 5.4 T6 was assigned category U due to the presence of *Perenniporia fraxinea* at base which can result in collapse of the tree in advanced cases. Being offsite this tree will still form a constraint unless permission is given for its removal. All of the remaining surveyed specimens were considered to be worthy category C.

- 6.9 A tall ash is present close to the dwellings in the garden to the south. This has surface roots which extend into the subject property and these are likely to have suffered damage / pruning in the past in relation to adjacent hard landscaping. The tree has also been heavily reduced to clear the buildings and is currently unbalanced with a single large limb over the adjacent garden.

View of T6

- 6.11 This assessment was made for development and should not constitute a full health and safety assessment of the ash, but based on the information gathered during our survey we would recommend that the ash is removed or at least subject to a more detailed inspection.

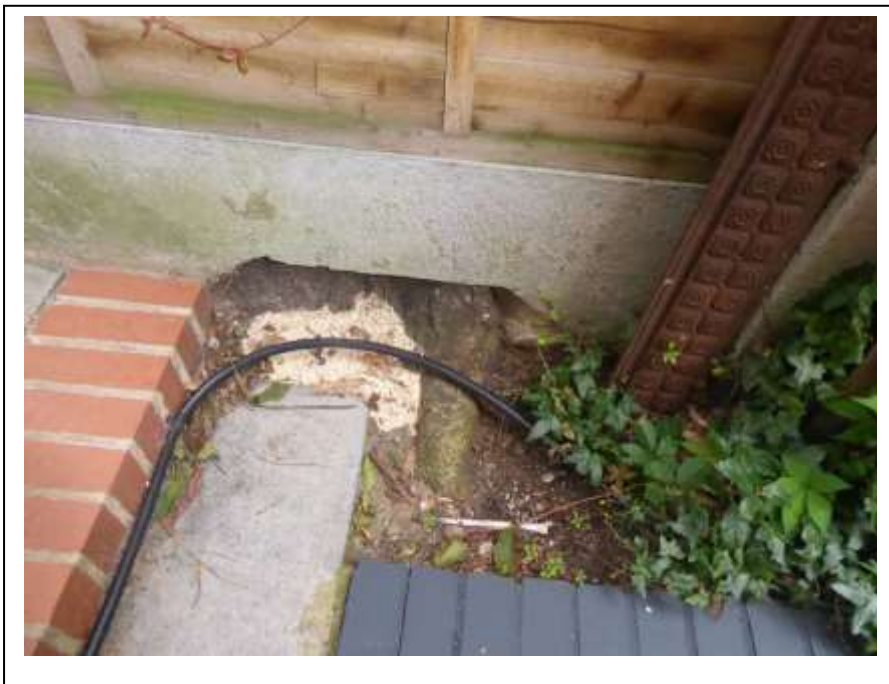
- 6.10 This ash has two areas of concern high concern. The first is a fungal fruiting body at base which is consistent in appearance with *Perenniporia fraxinea*, a fungus that is known to affect the roots and base of the stem and can cause stem breakage or uprooting. Of lower concern is an old *Inonotus hispidus* bracket on the main stem. This could not be viewed clearly from the subject garden but appeared to be associated with old pruning wounds. Ash can survive for many years with this species but in an advanced case this fungus can cause sufficient decay to cause the stem to break.

View of fungal body at base of T6
