APPENDIX 3: DRYING OUT WORKS- SCOPE AND EXTENT OF WORKS

Site Note 7: Preliminary Damp Condition Investigation (Masonry)- March 2020

Site Note 7: Preliminary Damp Condition Investigation (Masonry)

The Hope Project (KOKO): Phase 1 of the preliminary damp condition Investigation

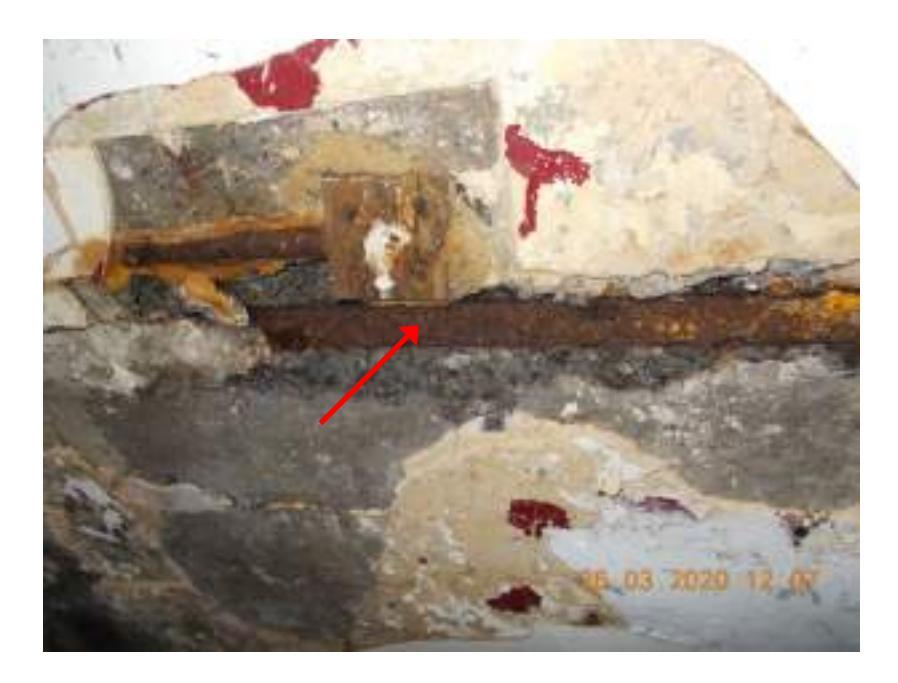
Fig 6:

Interior, escape stair on north side, RM.2-24; showing damage to wall and ceiling structures where recent water penetration had drained through the soffit from roof level and exasperated/ accelerated conditions for decay

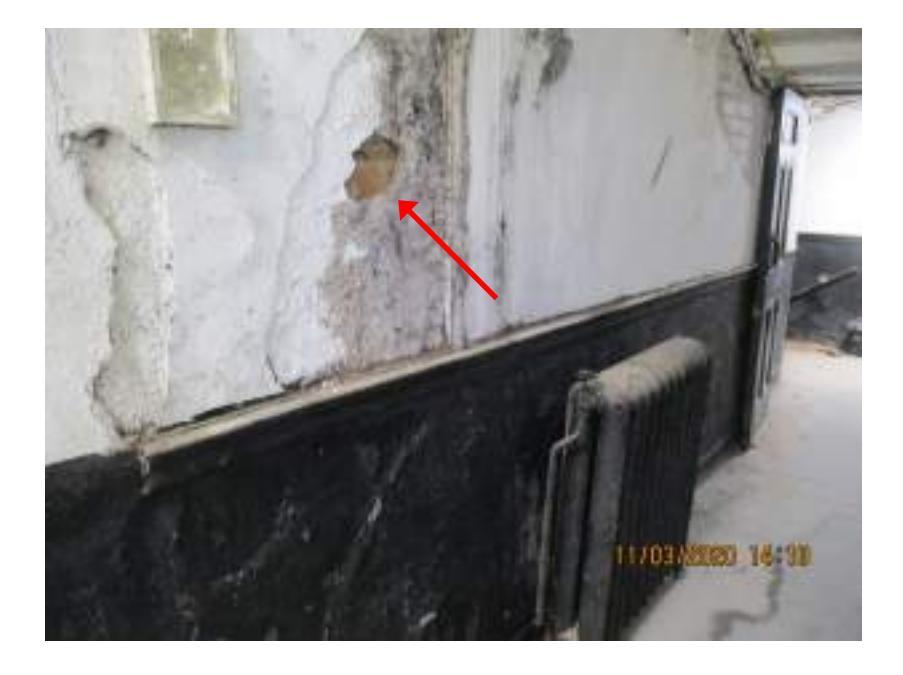
Fig 8:

First floor escape stair on south side, accessed from RM.1-10; showing surface mould growth sustained by enhanced humidity and restricted through ventilation exasperated by the retained moisture within the fabric of the property from the recent substantial water penetration

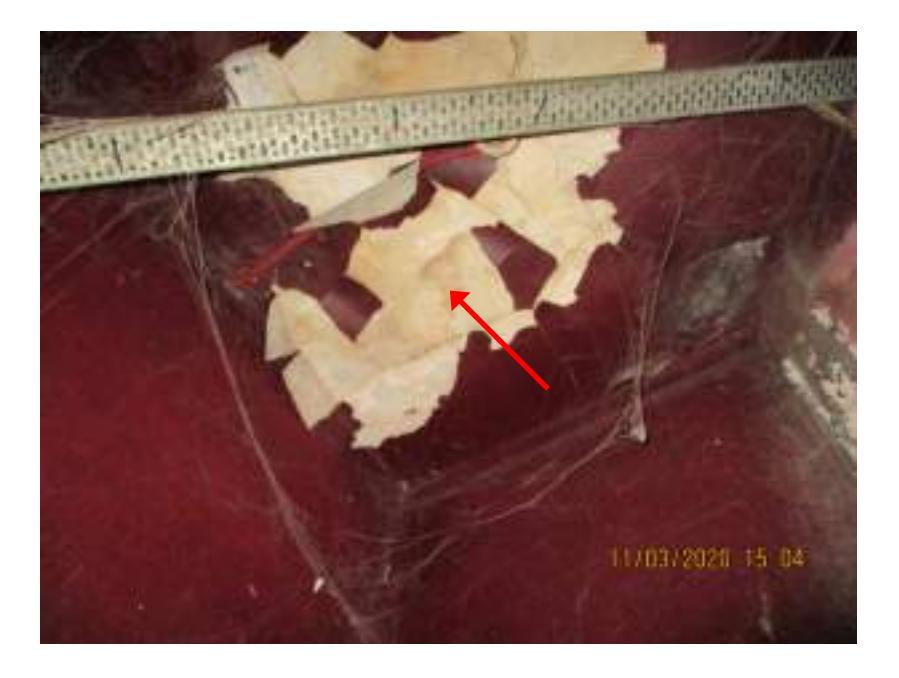
Fig 10:

Escape stair, north side, RM.G-24; showing typical failure of impermeable paint finishes following recent chronic intermittent condensation

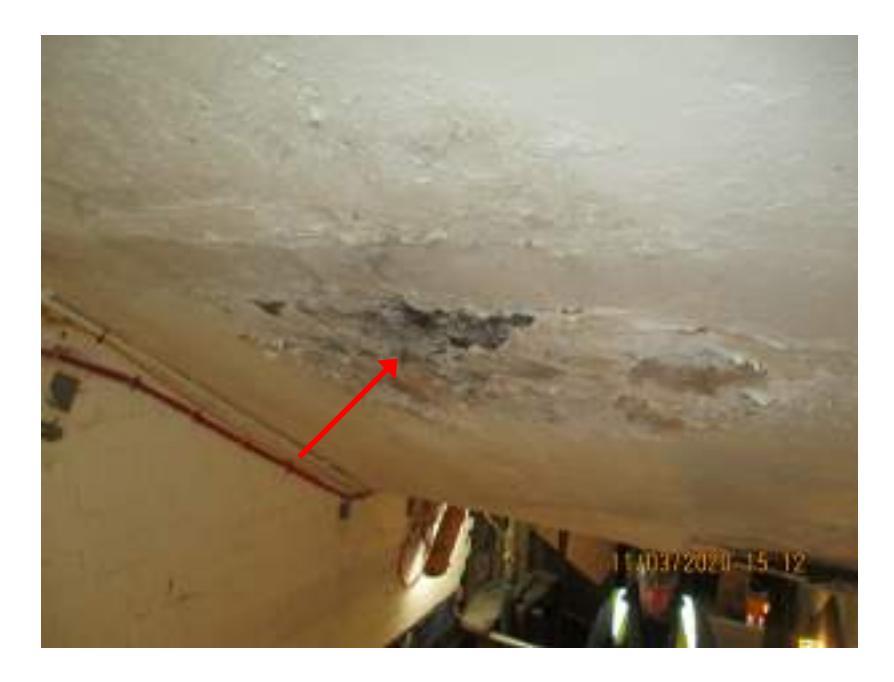
Fig 12:

Escape stair at ground floor level on south side, RM.G-07; showing historic corrosion of embedded steel structure and salt efflorescence damage to ceiling and wall finishes now substantially exasperated and accelerated by recent fire related moisture penetration

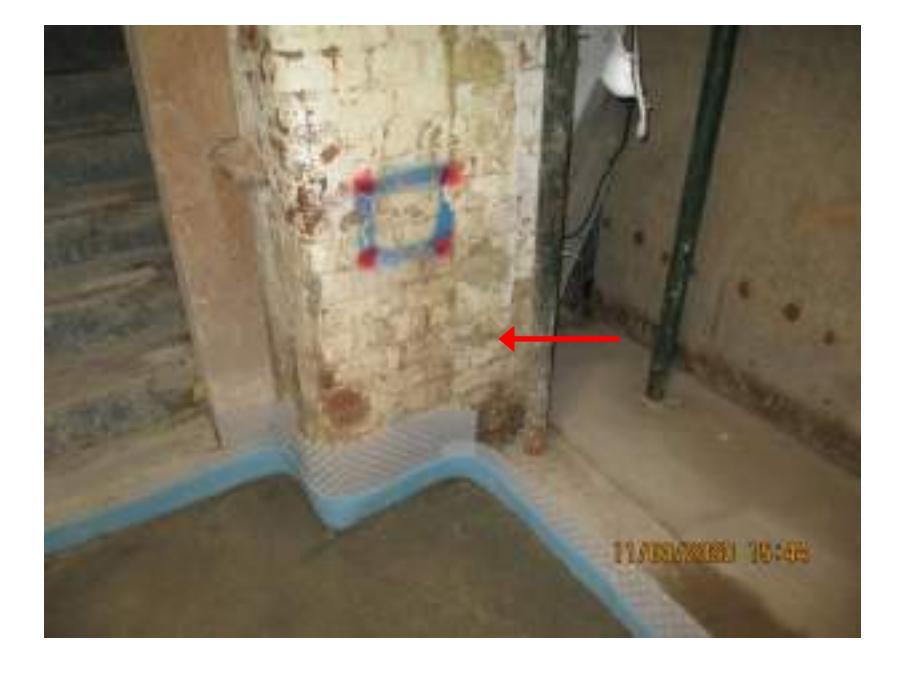
Fig 16:

Basement, east side, RM.B-18; showing persistently damp conditions at low level where recent moisture penetration had collected/migrated at lower levels

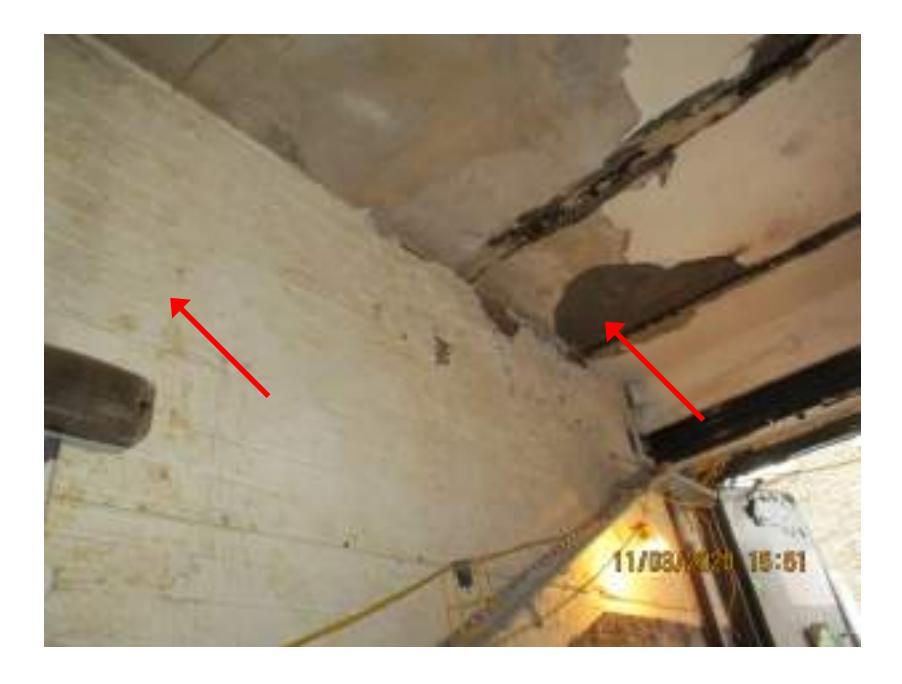
Fig 18:

Escape and service corridor on ground floor north side, DG-18; showing surface efflorescence of hygroscopic salts in areas that also show high residual moisture contents in brickwork. Area highly likely to be exasperated by negative conditions brought on by migrating moisture from the recent fire related water penetration

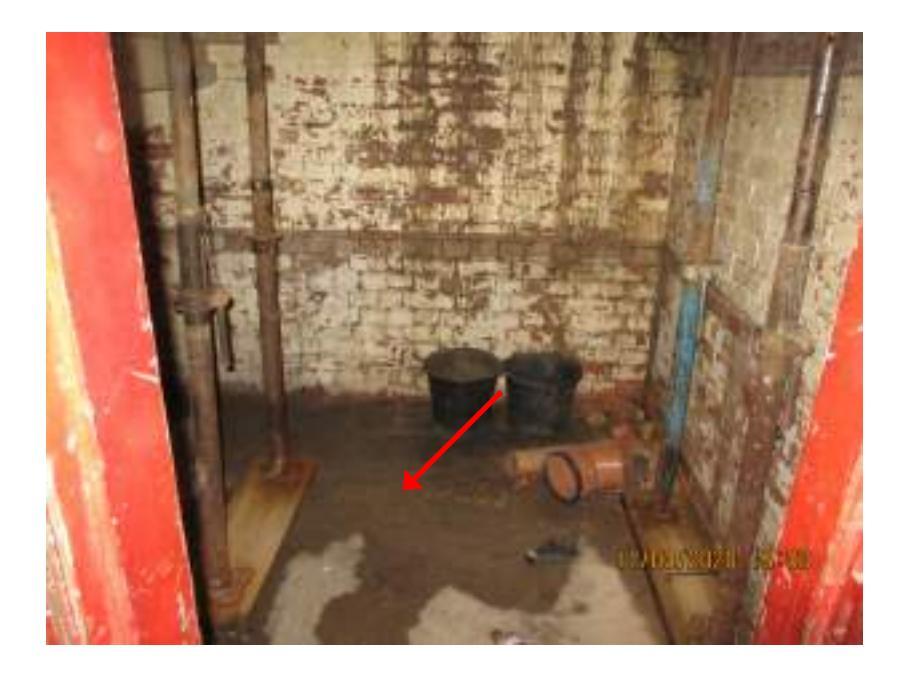
Fig 20:

Fire escape on north side, RM.B-40; showing salt and water damage to impermeable paint finishes trapping moisture within the masonry elements subject to chronic recent moisture penetration

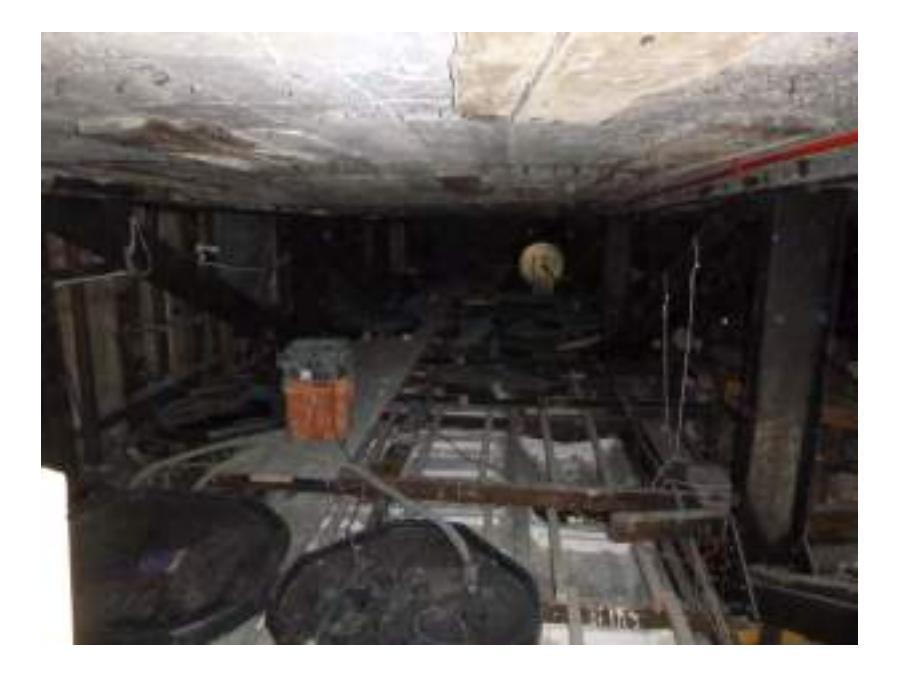
Fig 2:

Auditorium ceiling structures; showing general view from below looking south. Note west area inaccessible from below and supported with scaffold structures, historic plaster understood to be severely damaged to this area

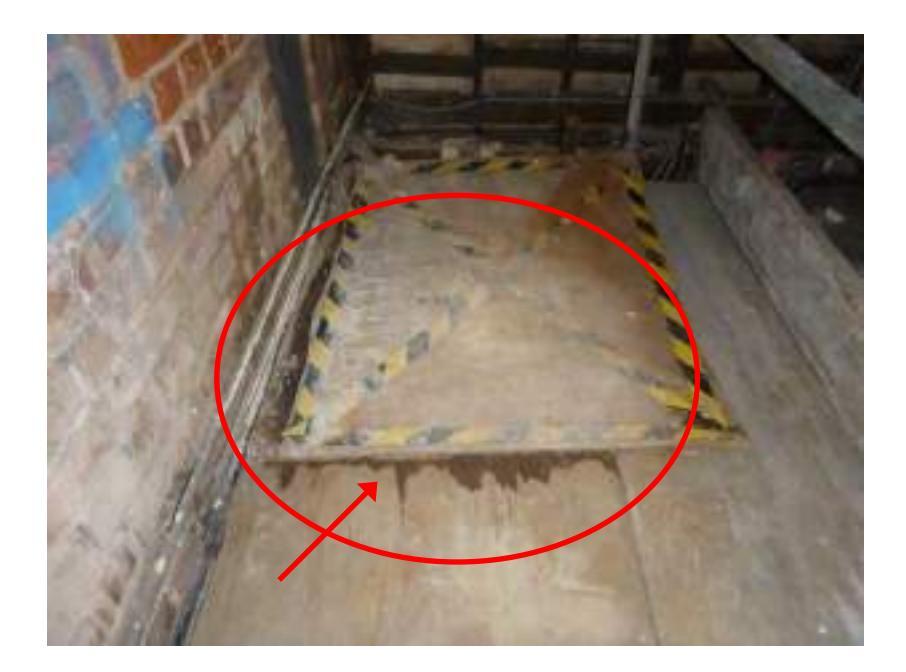
Fig 3:

Auditorium ceiling structures; showing structural deck at south-west corner with visible damp. Note area was exposed to severe moisture penetration during fire fighting efforts and during renovation/exposure works after

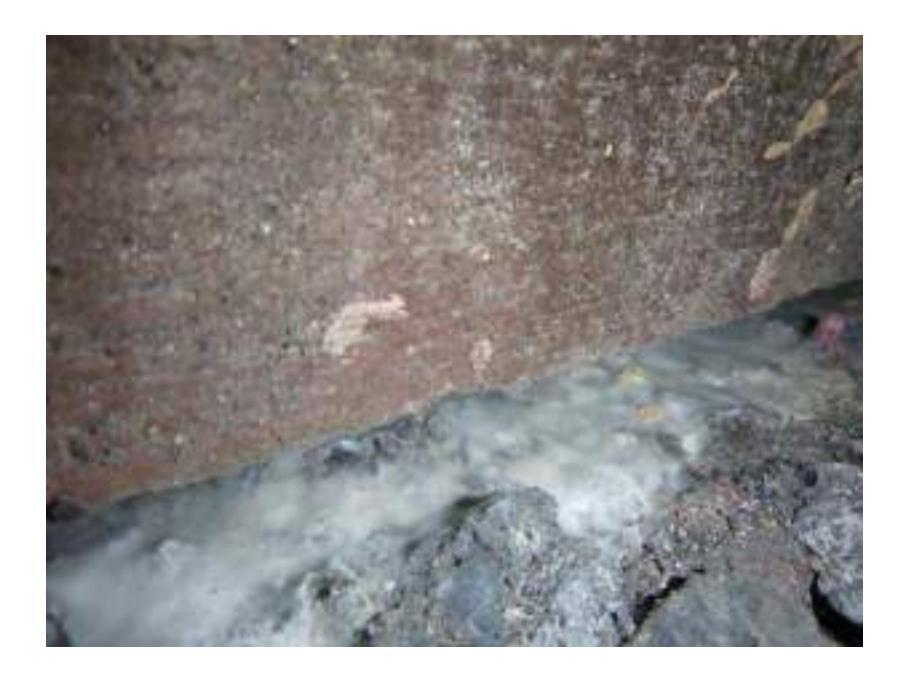
Fig 9:

Auditorium ceiling structures; showing west elevation plate timber with visible mould growth below timber element suggestive of chronically damp plaster. If left unchecked this may lead to severe plaster fungus. Timber deep moisture content raised but stable at ~15 per cent

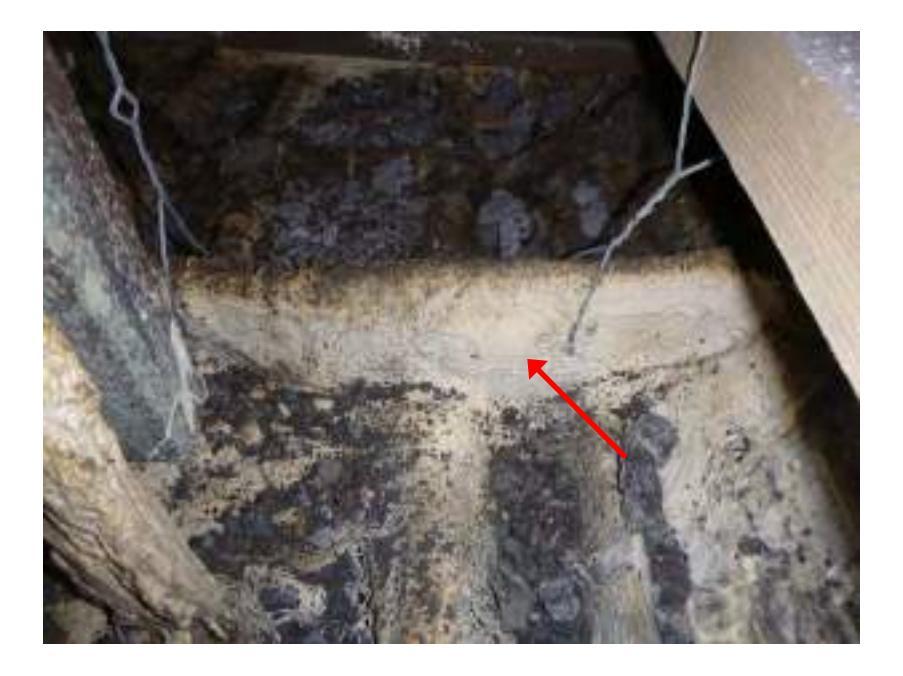
Fig 14:

Auditorium ceiling structures; showing deep moisture content of west elevation plaster retaining batten concealed with a reinforced plaster and hessian mesh. Timber reading dry at ~11%

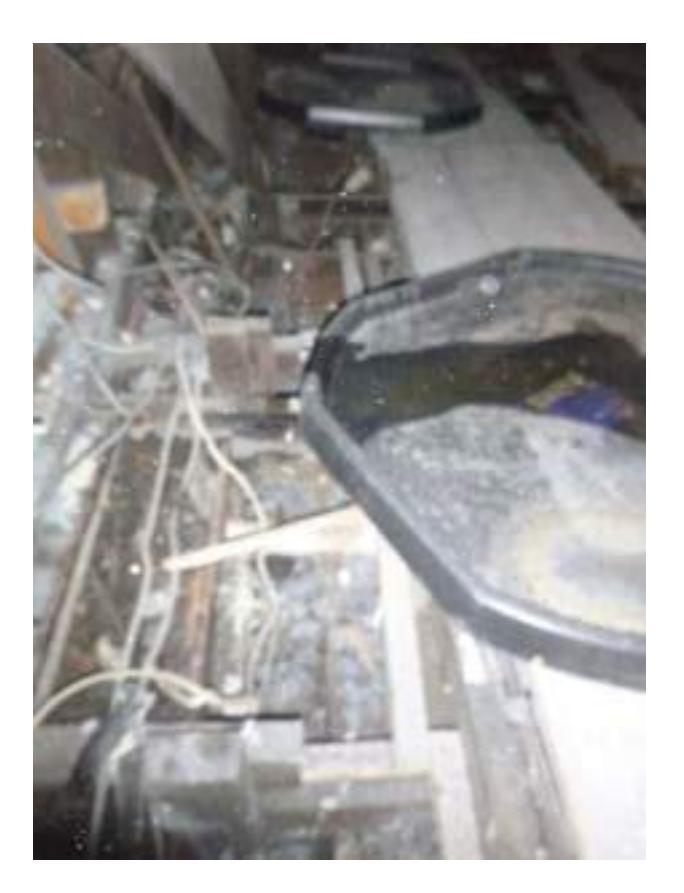
Fig 17:

Auditorium ceiling structures; showing west flat ceiling area. Note ceiling void visibly damp with significant loose debris and litter within void which will significantly slow the drying process

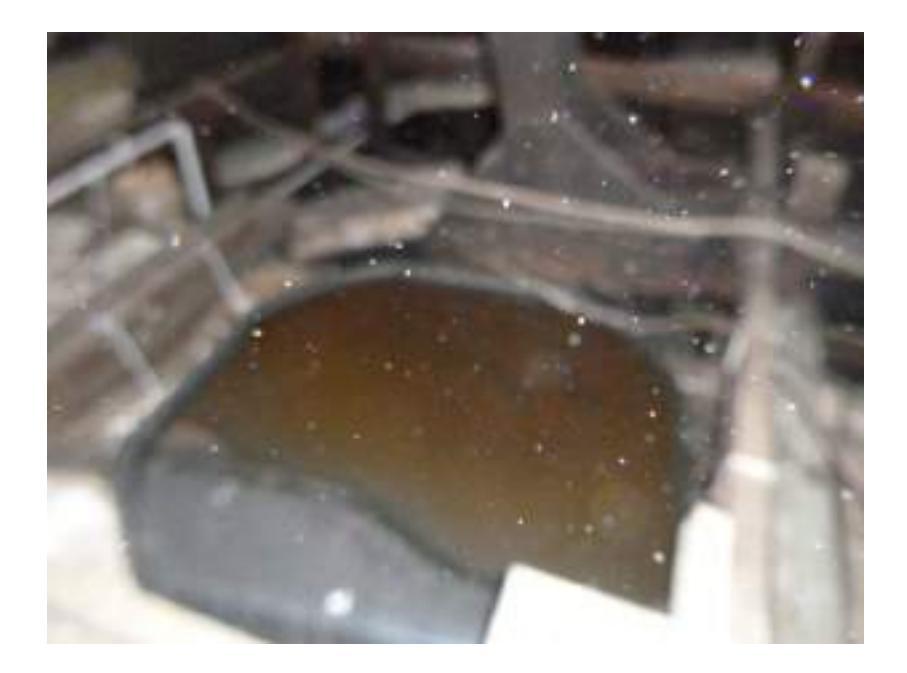
Fig 19:

Auditorium ceiling structures; showing ineffective leak containing tray at northwest area over-spilling onto vulnerable plaster and timber elements beneath and causing the conditions for damp and decay. Leak judged to be still active to this area

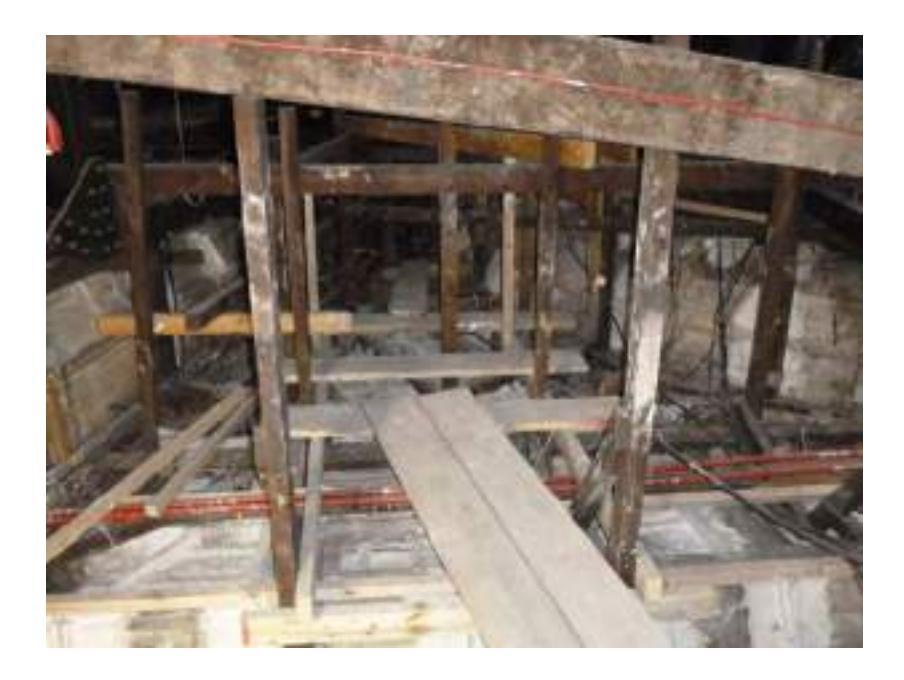
Fig 22:

Auditorium ceiling structures; showing area of raised west flat ceiling structures in general. Note west flat ceiling area defined as area between two western (north-south running) trussed bay RSJ division structures

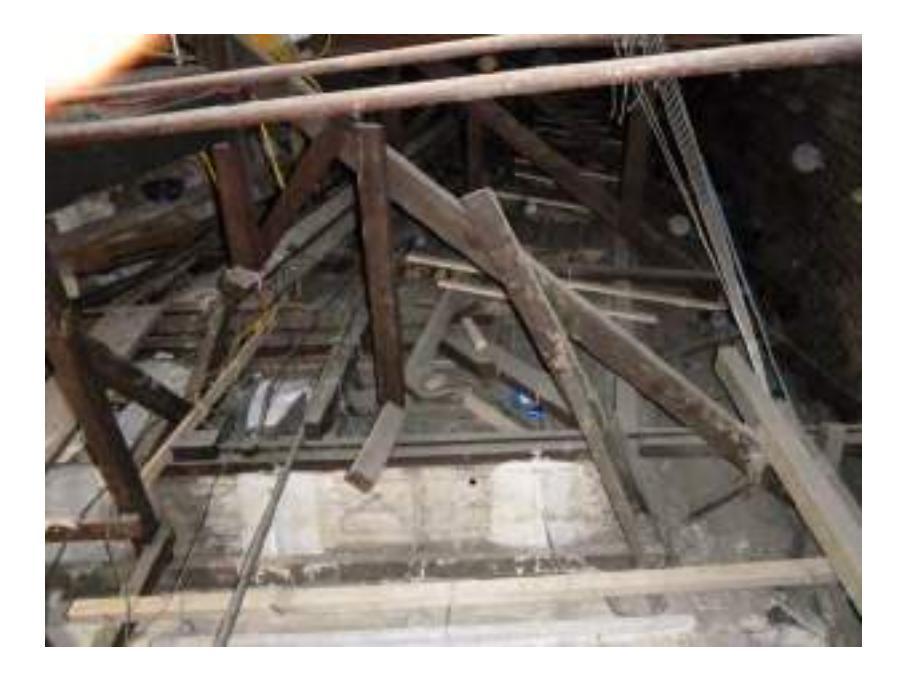
Fig 24:

Auditorium ceiling structures; showing typical upright timber stud element between most vulnerable west bay and the adjacent bay to the east. Note evident mould growth to timber surface suggesting of past chronic moisture penetration and subsequent ineffective ventilation/drying of area

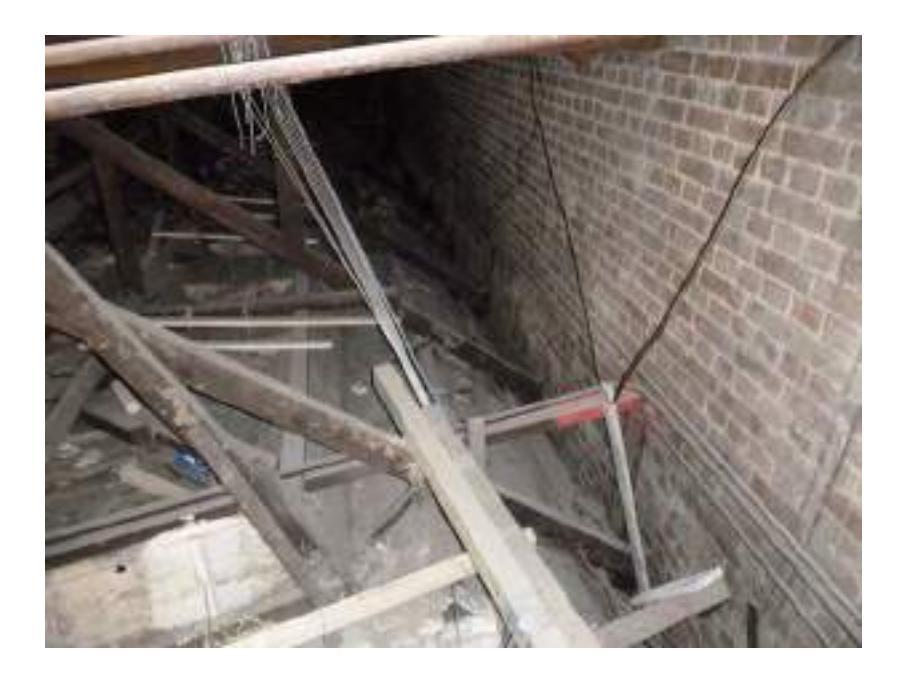
Fig 25:

Auditorium ceiling structures; showing east bay and the furthest from the most vulnerable west bay. Timbers in this area were representatively tested for surface and deep moisture contents. Results showed timbers to overwhelmingly have dry surface moisture contents as well as dry deep moisture contents

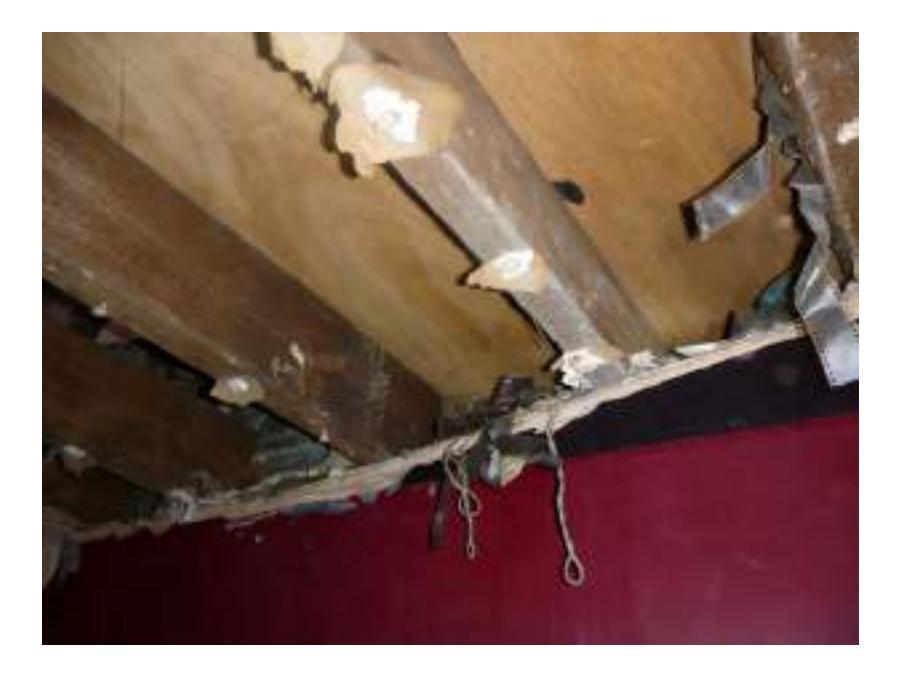
Fig 28:

Second floor ceiling structures, RM.2-16; showing area in general. All ceiling structures of solid construction apart from north bay where ceiling joists were discovered. These appeared to have originally formed (or replaced) a now defunct floor level, now concealed by a newer division solid floor structure from above

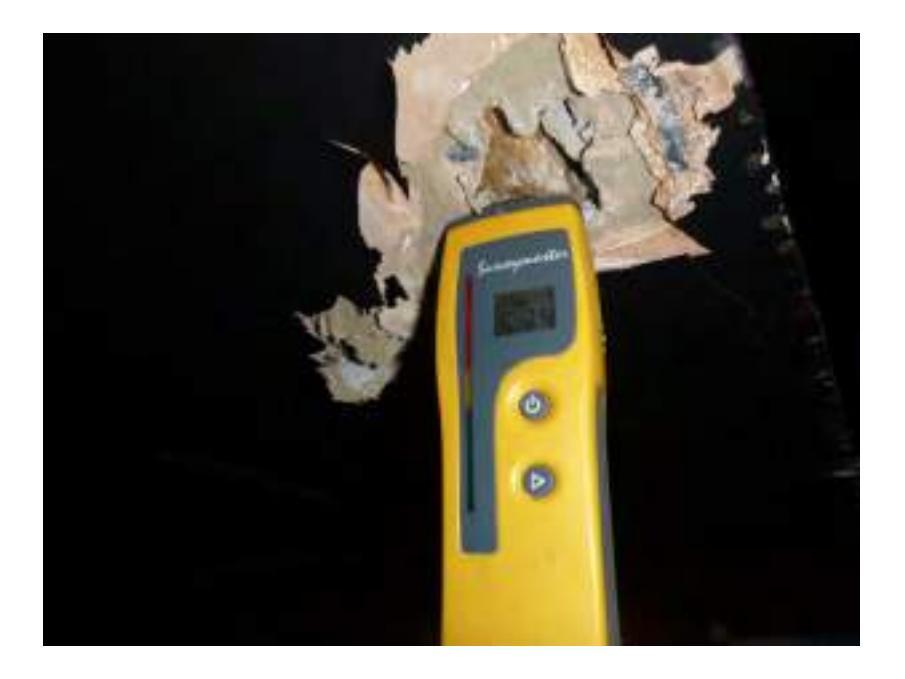
Fig 33:

Second floor ceiling structures, RM.2-16; showing exposed wet timber element within typical boxed beam RSJ structure. Plaster and concealed boxing timbers were found to be wet and highly vulnerable to damp and decay in these areas

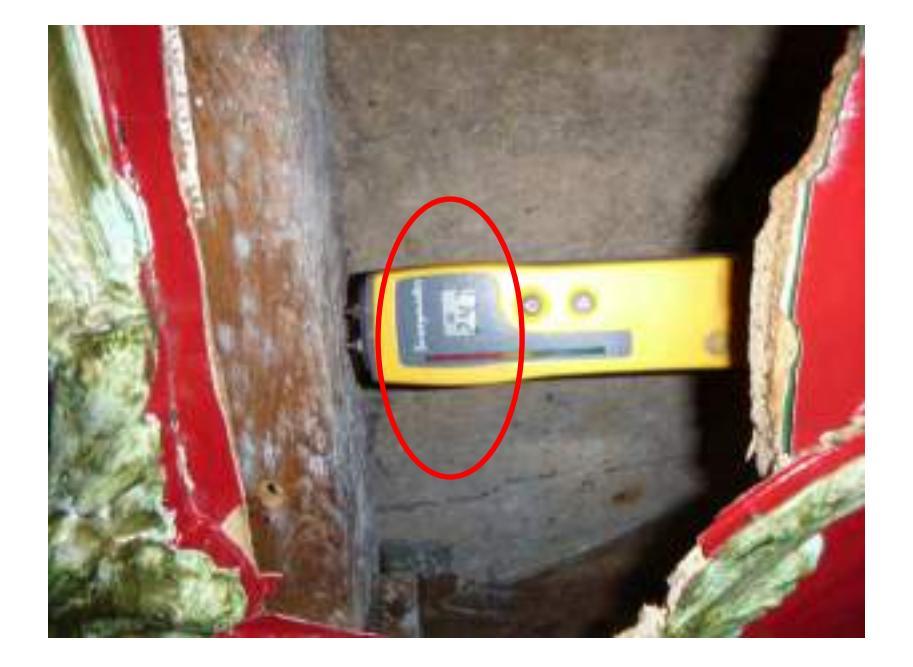
Fig 36:

Second floor ceiling structures, RM.2.22; showing historic timber and plaster ceiling structures above main access north-west stairs subject to damp and decay

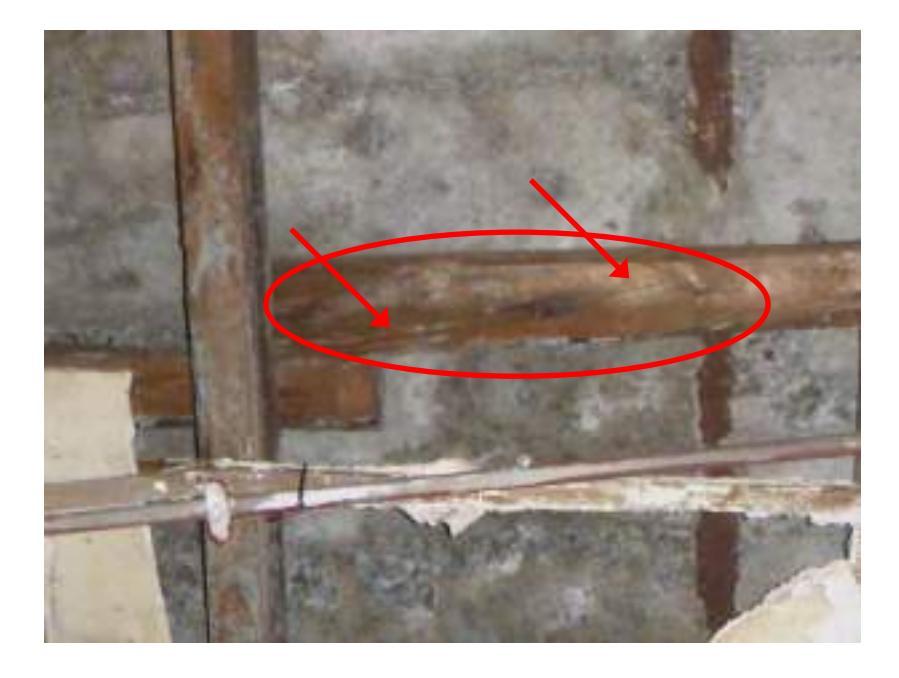
Fig 52:

First floor ceiling structures, RM.1-14; showing ceiling plate element supporting central span of ceiling joists structure. Note surface mould growth as well as evident corrosion to nail fixing into suspected wet masonry slab. Corrosion likely to worsen as moisture migrates down the structures from the upper levels

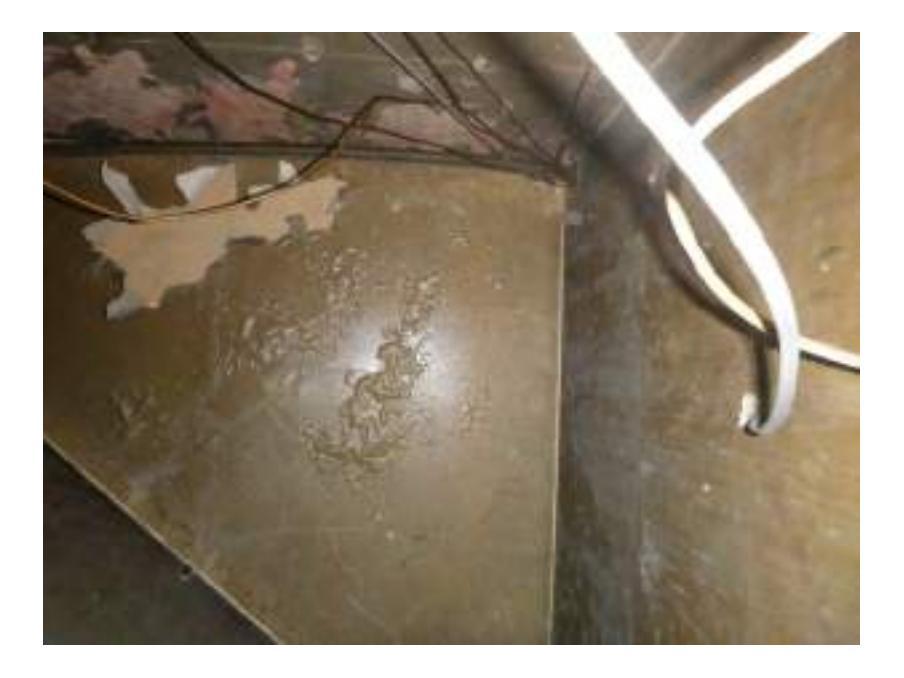
Fig 56:

First floor ceiling structures, RM.1-14; showing north-east corner above bar/ historic entry point into auditorium now containing small non-historic suspended timber ceiling

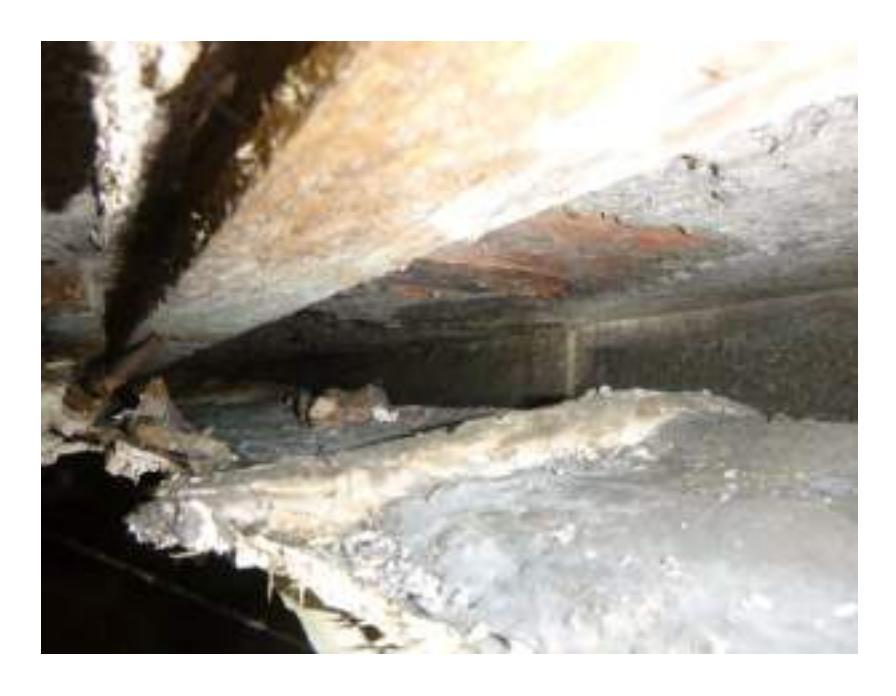
Fig 78:

Ground floor ceiling structures, RM.G-17; showing ceiling void at ~120mm depth to decorative plaster ceiling around octagonal ceiling light. Note timbers recorded as wet with moisture content readings of ~22 per cent. Ceiling voids require ventilation

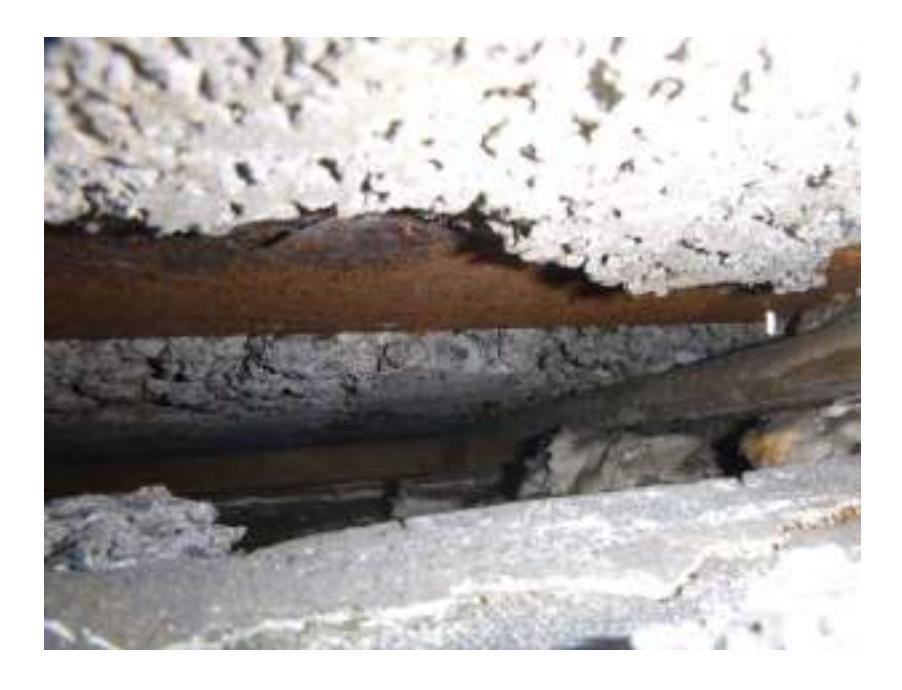
Fig 80:

Ground floor ceiling structures, RM.G-17; showing ceiling void above entrance lobby incorporating 3no. octagonal ceiling lights. Note timber battens visibly damp with soft frassy areas of remaining sapwood highly vulnerable to decay

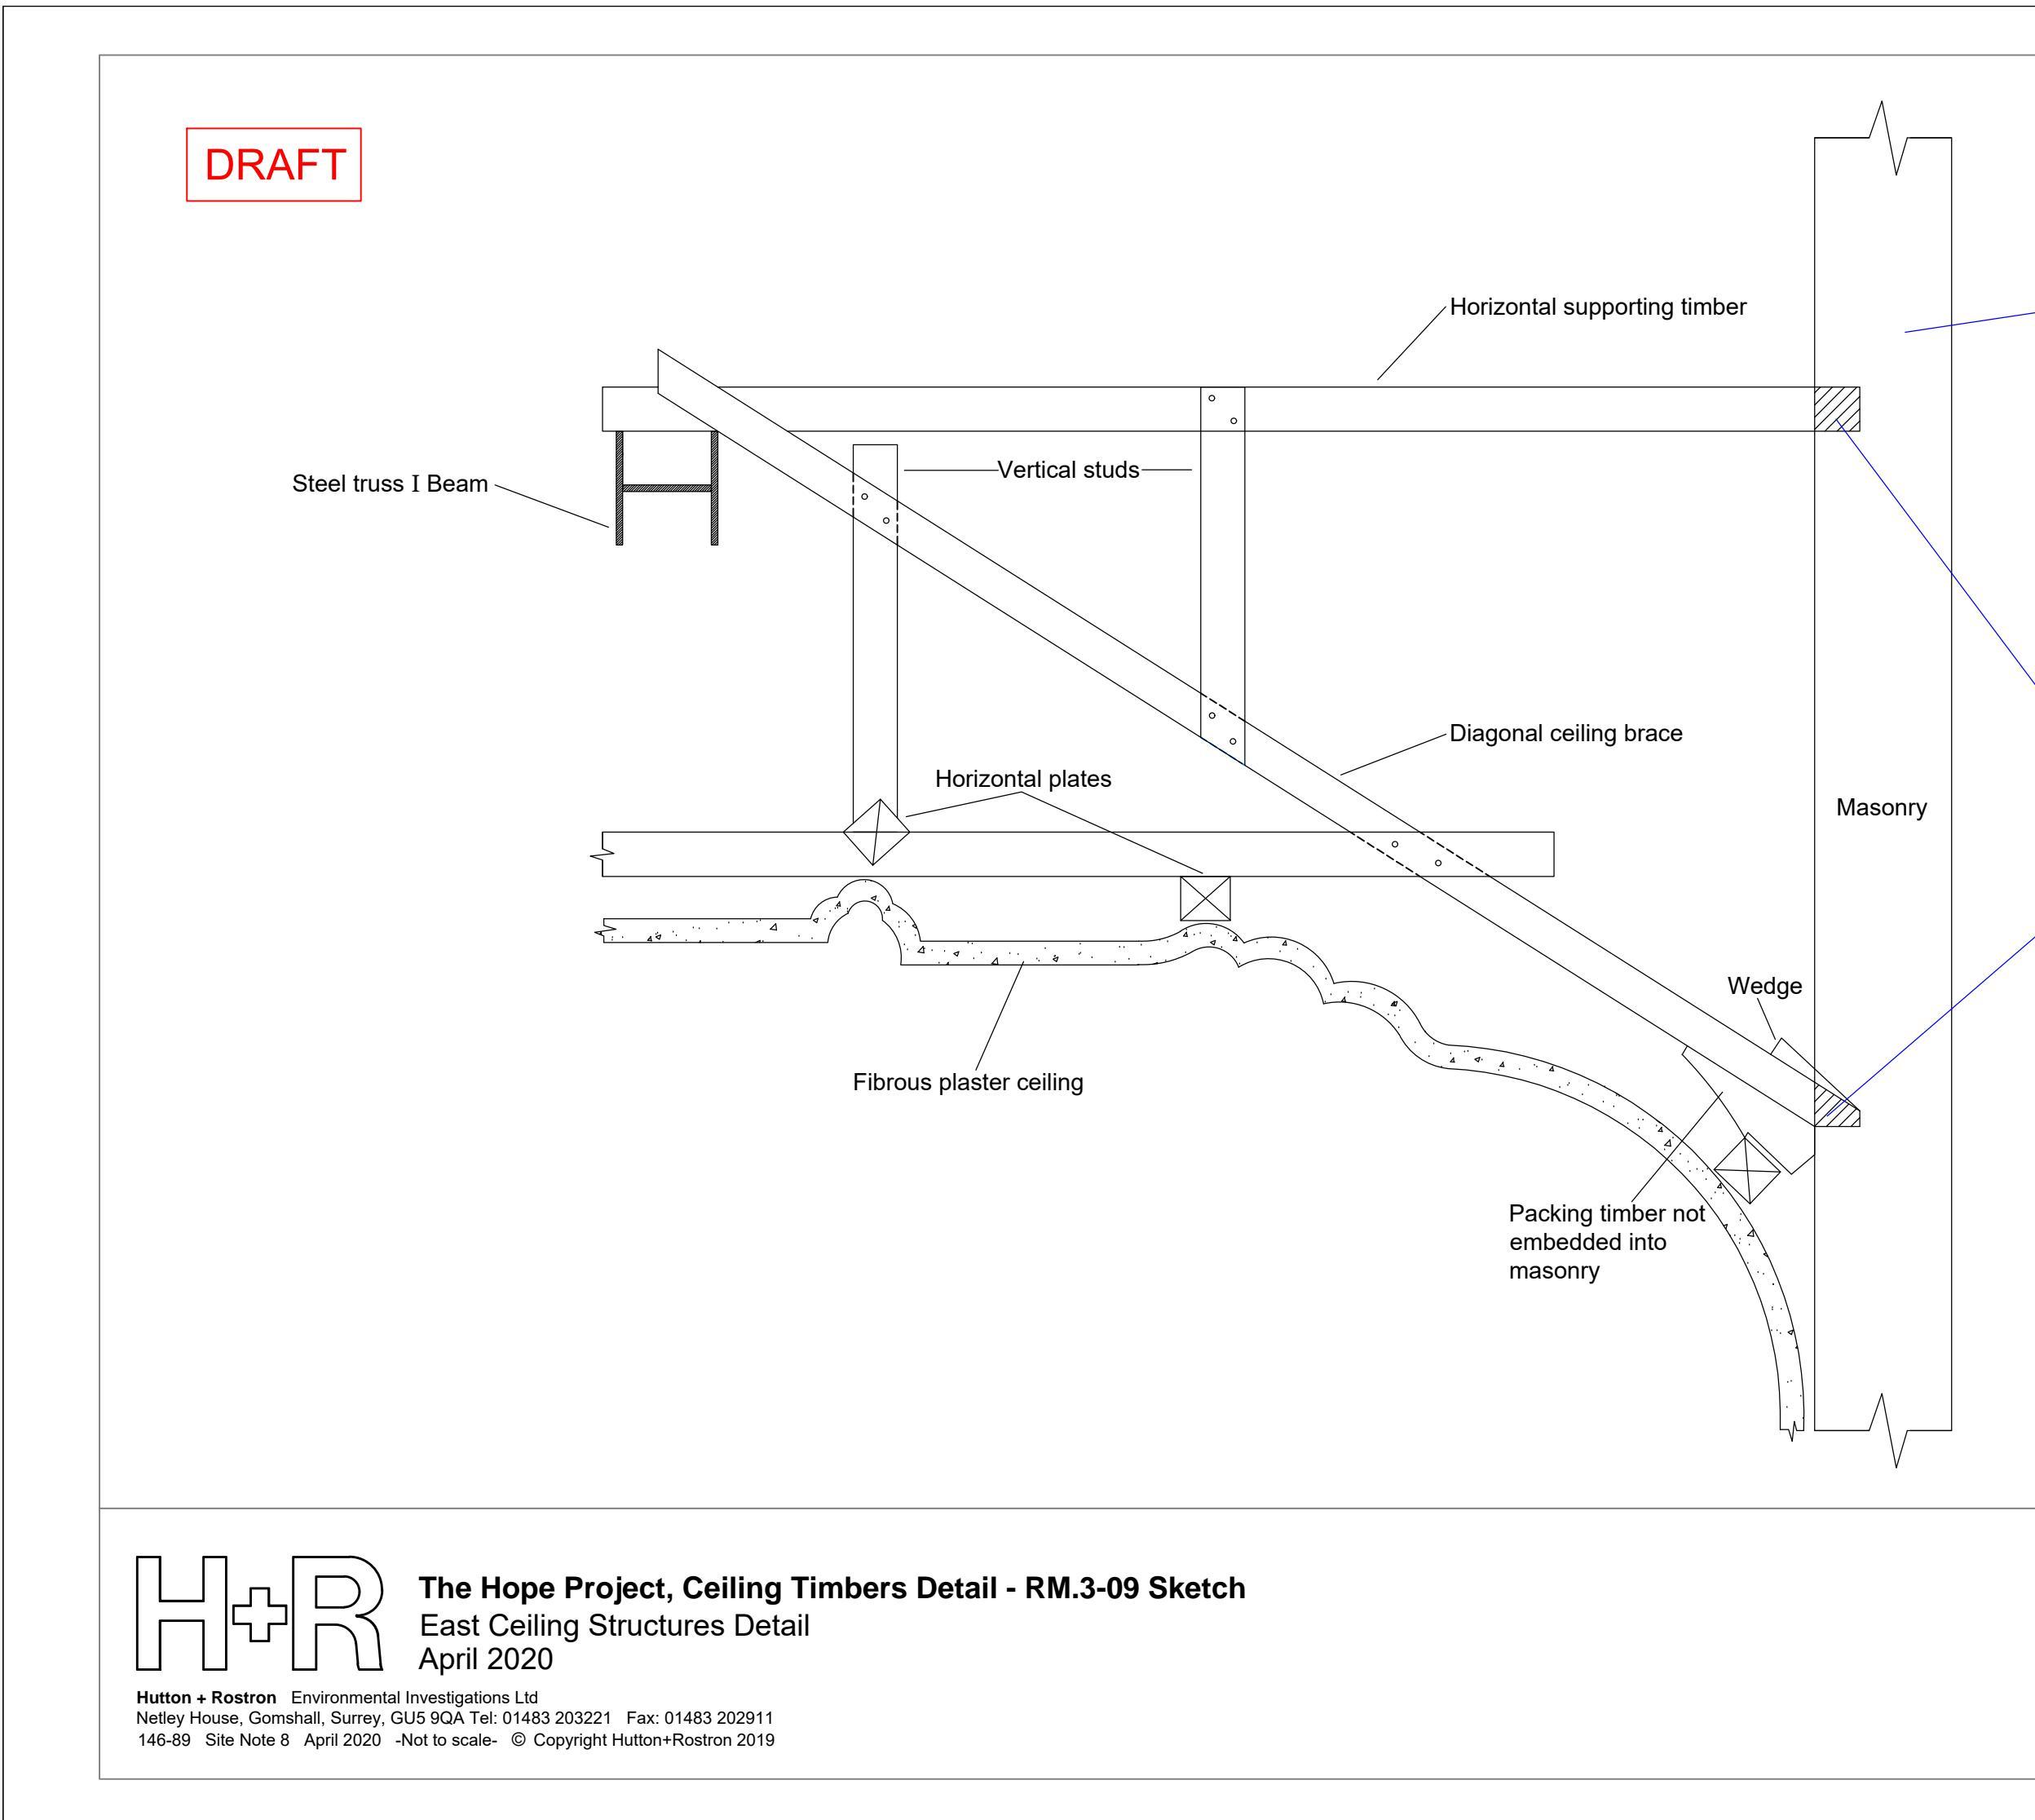
Potentially damp masonry dividing roof structure under investigation with the adjacent fly tower roof subject to damp and decay issues in the past
