hazard: outline method statement

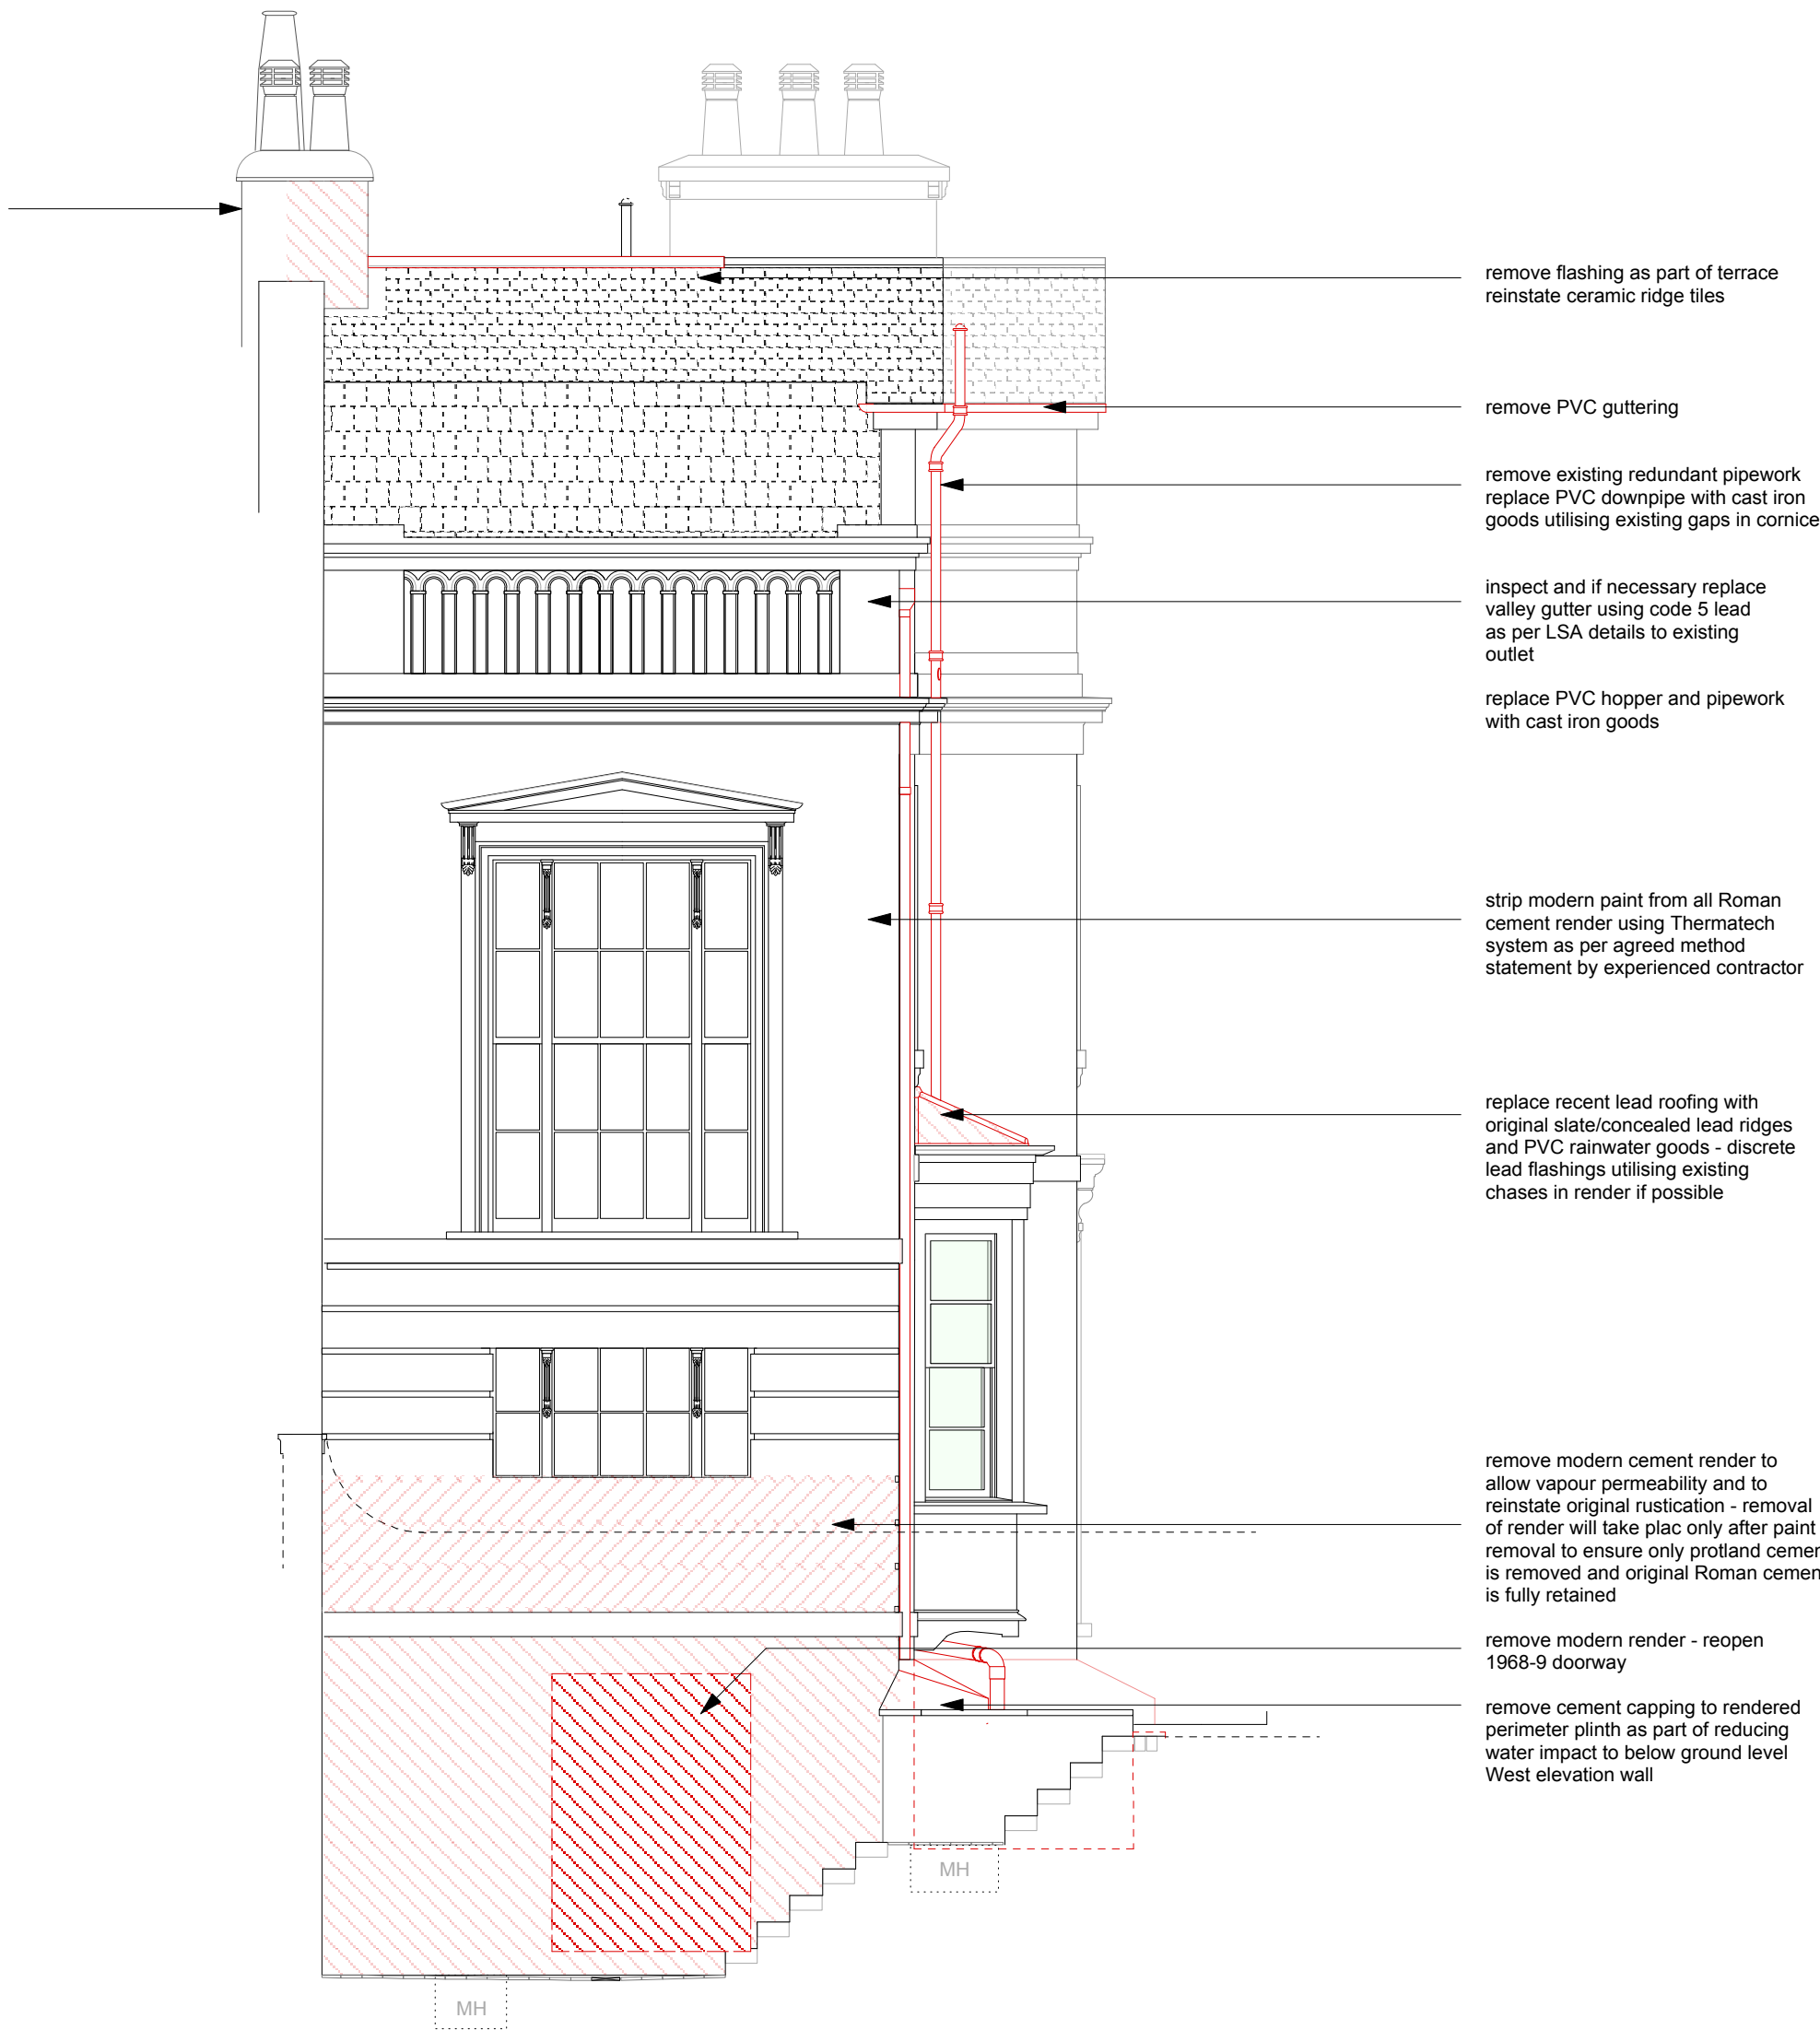
Note: all original / existing fabric retained in-situ unless indicated red for removal

remove 1969 cement render from house chimney, replace with Roman cement

take copy moulding from original bracket details and refix below reinstated projection based on remaining fragment to North West corner of stack, renew flaunching in Roman cement

stack redecorated in silicate paint as per facades
