hazard: outline method statement

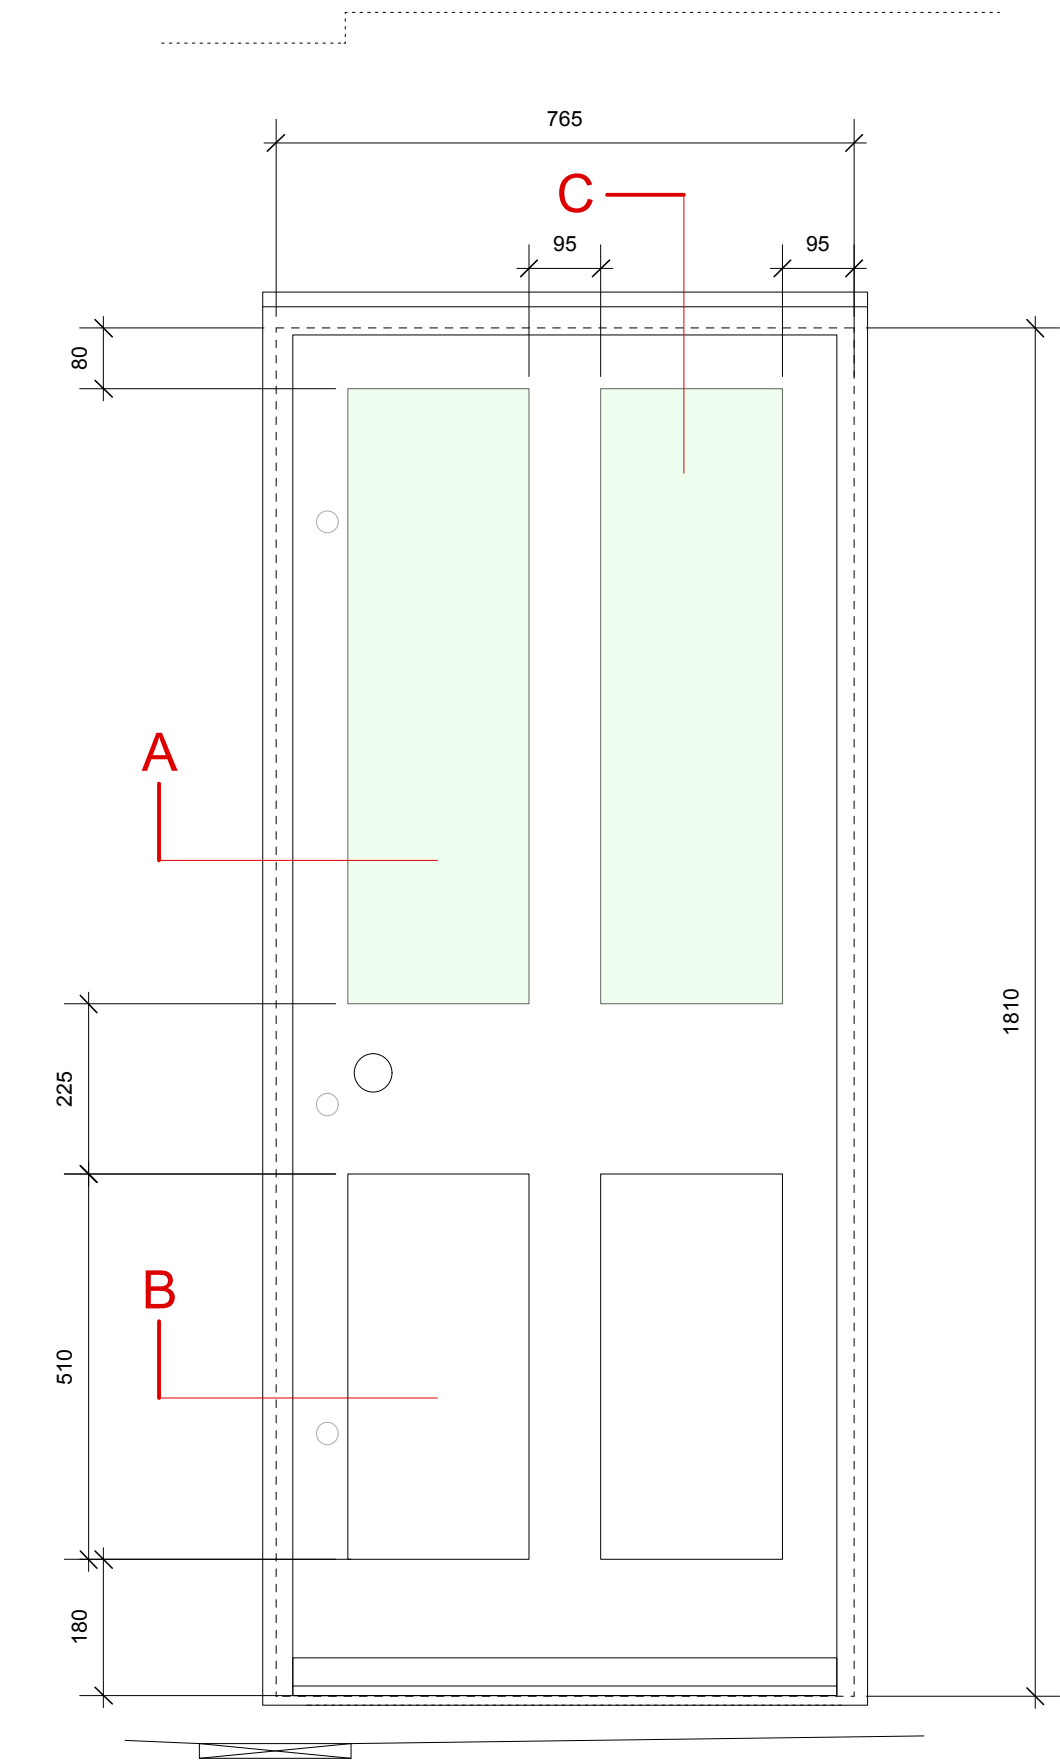
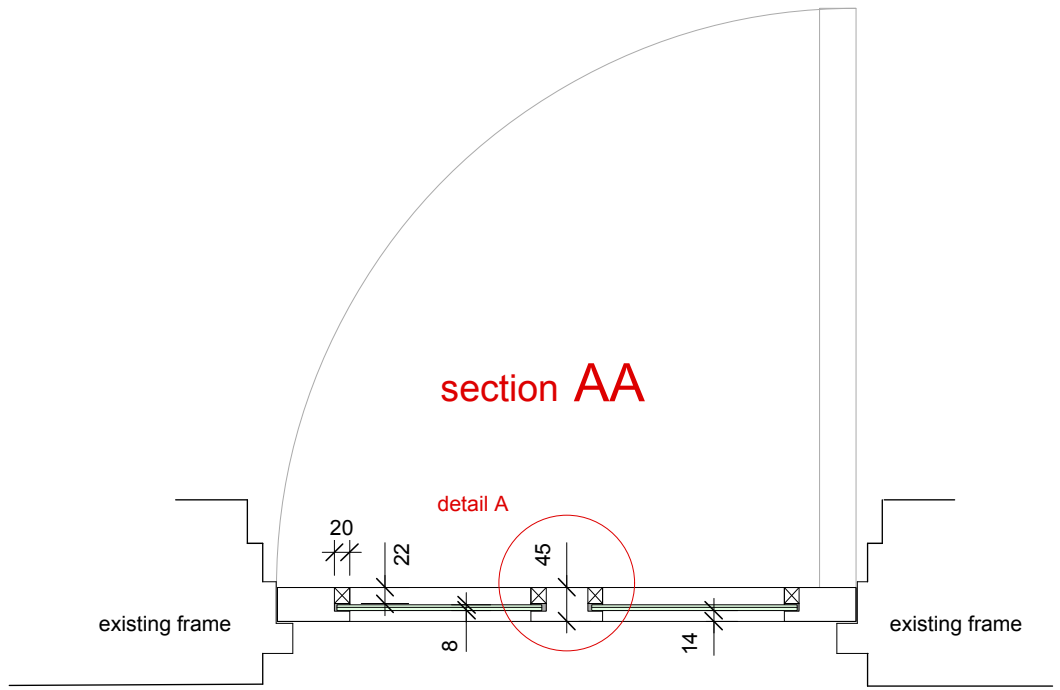
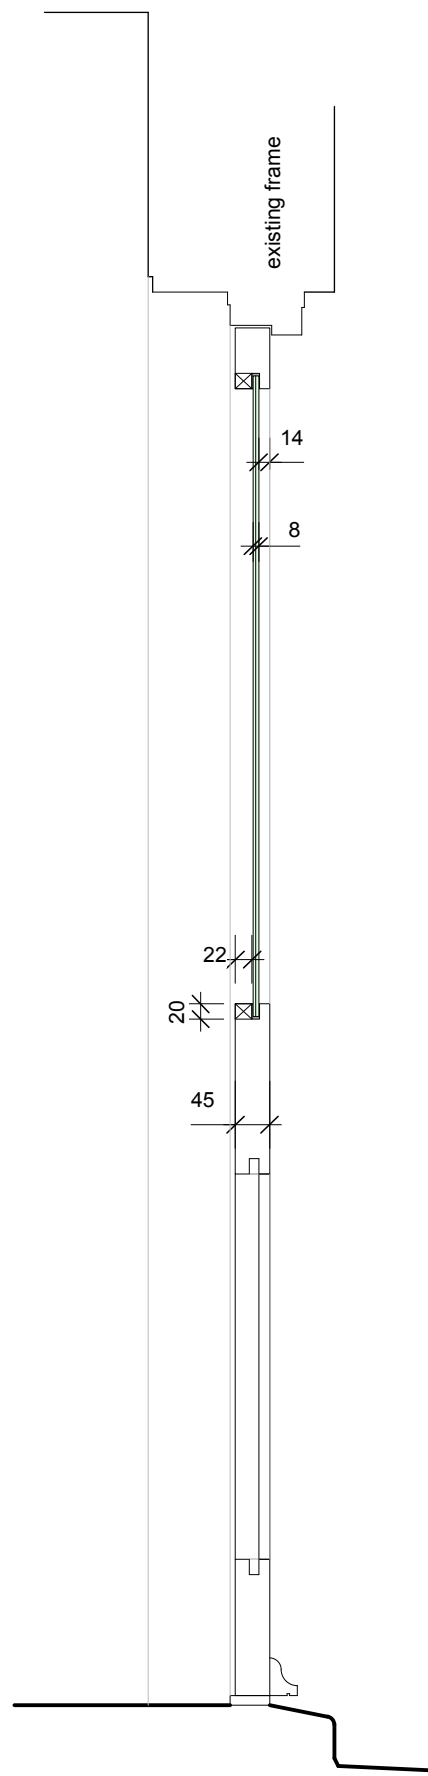
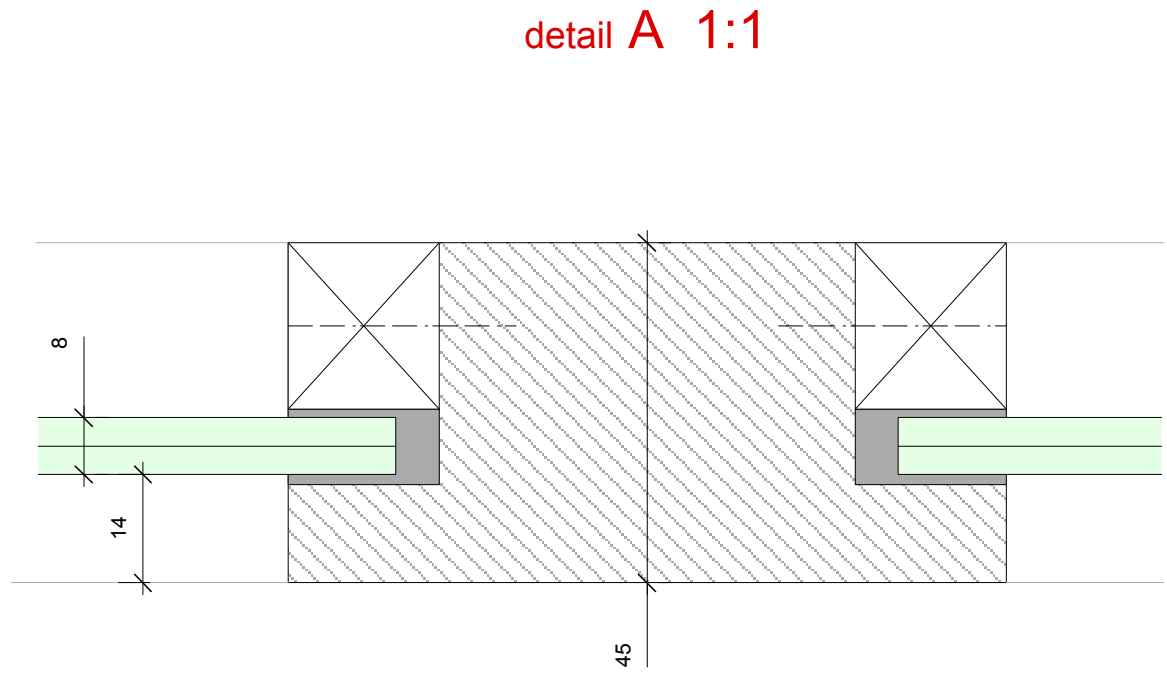
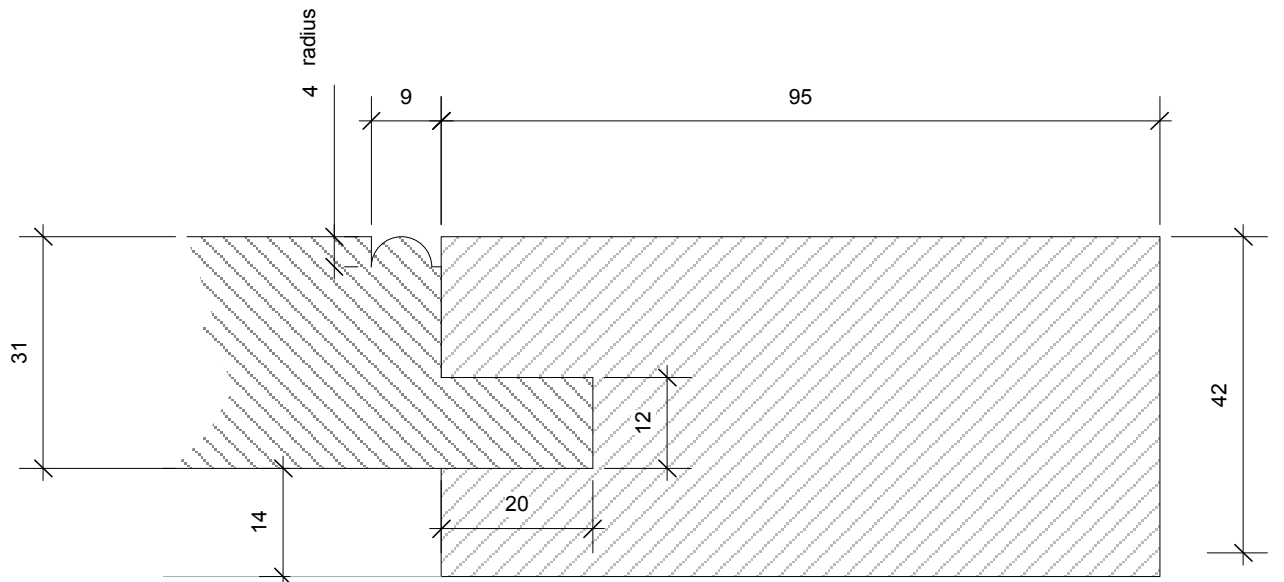
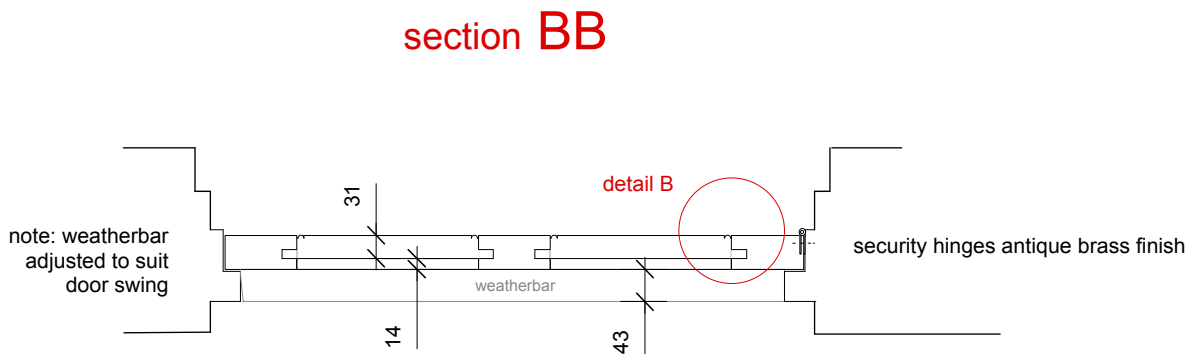
Door  
Existing solid flush door removed - frame  
to be retained in situ, decayed bottom threshold  
to be replaced using FSC certified European oak

Door fabricated offsite using FSC accredited  
European hardwood refitted to frame - draught  
stripping added to frame, ensure use of router  
by experienced joiner, Risk Assessment to  
cover operation.
