### CampbellReith consulting engineers

### 26 Netherhall Gardens

Basement Impact Assessment

Audit

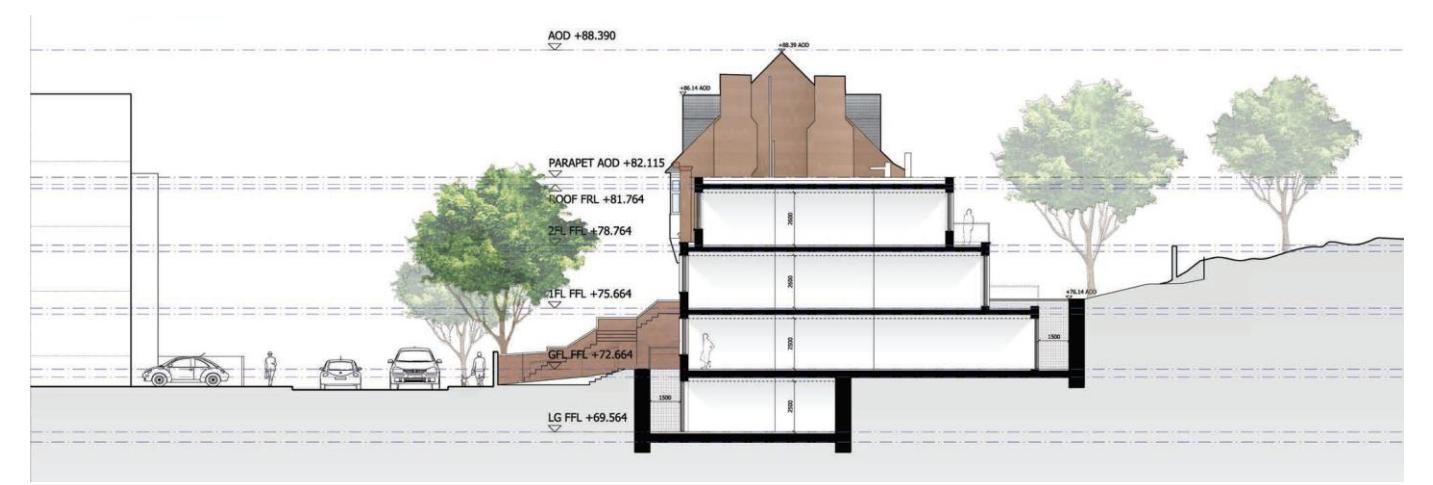
The drawings do not accurately portray the hillside. While the carriageway of Netherhall Gardens (NG) has been flattened out, this level does not continue. The houses on this other side of the road are considerably deeper and stepped both east-west and north-south.

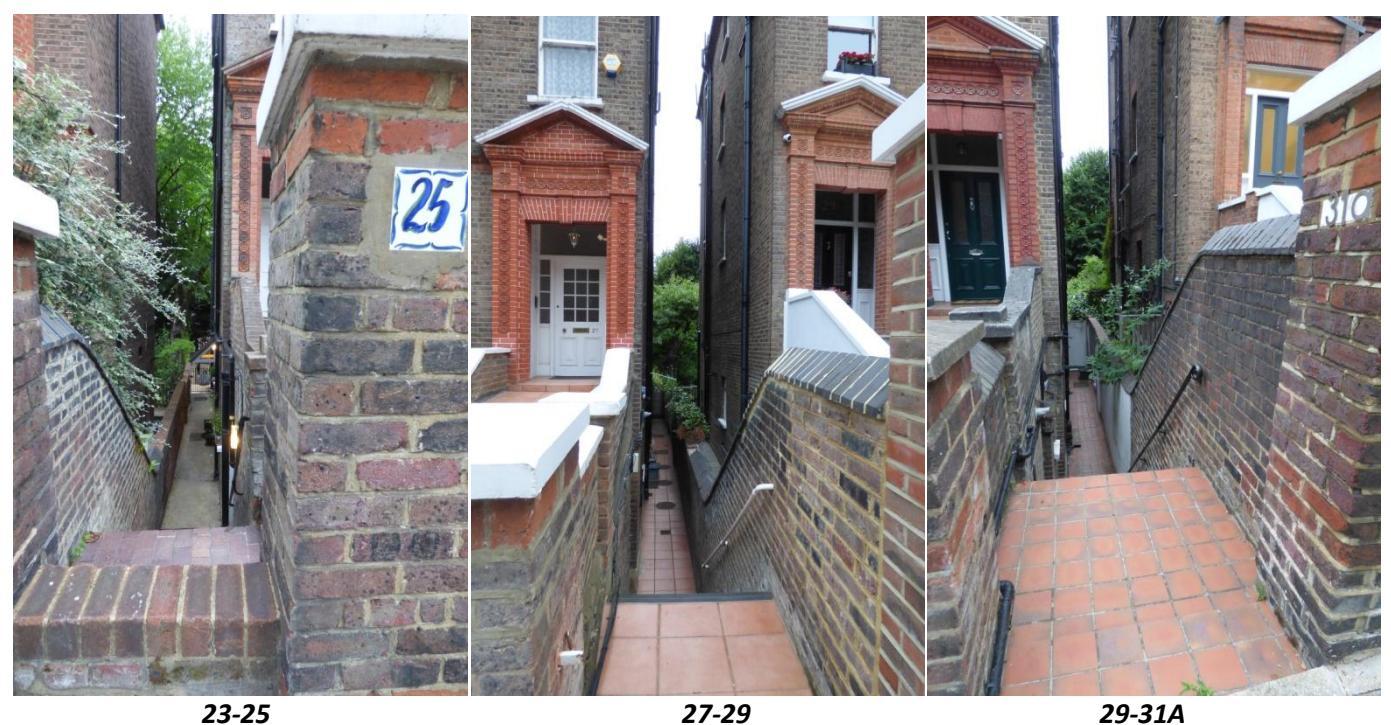
23-25 27-29 29-31A Gaps between the houses opposite number 26 in Netherhall Gardens, demonstrating the angle of the hillside here with stepping down between houses and a steep drop from the road to the rear gardens.

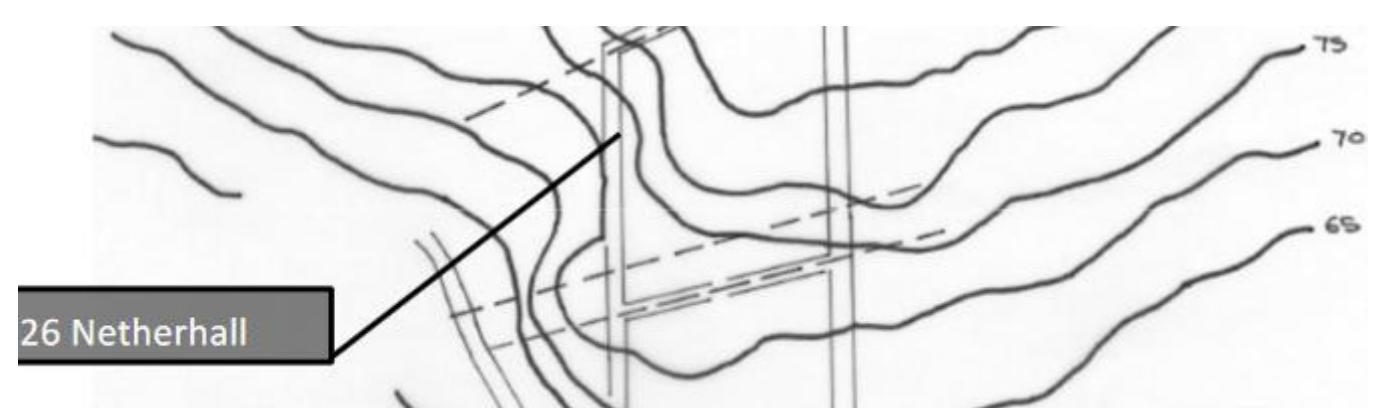
Flattening out of the contour lines along the western, down-hill side of the carriageway opposite 26 NG demonstrates how the carriageway has been built up rather than cut into the side of the hill, adding to its vulnerability to silt erosion by the action of groundwater and to landslip.

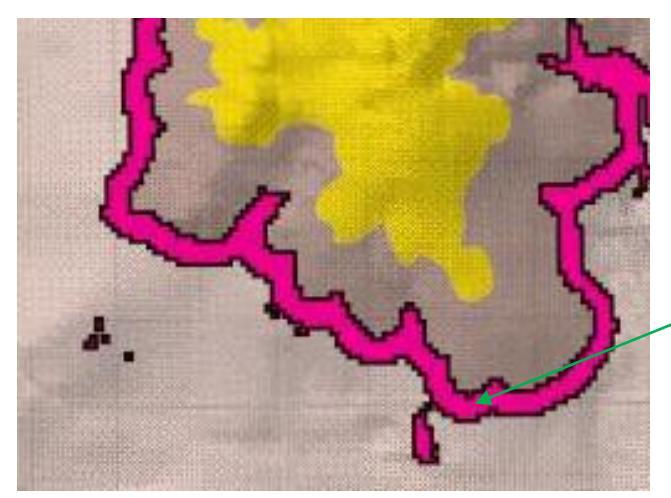
26 Netherhall Gardens

The BGS 'Areas for Greatest Potential for Slope Instability' is also Figure 17 of Arup's 'CGH&HS: Guidance for subterranean development' and shows 26 NG to be right over an area of High/Very High risk for slope instability as calculated by Forster A, Wildman G & Poulton C. (2003) Landslide potential modelling of North London. British Geological Survey Internal Report, IR/03/122R.

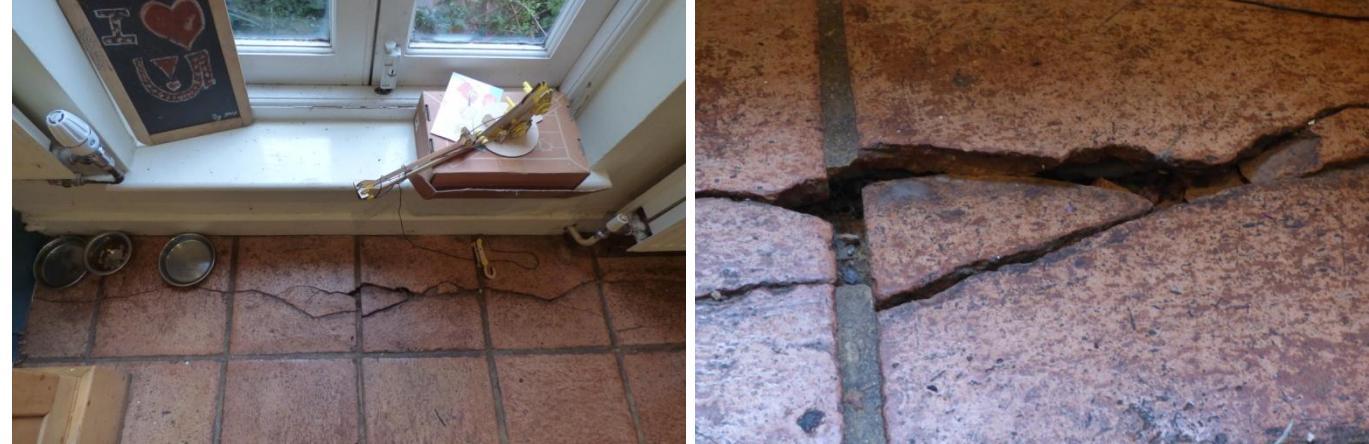
Crack across kitchen floor front of 24A NG

Detail of crack

24A NG itself suffers from significant cracking, that shown here in the kitchen floor evident throughout the front part of the house on all floors. The house - built in the 50s or 60s will have modern foundations but they are not as deep as those of the Victorian 24 or 26 NG so a vertical shearing crack from differential subsidence has appeared between 24 and 24a. 24 & 26 were built over basements to deal with the groundwater flowing down the hill, and

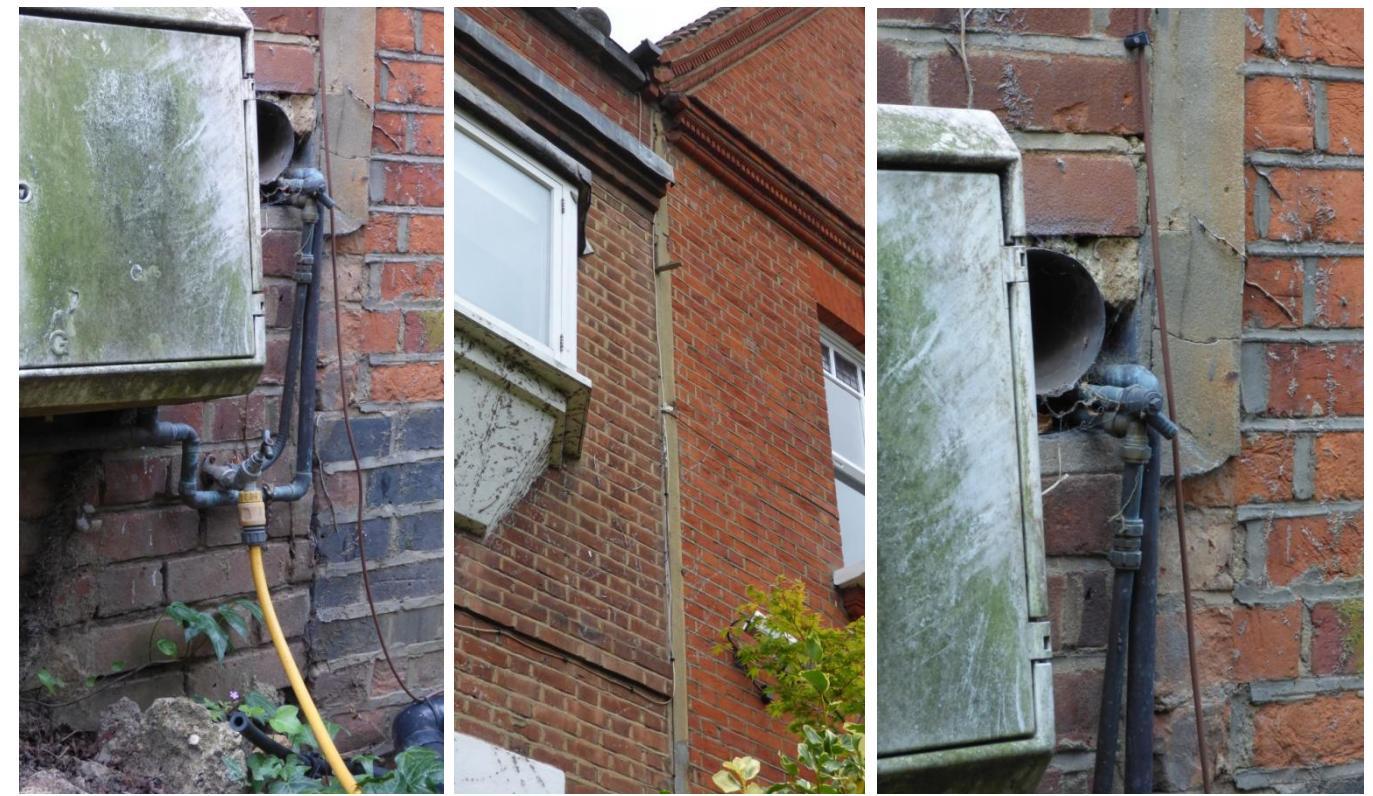
Horizontal mortar joints open as ground under 24A drops; the joint between 24A & 24 shows vertical shear

causing preferential flow of groundwater between 24 and 26 i.e. under the side garden between 24 & 26 then under 24A itself when it was built, with severe dampness appearing in the front garden & steps of the house when the groundwater is surcharged from upper Hampstead by storms . The pattern and severity of cracking in the kitchen - an opening crack and a step *up* from rear to front as the floor also drops away from the front wall it is bonded to - indicate the likely mechanism to be silt erosion by the action of groundwater in the ground beneath the foundations at the front of the house along with a longstanding tendency to slide down the hill. If this situation was to be compounded by vibration and ground pressure changes it will be likely to instigate a degree of further downhill landslide. The depth of 26 NG's proposed basement might prevent 26 NG from moving downhill, but its creation will mean that other gardens, properties and structures without deep foundations and within influencing distance of vibration and ground pressure changes are likely to be subject to landslide. This has happened time and time again in the north of Finchley Road regions along this BGS line of High and Very High Risk of Landslide with disastrous results, and the effects of basement construction on their buildings must be recognised.

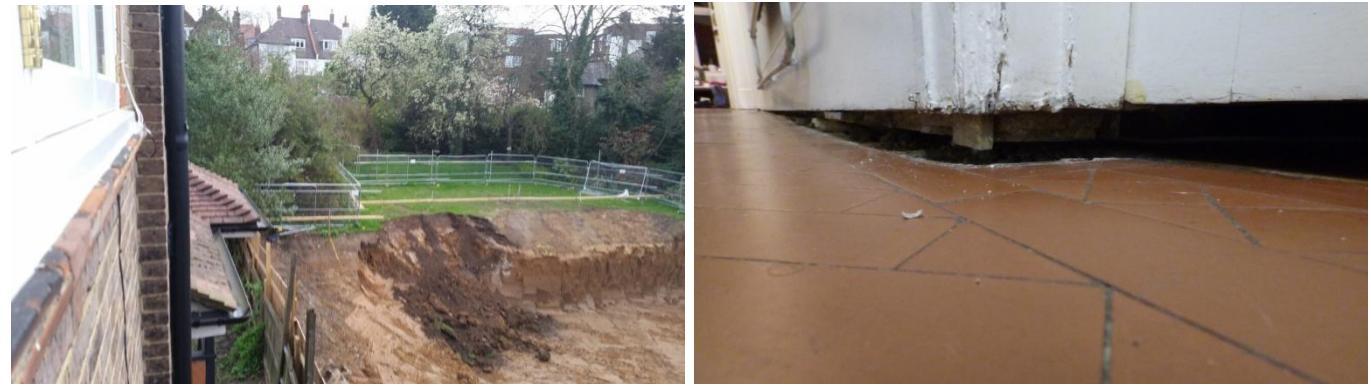
Screw piling is proposed, which is more vibration-free, though one suspects this is meant as a noise-reducing factor on Camden's insistence, rather than a serious attempt to reduce damage that the authors of the BIA seem to be doggedly denying or completely unaware of. However they are still advocating the driving in of temporary sheets thus adding vibration to ground pressure changes with this. Their only means of stopping landslide is to monitor building movement then determine what is to be done to the stable door after the horse has bolted. While Movement Monitoring may be appropriate for level stable ground, here it will merely indicate "Too late!!" as happened in Finchley Road in 2016. There had already been predictions of this by an expert and warnings as the neighbouring dig-out prompted a landslide into their own excavation. In any case the contractors of that development ignored red warnings for 10 days until forced to acknowledge them, then merely said that since it had already happened, there was no point in stopping. The results below are a fraction of the extensive severe damage throughout the entire building:

Landslide

Dropping sliding foundations

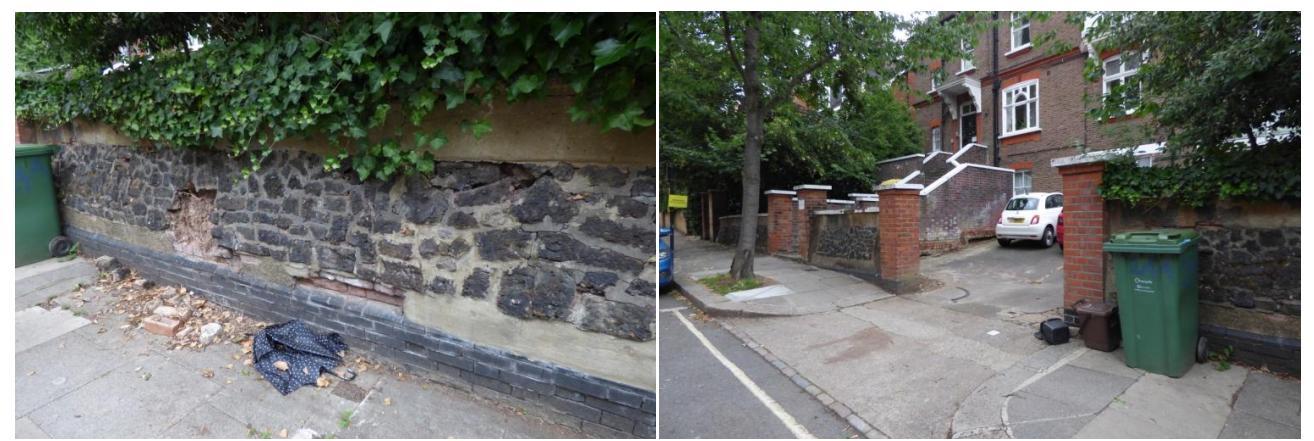
Clinker bricks are an historic feature of many boundary walls in Hampstead. During the construction of 24A NG great care was taken to preserve the side boundary wall with 26 NG which is formed from clinker bricks.

Front boundary wall of 26 Netherhall Gardens with its clinker brick panels

These bricks are therefore of immense historical interest for the wider Hampstead area and great care should be taken to both restore the walls and to rebuild using the retained bricks. This should be a condition if consent is given.
