**ARBORICULTURAL IMPACT ASSESSMENT
For amendment to a current planning consent**

**2 Maresfield Gardens
NW3**

1st June 2020

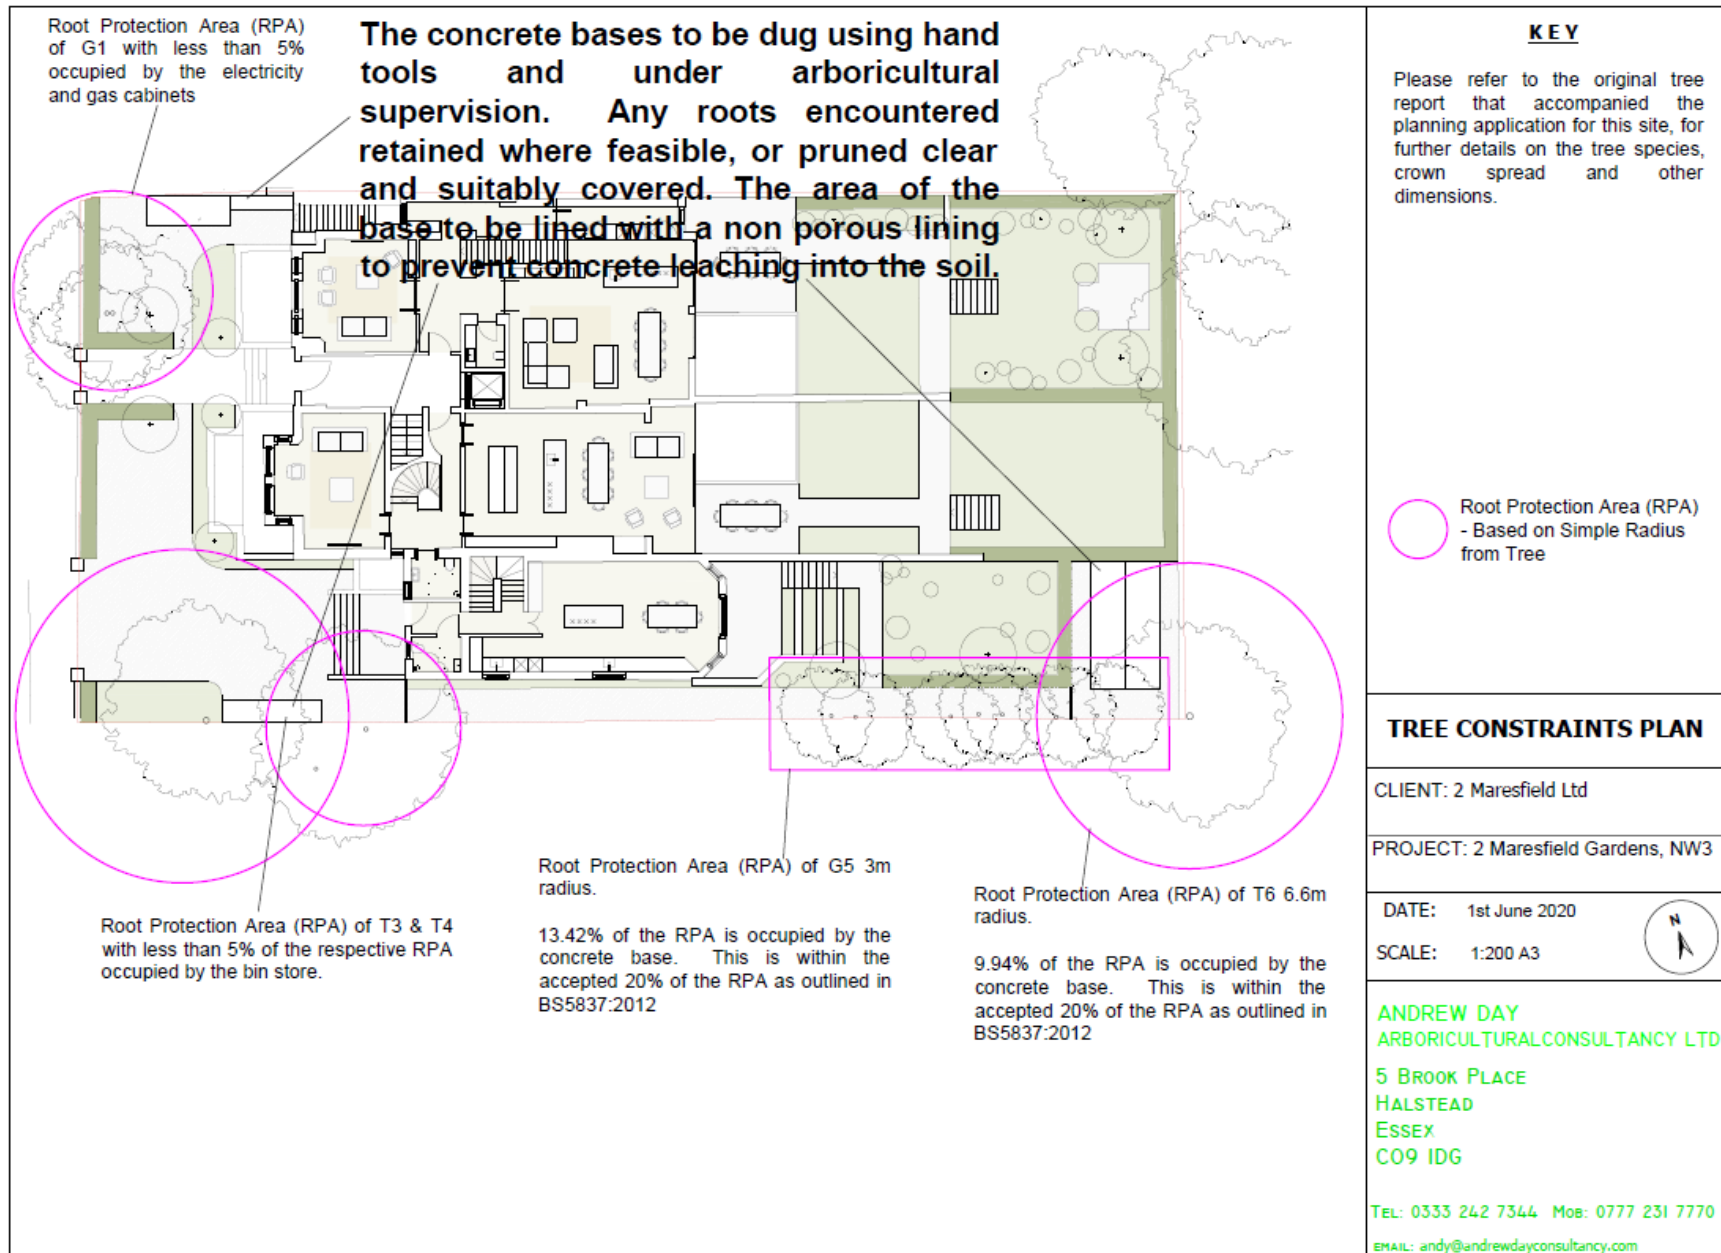
TREE CONSTRAINTS PLAN

(Not to Scale. Please refer to separate A3 plan if scaling is required)
