## Tree report in accordance with BS 5837:2012

Site Address: 18a Frognal Gardens, London, NW3 6XA  
Ref: 031682/v2

## Demolition of existing structure and construction of a new 4-storey dwelling in its place

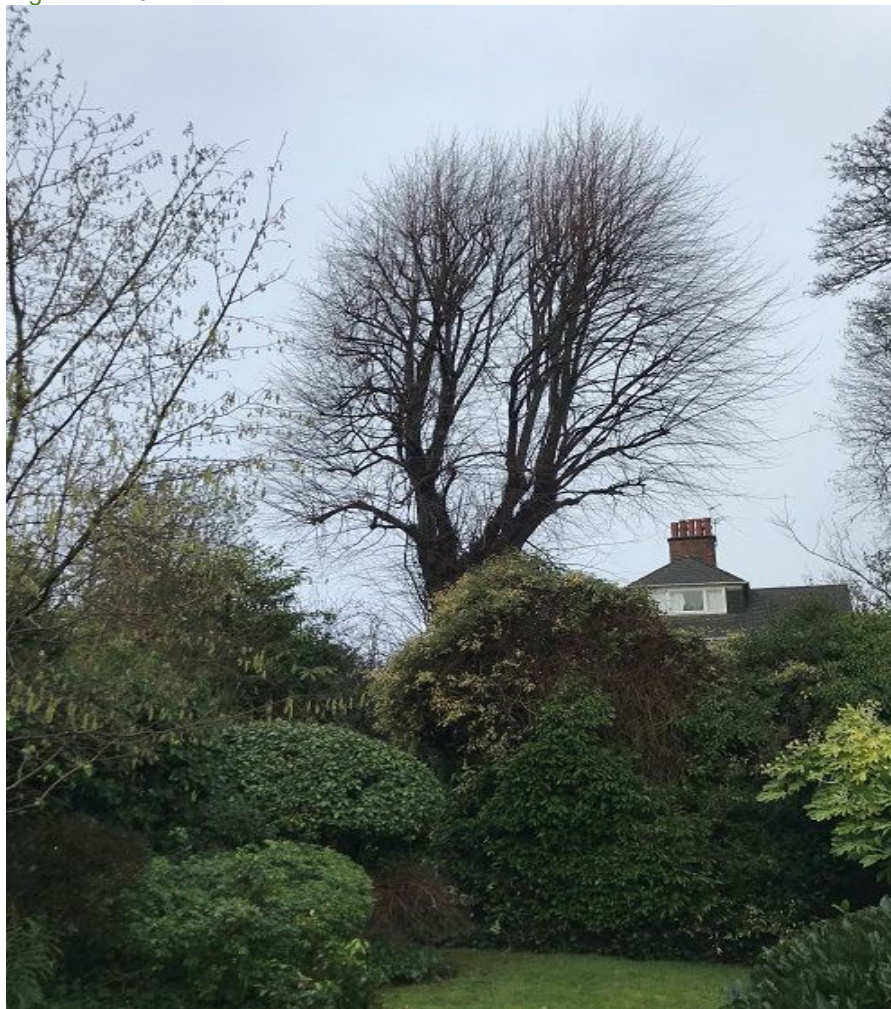
Figure 1 T10

2.2.4 The most significant tree with respect to the proposal is a lime (T10) [Figure 1] located towards the rear boundary of 18a Frognal Gardens' rear garden. No works are planned to occur within the RPA of this tree.

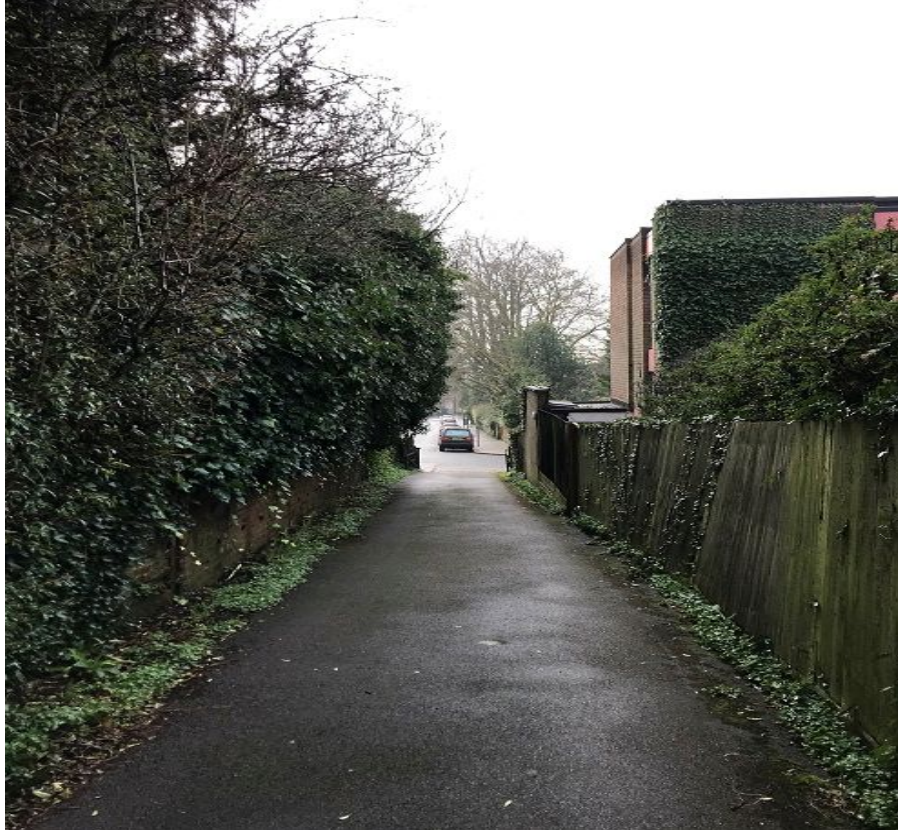
T4, T5 and T6 are 3<sup>rd</sup> party trees whose RPA clips the north-eastern corner of the site. Similar to T1, there is not an anticipation that significant roots will be found in this portion of the garden given the presence of a boundary wall and an established tarmac driveway [Figure 2] between the two.

Figure 2 Established driveway between 18a and 3<sup>rd</sup> party trees to the east
