BS 5837 Arboricultural Report for Development

CLIENT: Kordestani

SITE: 68 Fellows Road, London, NW3 3LJ

DATE OF REPORT: 14 December 2020

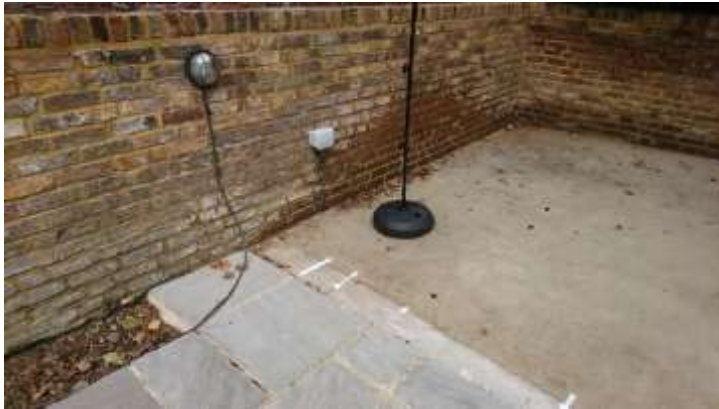
Figure 2 - Existing electrical supply

An electrical supply already exists (running along the rear and western boundaries) and no further services are proposed.

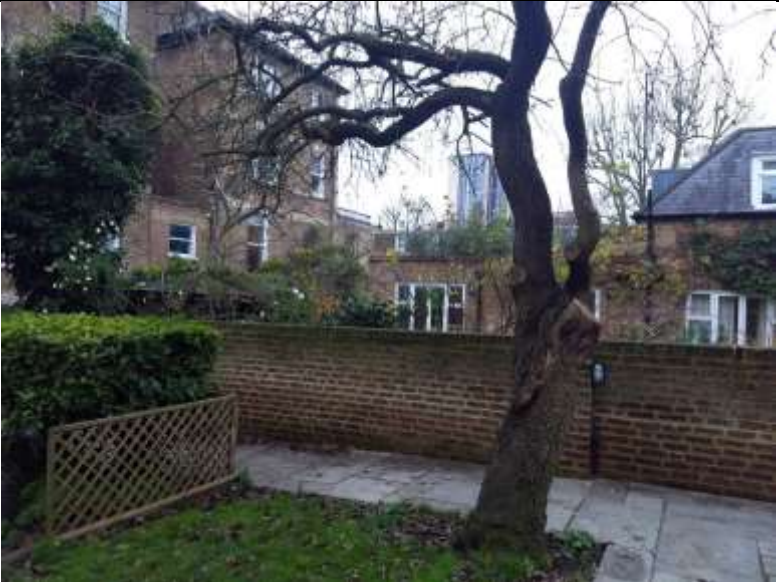
The other tree is a mature pear tree categorized as a B grade specimen on landscape grounds. A sub-dominant stem has been removed resulting in a somewhat asymmetric form with a bias to the south west.

This is more pronounced as a result of a 30° lean in the stem to the west that is historic, as evidenced by the gradual straightening up of the stem higher up.

<p>Photo 4</p> <ul style="list-style-type: none"> • T1 looking west

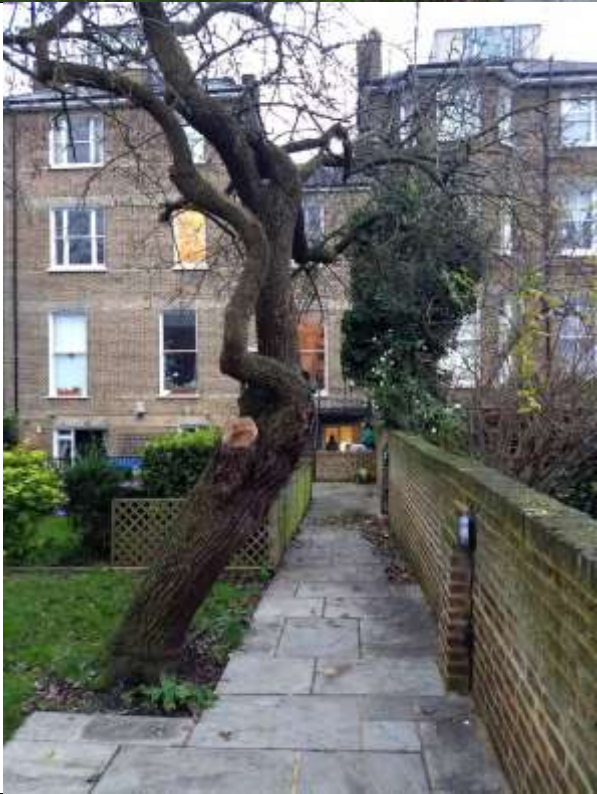
Since a lower limb extends westwards over the path at 1.5m (and rising), the tree is vulnerable to mechanical damage from materials being brought onto site.

<p>Photo 5</p> <ul style="list-style-type: none"> • Overhang of T1 over path

Suitable precautions, as detailed in the AMS, will be required to protect the branch from physical damage.

Wrap 4 layers of hessian
around overhanging limb

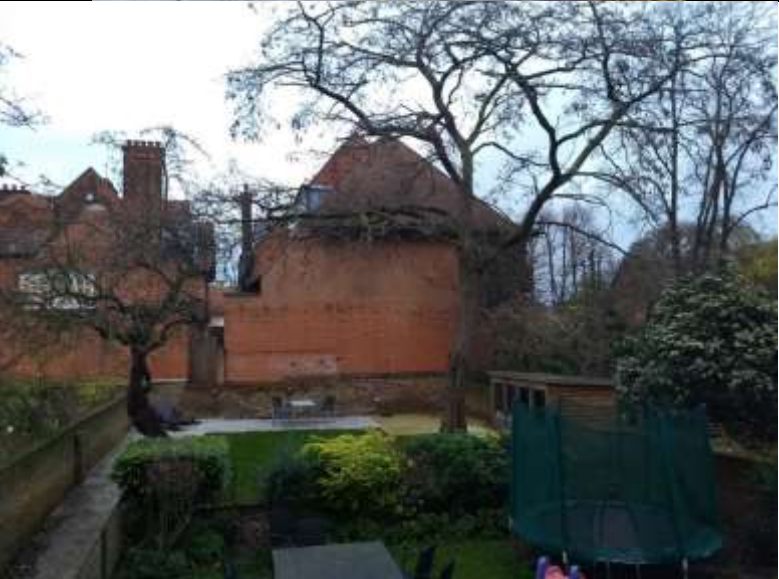
There are only two trees noted in the garden, one of which, the large black locust, is subject of a No Objection Notice to be removed and is not specified in the report but shown on the tree survey plan.

<p>Photo 6</p> <ul style="list-style-type: none"> • Overview of rear garden • Mature black locust has permission to be removed
