# Arboricultural Method Statement & Tree Protection

Property address  
Flat A  
25 Maresfield Gardens  
London  
NW3 5SD

Inspection date: Friday 27<sup>th</sup> January 2021

Date of Report : 28<sup>th</sup> January 2021

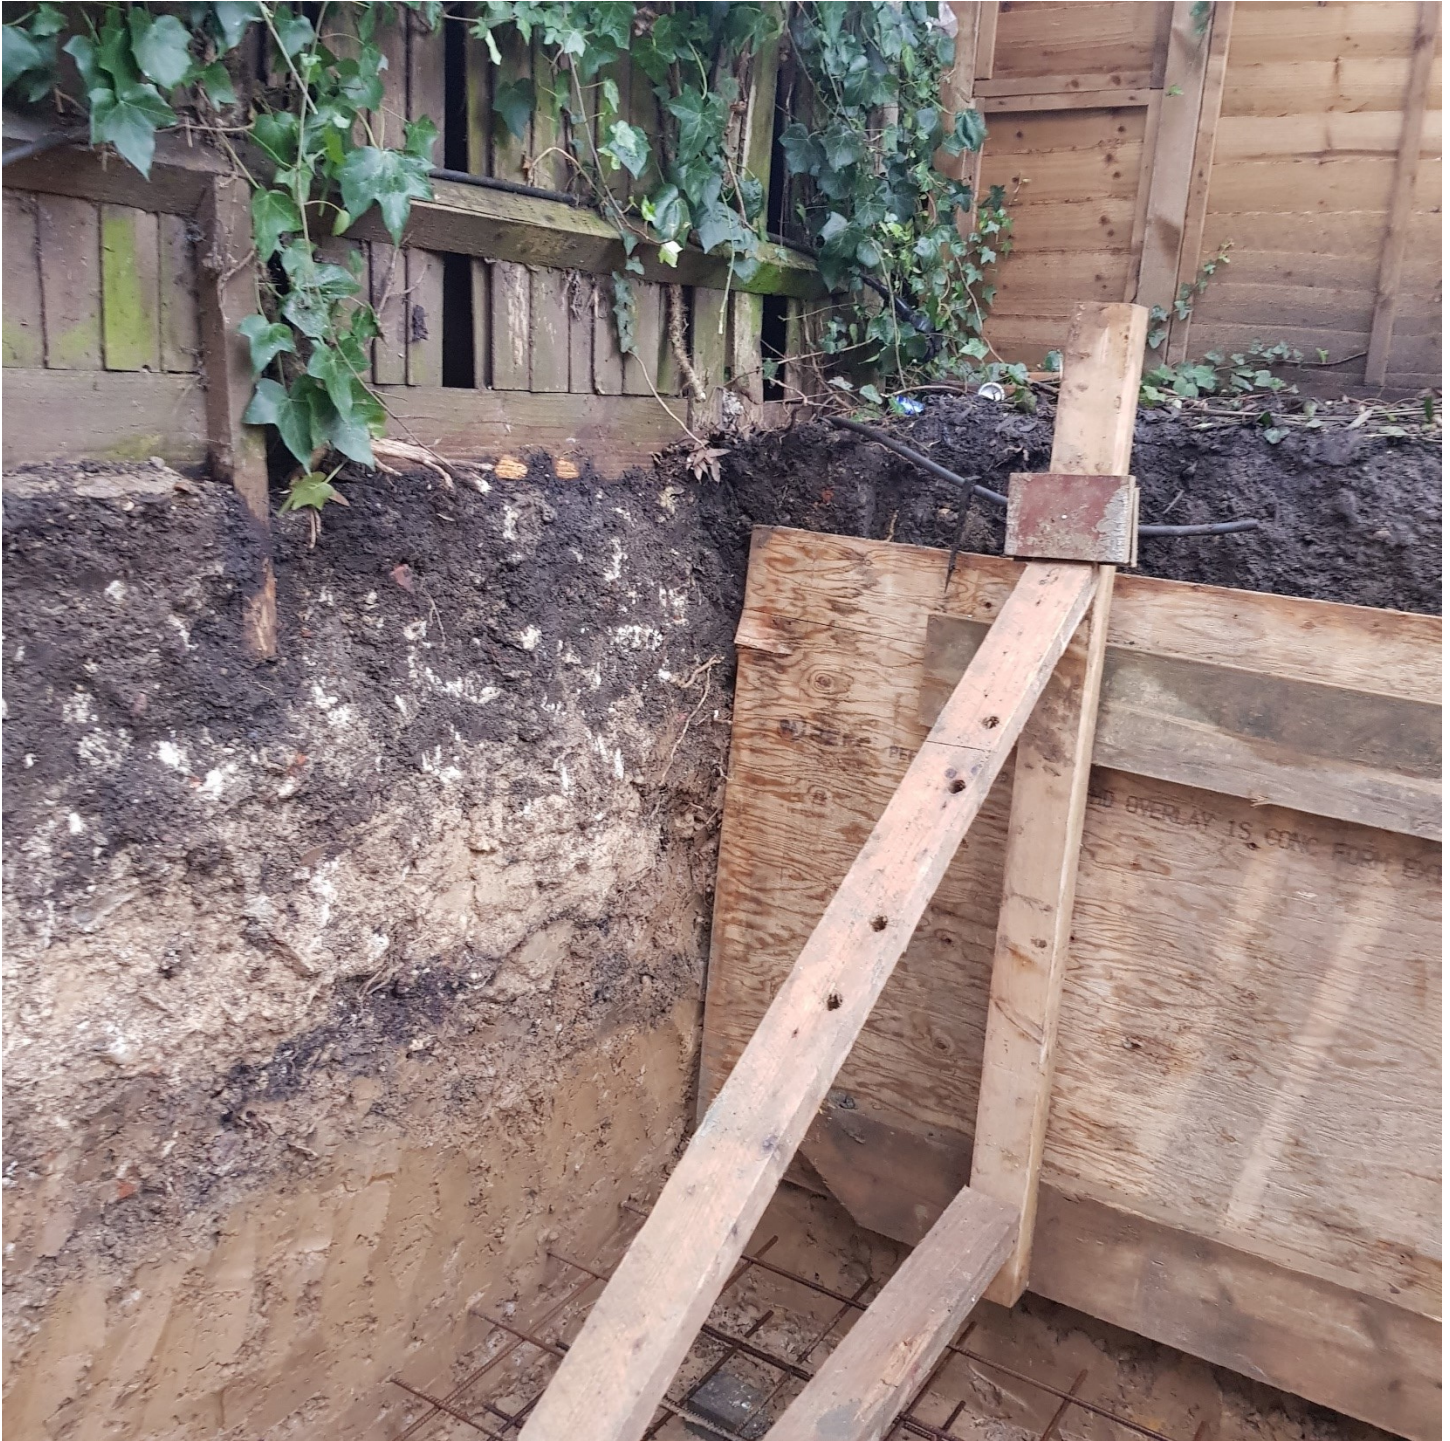
Some construction work in the form of a reduction in the level of the No.25 rear garden within the rear left section of the garden has already occurred.

Expressed as a percentage of the root protection area, around 2% to the edge of the root protection area has been dug out and disturbed. This work was carried out prior to my inspection or involvement and without my prior knowledge or approval.

Unfortunate as it is that some digging work has been carried out in the theoretical root protection area of the tree; in view of the above, I think it highly unlikely that any significant roots have been disturbed.

This is further confirmed by the below photograph showing the ground reduction works that do not show any large roots adjacent to the trench. The small scale visible roots may also emanate from the ivy bush as seen in the photograph.

Photograph 01 showing the trench to the rear of the No.25 garden. Note the concrete foundations above the clay and the lack of visible significant roots.

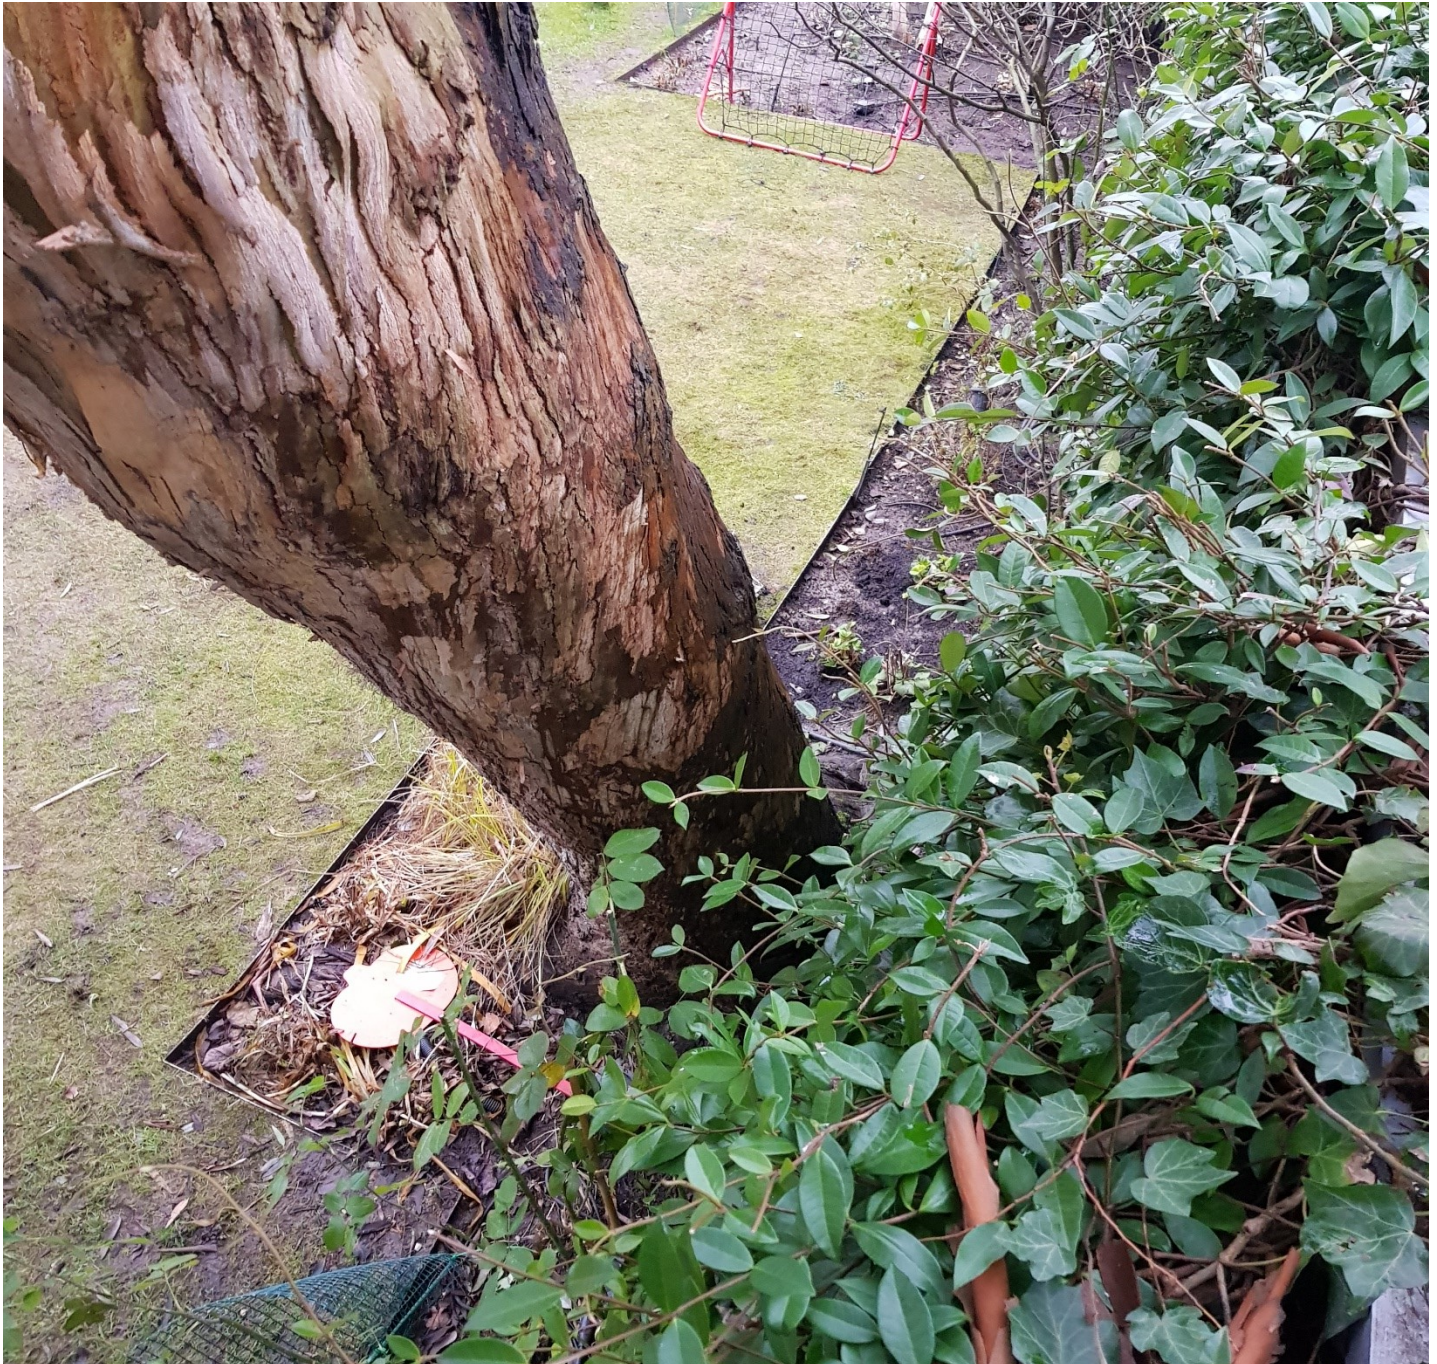
Photograph 02 – showing the tree stem

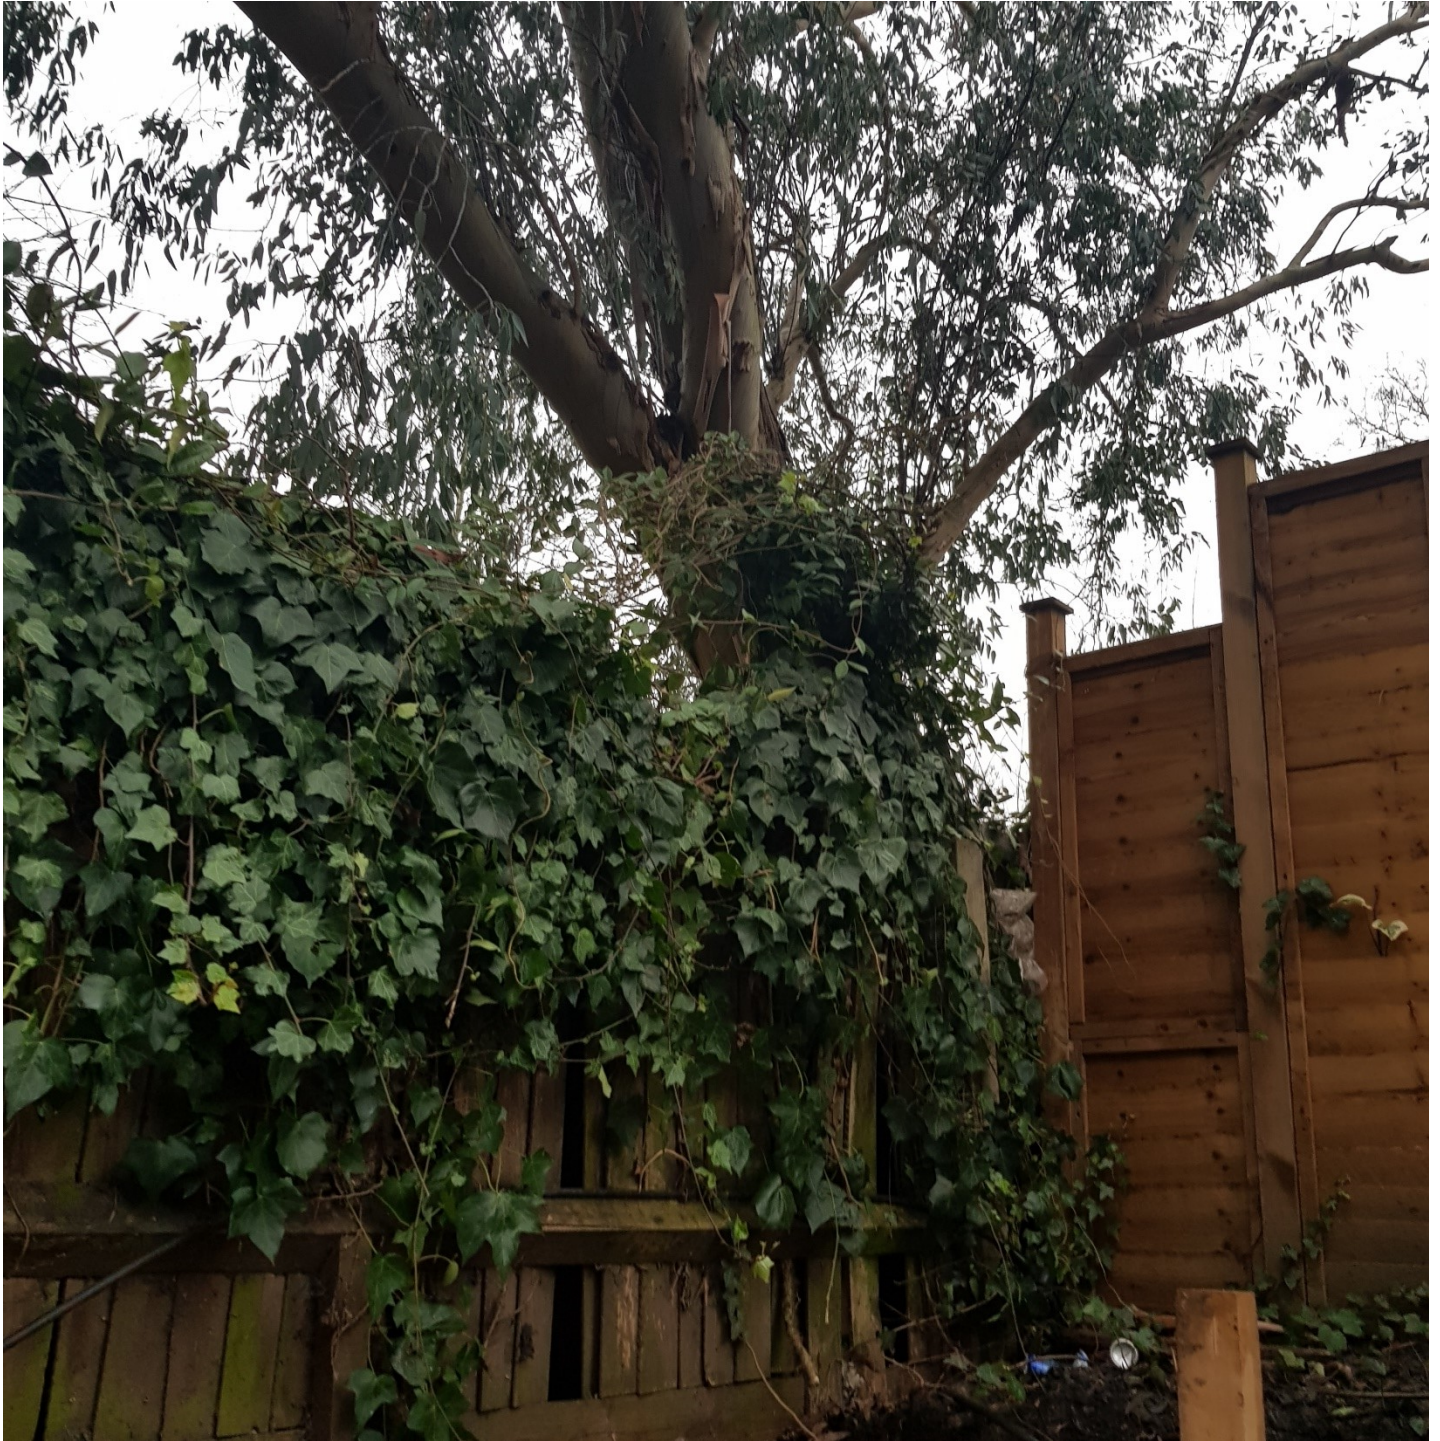
Additionally, the concrete foundations for the separating fence between the gardens of No.23 & No.25 close to the tree effectively form a root barrier to stop tree roots spreading into the No.25 garden.

Photograph 03 showing the garden fences separating the tree from the No.25 rear garden

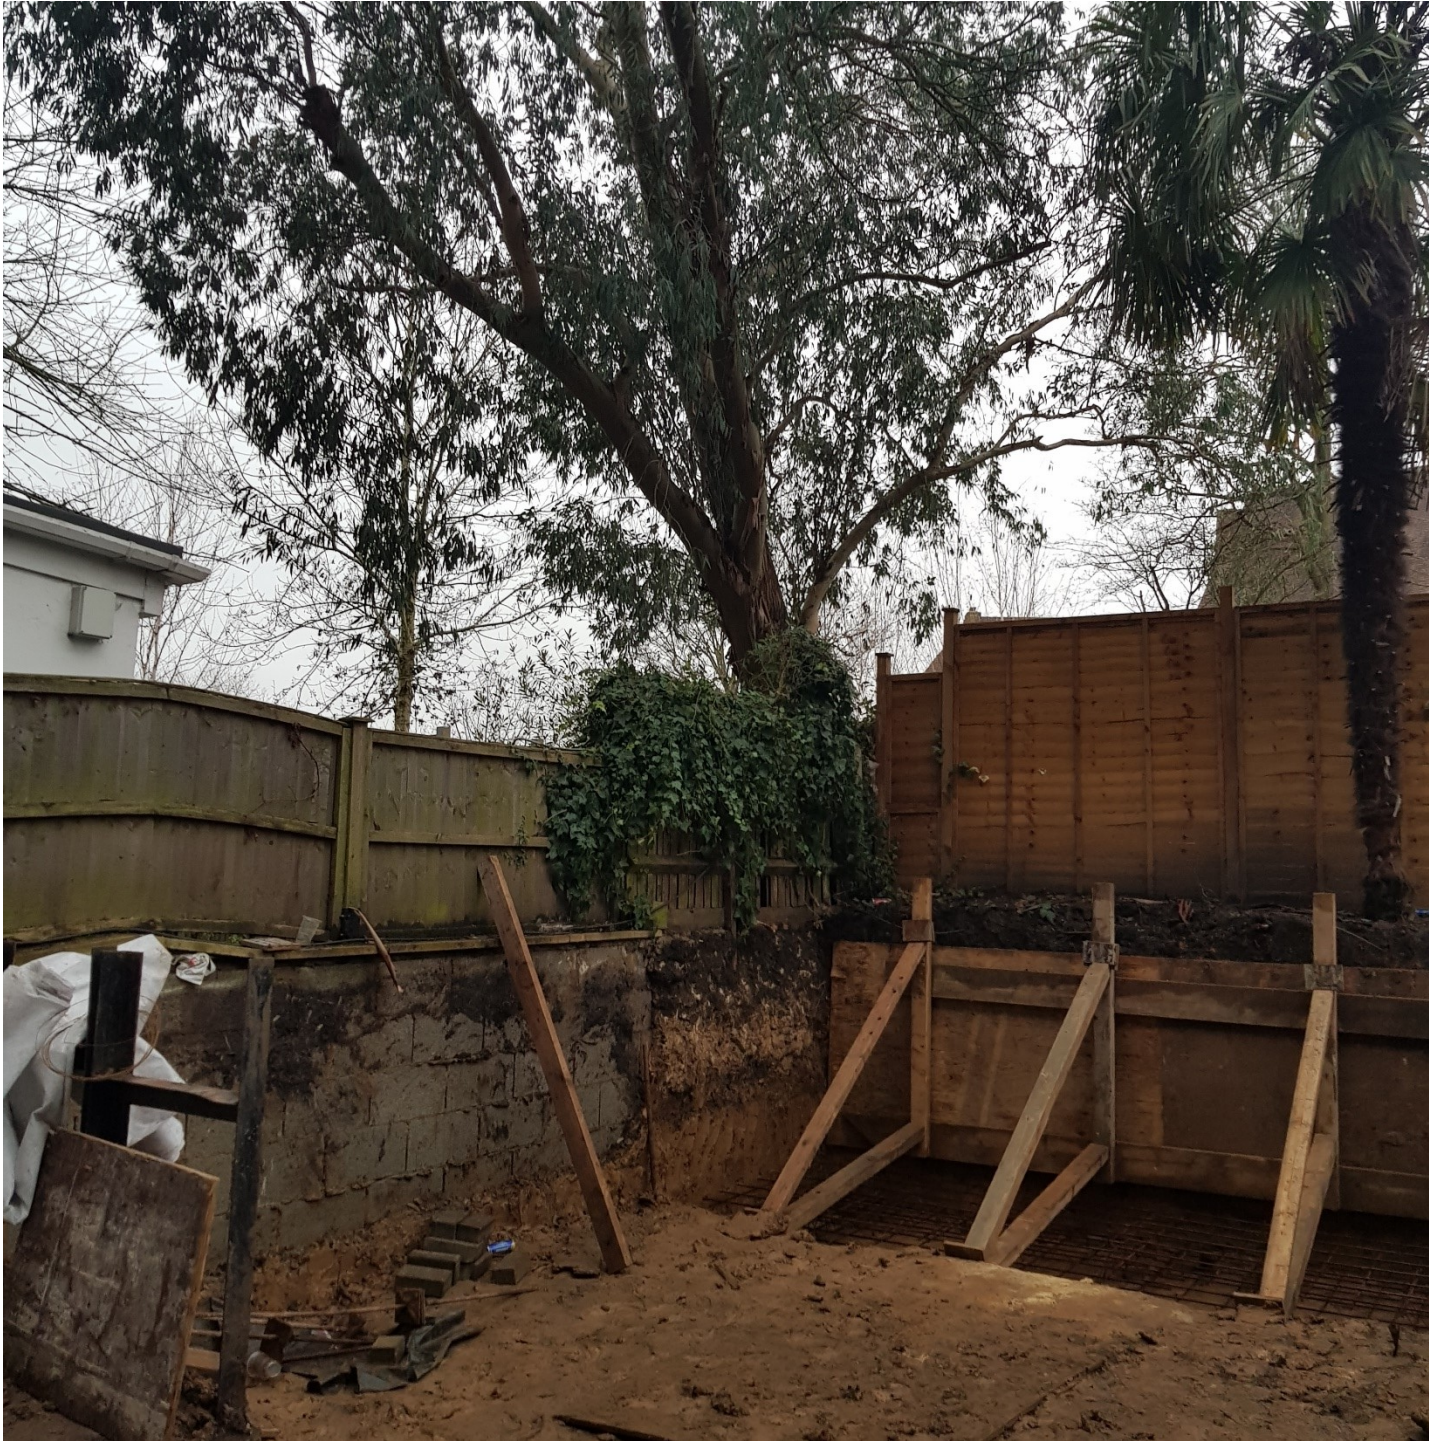
The previously existing ground level in the main part of the rear garden of No.25 was between 1.4m and 1.6m higher than the ground level of the tree and in the garden of No.23.

As the soil in the No.25 garden is around 1.4 - 1.6m higher than the tree rooting level, it is unlikely that there will be significant tree roots in this soil due to reduced levels of nutrients, air and water at deeper levels of the soil.

Photograph 04 – showing the tree and No.25 rear garden. Note the No.23 tree ground level is approximately at the bottom of the block wall
