Shaldon Mansions Lightwell - Context photos

Introduction

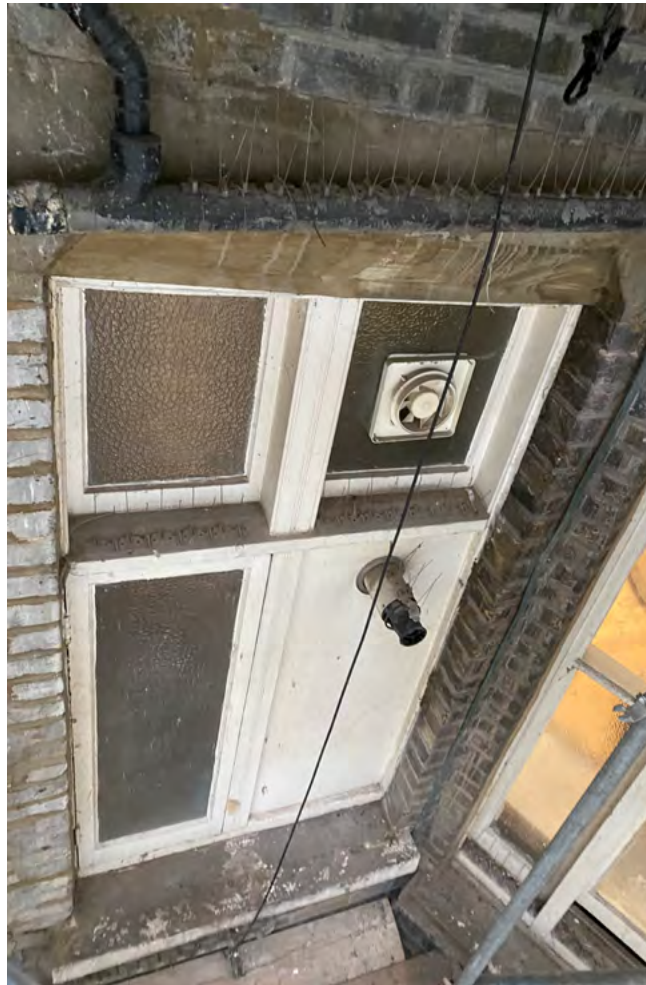
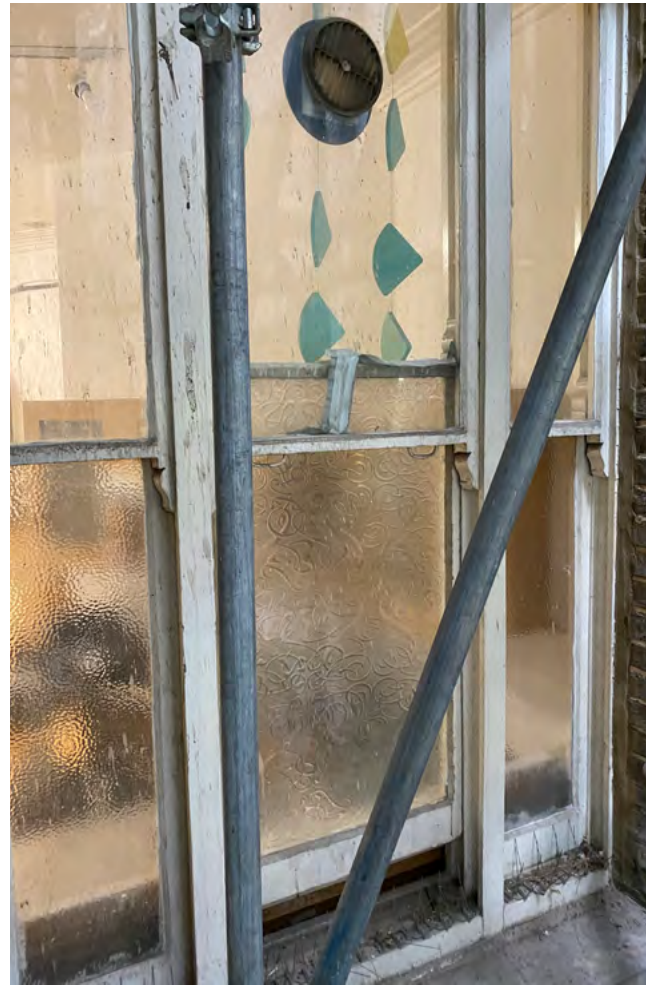
1st floor windows.
Left hand window is fully obscured.
Right hand window partially frosted at low level.

1st floor level - south side, looking north (beneath a temporary scaffold).

Both form part of new double aspect apartment currently being reconfigured. Windows are replaced as part of the recent planning consent. Daylighting into the spaces is improved considerably.

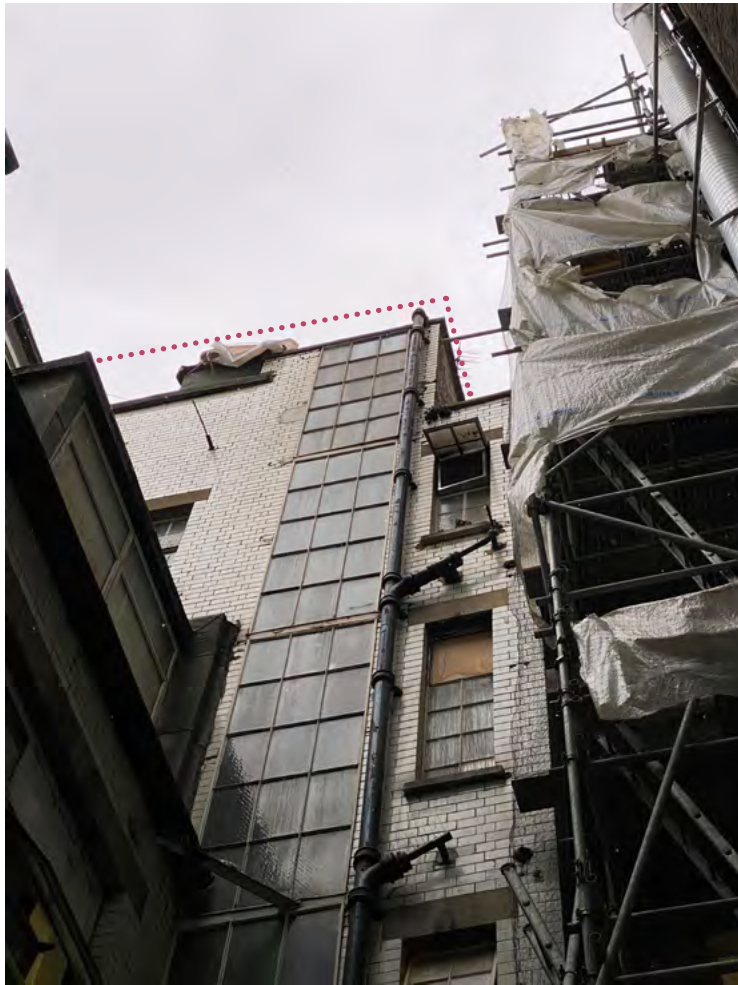
2nd floor
Window to kitchen -
Triple aspect
apartment

View from 2nd floor looking south side - Northside windows visible opposite.

All windows are replaced as part of the recent planning consent. Daylighting into the spaces is improved considerably.

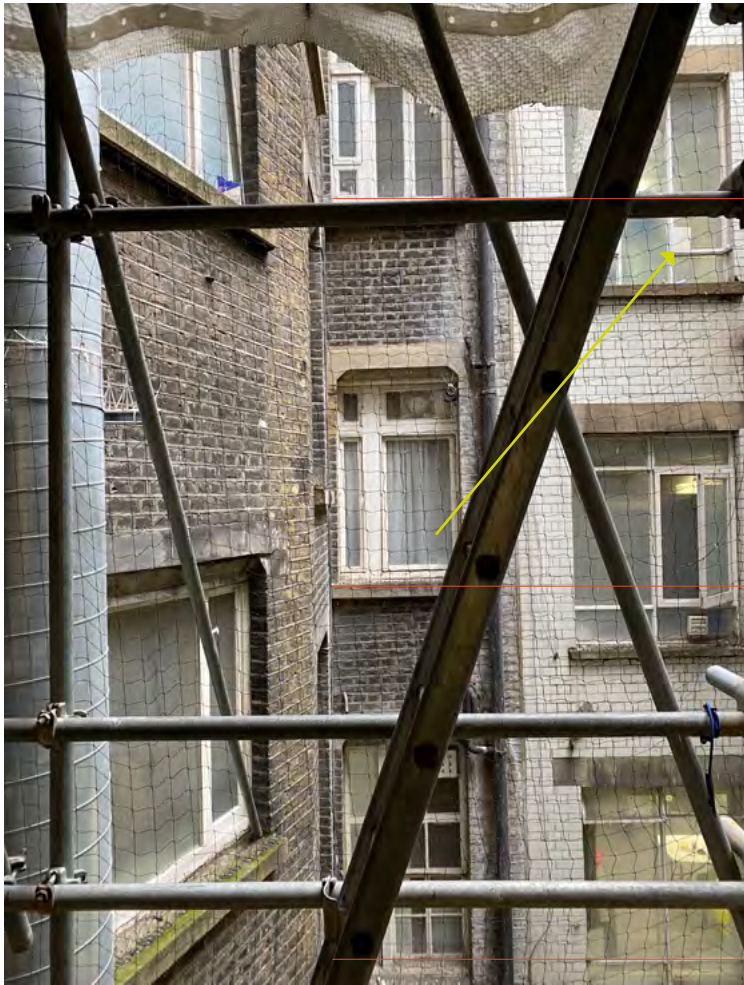
1st floor
Toilet to Dentists
practice

View from 1st floor looking south (2nd floor window is higher than this so view would be 'improved').

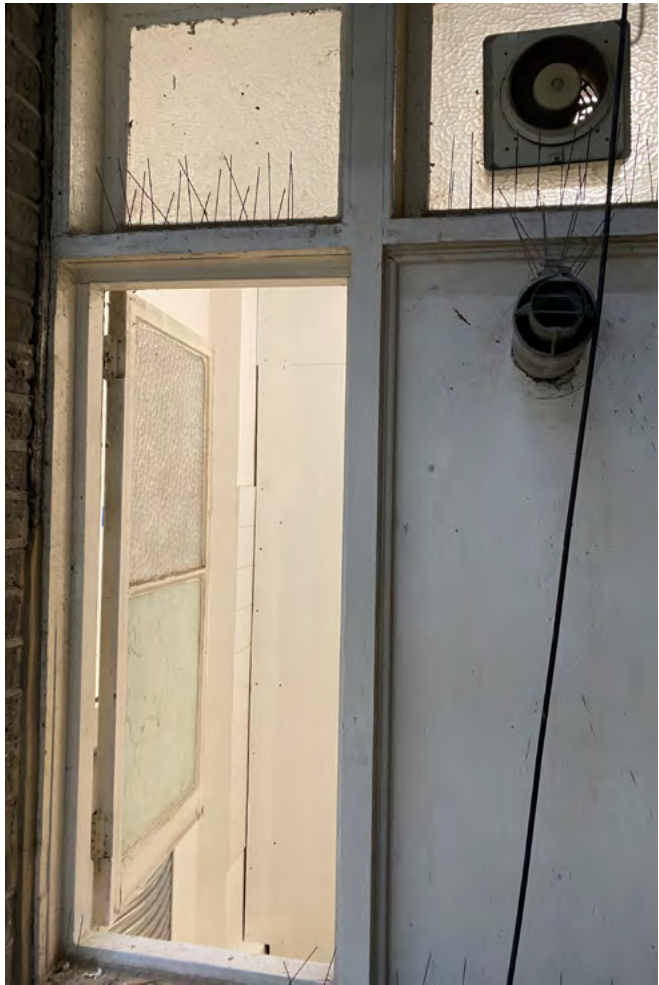
2nd floor window (currently a toilet)

Both windows form part of new double aspect apartment currently being reconfigured. Windows are replaced as part of the recent planning consent. Daylighting into the spaces is improved considerably.

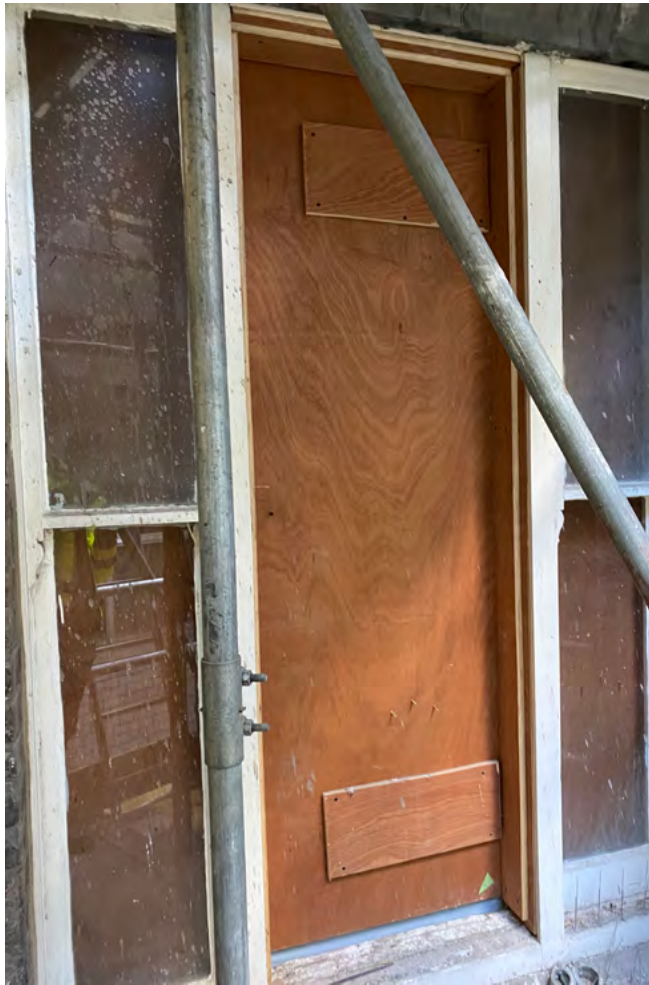
2nd floor toilet window (currently a site office reception)

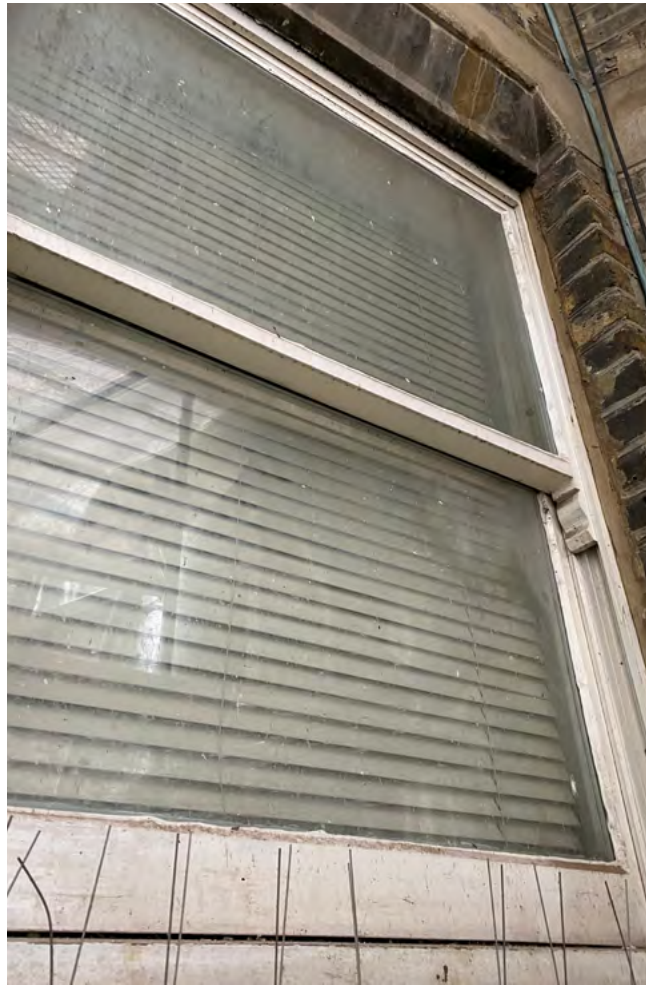
3rd floor south side shower room
(Double aspect apartment).

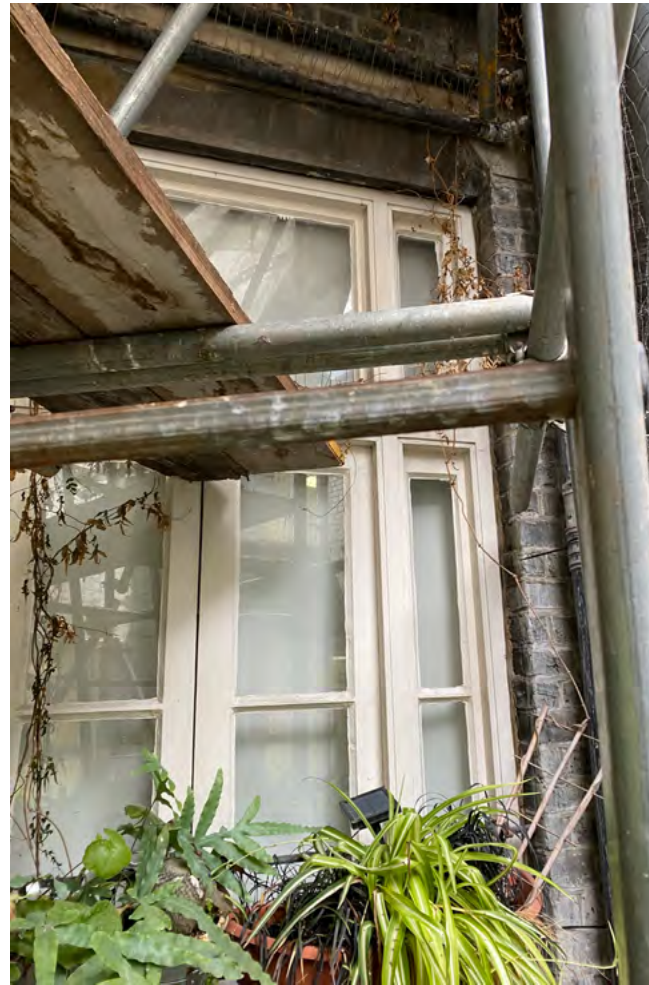
3rd floor south side kitchen
(Double aspect apartment).

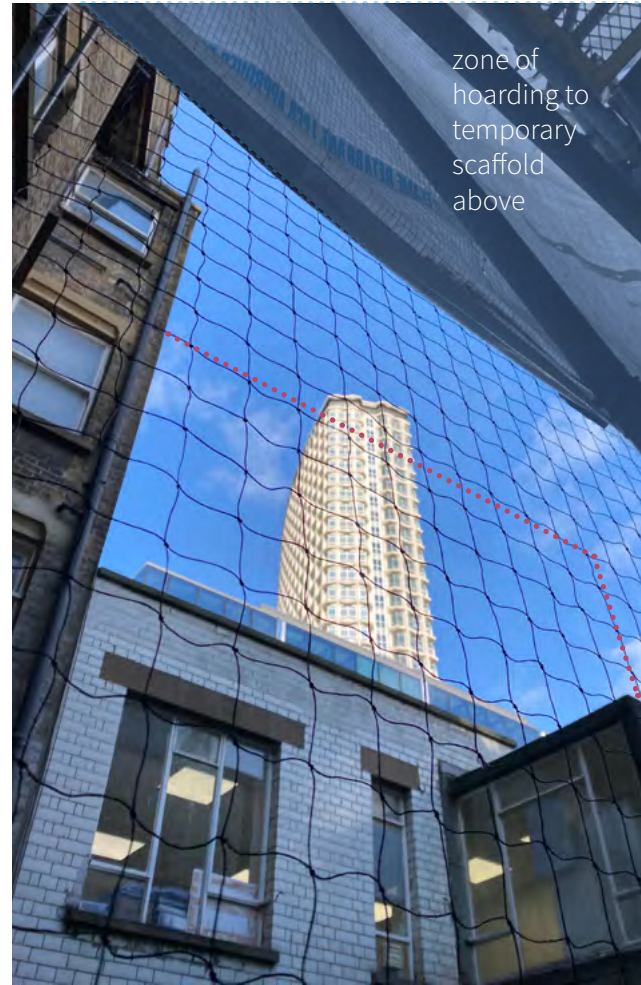
zone of
hoarding to
temporary
scaffold
above

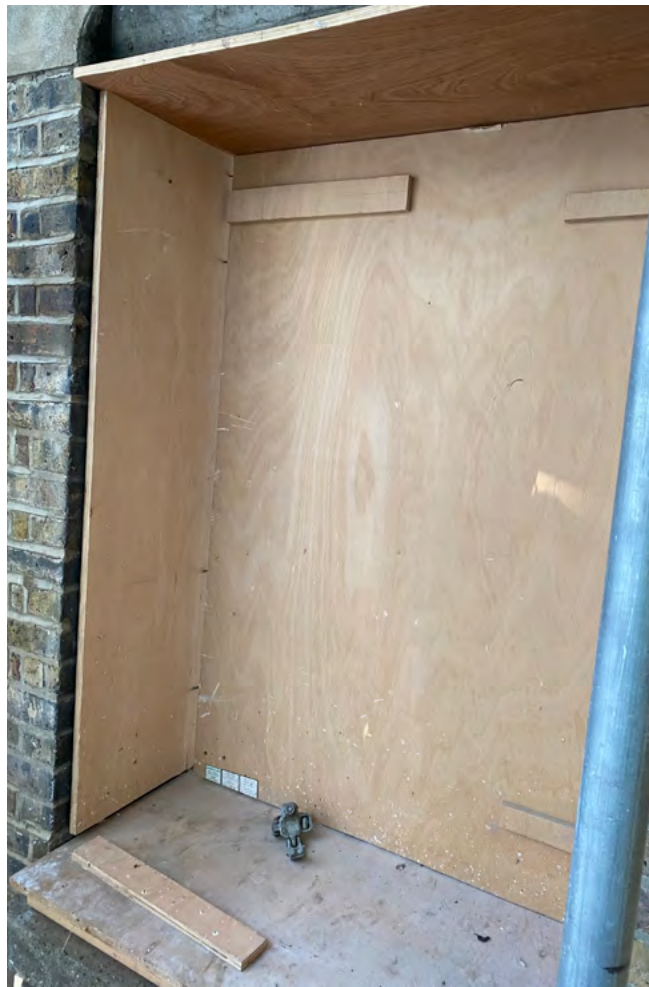
3rd floor south side. Unused.

Both form part of new double aspect apartment currently being reconfigured. Windows are replaced as part of the recent planning consent. Daylighting into the spaces is improved considerably.

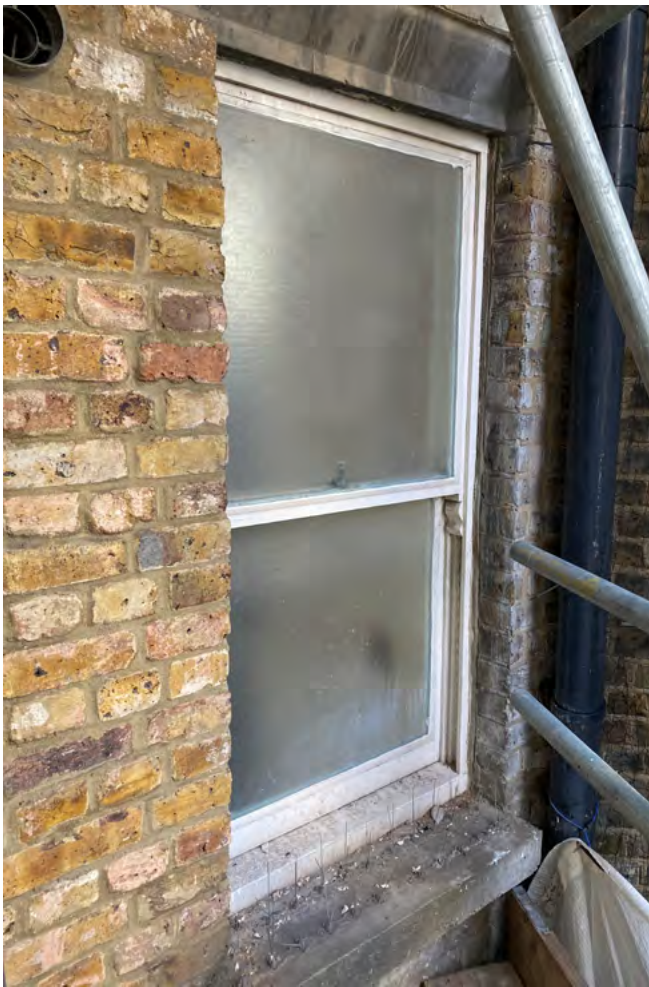
3rd floor south side former kitchen. Unused.
