- 1.1 This report has been completed by Martin Shortt (MIStructE, CEng) for Harrison Shortt Structural Engineers Ltd.
- 1.2 Harrison Shortt Structural Engineers Ltd. have been appointed by Mrs Janet Jacobs to advise on the proposed refurbishment works to 33 Cumberland Terrace including forming the opening through the party wall between the Dining Room (2.08) and Reception Room (2.09).
- 1.3 Our client does not currently own the property as such it has not been possible to complete opening up works.
- 1.4 We have not visited the building.

- 2.1 The existing building is a Grade I listed five storey (including lower ground floor) building constructed in 1826 as a series of terraced houses.

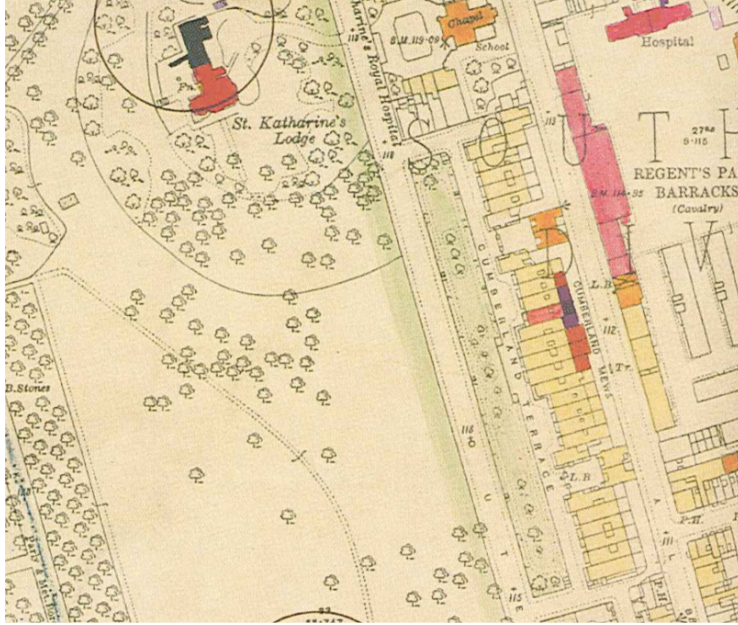
#### 3.1 London County Council Bomb Damage Maps 1939-45.

- 2.6 The building is likely to be founded on corbelled brickwork foundations on London Clay.
- 2.7 The building was severely damaged during World War II and the building was rebuilt in 1959 with a concrete frame and concrete beam / clay pot floors. Refer to 3.1 showing the bomb damage and 3.2 showing the rebuilt structure.

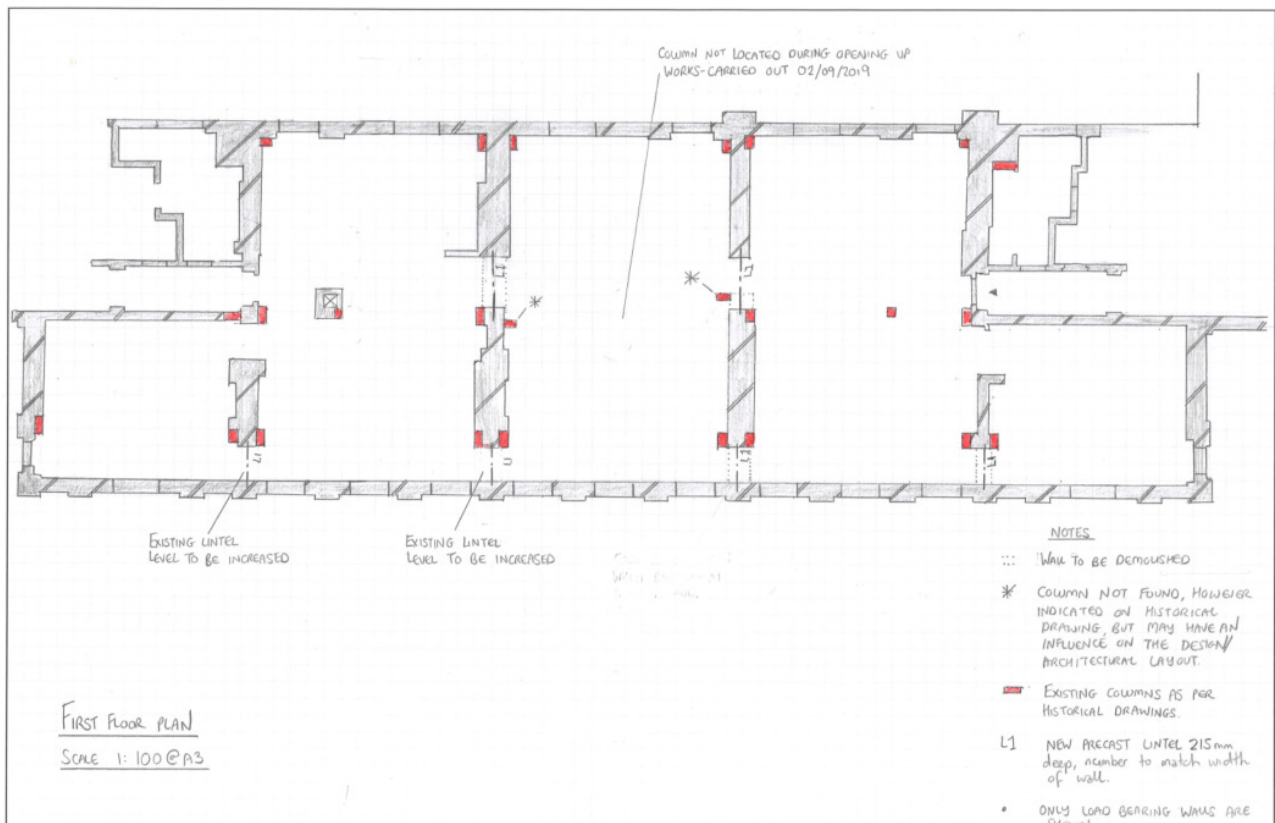
#### 3.2 Price and Myers drawing showing existing structure and proposed works 31 and 38 at first floor.

- 2.12 No.31 is on the first floor and directly beneath No.33.
- 2.13 As part of the works completed at No.31 on the first floor in 2019/20 openings were formed through the party walls at the front of the building. Refer to 3.2 below.

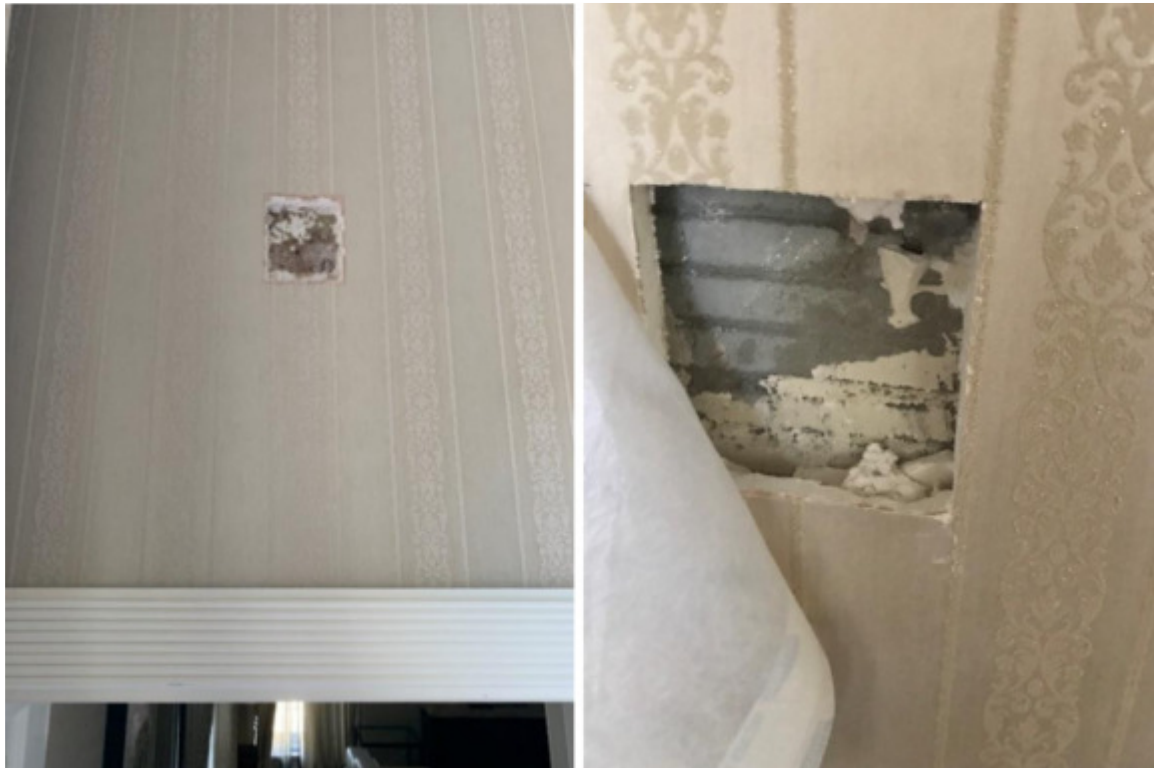
- 2.8 Parts of the front and party walls were rebuilt as part of these works with concrete / blockwork. Refer to 3.3 showing the junction of the front and party walls at No.31 at first floor level.

**3.3 Openings made within the existing party wall at No.31 at first floor showing concrete construction.**

- 4.1 The proposed works involve forming an opening through the party wall to connect the Dining Room (2.08) and Reception Room (2.09).
- 4.2 The front and party walls were rebuilt in 1959 with concrete / blockwork at first floor and second floor level. Refer to 3.3 showing the junction between the front and party walls at No.31 at first floor level.
- 4.3 The party wall between the Dining Room and Reception Room appears to be 18 ½" thick (470mm). It will be necessary to install 4No. Supreme R22A precast concrete lintels (215mm deep x 100mm wide) with 150mm minimum bearing.
- 4.4 The lintels should be installed using a "half and half" method where 2No. lintels are installed from one side of the wall and drypacked in place and then the other 2No. lintels are installed from the other side of the wall and drypacked. The reveals should be rebuilt when the lintels are installed.
