Version: 2.0

6th October 2020

Proposed Removal of Asbestos - Dr Williams's Library: Heritage Statement

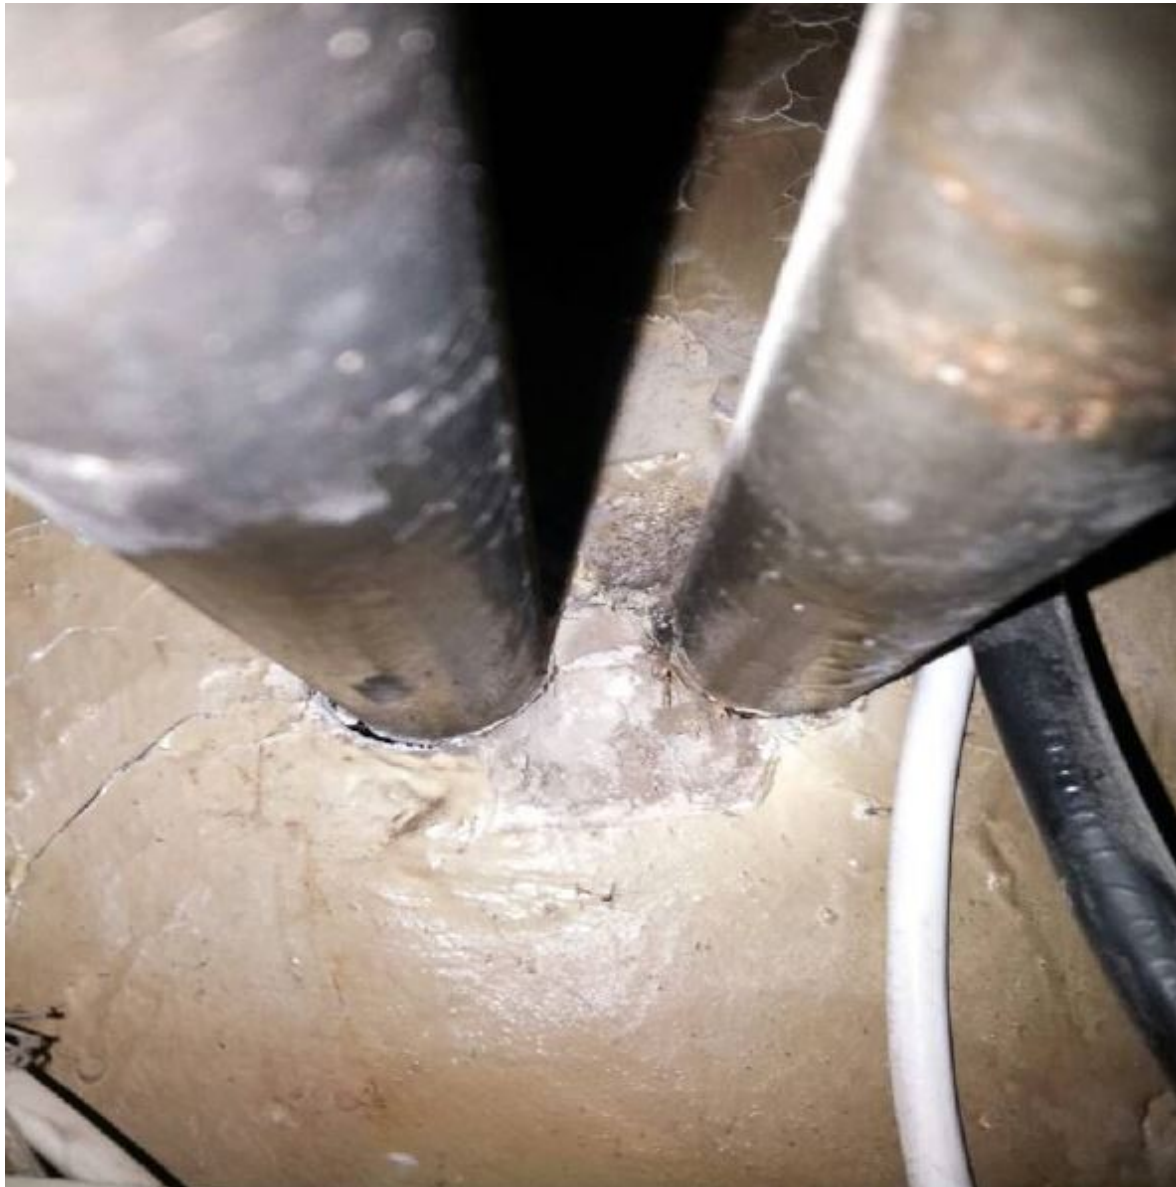
Figure 17: Extract from RPS Asbestos Survey Report 2017 – Photo of Pipes Penetrating Wall in Basement Level 1

-1/007	Present	B507788B	Insulation Products	Pipe insulation in wall cavity at pipe penetration	<1 sqm	10/A	13/11/2017
		Recommendations: Seal gap around pipe penetrations leading to wall cavity and label appropriately. Re-inspect at recommended intervals.					
-1/010 Archive	Present	B507787B	Cement Products	Ceiling panels above metal ceiling	18 sqm	3/D	17/05/2018
		Recommendations: Re-inspect at recommended intervals.					
-1/011 Store	Limitations	-	-	Access limited by stored items	-	TBC	Before Works
		Recommendations: Non-accessed area. This area should be regarded as containing asbestos until assessed by a competent person.

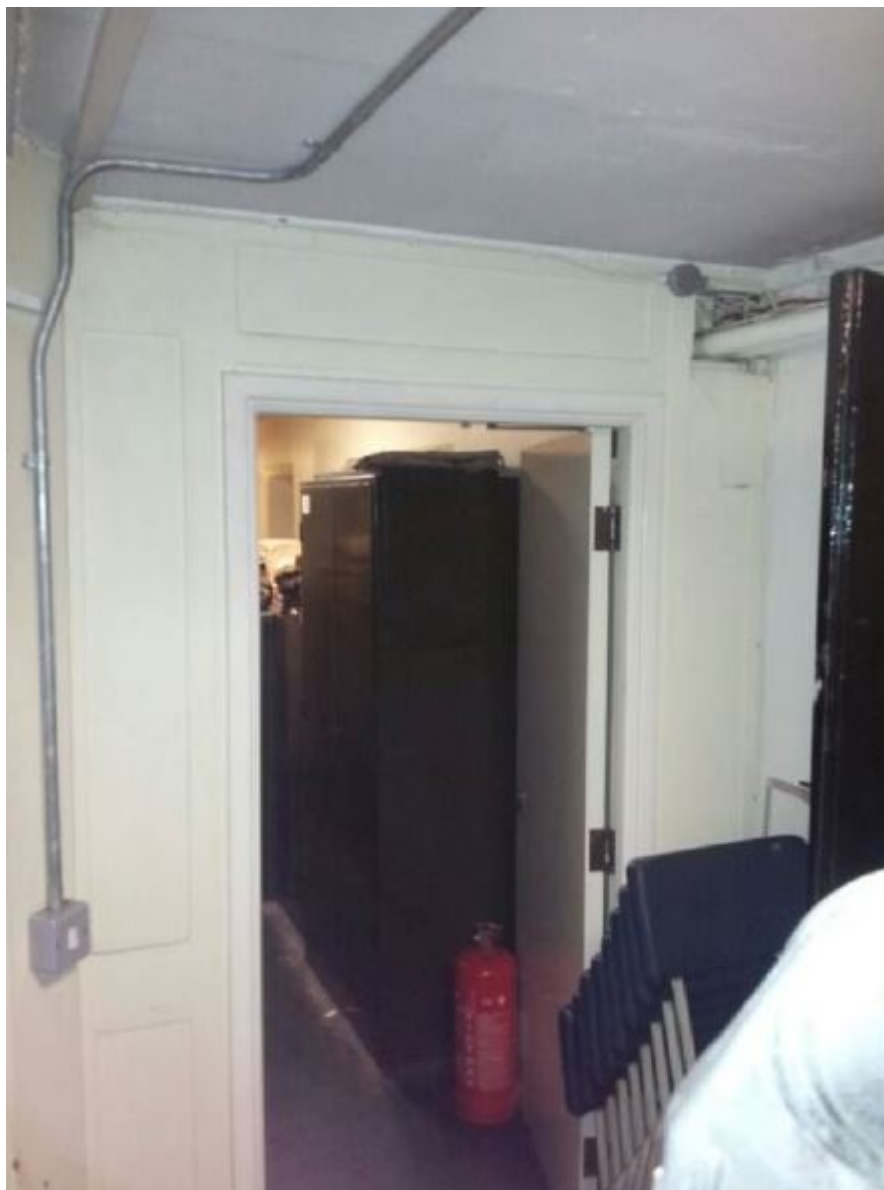
Figure 19: Extract from RPS Asbestos Survey Report 2017 – Photo of Insulation Boards around doorway on Ground Floor Level 2 Stair Lobby

10	Rm 0/010 Stair Lobby – remove insulating boards panels around door.	C20 insulating boards around door.	Residue – Detrimental and Historic Fabric - Negligible	Remove insulation panels. Drill out any fixing holes and fill with filler.	Care taken to minimise damage to historic fabric.	Slight loss of historic fabric around fixing holes to ensure all asbestos material has been safely removed. Negligible Impact	Neutral
11	Rm 0/011 Corridor - remove insulating boards panels around door.	C20 insulating boards around door.	Residue – Detrimental and Historic Fabric - Negligible	Remove insulation panels. Drill out any fixing holes and fill with filler.	Care taken to minimise damage to historic fabric.	Slight loss of historic fabric around fixing holes to ensure all asbestos material has been safely removed. Negligible Impact	Neutral
12	Rm 0/015 Store - remove insulating panels behind shelves	C20 insulating boards behind shelves	Residue – Detrimental and Historic Fabric - Negligible	Remove insulation panels. Drill out any fixing holes and fill with filler.	Care taken to minimise damage to historic fabric.	Slight loss of historic fabric around fixing holes to ensure all asbestos material has been	Neutral

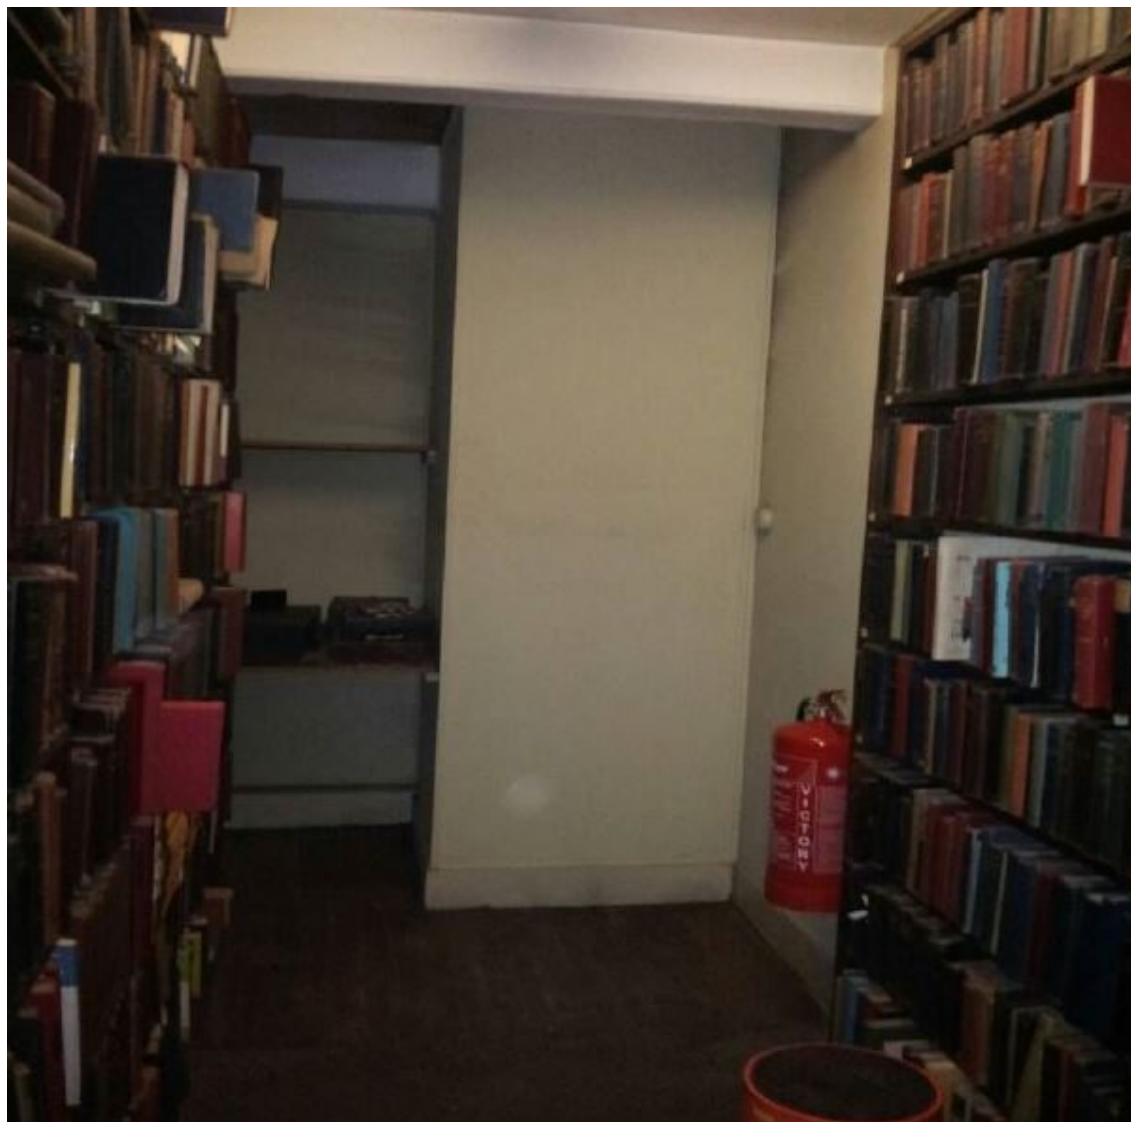
Figure 20: Extract from RPS Asbestos Survey Report 2017 – Photo of Shaft Panelling on Level 6

Level 6						
20	Rm 4/003 Corridor - Remove shaft panels	C20 panels around C20 service shaft	Fabric Detrimental	Remove shaft panels. Drill out any fixing holes and fill with filler.	Care taken to minimise damage to historic fabric.	Slight loss of historic fabric around fixing holes to ensure all asbestos material has been safely removed. Negligible Impact	Neutral
21	Rm 4/005 Office – remove cement panel in bookcase	C20 bookcase	Fabric Detrimental	Remove cement panel in bookcase. If required drill out	Care taken to minimise	Slight loss of historic fabric around fixing holes to ensure all asbestos material has been	Neutral
