**ARBORICULTURAL IMPACT ASSESSMENT REPORT
& OUTLINE METHOD STATEMENT:**

14 Greenaway Gardens
London
NW3 7DH

Ref: DKS/14GRW/AIM/01a

Date: 4th March 2021

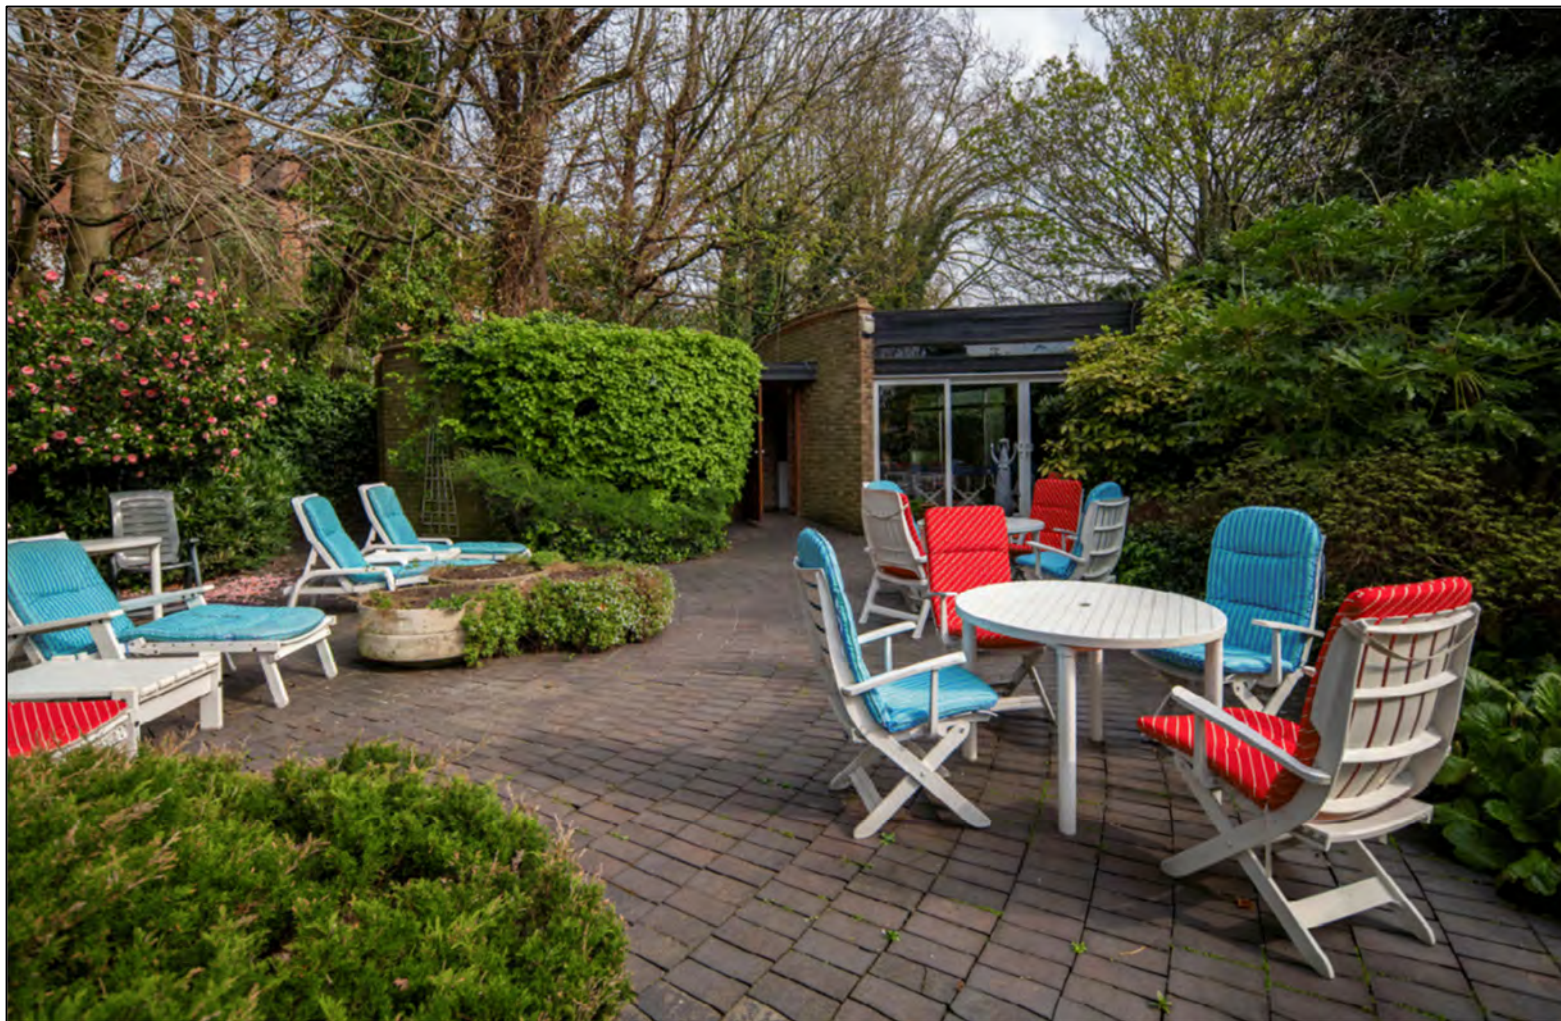
Photograph 2: Summer house and surrounding hard surfacing to be removed

9.8.4 Following removal of the summerhouse and swimming pool, the hard surfacing surrounding them and its sub-base will be broken up using hand-held power tools before being removed by light plant using a toothless bucket working away from trees. This work is to be carried out under arboricultural supervision and the discovery of any significant roots (>25mm diameter) within the sub-base will necessitate the manual removal of the sub-base around them. Exposed sub-base / soil will not be left open to vehicular access, but boarded over for temporary pedestrian access only until the replacement topsoil is introduced.

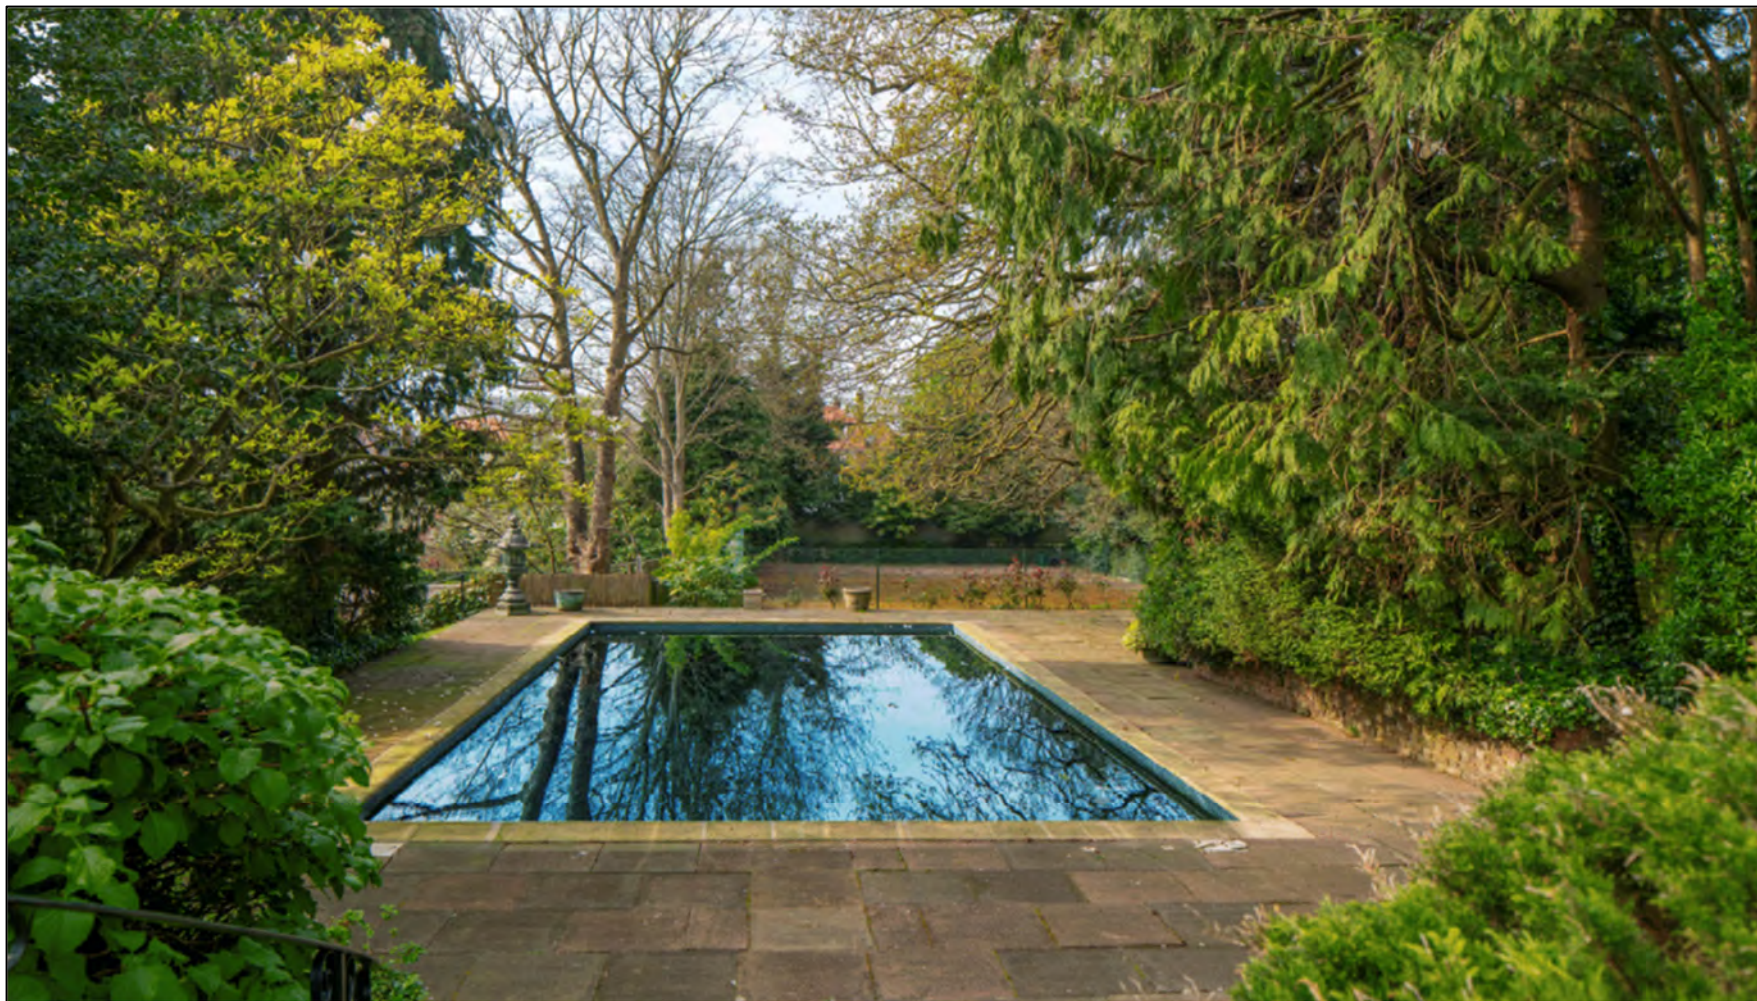
Photograph 3: Swimming pool and surrounding hard standing to be removed

9.8.3 The swimming pool will be broken up using hand held tools only before light plant removes the resulting spoil to the conveyor belt system.

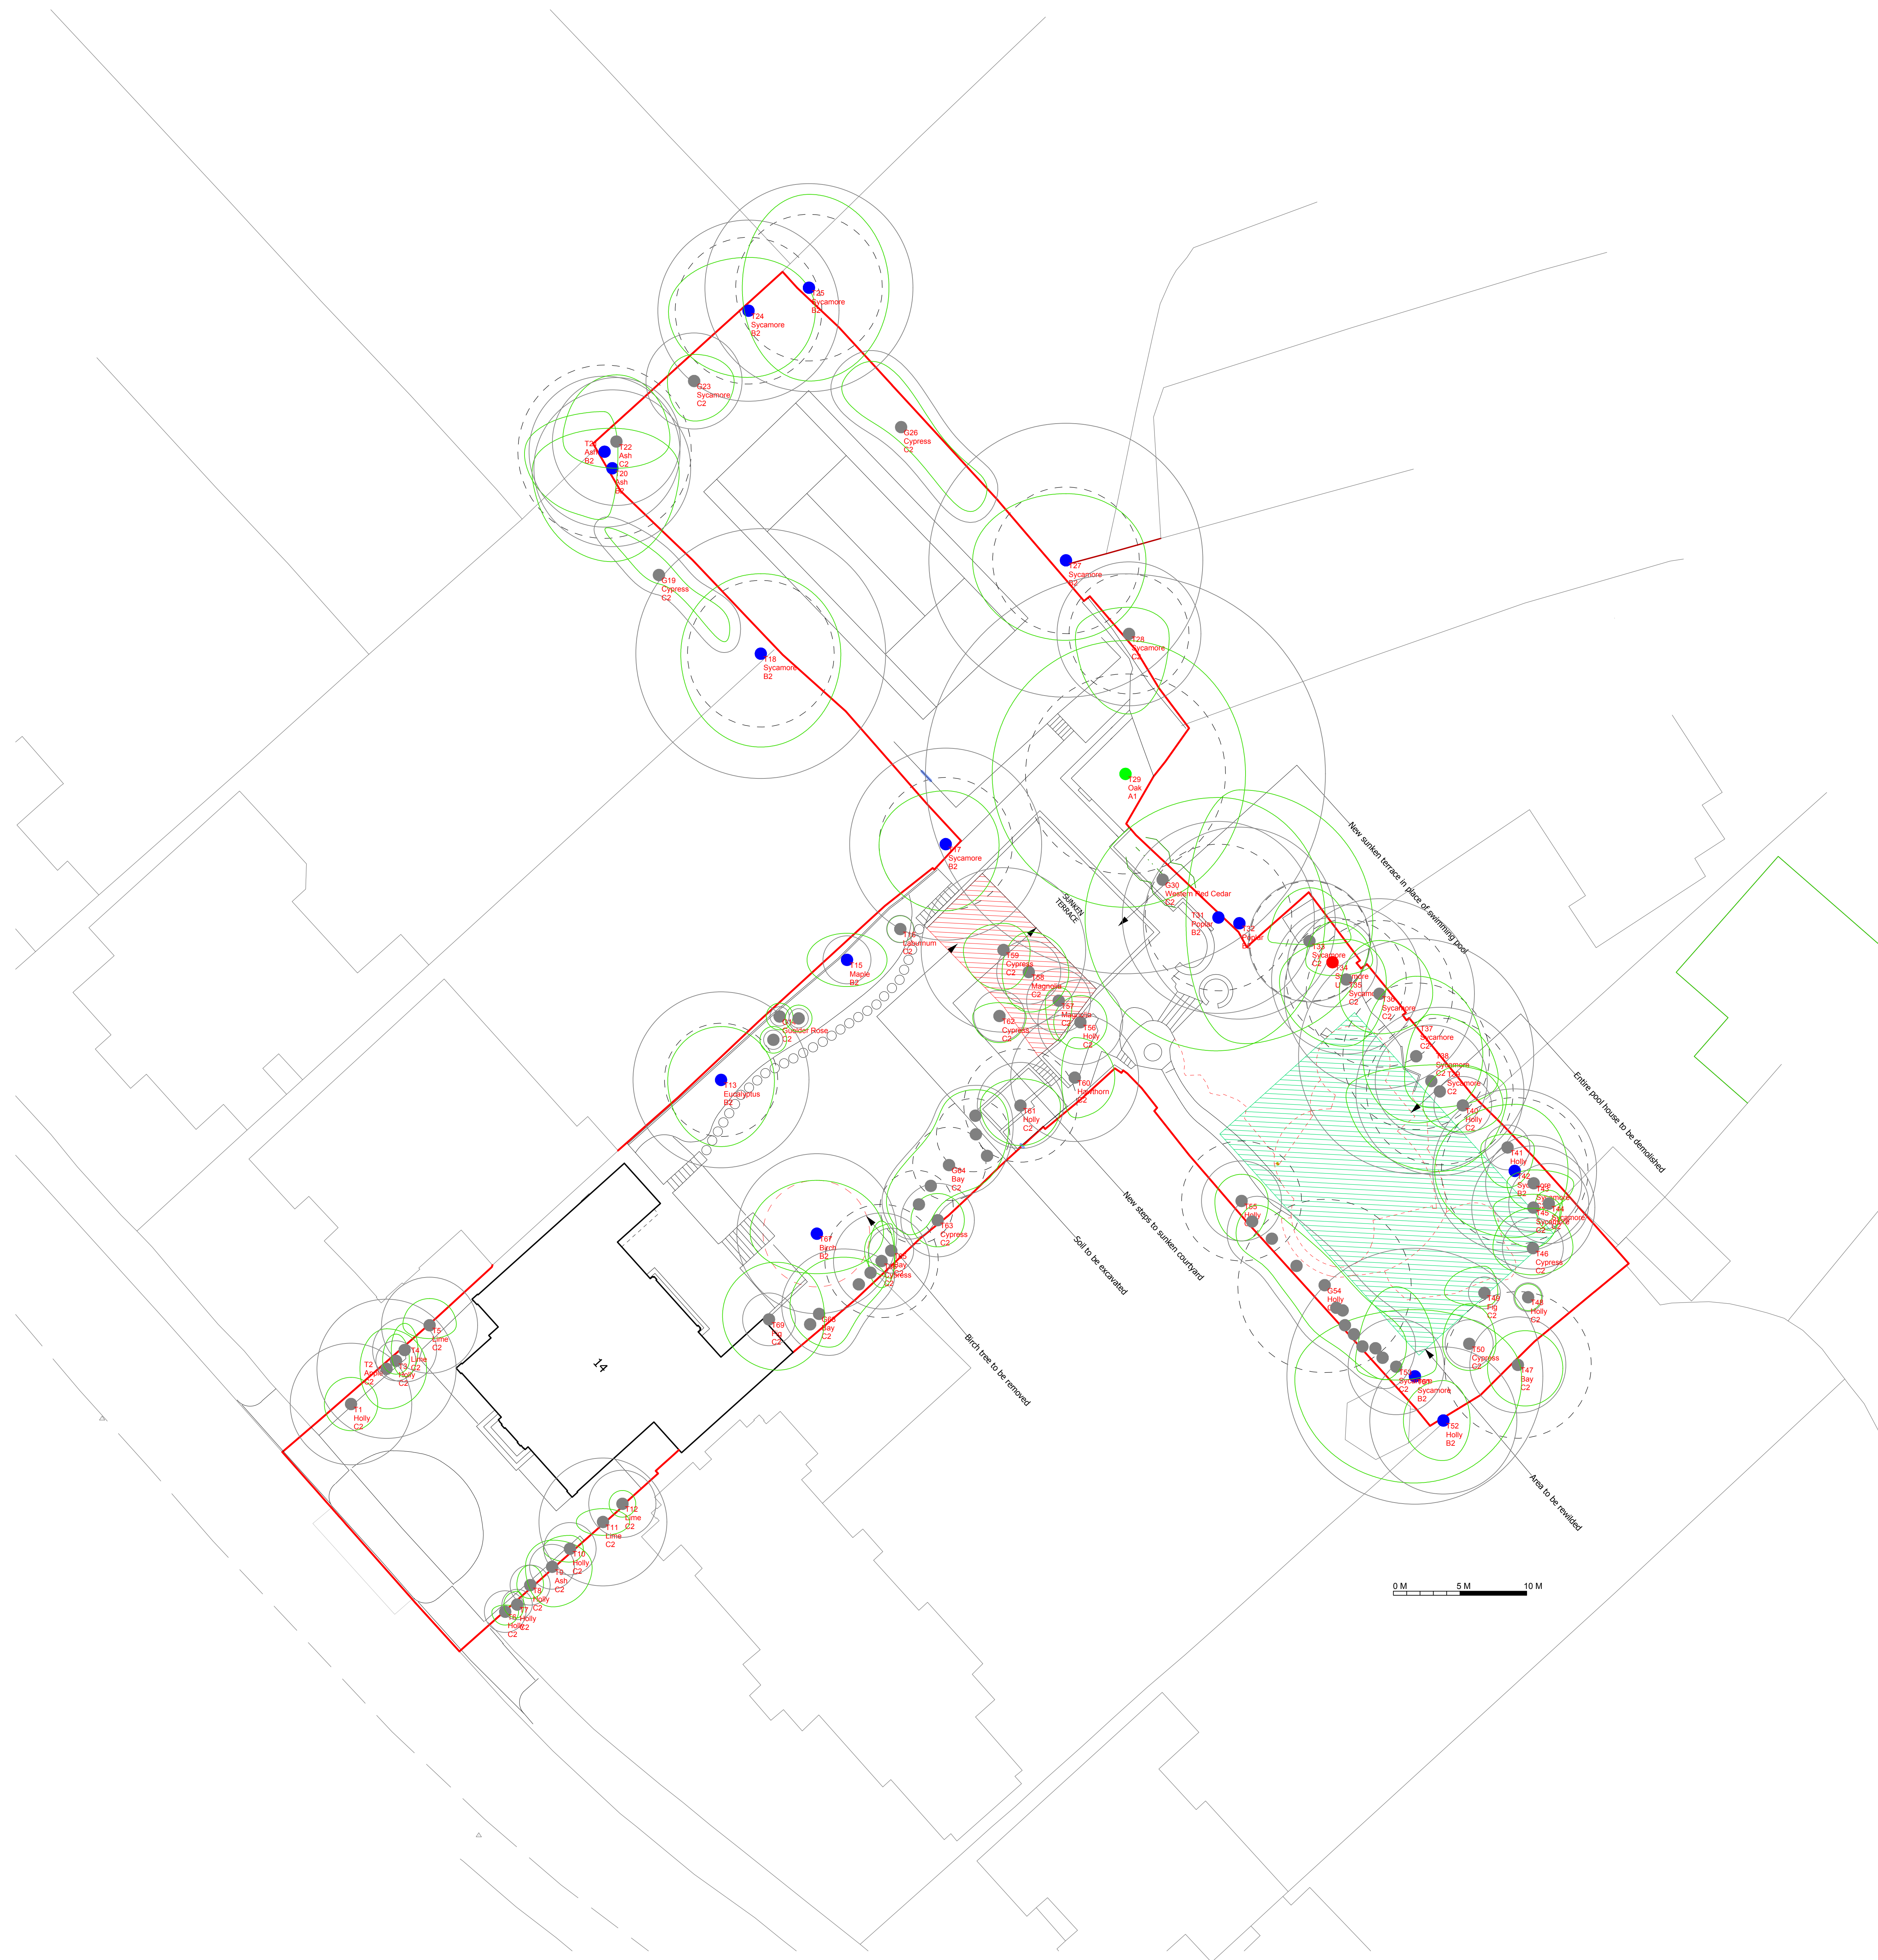
PLAN 2**ARBORICULTURAL IMPACT ASSESSMENT PLAN (S)**

| 6.1.4 | With regard to the groundworks within the RPAs of T17 and T60, the encroachments comprise 11% and 8% of the respective total areas and in the case of T17, trial pit findings indicate the impact will be significantly less than is indicated on plan. Thus, in our view, the tree(s) are of a species, age and condition sufficient to remain viable in the circumstances, given that the area lost to encroachment can be compensated for elsewhere, contiguous with the RPA, and provided the series of mitigation measures outlined below are followed to both reduce the immediate impact of working methods and also improve the soil environment that is used by the tree for growth. Supervision and monitoring of such measures will also be essential. Subject to these provisos the net impacts are assessed as being low. |

| 6.3.2 | RPA encroachments of >5% area are shown in Plan 2 compensated for elsewhere on contiguous land. Soft ground within the unaffected parts of the RPAs of T17 and T60 will be treated with biochar or similar to improve rooting conditions therein. |
