Proposals for the Conservation and Environmental Protection of Window nIII (The Butler Window), Lincoln's Inn Chapel, London

August 2020

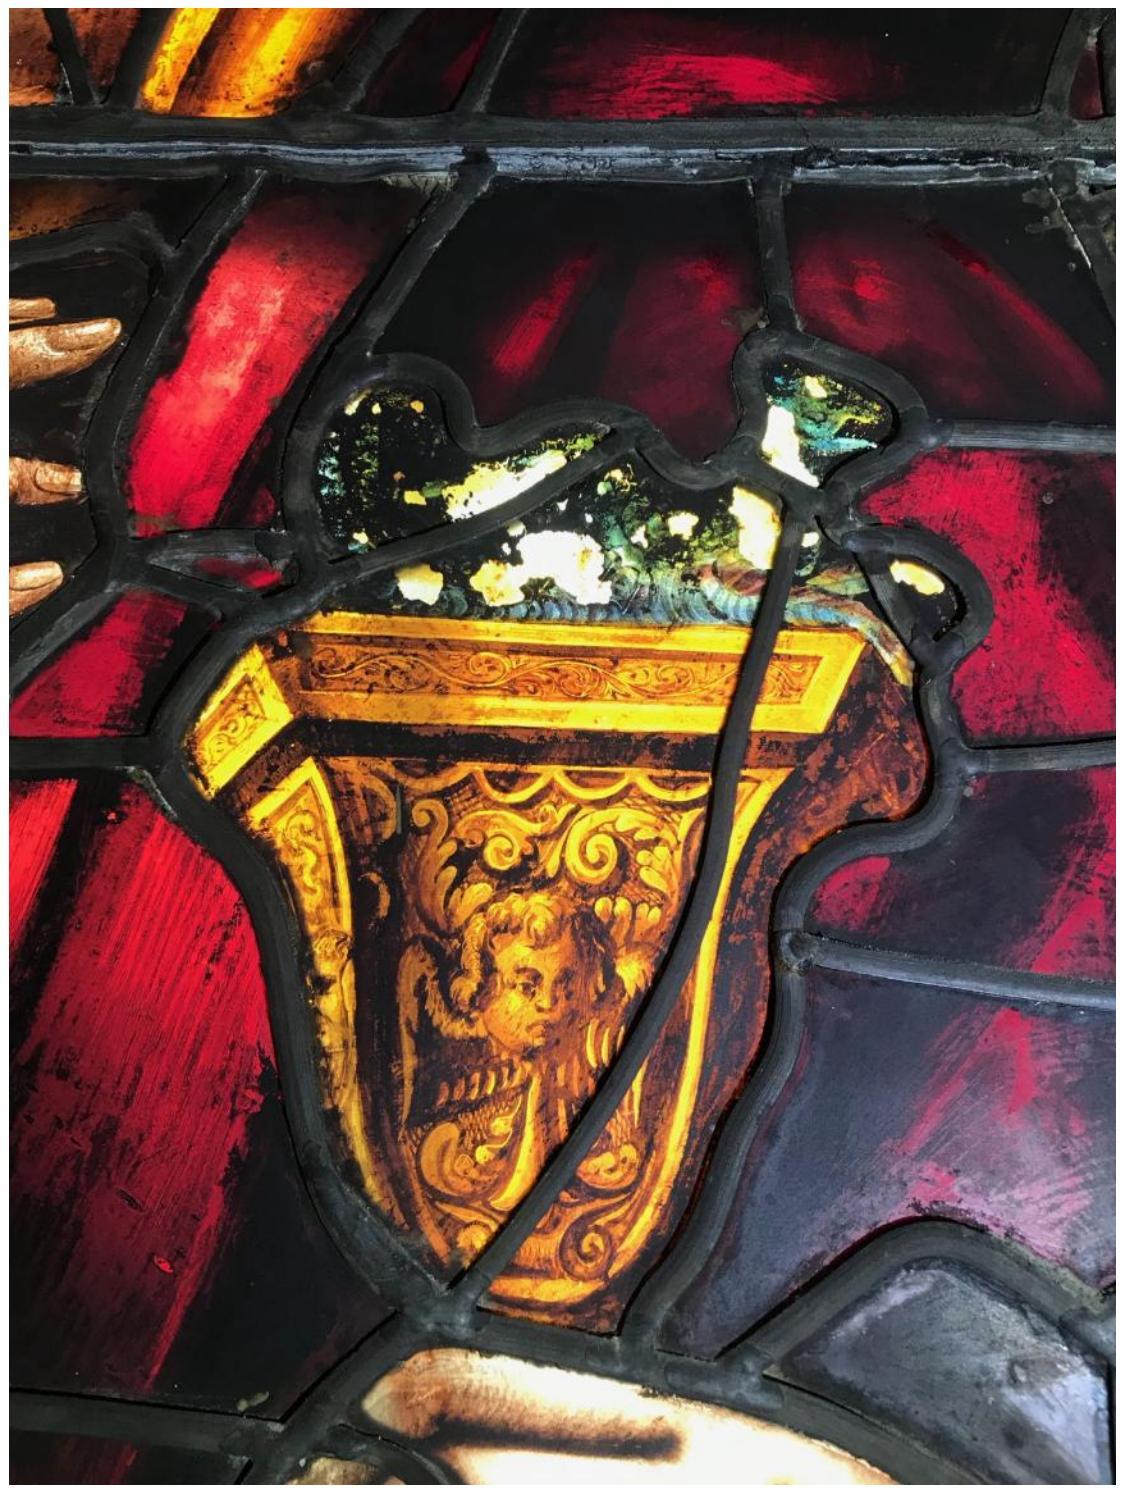
We can see in window nIII many examples where enamel pigments have been lost completely, leaving a bright patch of clear base glass (see Figure 4.). Cycles of condensation have also over time triggered chemical reactions at the glass surface which have led to corrosion of the pigment layers, as can be seen in the illustration in Figure 5. The numerous fractures in the window have in places revealed the glass edges showing the glass thickness to be generally less than 2mm (see Figure 6). The wider array of tones of pigment being used by stained glass artists of the period also encouraged the use of larger pieces of glass, as glass artists sought to emulate the effects of their peers working on canvasses, exacerbating the problem of structural security from wind pressures or impact damage. The ongoing nature of the environmental deterioration of the decorated surfaces of the window and the fragile nature of the medium mean that protection of the window is of paramount importance for it's long term survival.

Figure 4. Enamel losses to the serpent of St John's chalice, panel 3d.

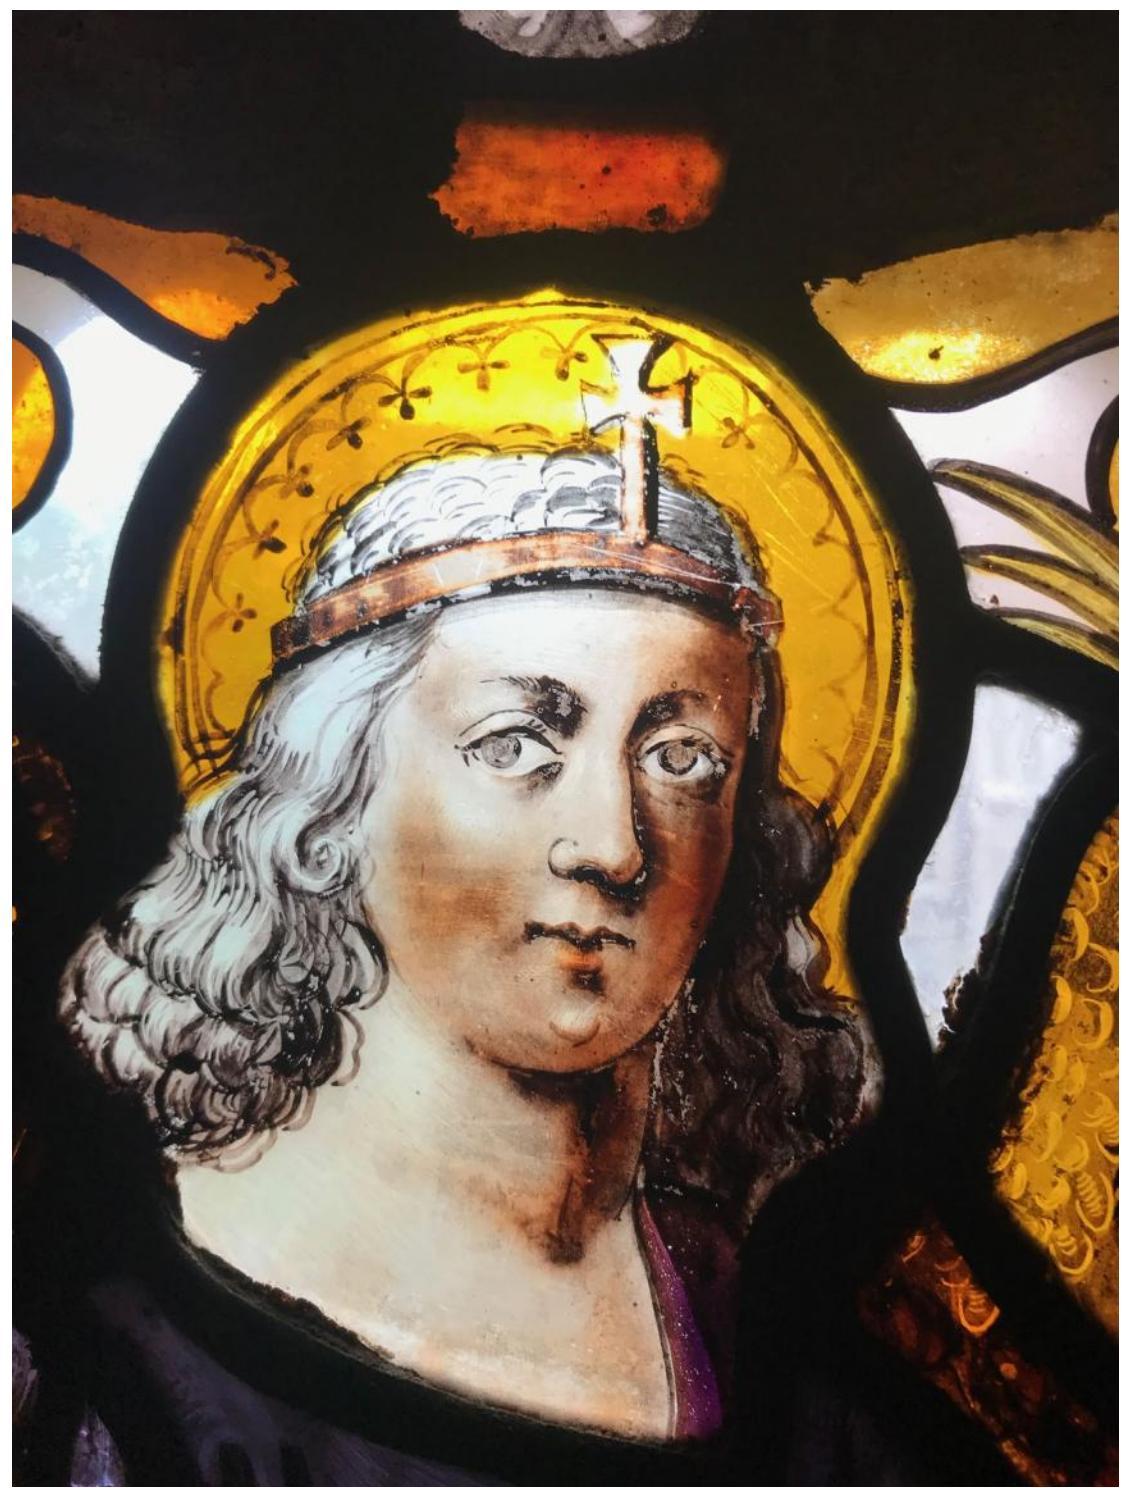
Figure 5. On-going loss and fading of fired oxide pigment, particularly noticeable around the eyes of the angel in panel B2.

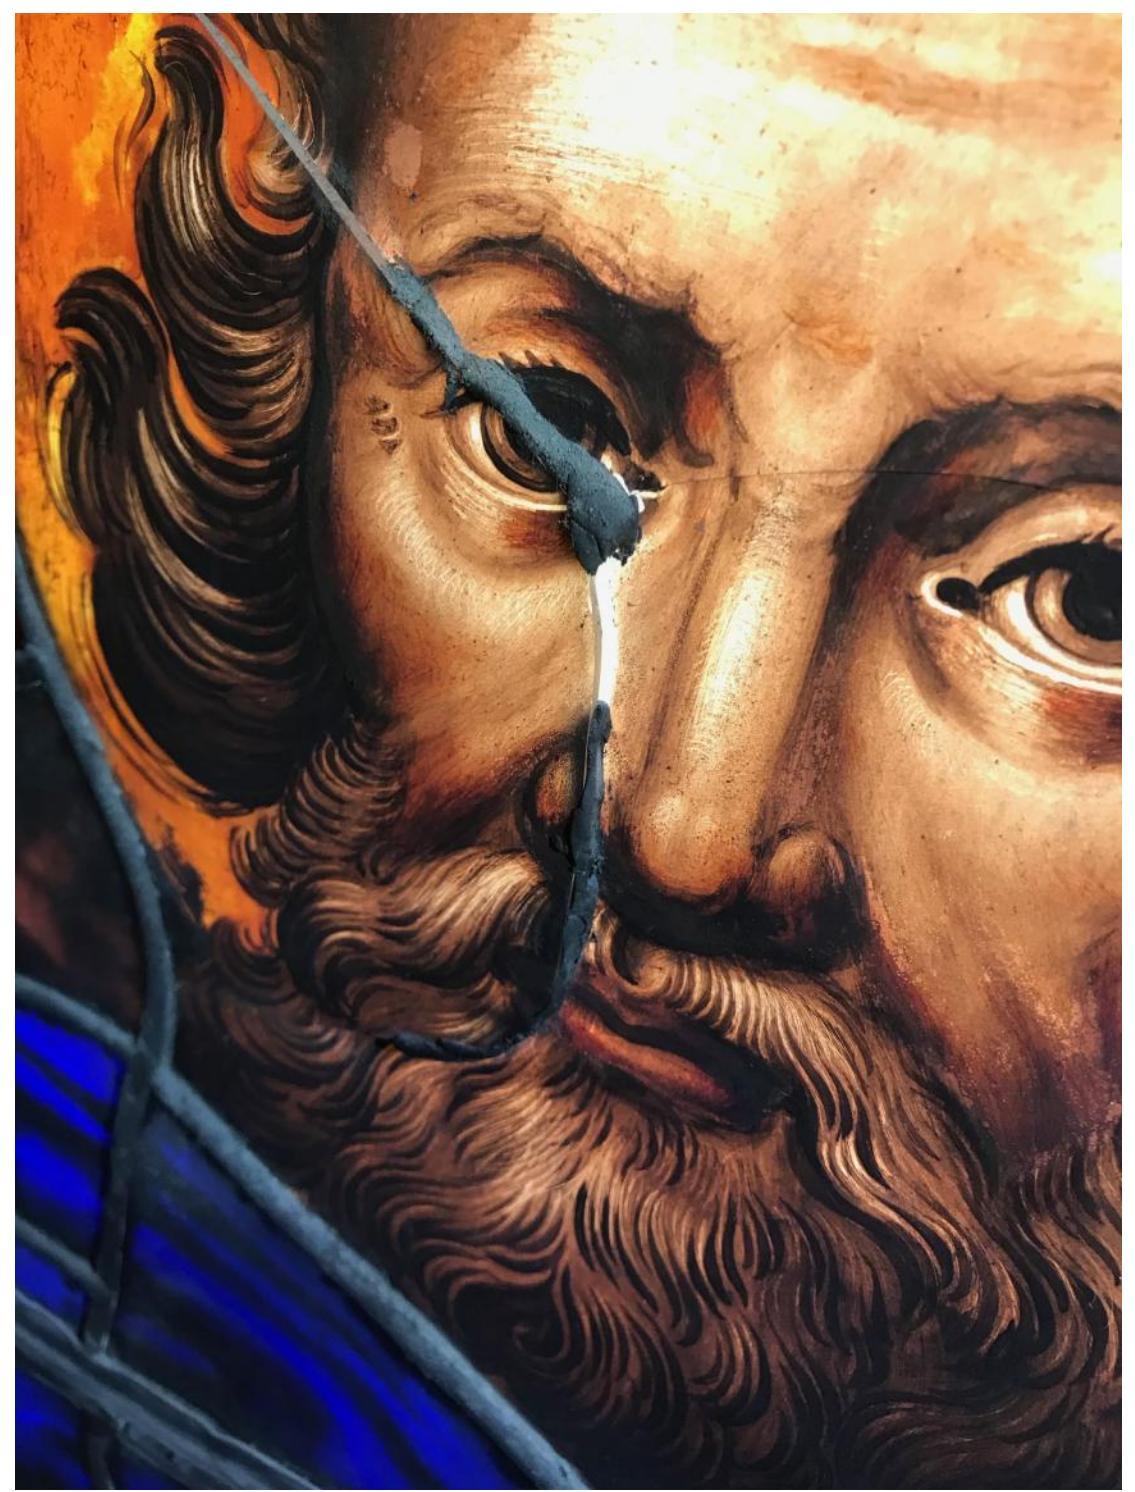
Figure 6. Fractures in the face of the figure of St Peter in panel 4a (repaired previously with putty), reveal the extremely thin glass used.

Single tight breaks with no movement within the lead may be left as they are, especially as with a protective glazing system they will no longer be exposed to wind pressure. Larger areas of damage, areas where there is the threat of losing glass, or instances where the edges of broken pieces rub together causing the glass to shale are all issues that will require further attention. The installation of protective glazing would enable the use of conservation grade adhesives, and therefore in the aforementioned circumstances, an epoxy resin may be used to stabilise these breaks. In many instances it is possible to undertake this without removing the glass from the lead, but in some cases glass pieces may require 'stopping out' of the lead in order to repair them. This is a localised treatment and would not require the dismantling or releading of the panels.

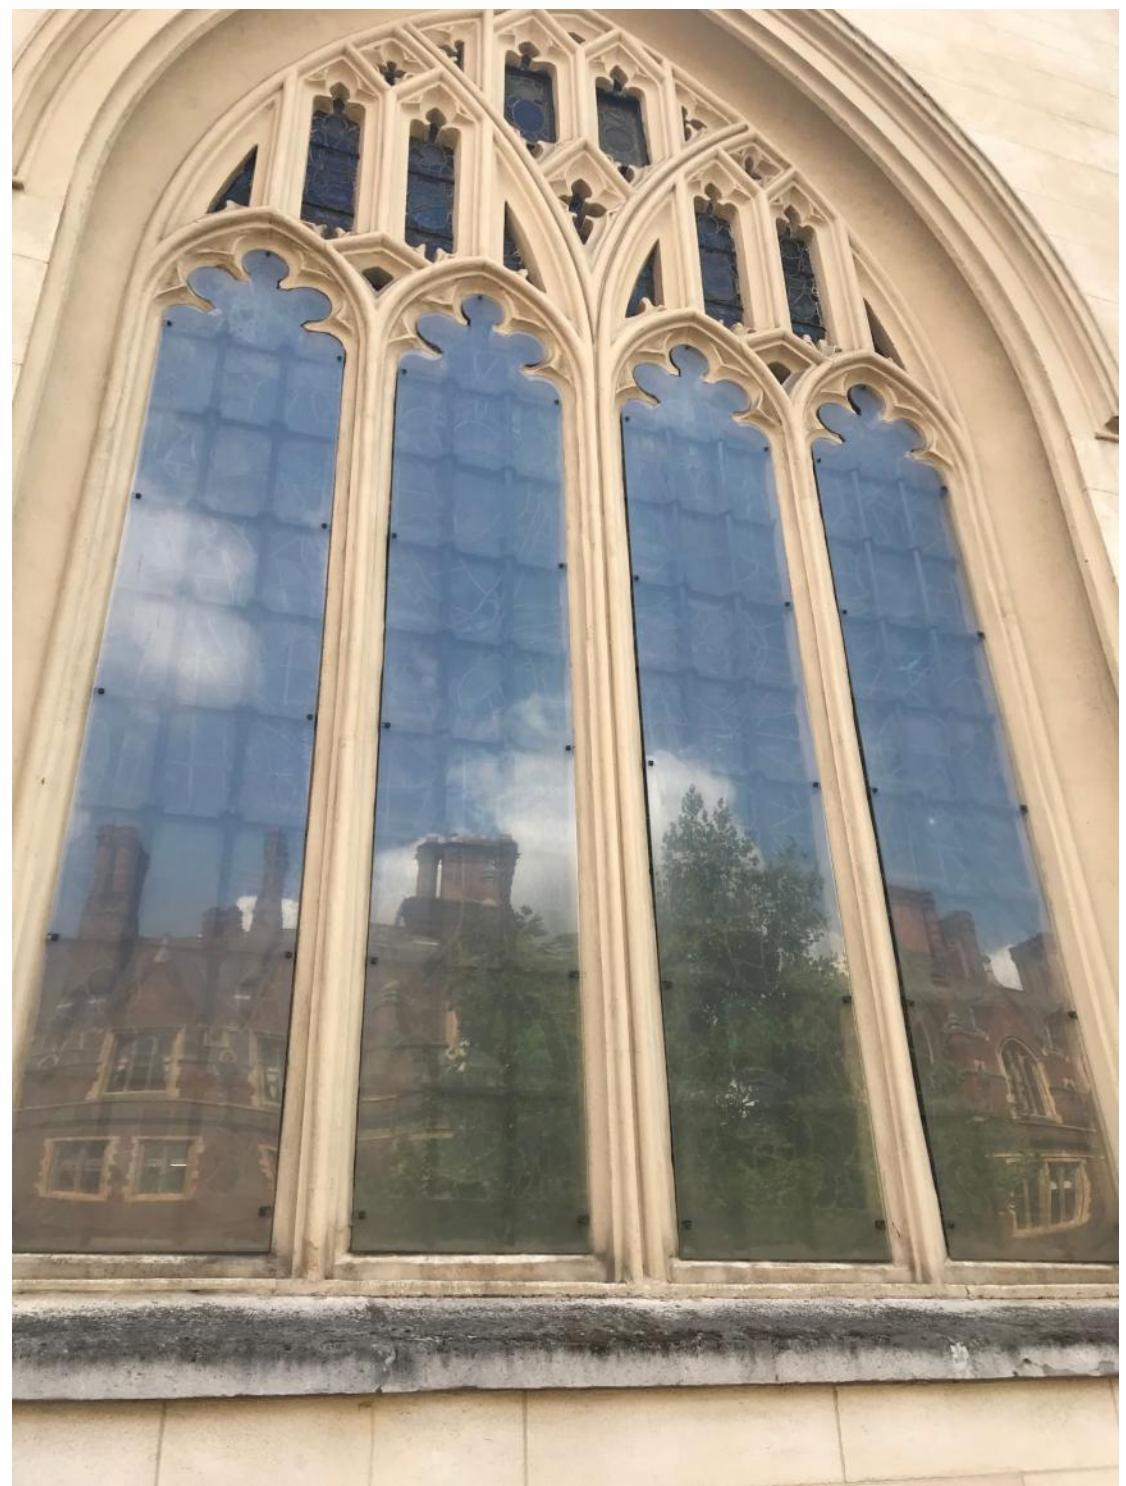
- The existing external polycarbonate protection is ugly and offers little or no environmental protection to the stained glass and should be removed, enabling the external ferramenta and the intended character of the window to be revealed.

Figure 15. Window nIII, Lincoln's Inn Chapel. The existing polycarbonate protection to the main lights, which it is proposed should be removed following the installation of an environmental protective glazing system.

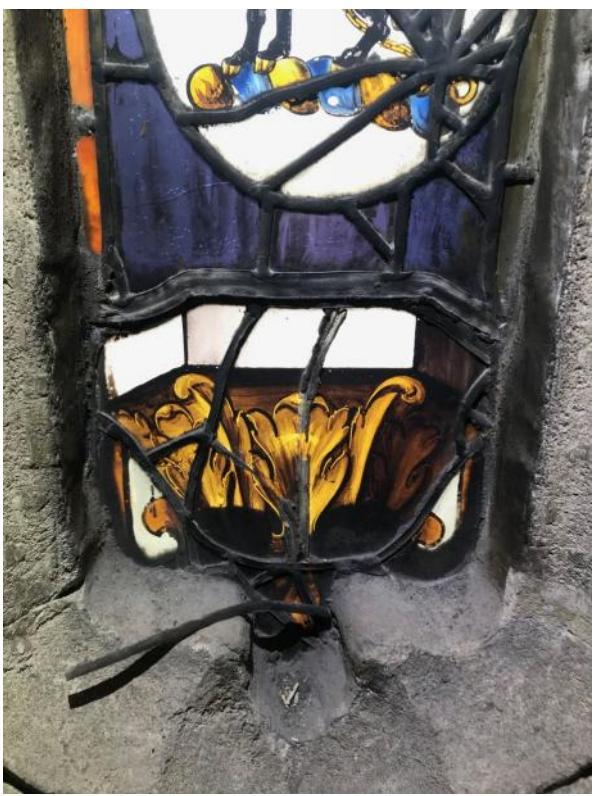
Figure 18. Window nIII, Lincoln's Inn Chapel. An example of a loose strap repair lead., panel B2

Selective areas of previous lead repair that have left areas of key iconography illegible will be considered for alternative treatment. Where technically possible without risk to the fragile glass some areas of heavy leading will be removed and the glass edges bonded as an alternative. What is achievable will be limited in scope to only what is deemed technically possible and where legibility can be significantly improved. This will be carried out at the discretion of the conservation team following a thorough examination on the conservation work-bench. It may also be technically possible to reduce the width of certain repair leads, to improve legibility by a process of thinning; again at the discretion of the conservator.

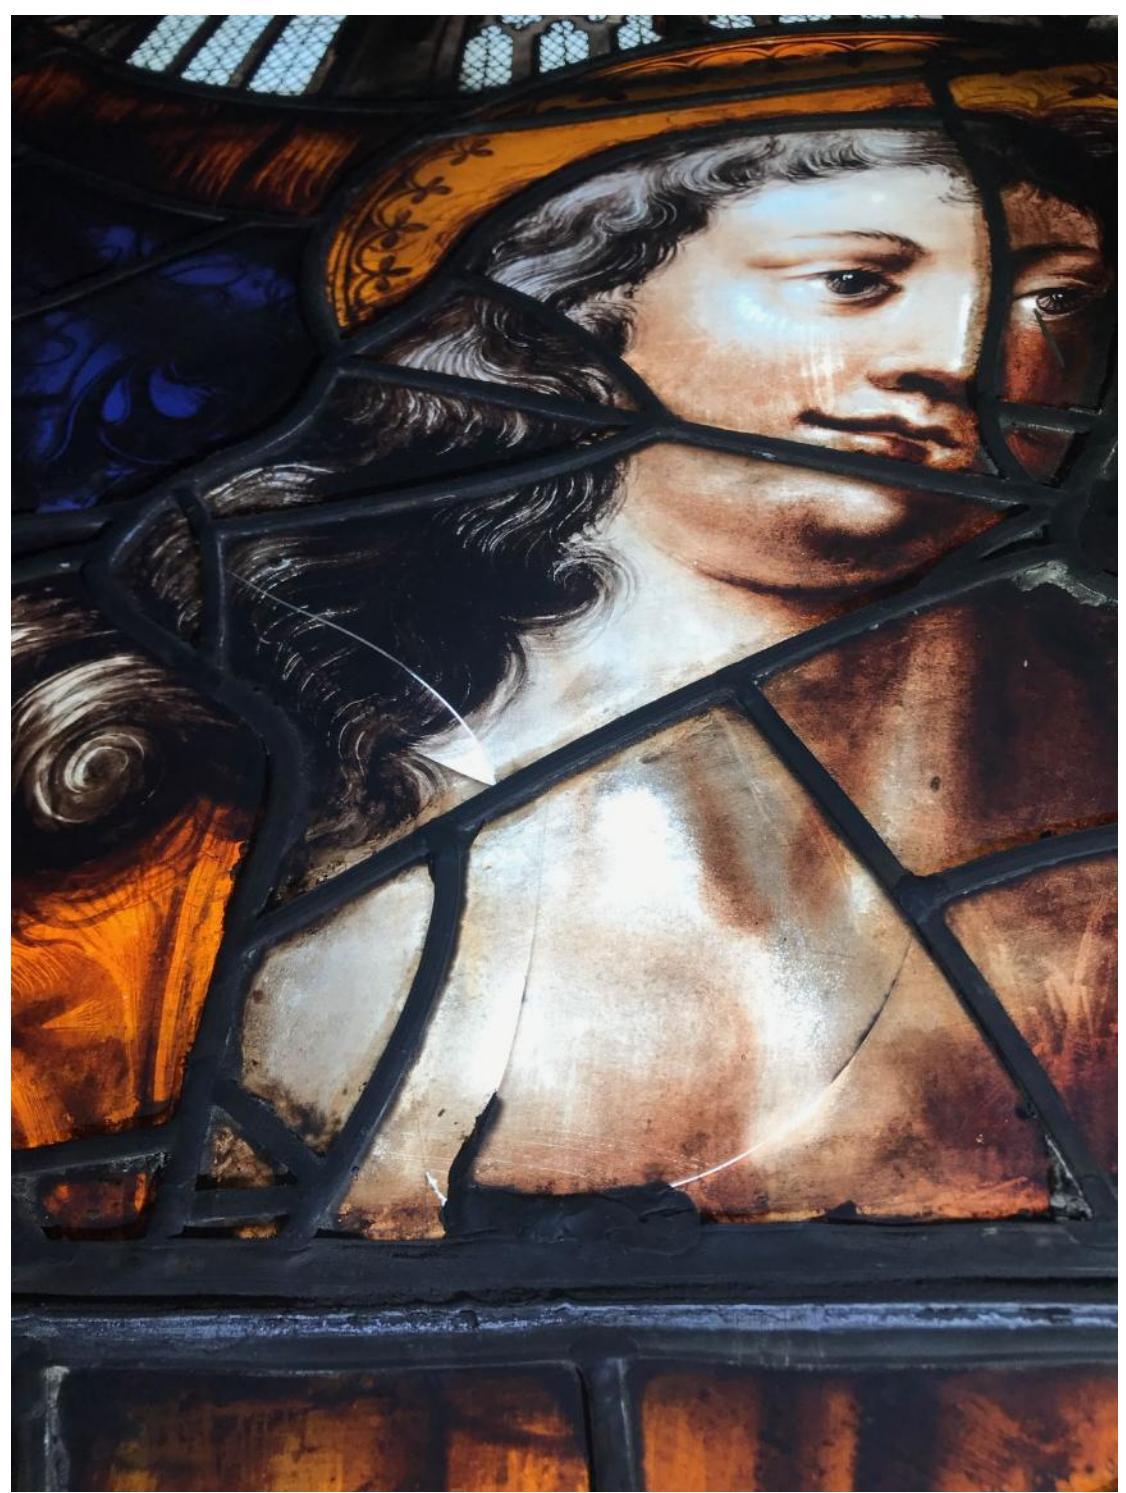
Figure 19. Fractures and repair leads to panel 4d.

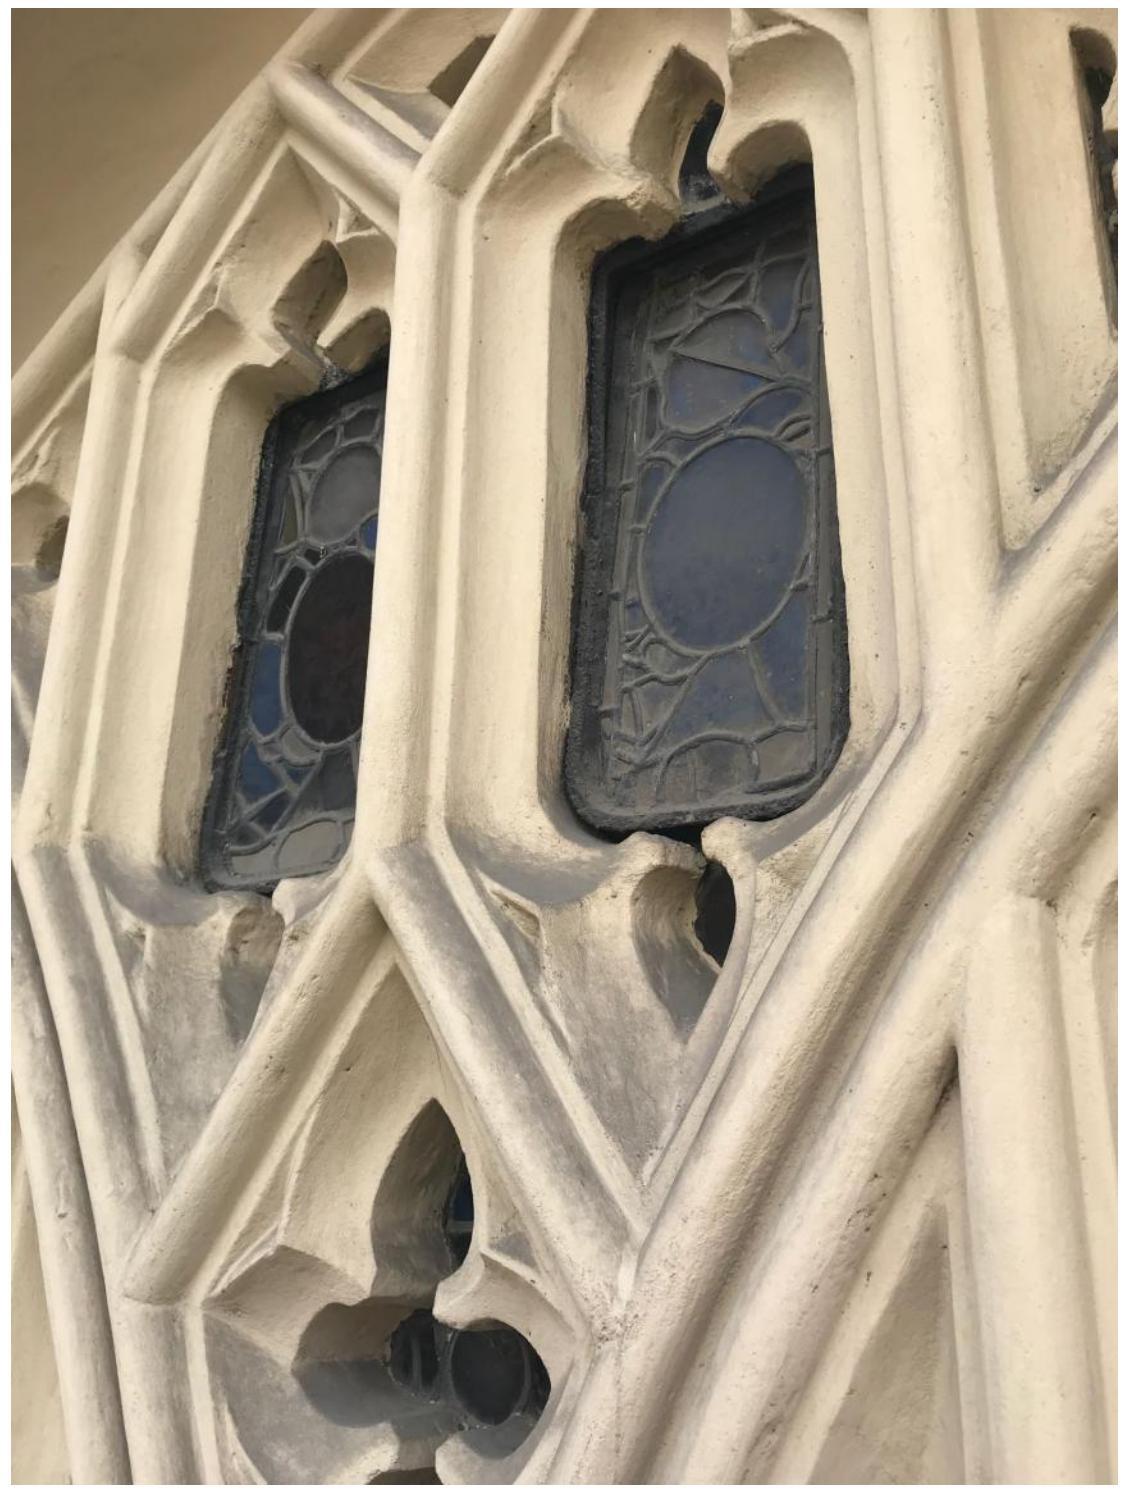
Figure 23. Tracery sections D1 & D2 as viewed from the exterior, showing existing metal casements.

The tracery of the window contains two opening metal casements that have been sealed shut with mortar and are no longer functioning. It is proposed that these should be removed in order to appropriately facilitate the installation of the protective glazing system. As the efficacy of the environmental protective glazing system relies on the free flow of air from within the building, it is critical that the exterior glazing remains sealed and weather-proof. Any ventilation required to the interior of the building should be explored by other means.

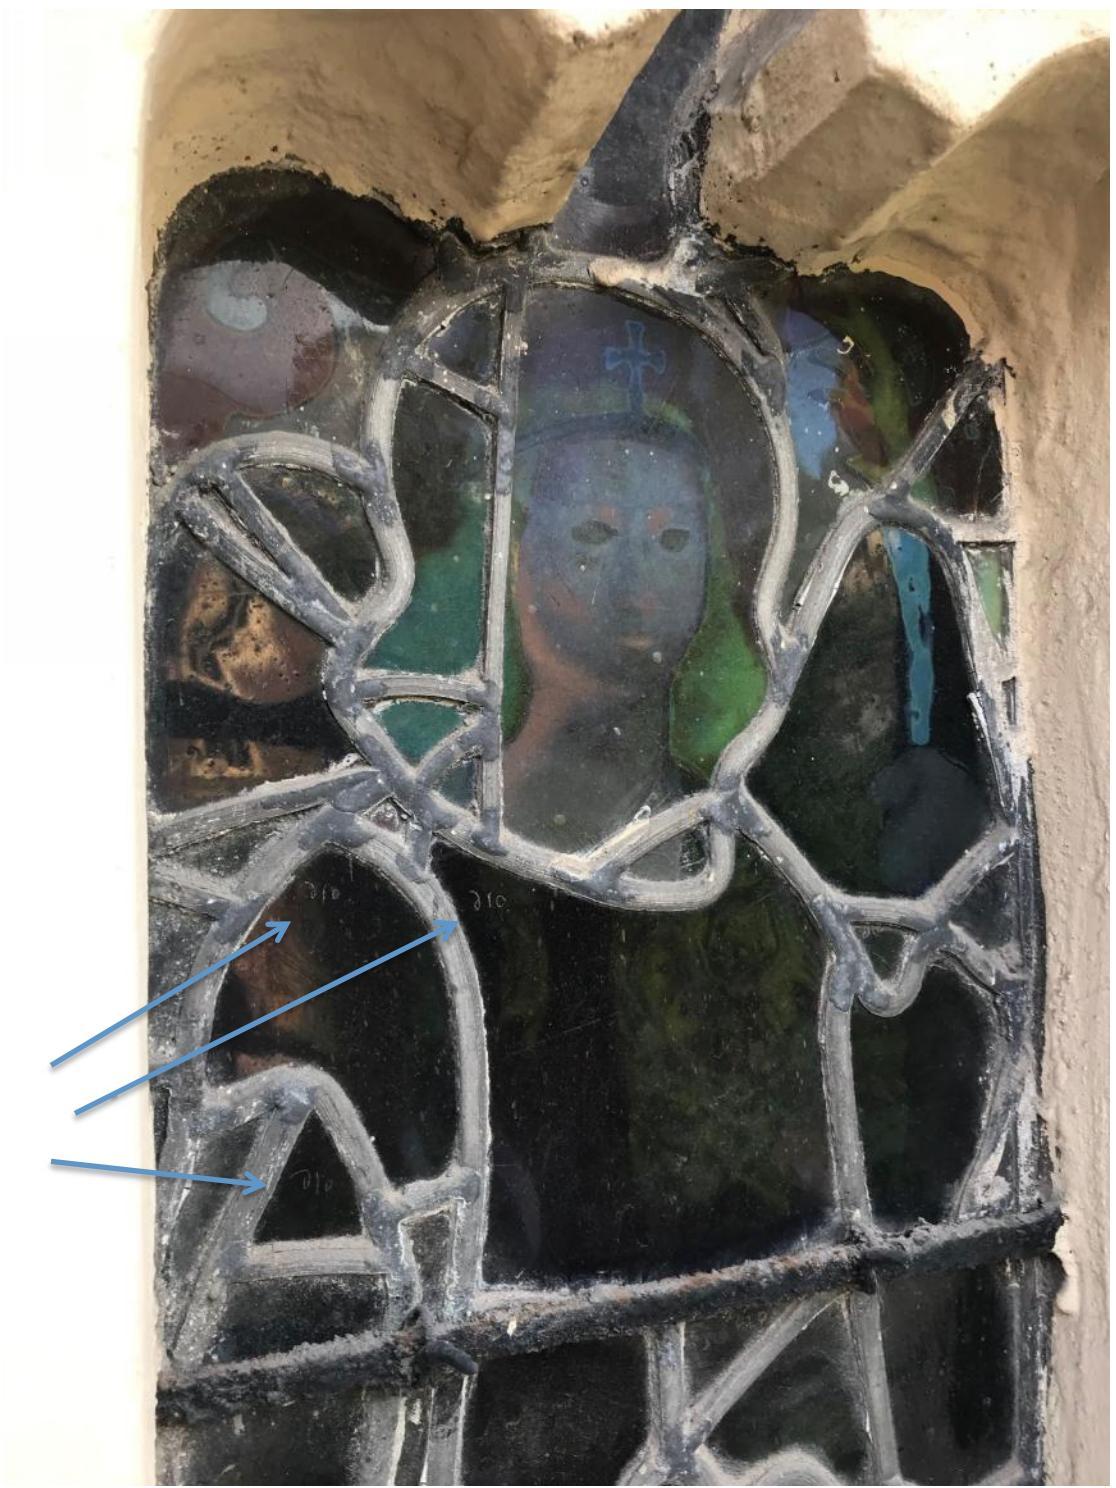
Figure 24. Tracery panel B3, viewed from the exterior. Note the inscribed position marks, which are possibly original to the panels.

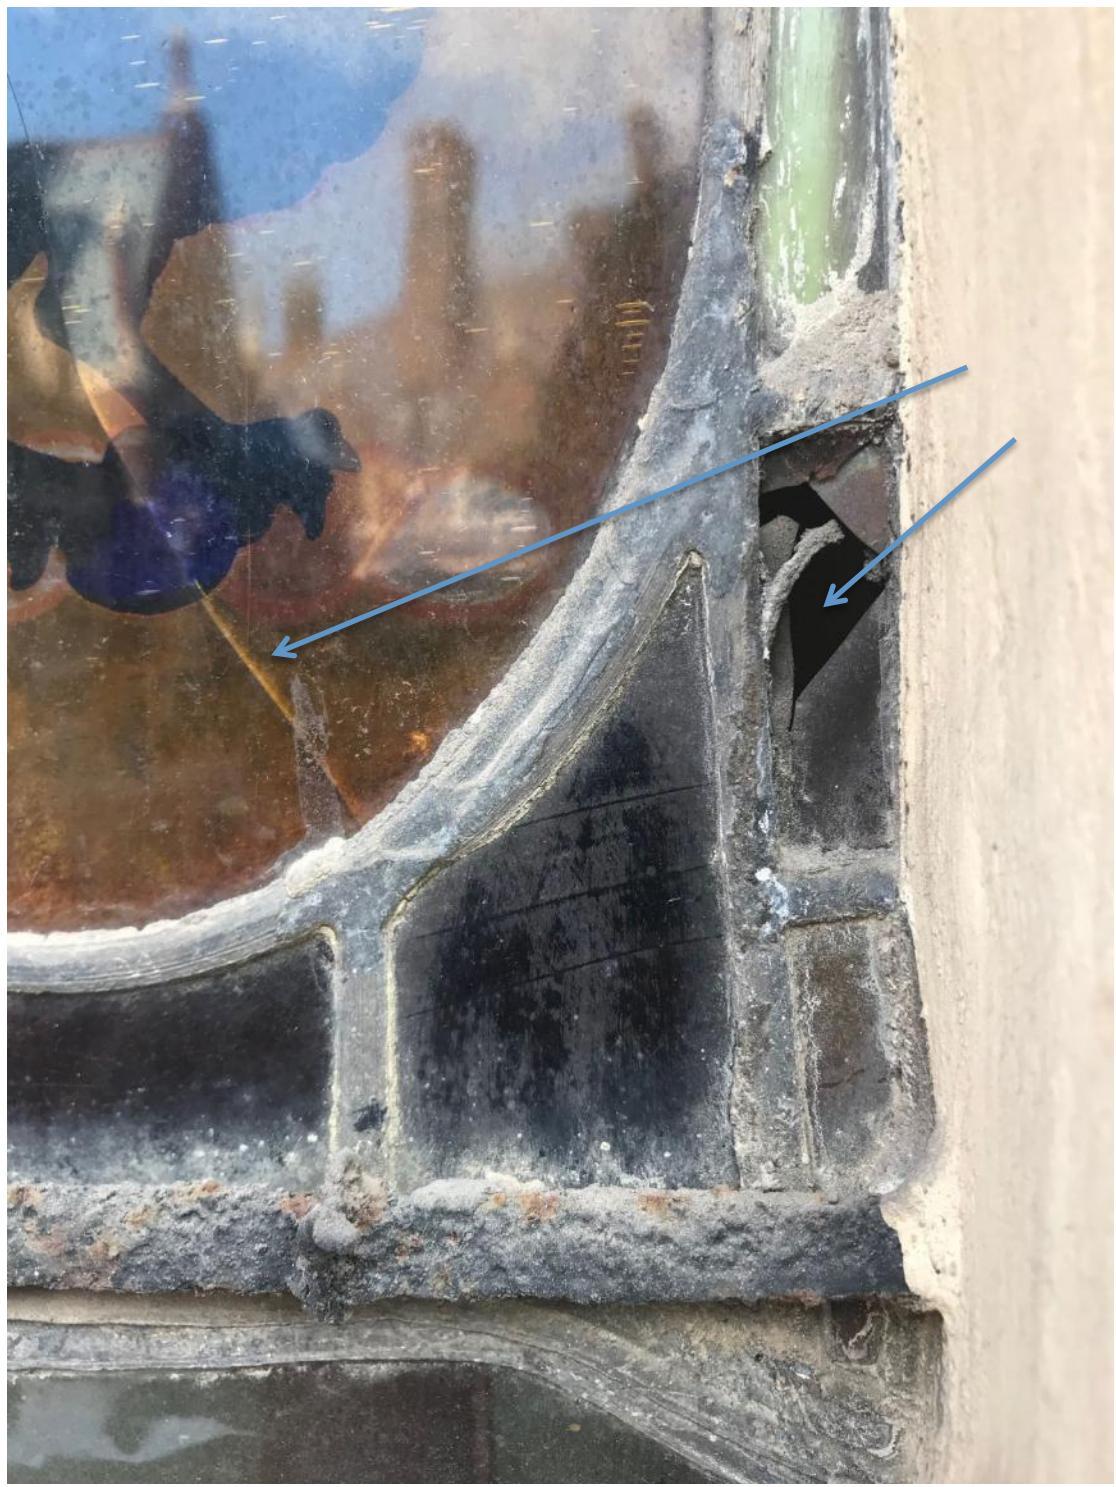
Figure 25. Tracery panel B3. Note cracks and losses of glass in the border section.

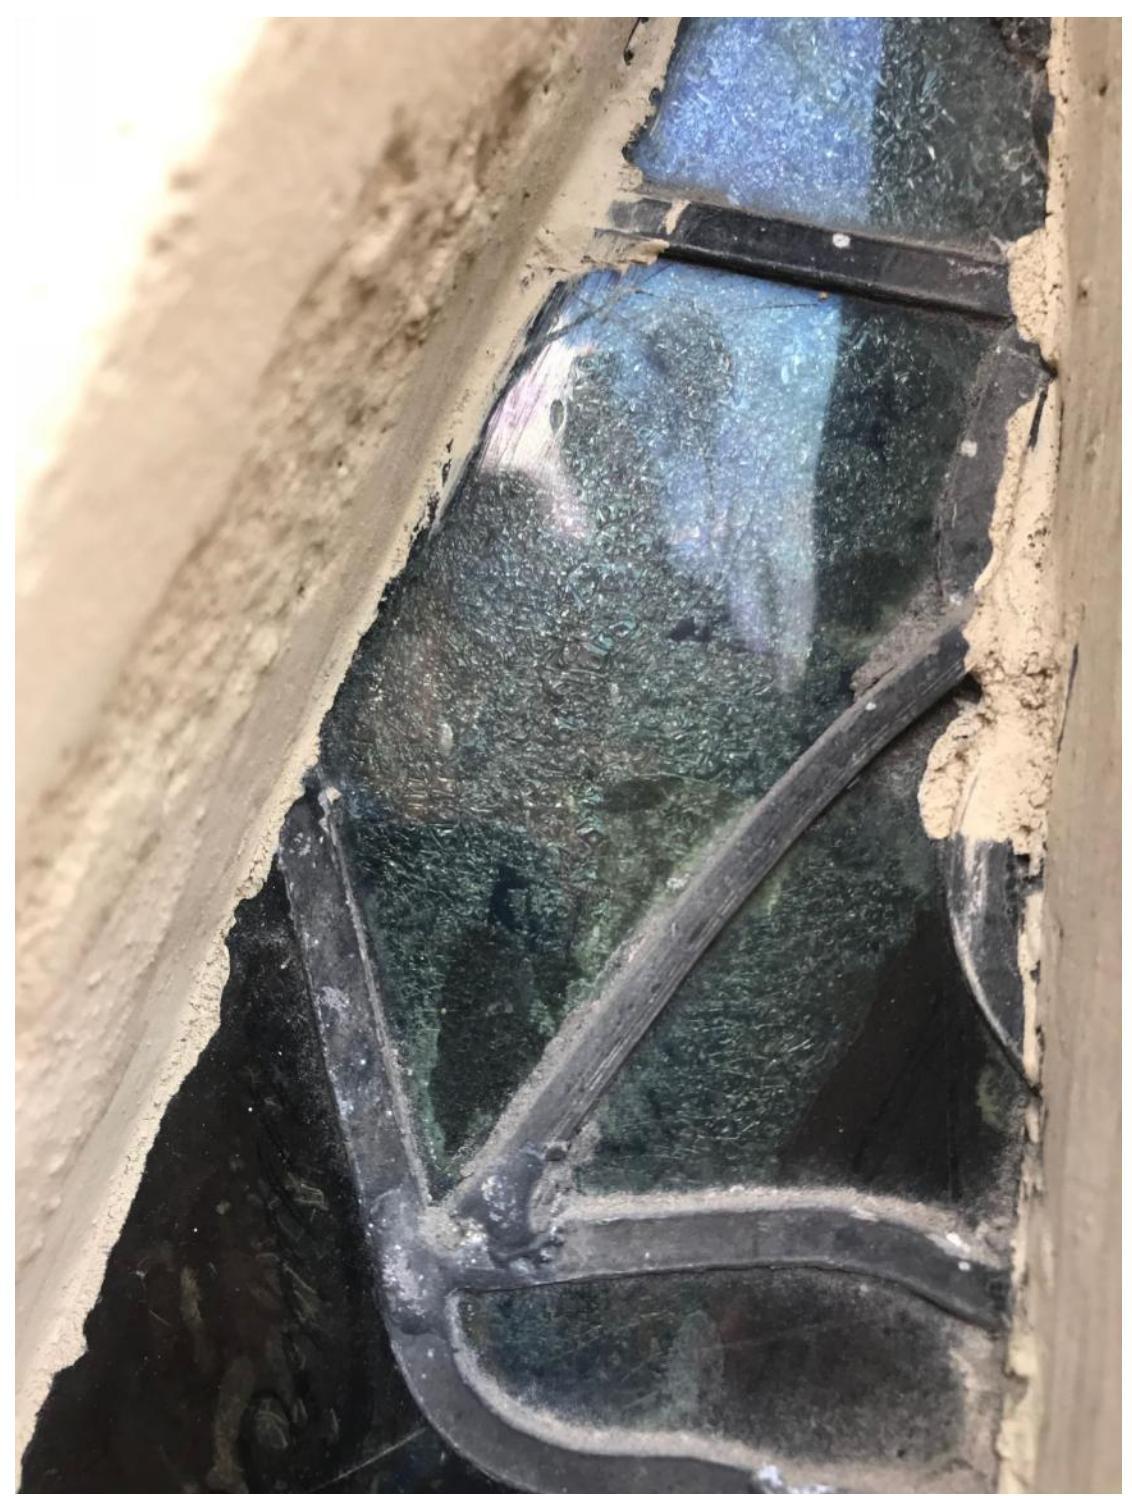
Figure 26. Panel B8, exterior view. The crizzled appearance of the glass demonstrates the delamination of the blue enamel painted layer from the base glass, which has been exacerbated by environmental damage. Note also that the previous application of shelter-coat to the stone surround has coated the glass edges in places.

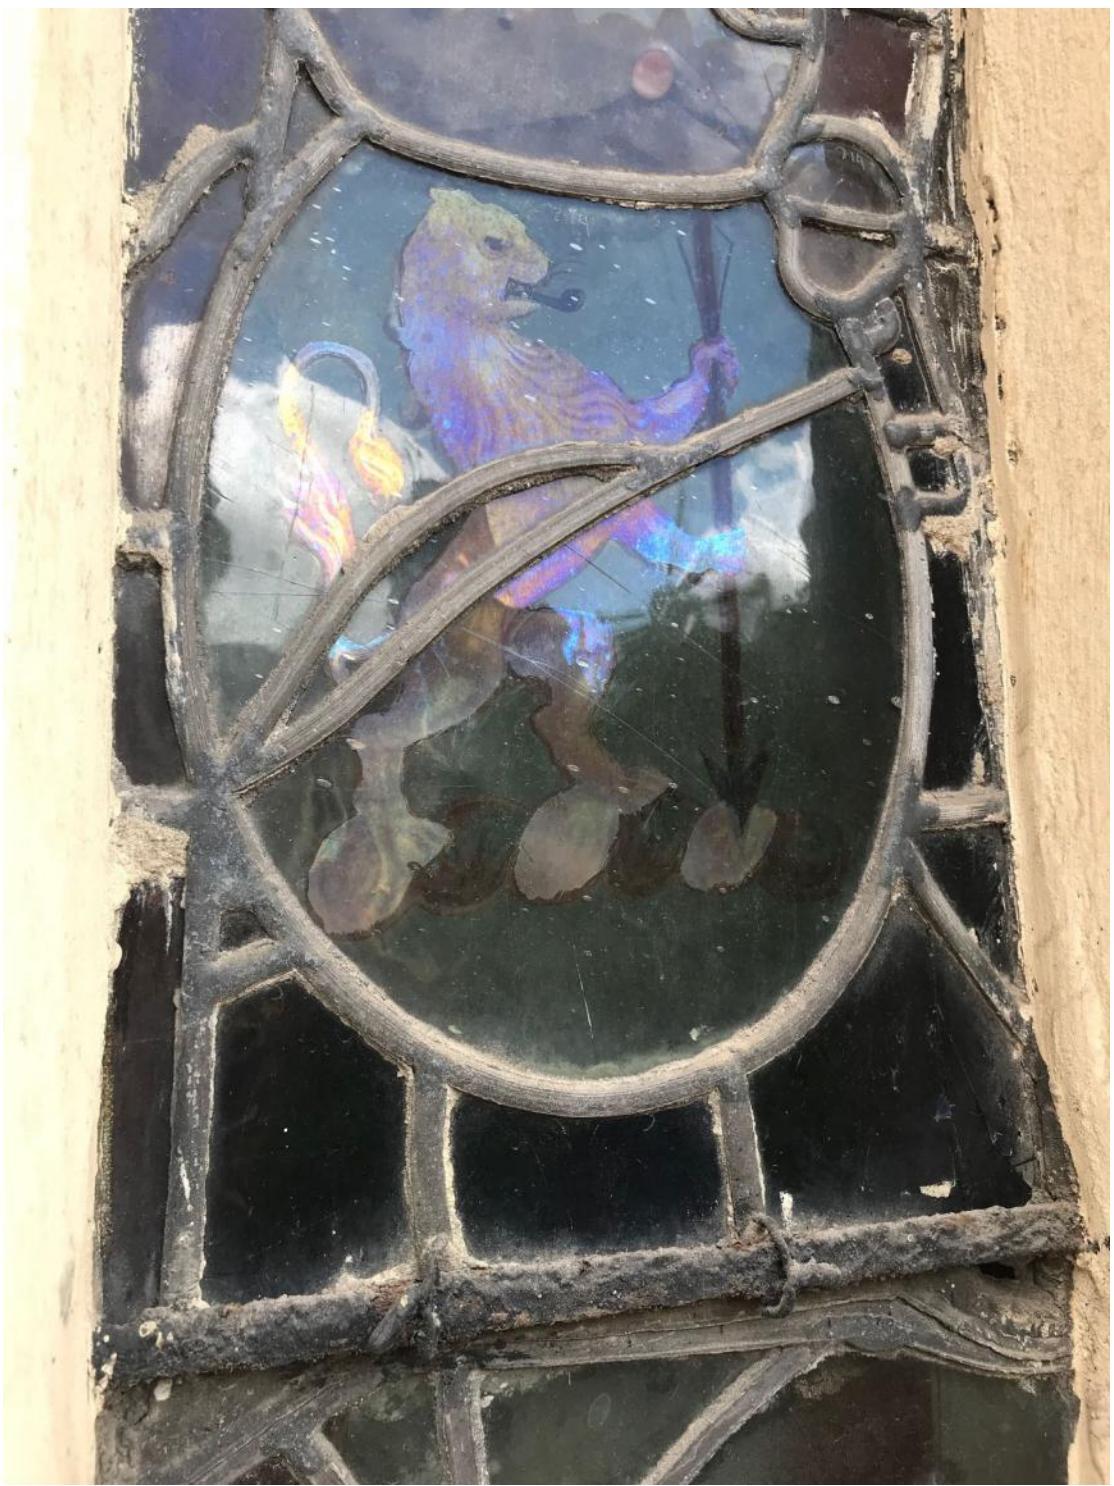
Figure 27. Panel B6 exterior view. Mending leads across the heraldic medallion as repairs for previous damages. It may be possible to reduce the profile of these leads to allow greater legibility during the conservation process.

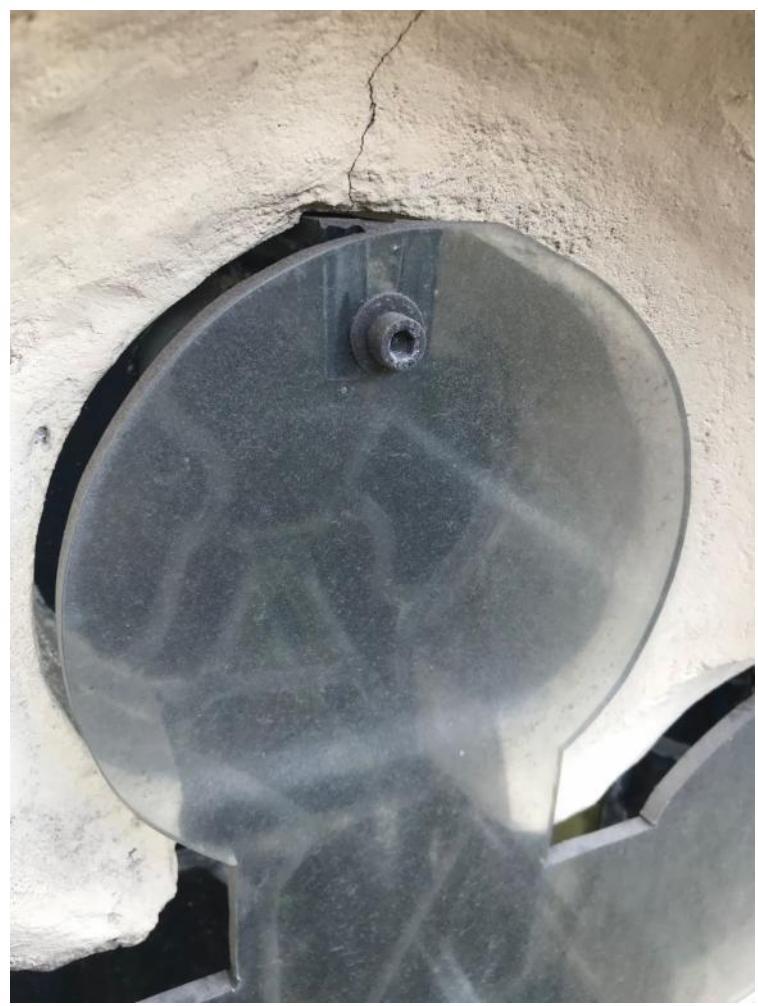
Figure 28. External polycarbonate sheet protection at the apex of lancet "a". Note the cracking to the stone above the fixing point.

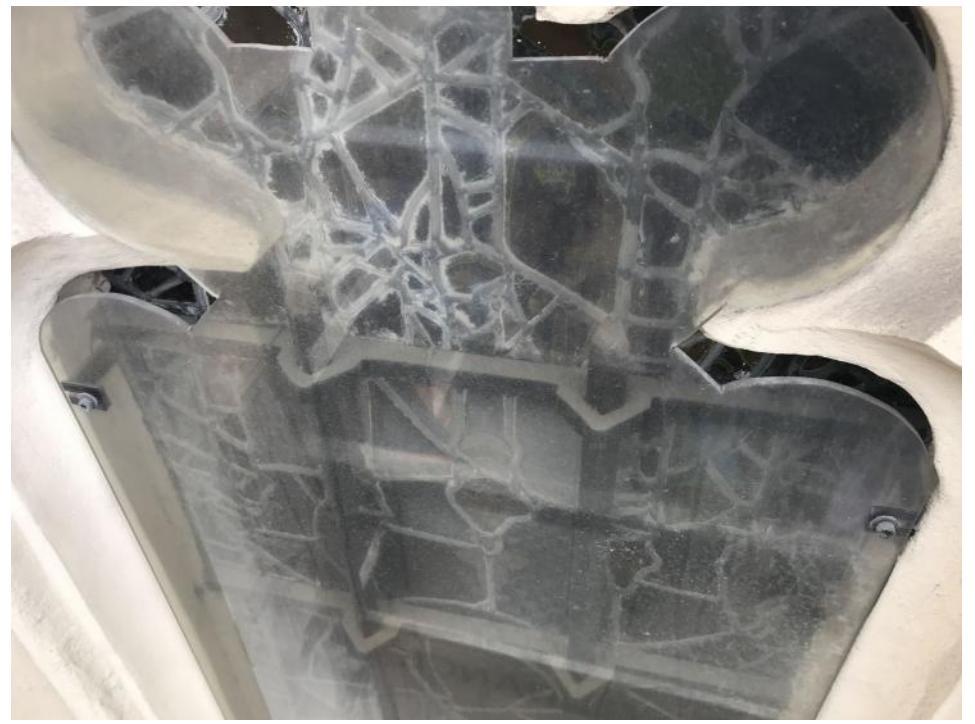
Figure 29. The external ferramenta viewed through the external polycarbonate sheeting.

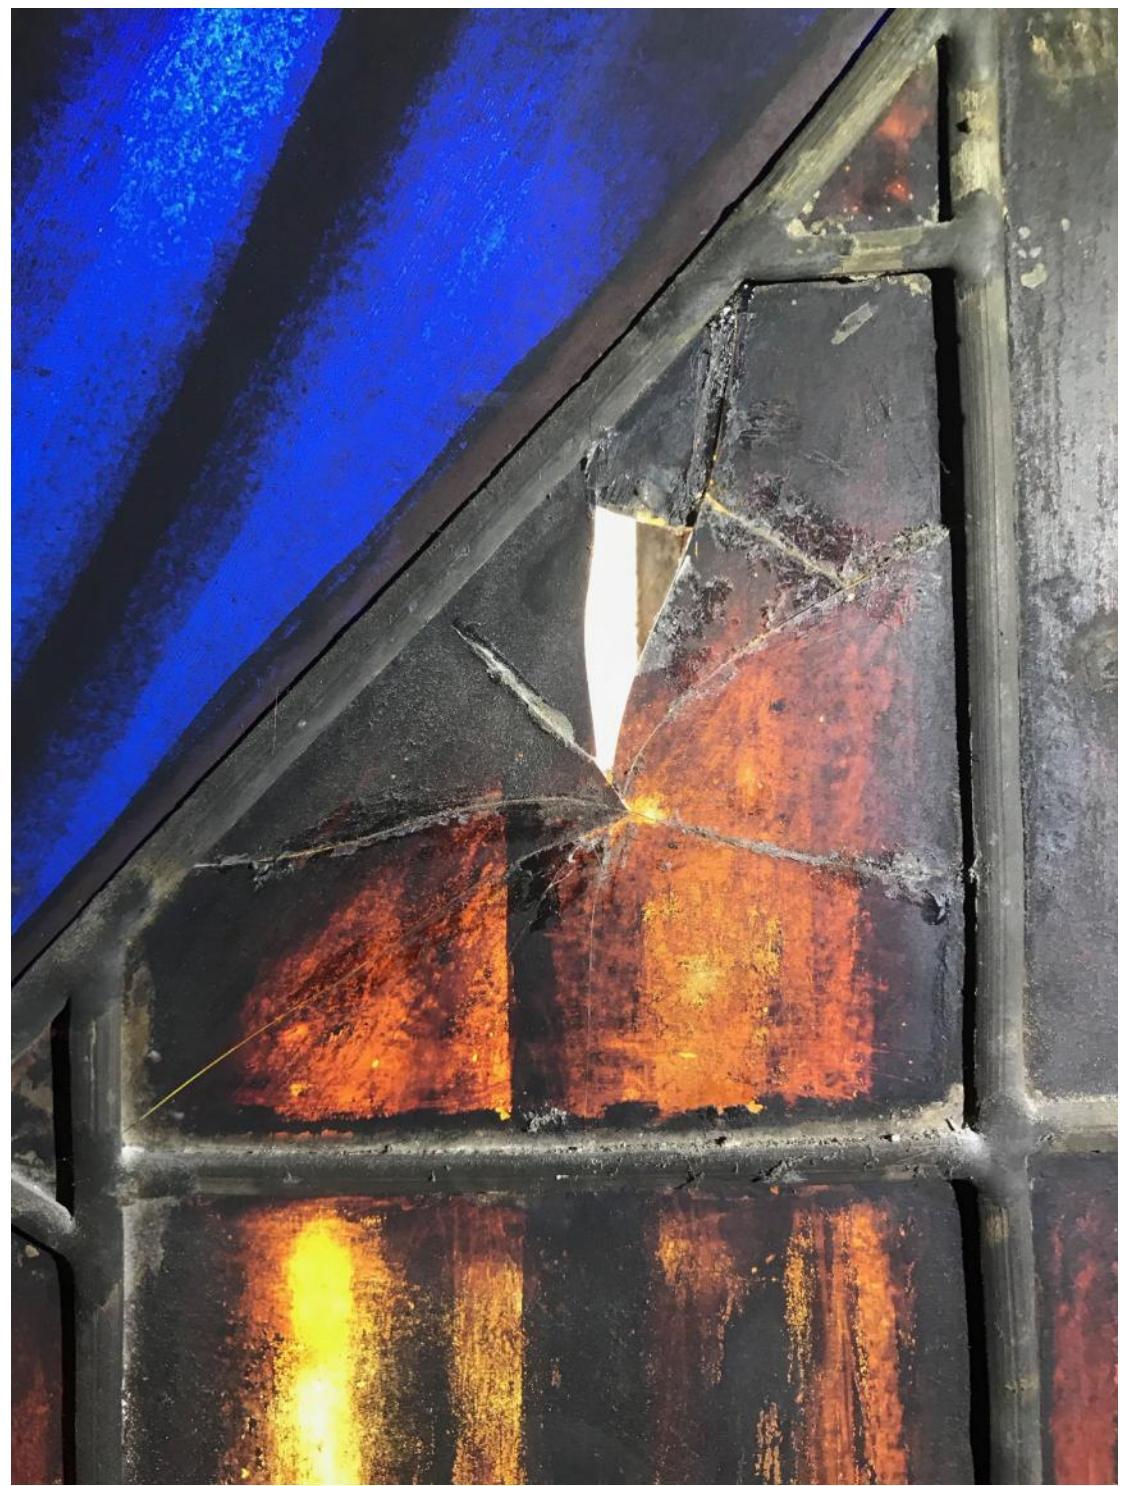
Figure 30. Panel 2a, viewed from the interior, showing fractured glass and loss of glass. Adhesive residues are visible indicating previous attempts to repair the pieces in situ.

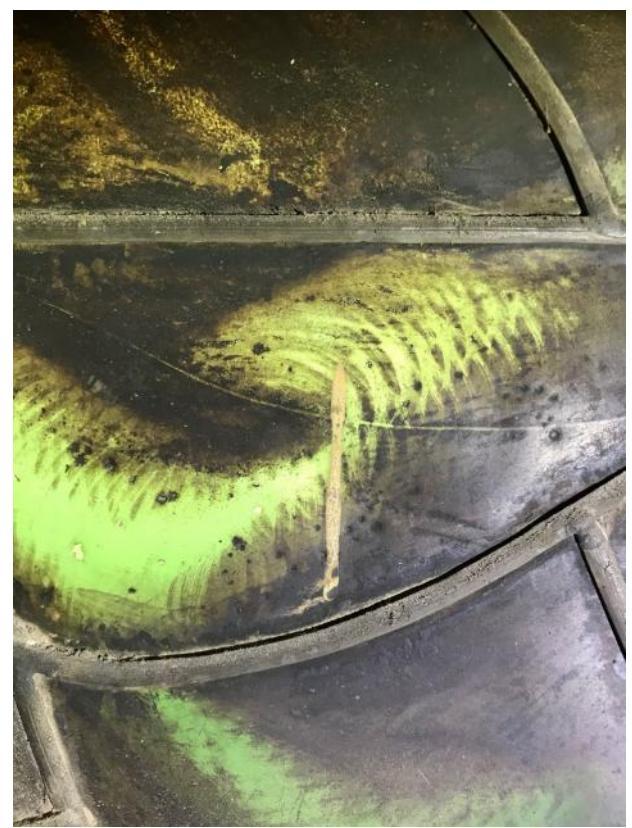
Figure 31. Panel 3b. Paint splashes visible on the stained glass surface.

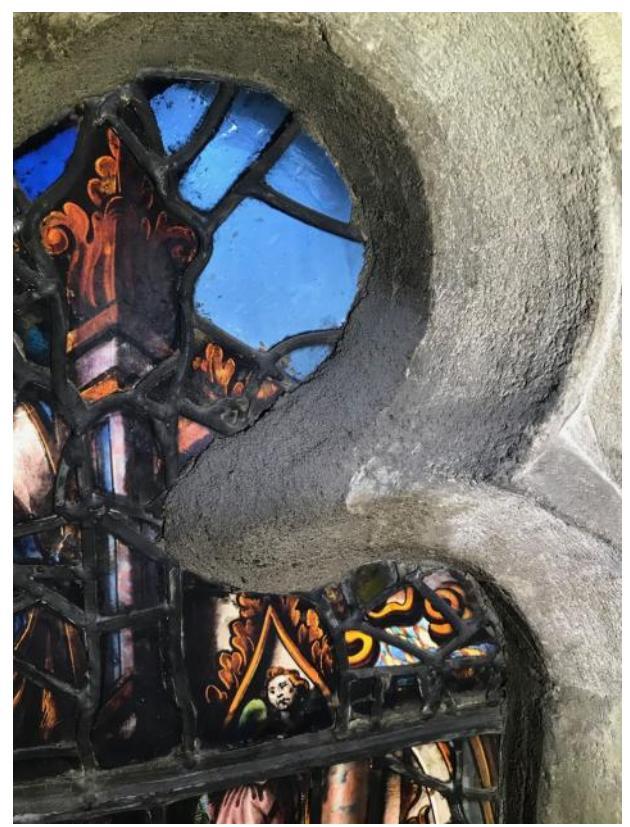
Figure 32. Panel 5d viewed from the interior, showing extensive mortar repairs to the stone cusps.
