Proposals for the Conservation and Environmental Protection of Window nIII (The Butler Window), Lincoln's Inn Chapel, London

August 2020

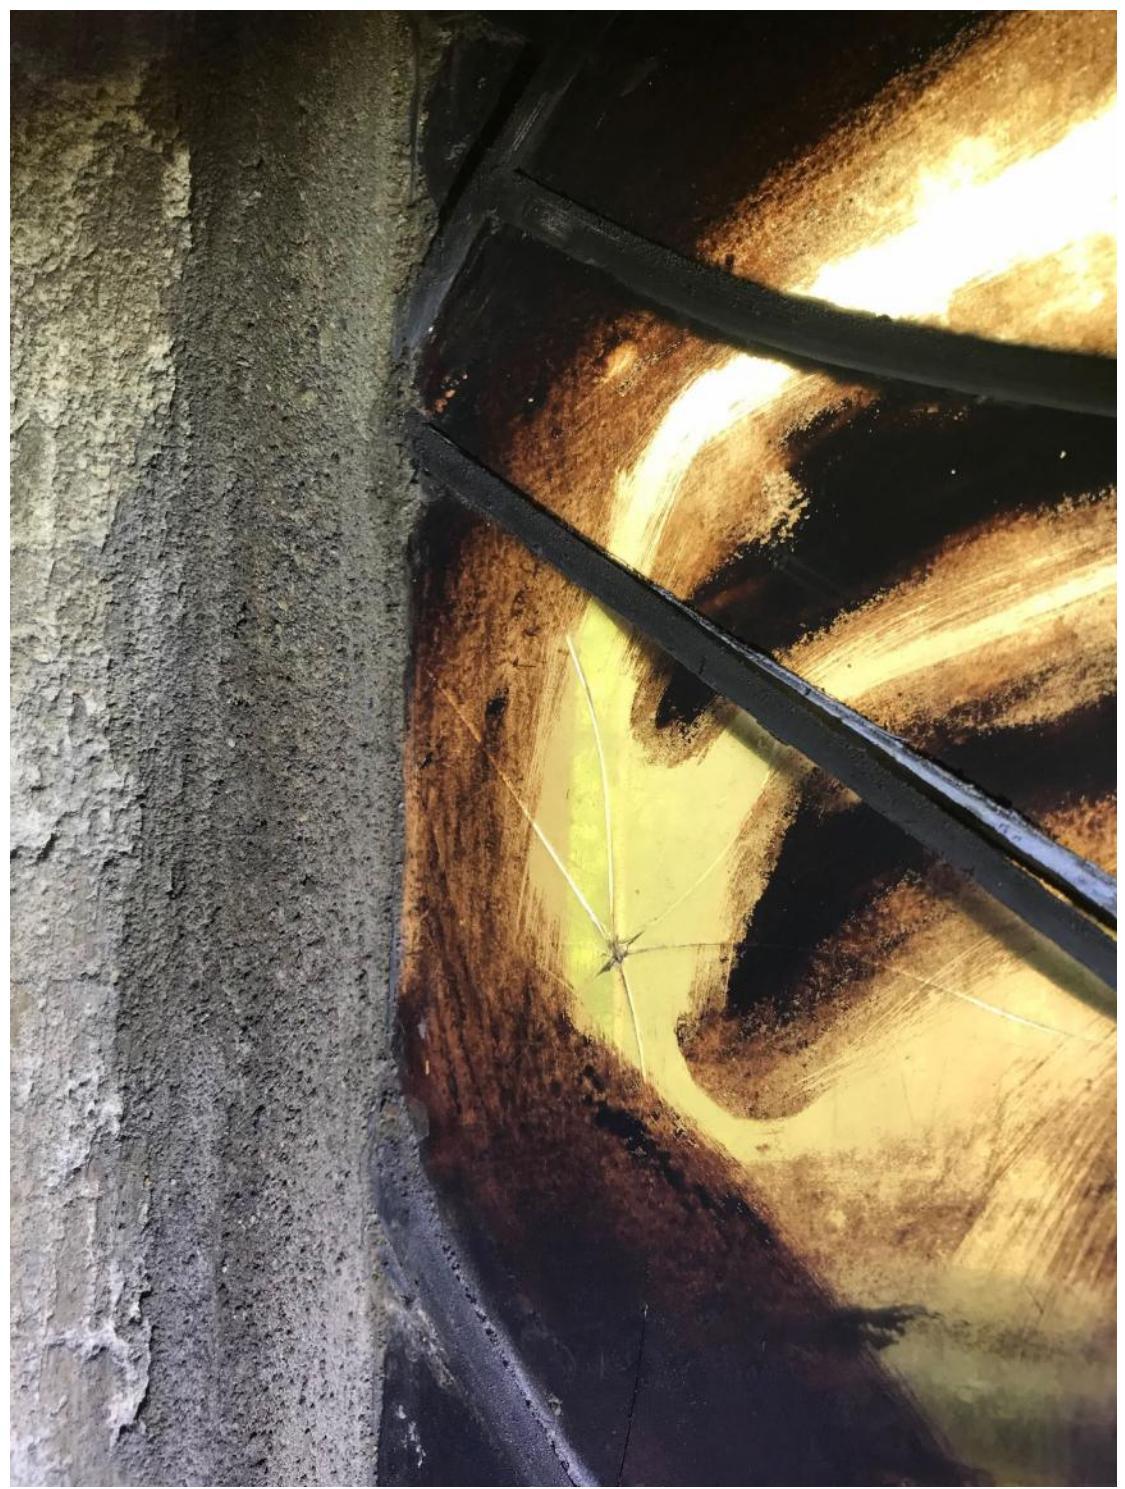
Figure 33. Panel 3c, showing glass fractures and strap lead repairs, now loose.

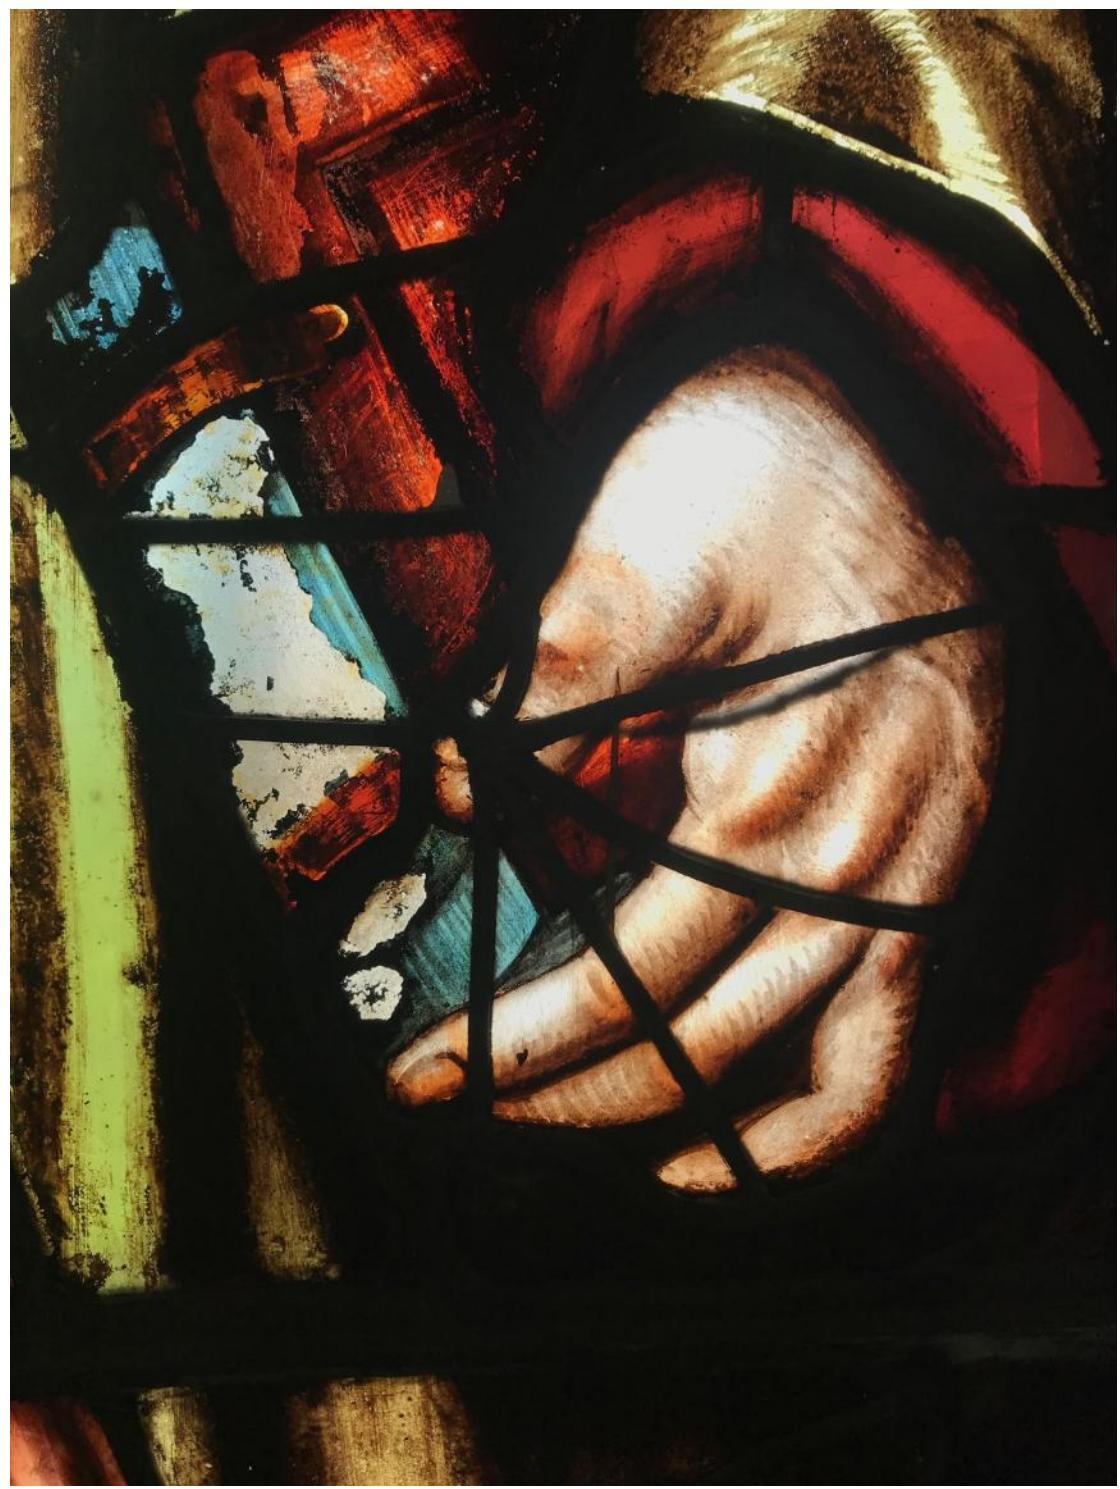
Figure 34. Panel 3c, showing severe enamel pigment losses to the spine of the book and mending leads to the hand.

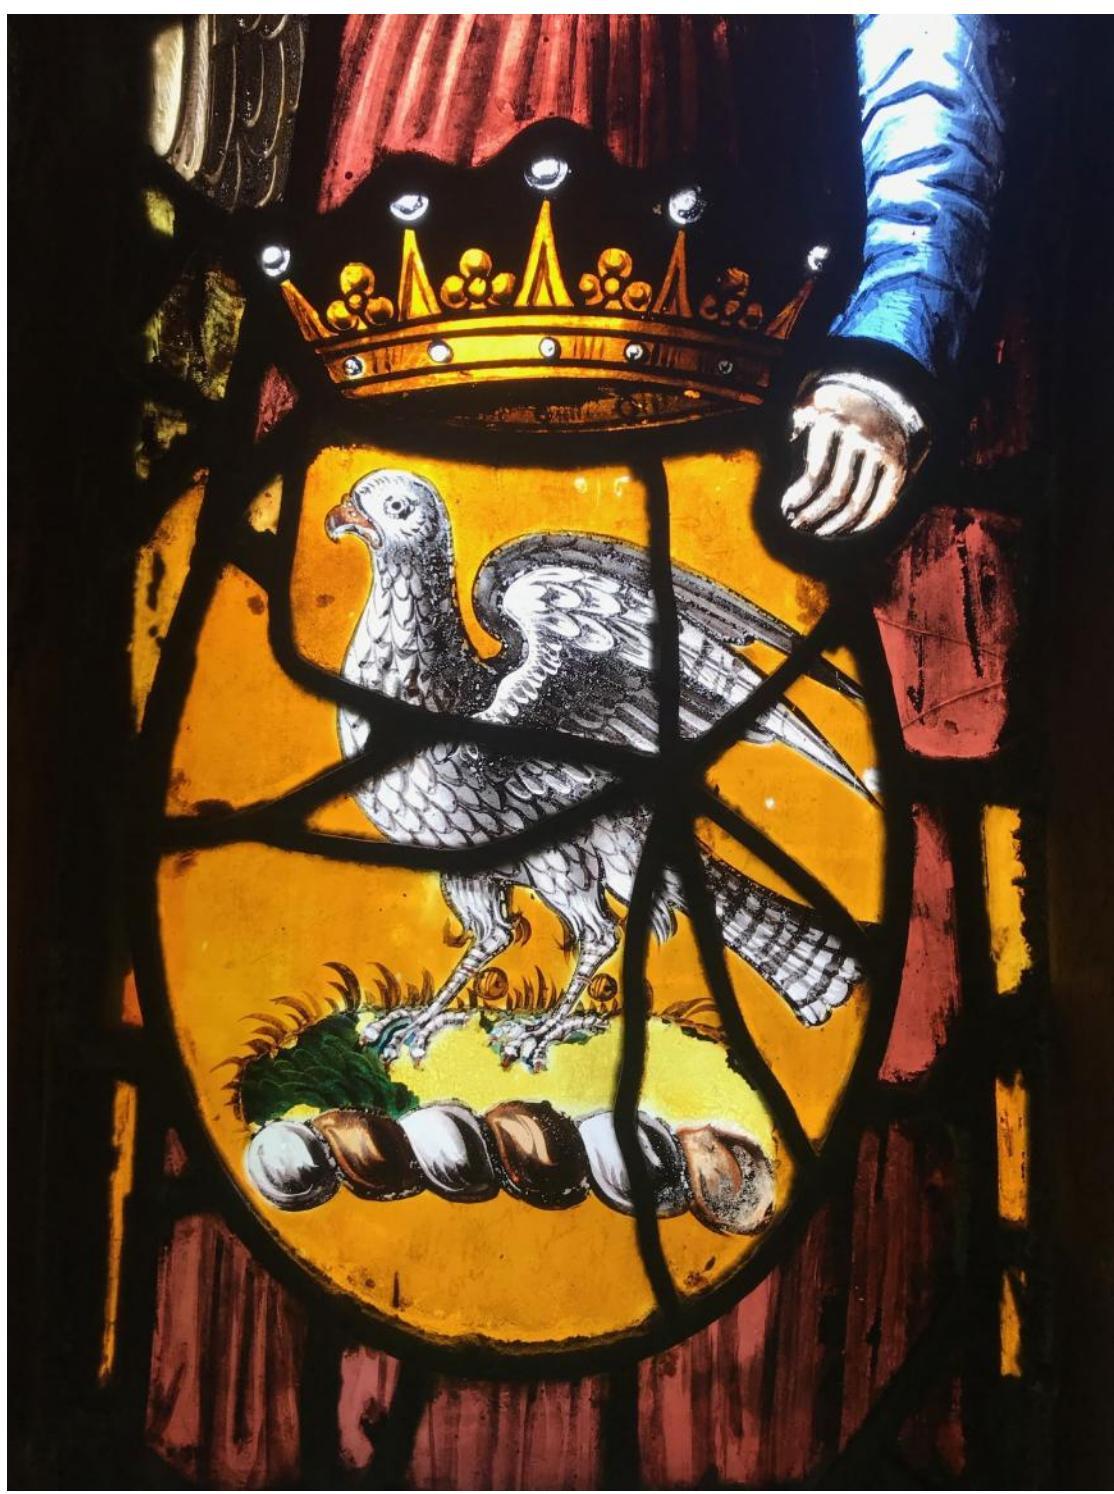
Figure 35. Mending leads to the medallion in tracery panel B7.

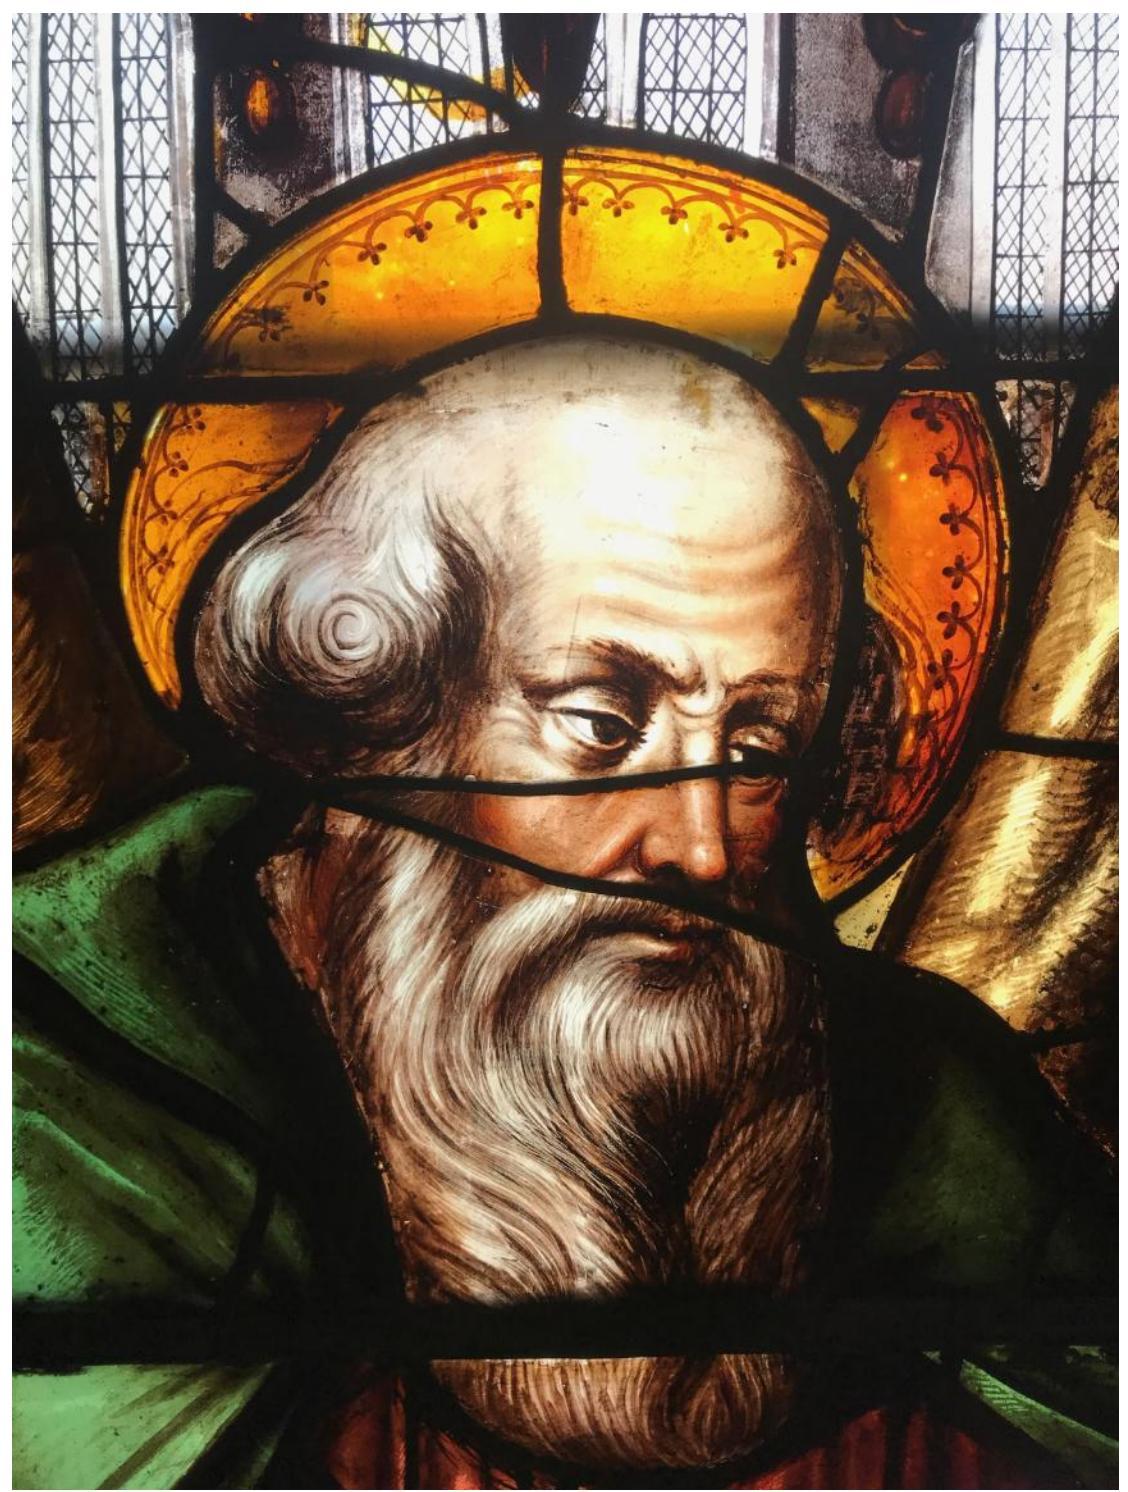
Figure 36. Panel 4b, showing a painted repair to the central section of the face of St Andrew, likely to date from the 1920's restoration.
