ARBORICULTURAL IMPACT ASSESSMENT REPORT FOR:

31 Elsworthy Road

Ref: BBP/31EWR/AIA/01b

Date: 29th March 2021

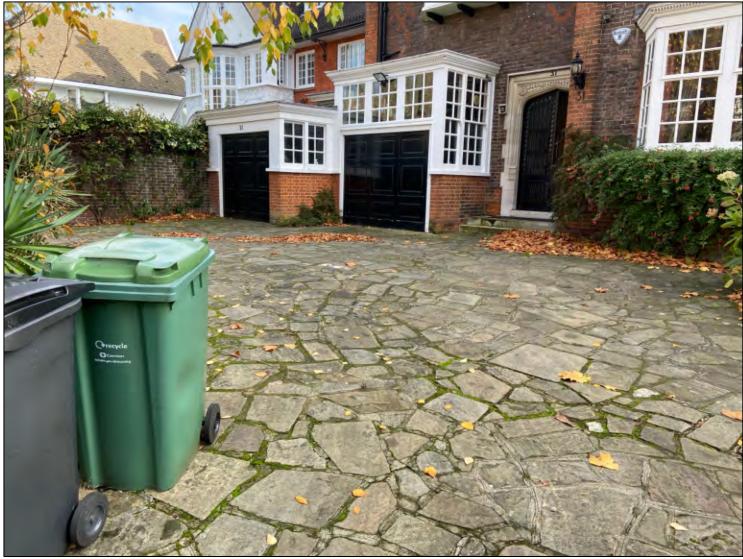
Photograph 2: Existing front driveway surface

- 6.1.3 The replacement of the front driveway encroaches within the RPA of the retained trees on the site's frontage and therefore will need to be undertaken in a controlled manner.

- 6.3.5 The replacement paving/hard landscaping will require a no-dig construction technique, either using a cellular confinement system with no fines aggregate for the sub-base or simply building upon the existing sub-base without disturbing the ground below. Choice of construction method will initially depend upon root penetration within the existing sub-grade. The key principle is not to excavate in the presence of roots and to provide a porous surface to promote healthy soil water relations for future root growth. A further consideration in the use of a more expensive cellular confinement system or similar, may be the claimed reduction in risk of possible future slab / surface displacement by roots of trees growing in paved areas.
- 6.3.6 The immediate canopy encroachment can be avoided with a minor crown reduction to T2.

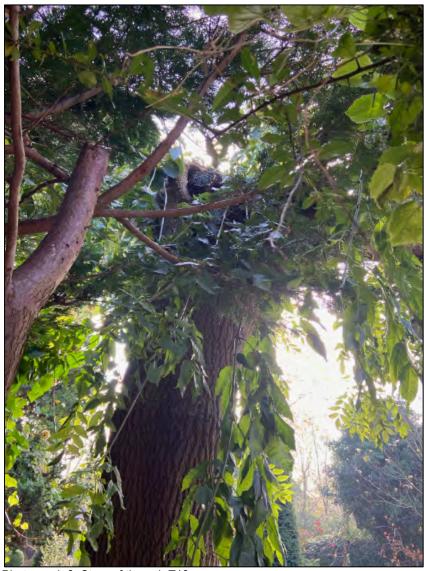
Photograph 3: Stem of the ash T13

- 6.3.3 The path of the basement foundations through the RPA of T13 will be manually excavated to 750mm depth under arboricultural supervision; any roots encountered within the trenches / pits will be cleanly pruned back to an appropriate junction with a sharp pruning saw or secateurs back to a junction. Roots larger than 25mm diameter may only be cut in consultation with an arboriculturalist. The path of services to the A/C unit could be box hoarded above ground through the shrub border above the roots of T7 birch.

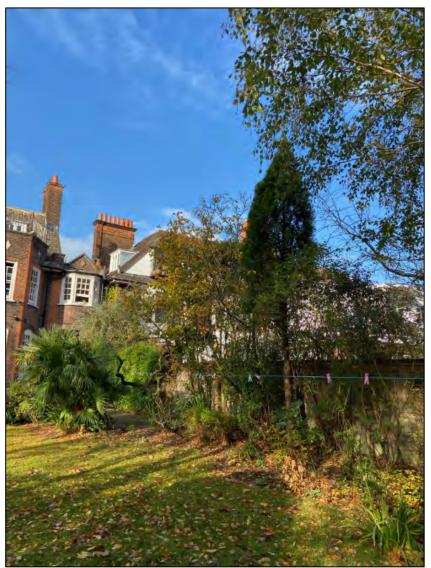
Photograph 4: The low quality T8 – T12

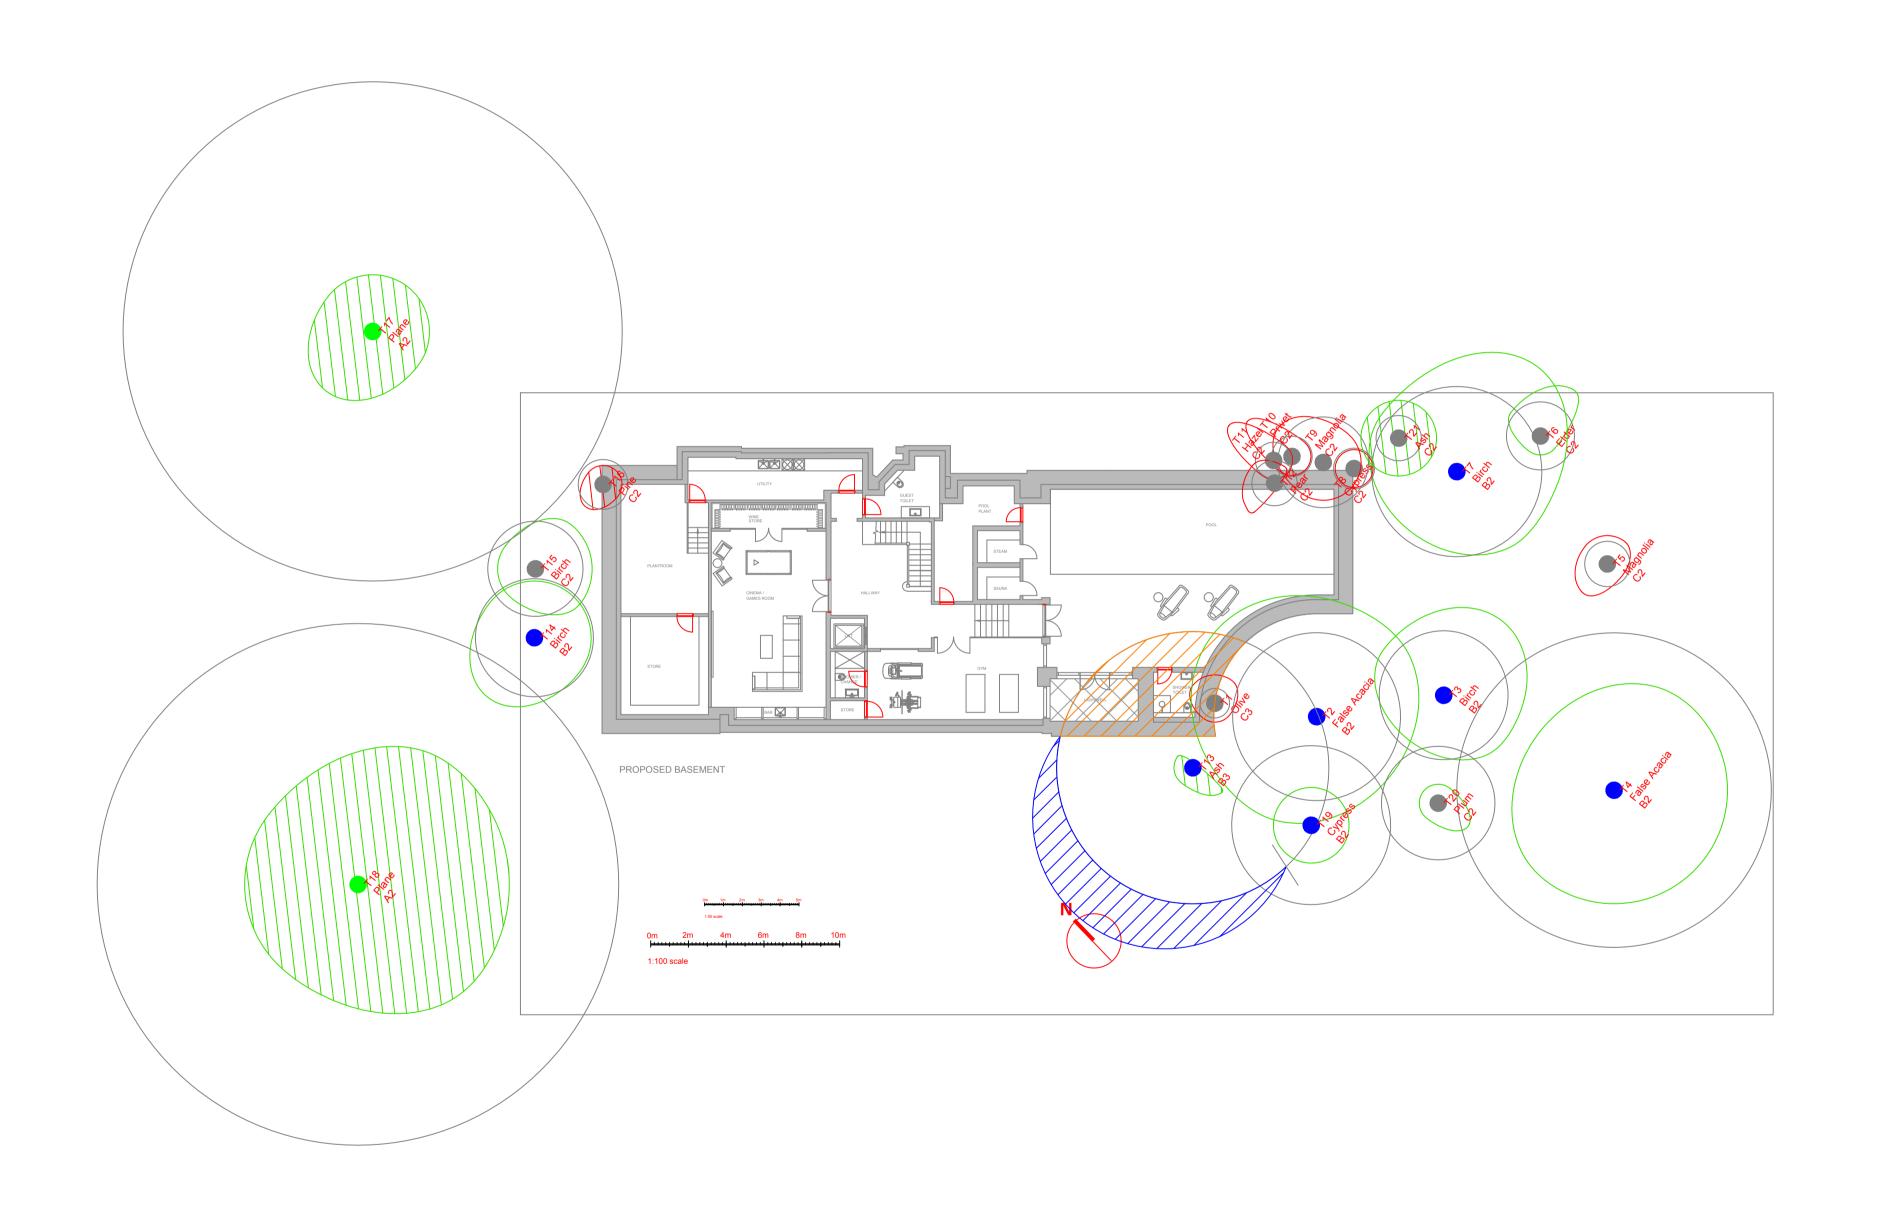
PLAN 2

- 6.3.2 RPA encroachments of >5% area are shown in Plan 2 compensated for elsewhere on contiguous land. The parts of the RPA of T13 within the application site that are outside the basement footprint will be treated with biochar or similar to improve rooting conditions therein. Although T7 is not directly impacted, it is close to the basement and there would be no harm extending the treatment to this specimen tree.

ARBORICULTURAL IMPACT ASSESSMENT PLAN (S)
