DESIGN & ACCESS STATEMENT

**5 & 6 NEW SQUARE,
LONDON,
WC2A 3TL**

**THE HONOURABLE SOCIETY
OF LINCOLN'S INN,
NEWMAN'S ROW,
LONDON,
WC2A 3TL**

REFERENCE: 210003

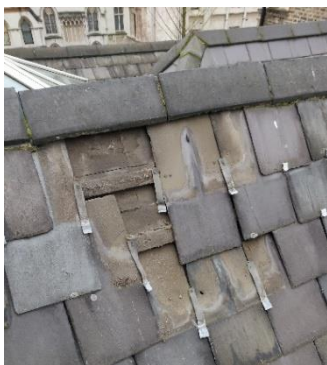
Image 4: 5 New Square East Pitched Roof Section

The existing slates to the pitched roof sections at the front and rear are fixed onto battens which are fixed directly onto close boarding. There are no counter battens or sarking felt present (See Image 4 below and Figure 6 of the Photographic Schedule).

Prior to reinstating any slates, any areas where breathable waterproof membranes are non-existing will have Tyvek breathable waterproof membranes installed with new pressure impregnated counter battens to which the slates will be nailed into.

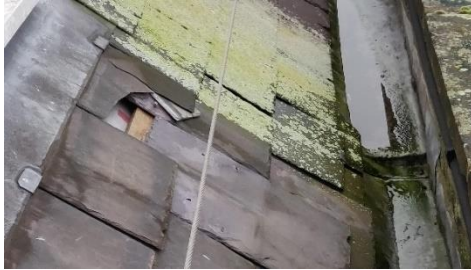
Image 5: Existing Roof Construction

The existing slates to the pitched sections of the mansard roof are fixed onto battens and there is a waterproof membrane present. It is not known what is beneath the waterproof membrane as this area was inaccessible at the time of the survey. Further investigation will be carried out when safe access can be obtained via a scaffold. See Image 5 below:

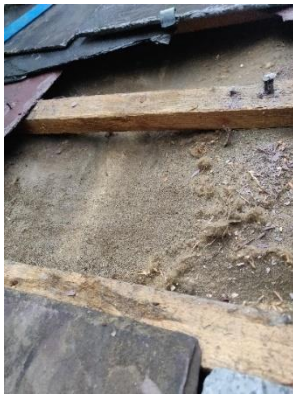
Image 6: 6 New Square Front Pitched Section

The existing slates to the front and rear pitched sections of 6 New Square mansard roof comprise of slates fixed onto battens with 2 layers of felt beneath and counter battens to the underside of the felt (See Images 6 & 7 below).

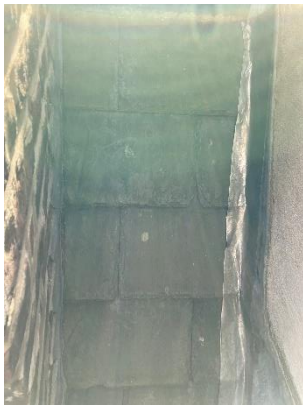
The existing flashings are in poor condition (see Figure 5 of the Photographic Schedule and Image 8 below) and Flashband repairs have been carried out to prevent water ingress into the building.

Image 8: Flashband Repair to Flashing

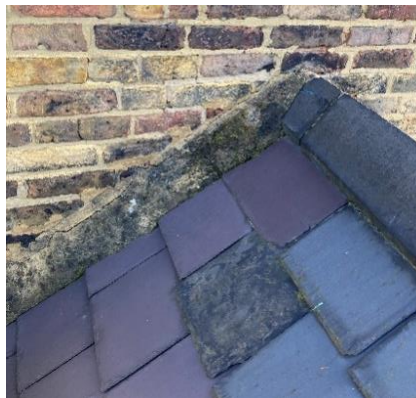
Image 9: Failed rendered plinth detail

Where the pitched sections of roof meet the party walls of the adjoining buildings, a rendered plinth detail has been formed to divert water away from the buildings. As shown in image 9 above, the render has failed, and extensive cracking has occurred, creating a pathway for water to enter the building. The proposed works will involve replacing the defective lead flashings and failed rendered detail with new Code 4 lead flashings to create a watertight roof.

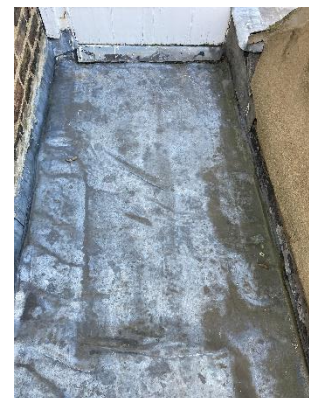
Image 10: Rucking of Lead Bay

Image 10 above shows rucking of lead which has been caused due to the absence of a lead step detail in the bay. The existing lead sheet is too long and has not been installed in line with the Lead Sheet Association guidelines therefore fails to achieve the required falls to divert rainwater away from the building. The proposed works will involve removing the existing lead bay and installing two sheets of new lead with 600mm centres and a step detail to prevent splitting of the lead.
