## **Tree Inspection Report**

Site 22 Churchill Road, London NW5 1AN

13<sup>th</sup> March 2019

**Ref** TI21021901

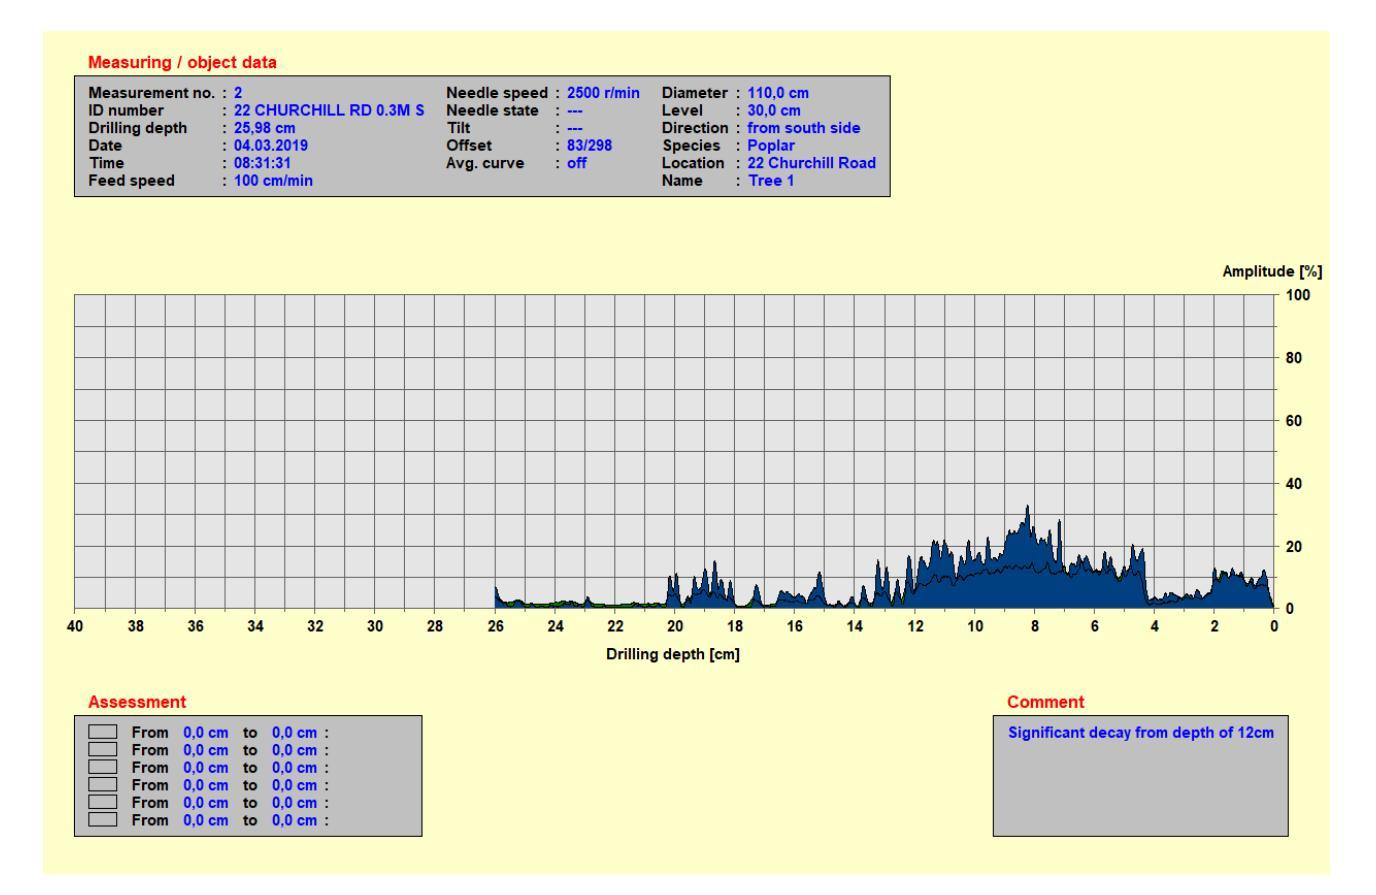
Figure 2. PD resi test. Tree 1. 0.3m above ground level on south side

- 3.2.3 Previous drill tests undertaken from the south, west and east sides indicated that the stem had a residual wall of sound wood with thicknesses of around 22-23cm at a height of 1 metre. During the most recent site visit, drill tests from 22 Churchill Road indicated wall thicknesses of around 12cm from the south side and 26cm from the west side (see Figures 2&3).

- The apparent reduction in sound wall thickness on the southern side previously this was noted at around 22cm; however the most recent drill test indicates it to be 12cm.

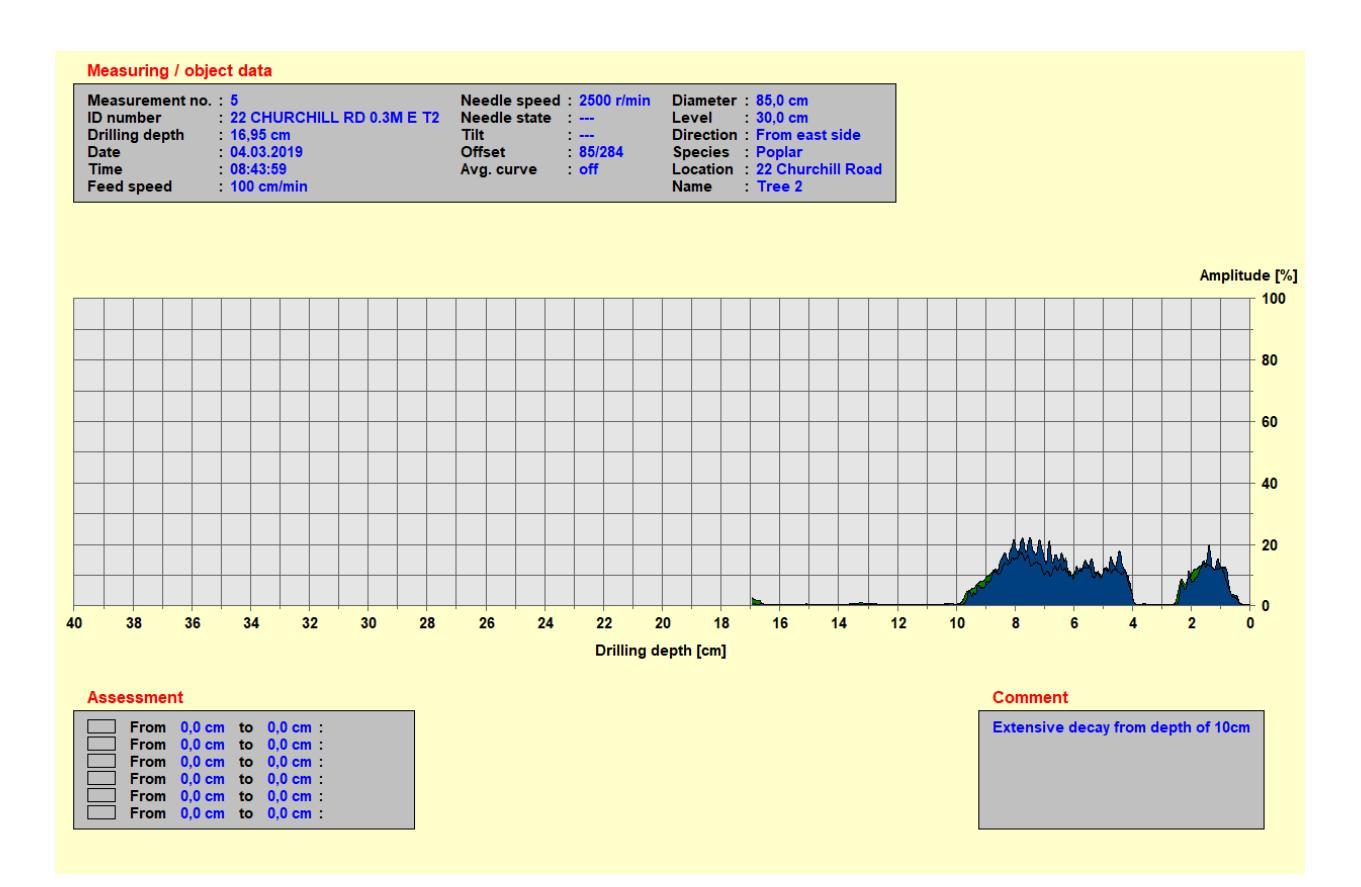
#### Figure 4. PD resi test. Tree 2. 0.3m above ground level on east side

- 6.1 It is apparent that the tree has significant decay on its eastern side; however from the north and south sides it has sound wall thickness of 36 37cm which I consider provides good support, particularly given the tree's small size and upright form.
- 6.2 It is possible that with time the tree's condition might deteriorate to a point where the stem becomes unstable; however this is unlikely to occur for several years at least and I consider that the tree can reasonably be retained on the basis that it is re-pollarded every two to three years.

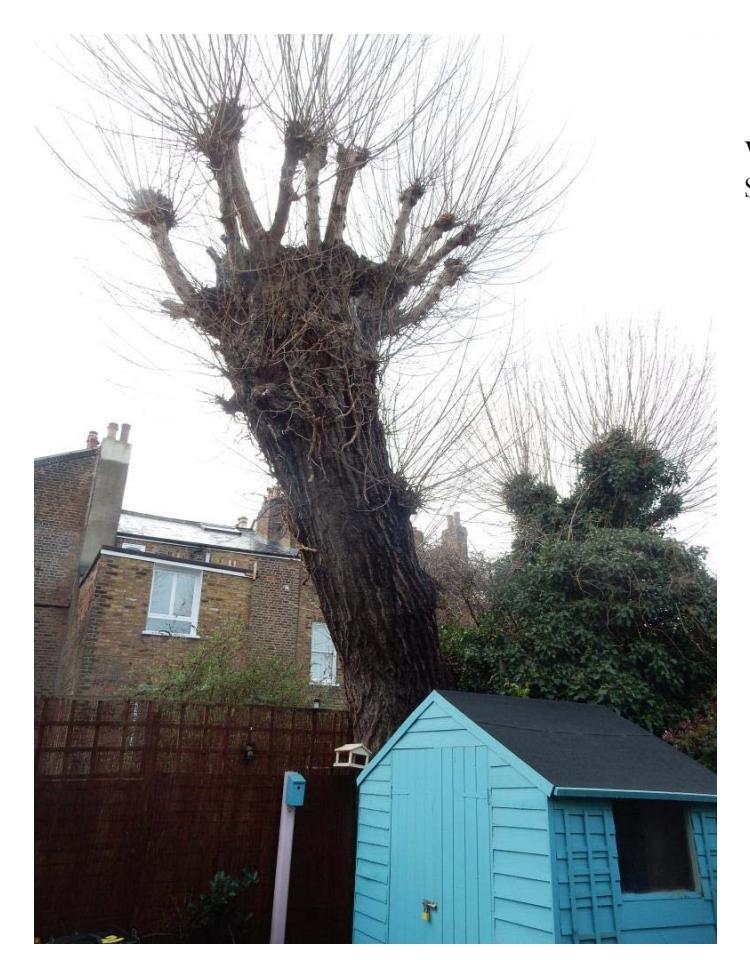
### Photograph 1

- 3.2.1 The tree has a single wide stem with a pronounced lean to the north-east, overhanging the garden of 24 Spencer Rise. At a height of approximately 7 metres the stem divides and at this point the former crown structure was topped many years ago leaving extensive decay where the former large-diameter scaffold branches were severed. From the original topping points secondary growth stems emerge. These comprise several short stem sections with a length of approximately 1 metre and average diameter of around 150mm. The top of the secondary stubs has been managed through regular recent pollarding. At the time of inspection there is two season's growth emerging from the top of the stubs, having re-grown from pollarding following my previous recommendation.

View of Tree 1 from 24 Spencer Rise

- 7.1 I recommend that Tree 1 is removed within the next three months.
- 7.2 I recommend that Tree 2 is re-pollarded within the next twelve months, and that this be repeated every 2-3 years.
- 7.3 I recommend that Tree 2 is re-inspected in three years' time.

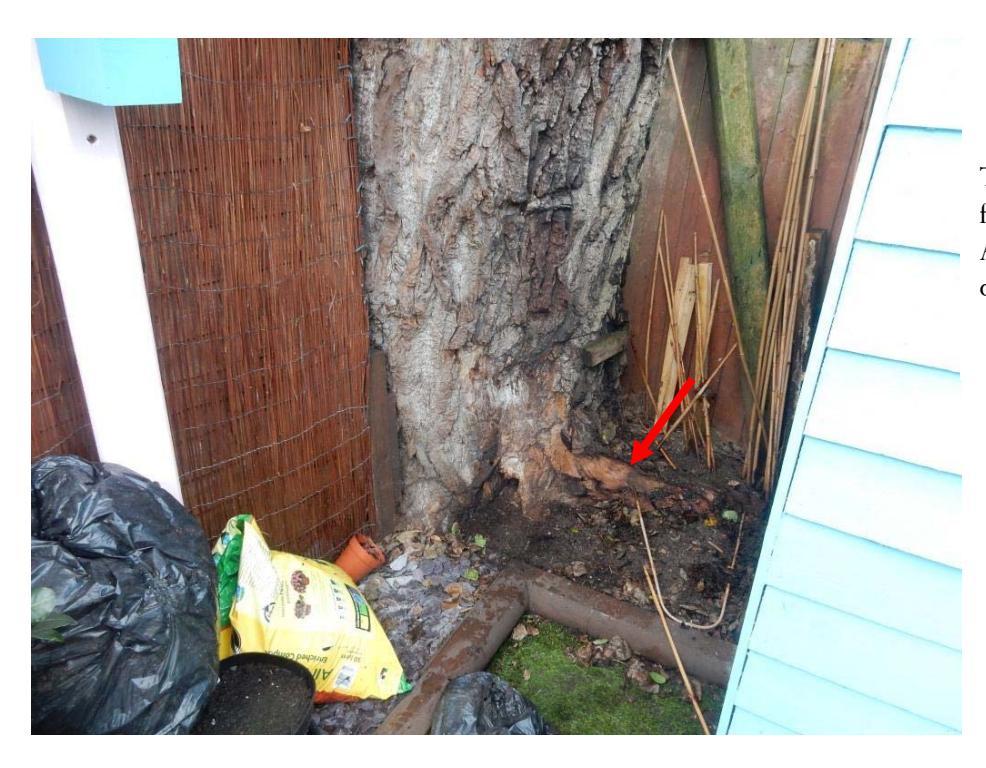
### Photograph 2

- 3.2.4 During my previous inspection I noted that the tree's base was extensively decayed on the north-east side as viewed from the garden of 24 Spencer Rise. During the most recent site visit I observed that this had deteriorated further, with a surface root now dead and decayed. I undertook a drill test on this side of the tree which indicated that the sound wood around the outside of the stem has a thickness of 13cm (see Figure 1).

- The death and decay of a surface root on the north-east side in the garden of the property adjacent.

Tree 1. View of base from 24 Spencer Rise. Arrow points to dead and decaying surface root

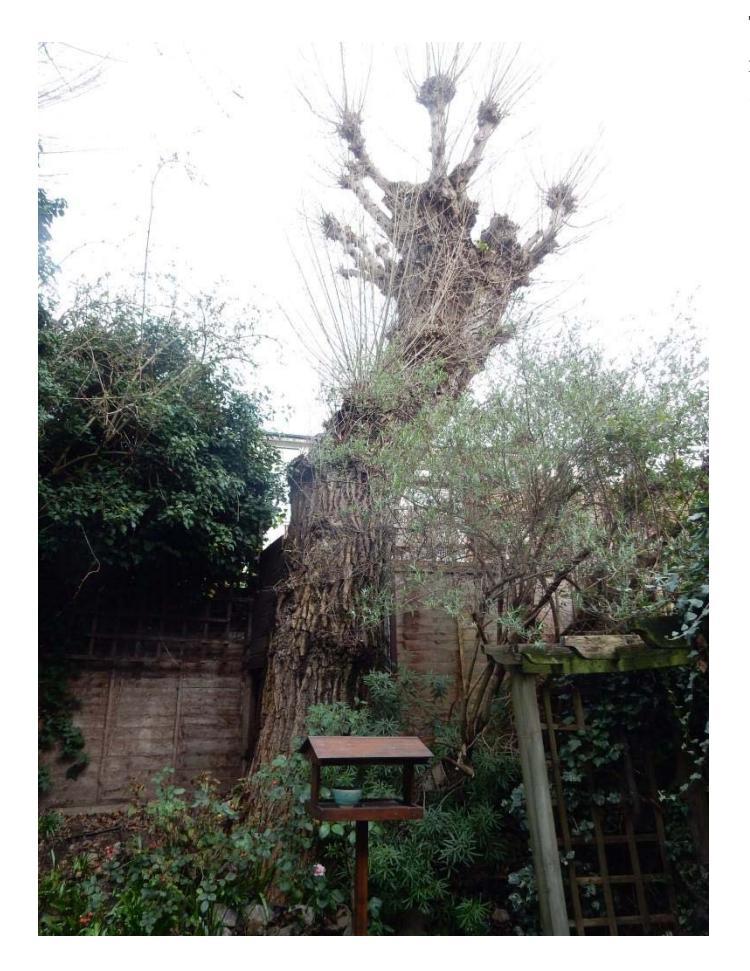
### Photograph 3

Tree 1. View from 22 Churchill Road

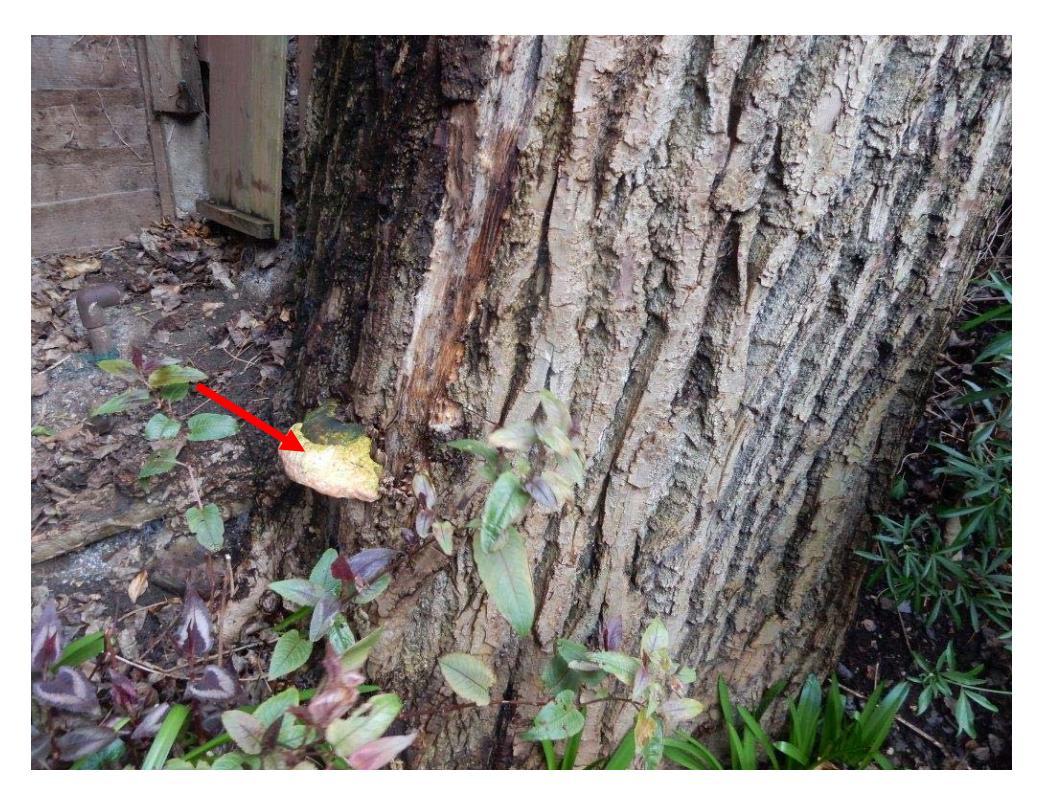
### Photograph 4

- 3.2.2 A previous observation of the tree's base from 22 Churchill Road was that it was in good visual condition with no defects seen. On this latest site visit however I observed a *Perenniporia fraxinea* fungal fruiting body at a height of 0.2 metres above ground level on the south-west side.

- 4.2 Since my previous inspection of the tree there are significant changes to its condition, notably:
  - The presence of a *Perenniporia fraxinea* fungal fruiting body on the south-western side of the stem. This is a fungus that causes extensive decay and the emergence of a fruiting body on the tension side (the tree leans to the north-east) is a cause for concern.

Tree 1. *Perenniporia fraxinea* fruiting body on southwest side

- 4.3 From these observations it appears that the stem has deteriorated in quality within a relatively short time scale. The tree has a very wide stem, particularly below the pollard point with weight imbalance caused by its lean, and I consider that failure is now foreseeable. Given the nature of the tree species and the fungus involved I consider it entirely likely that deterioration in wood quality will continue, resulting in an ever-increasing hazard of tree failure.
- 4.4 I do not consider that realistic pruning options remain, and I recommend that the tree is removed within the next three months.

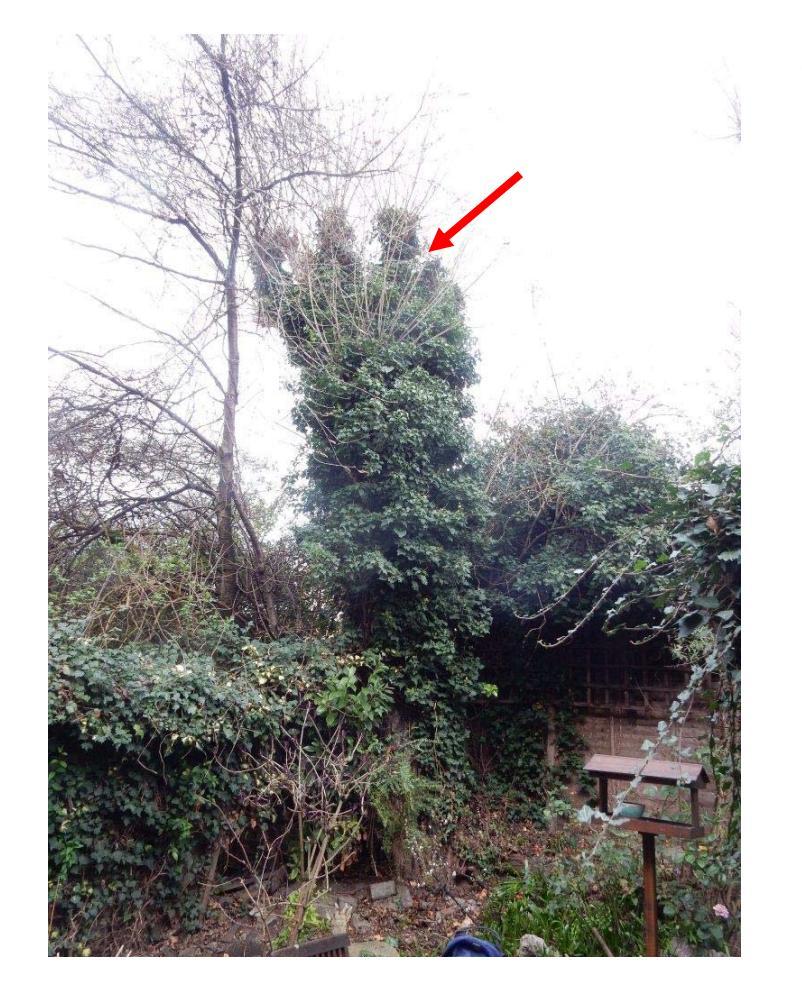
# Photograph 5

- 5.2.1 The tree has a single, upright, ivy-covered stem to a height of 7 metres. The view of the tree's top is obscured by ivy; however it is apparent that it has been subjected to the same management as Tree 1, and it is likely that there are large decaying wounds where the primary scaffold branches where severed in the past. The tree has re-grown from past pollarding undertaken since the previous inspection with 1-2 seasons' re-growth.
- 5.2.2 Use of a sounding mallet implied the presence of decay on the east side. I undertook drill tests in three locations where the tree could be accessed on the north, east and south sides (see Figures 4-6)

Tree 2
