PROJECT  
**The British Museum Roof Repairs**

TITLE  
**Gallery 10 Access Works**  
**Existing Plan**

SIZE	SCALE	LAST REVISED	DRAWN	CHECKED
A1L		15/04/2021	TM	TM
REV	SUITABILITY/REASON FOR ISSUE			
P02	S4 - Listed Building Consent			
DRAWING NAME				
24102600-XX-DR-A-1005

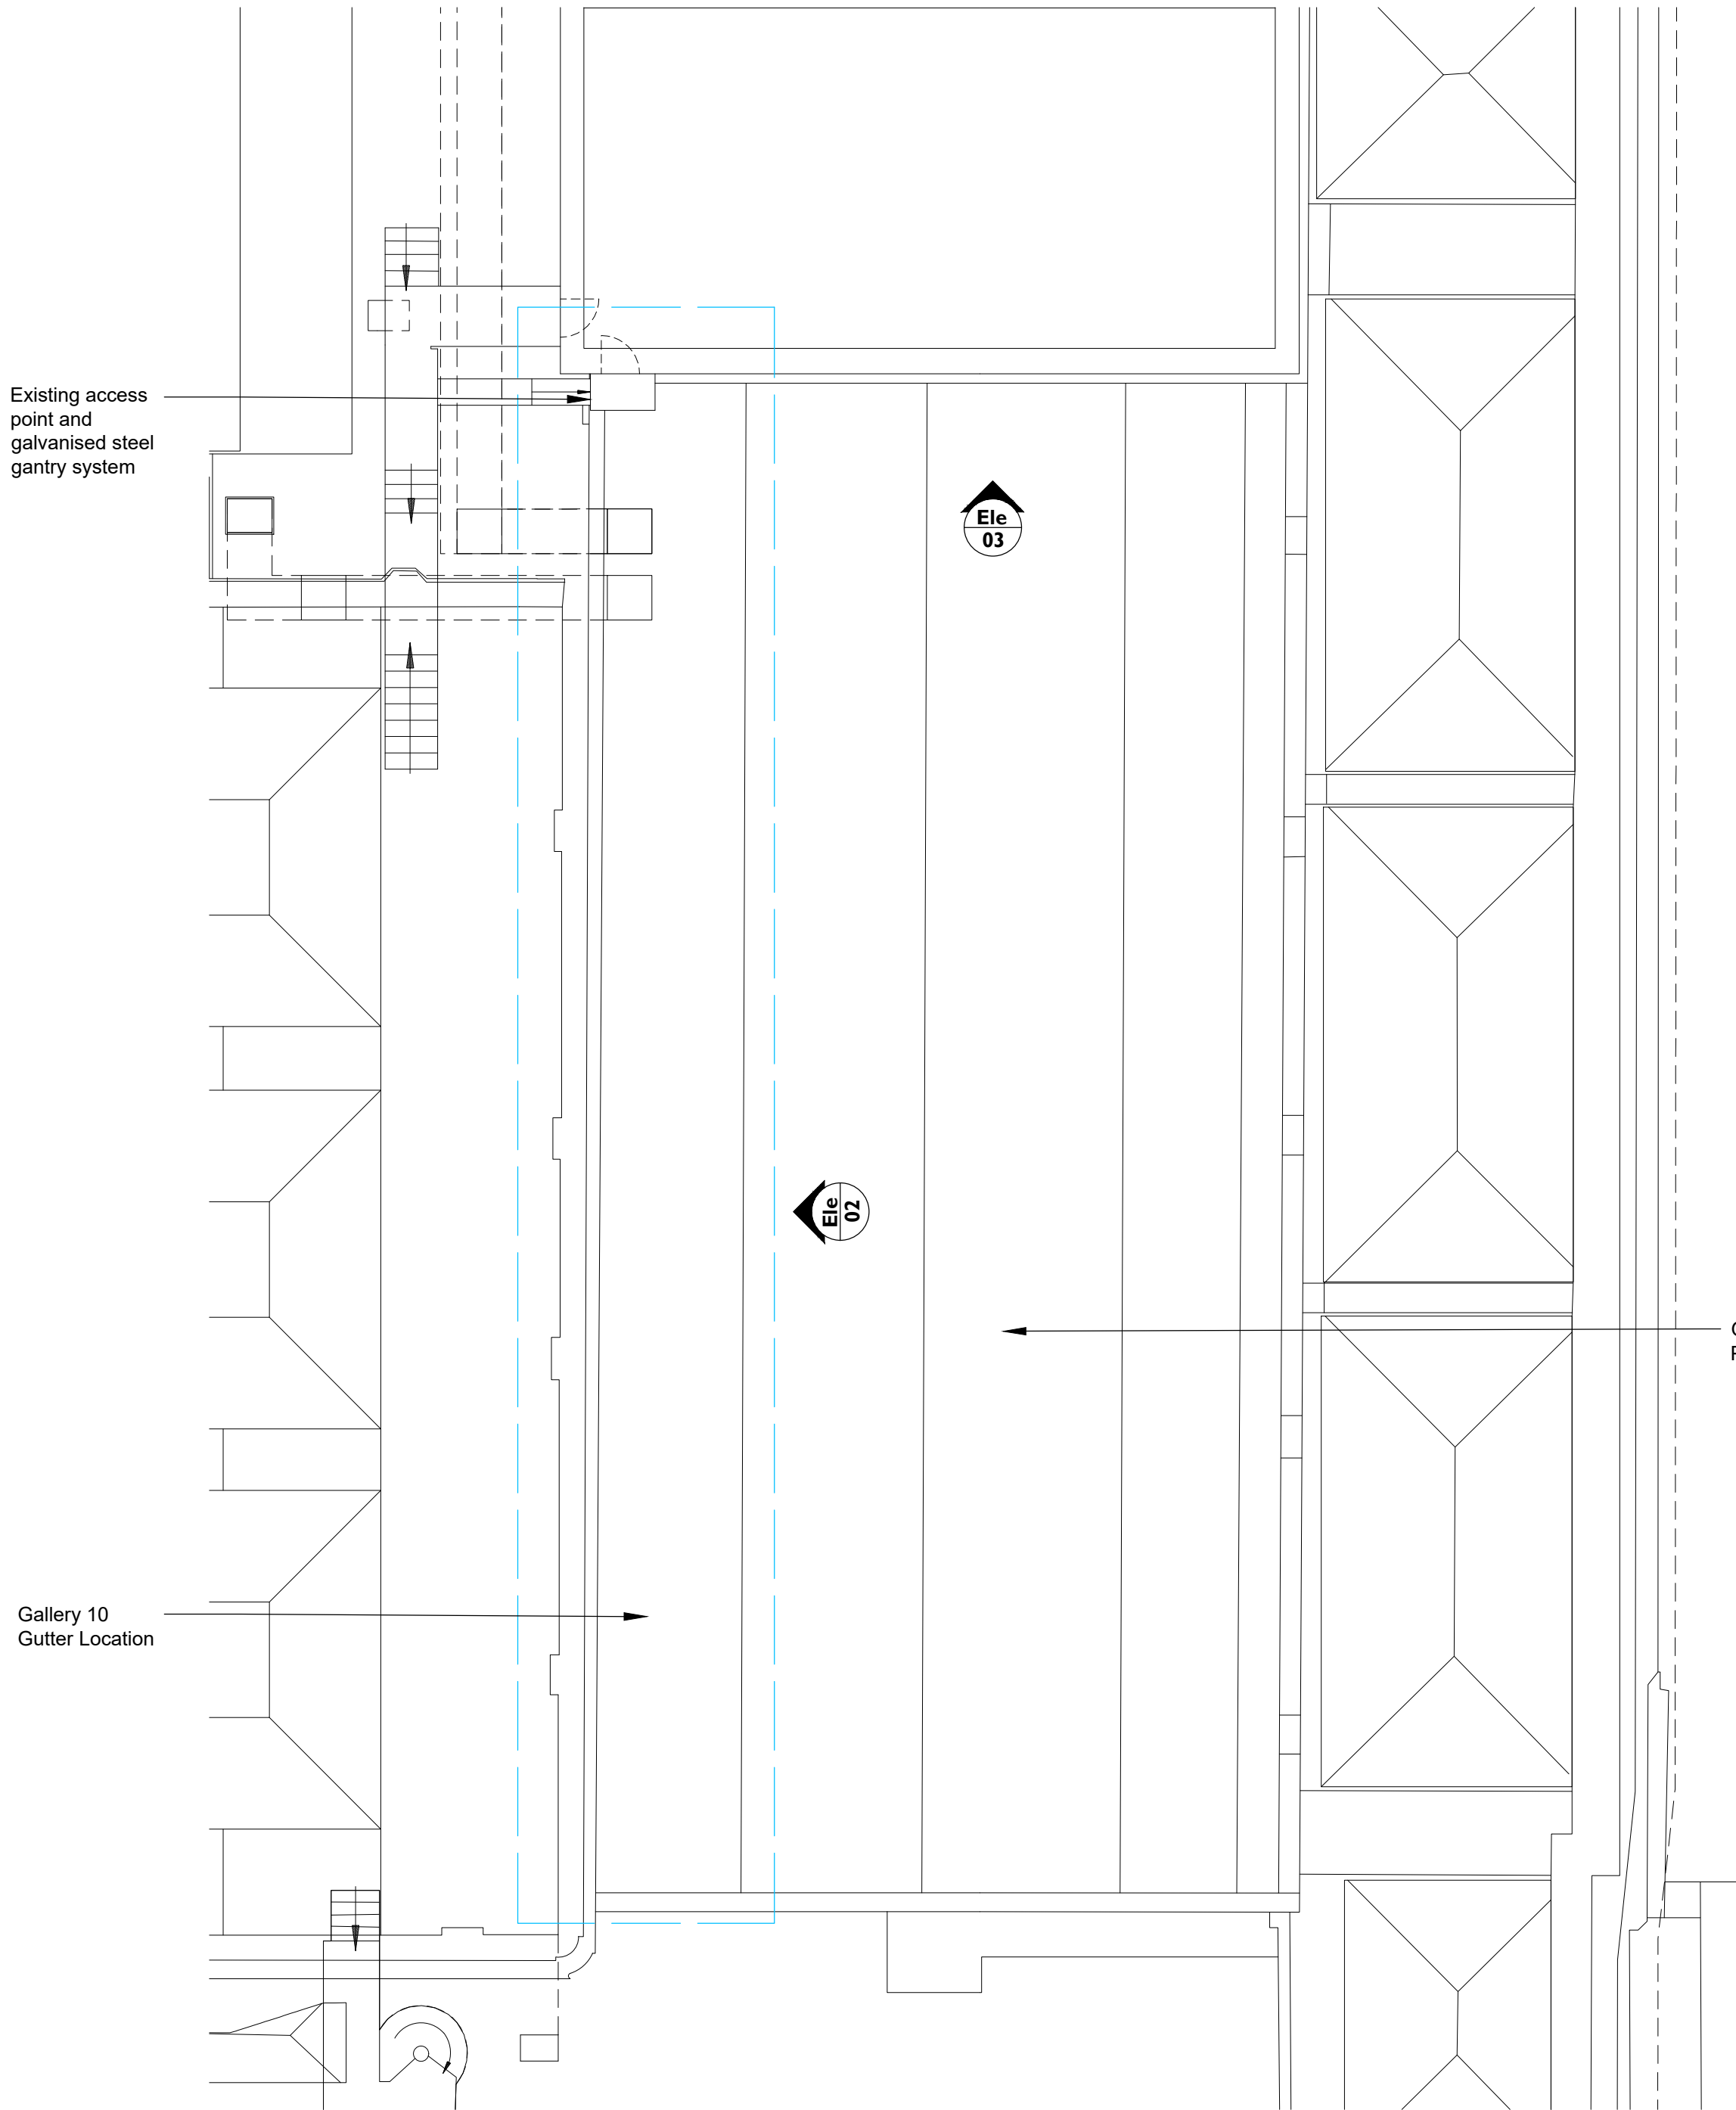
**01**  
**1005** **Gallery 10 Existing Roof Plan**  
**1:100**

Organic growth on wall along gutter line where there is currently no access

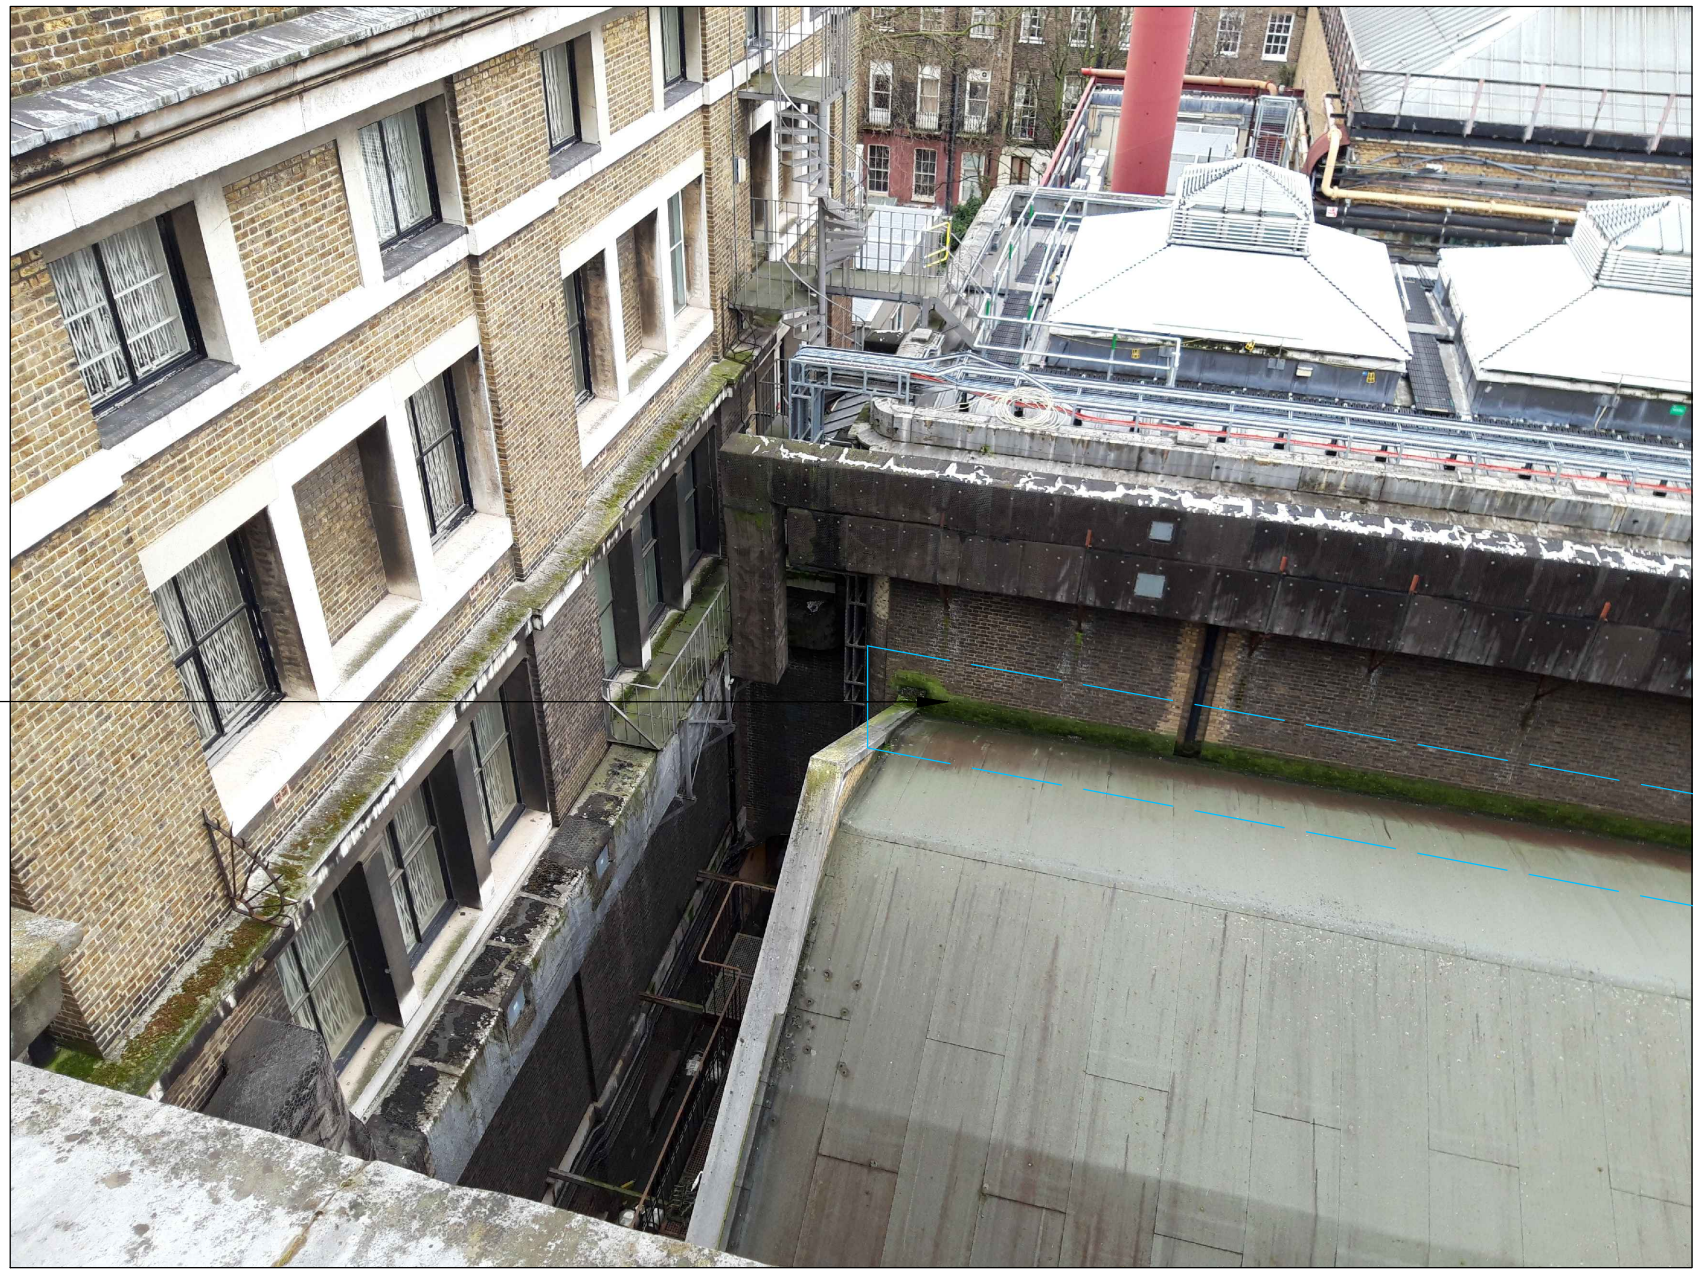
**02**  
**1005** **Gallery 10 South End Photograph**

Gallery 10 Covered Pitched Roof

Existing access door & gantry system

Roof gutter that requires access for maintenance
