23 Gloucester Crescent

*Heritage Impact Assessment of
Proposed Amendments to LB 2020/4735/L*

May 2021

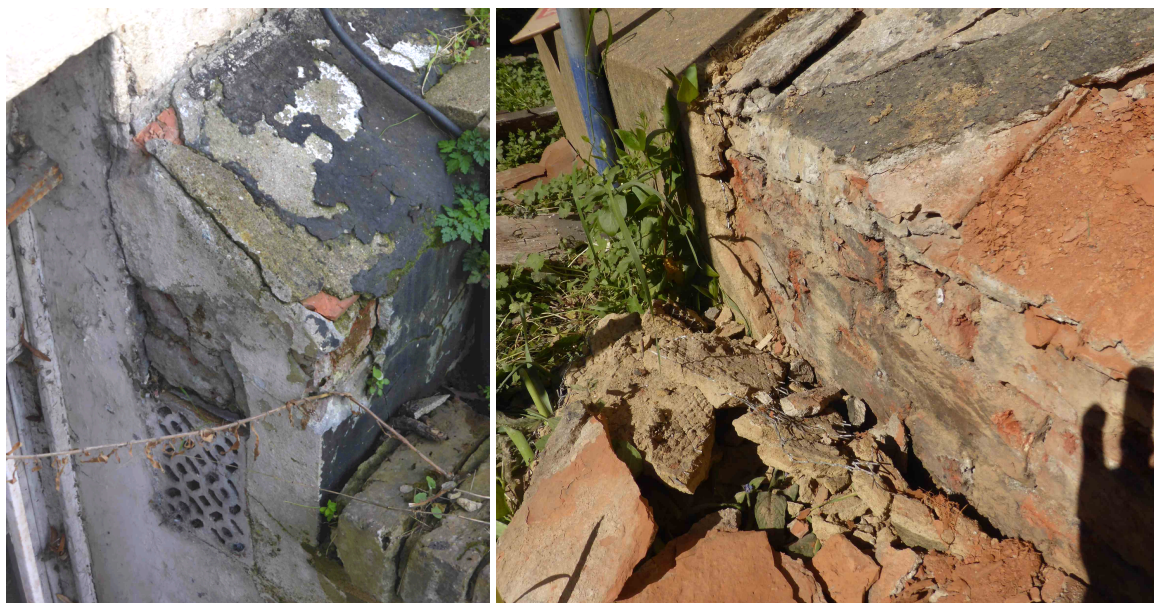
Fig. 1 West wall lightwell showing vented plinth detail

Fig. 2 Removal of expanded metal mesh reinforced cement render over original Roman cement and creasing tiles

Opening up works to the plinth, seen in progress in fig.1, have revealed 25-30mm of cement with expanded metal reinforcement and various layers of bituminous paint, underneath which moisture has been trapped within the plinth structure. The two layers of creasing tile used to form the sloped top to the plinth have decayed to powder in most instances (fig. 2). It is proposed to replace these tiles with matching clay equivalents bedded in lime based and cement free mortar.

It is proposed that the existing cavity will be cleaned of loose debris, the crumbling creasing tiles will be replaced with matching clay creasing tiles and the construction re-rendered with breathable Roman cement as per the consent.

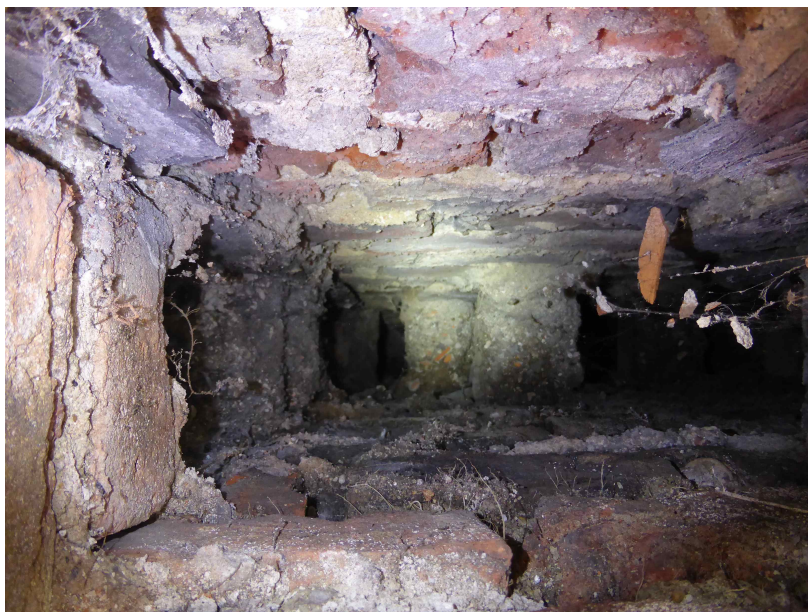
Within the cavity revealed under the decayed creasing tiles a series of irregularly set brick stretchers create an open slot of 4" width, which is as deep as the internal basement sub-floor level. Each stretcher 'tie' is not bedded into the internal structural wall leaf (fig.3), but bonded to it using lime mortar and a slate tile acting as a DPC. Unlike other contemporary early Victorian cavity experiments, this example has been created specifically as a waterproofing strategy to hold the external ground level away from the inner wall.

The presence of ponds slightly above and to the West of the house as indicated on early maps, may have prompted this invention. Whatever the reason, this highly unusual cavity design is of historic technical interest.

Fig. 3 View down into the vented cavity showing staggered brick stretcher ties

The separation of the inner house wall from the earth due to the external vented cavity (with its outer wall being the retaining wall), affords the opportunity to avoid using a Newton membrane internally within the basement: thus a vapour-open construction is now proposed to be reinstated internally in the house at this level (see following section). This return to a fully 'breathing' construction is significant for the long term security of the house and is in line with technical advice from Historic England, the SPAB and Historic Scotland.

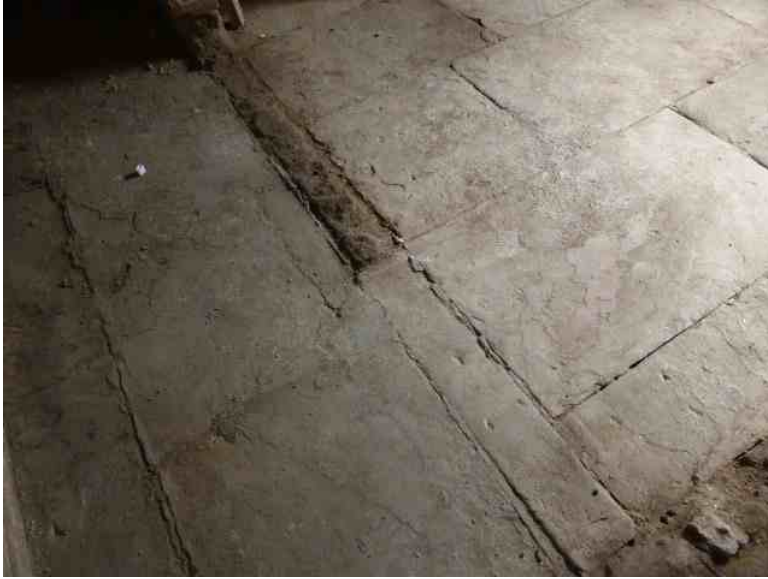
The consented scheme allowed for a renewal of the floor finish in the basement. Careful removal of the quarry tiles and underlying leveling screed laid in the 1960s has led to the uncovering of the original York flagstone floor underneath (see fig.4) in the former passage and scullery. There was no indication that this floor would have survived in situ, given the complete removal of the original walls in the basement in 1969, as noted in the construction drawings of the time, and indeed the quarry tiles within what was originally the kitchen of the house (but later became a dining room) were laid onto a thick concrete slab with no flags present.

Fig. 4 Uncovered flagstone floor showing original threshold between hallway and scullery

There is now an opportunity to bring the original stone floor back into use – it remains in good condition with tightly fitting flags. This discovery has transformed the assessment of significance of the kitchen floor from 4 to 2.

The importance of the floor is enhanced further due to the fact that the stones are not bedded onto a sand blinding on the ground, as is typical, but each stone is instead supported on corner bricks with a slate DPC laid onto a flattened clay base. The void thus created below the flags is around 65mm in height, and is vented via perimeter holes within the base of the west (external) wall (see fig.5). These holes lead to the full basement storey-height vented cavity outside the structural walls that operates as a very unusual damp-proofing feature (see also drawing GC 321).

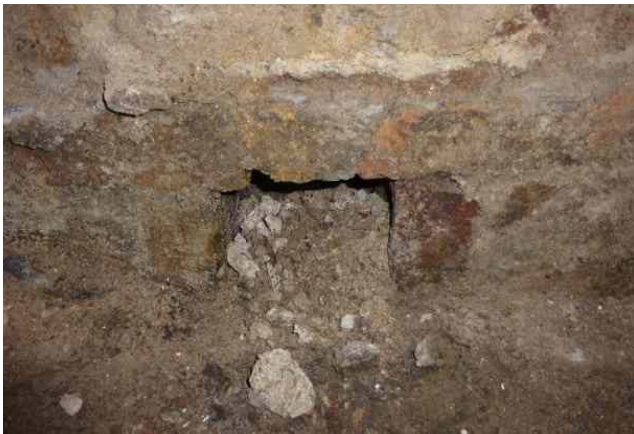
Fig. 5 Below slab vent to external cavity still semi-blocked with concrete

It is surmised that internal moisture in the house during the last 50 years was not caused by direct water ingress from the external ground but by internal entrapment of moisture as condensation following renovation works including the impermeable concrete slab replacing the vented flag floor in the dining room and the covering of the scullery flags in impervious tiling, along with non-breathable finishes on the walls.

In order to re-introduce adequate air movement around the footings of the wall in the dining room (where the existing concrete slab is to be retained as per the consented scheme), it is now proposed to replace the limecrete lung along the western wall with an open channel under a thin limecrete slab with floor finishes on top. This channel void will be vented to the exterior slot cavity via the 2 original existing interconnecting vent hole and effectively reinstates the original detail here, albeit that the void is not present under the concrete slab. However the vastly improved ventilation directly adjacent to the walls is considered to provide an adequate break to ensure that any residual ground moisture is not driven up the inner face of the wall.

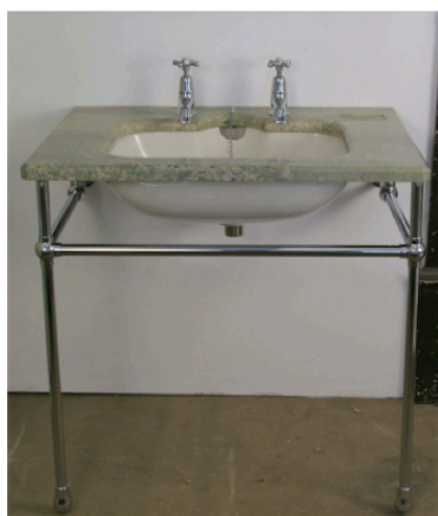
The basin vanity unit was unfortunately damaged beyond repair during unauthorized removal, with previously repaired cracking also failing. The consented proposal for its replacement is as follows:

Fig. 7 Replacement Shanks basin with marble top

Given the relative rarity of Shanks basins with fitted marble surrounds in good condition, the example shown (fig.7) has been purchased to secure its availability. The green colour is appropriate to the Vitrolite splashback, which is being reinstated, and an integral metal stand will provide support, as stated in the consented proposal.

Consent is sought to omit refitting the mahogany support pieces directly under this basin owing to the location of the metal legs which are too close to the corners of the marble. It is proposed instead to use the mahogany pieces to form the consented shelf immediately adjacent to the sink (in lieu of new material).

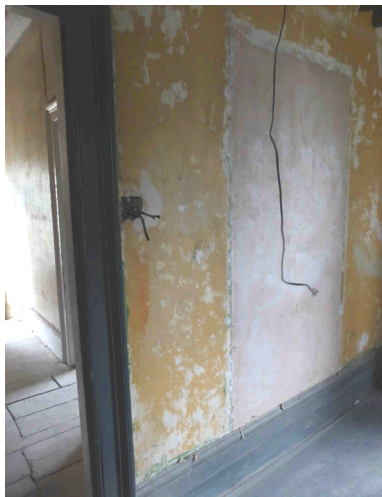
Fig. 8 Gypsum plaster door infill to be retained as found

It is proposed to not re-open the doorway into the linen cupboard to provide ensuite access between the bedroom and bathroom, and the wall/skirting will therefore remain in its present condition. It is not proposed to reinstate lime plaster in lieu of the gypsum plaster installed in 1968 when access to the cupboard was moved from the bedroom to the bathroom, as the gypsum records that an alteration was previously made here (see fig.8). The linen cupboard will therefore be retained as is and access will continue to be from the bathroom. This proposal is considered to be neutral.

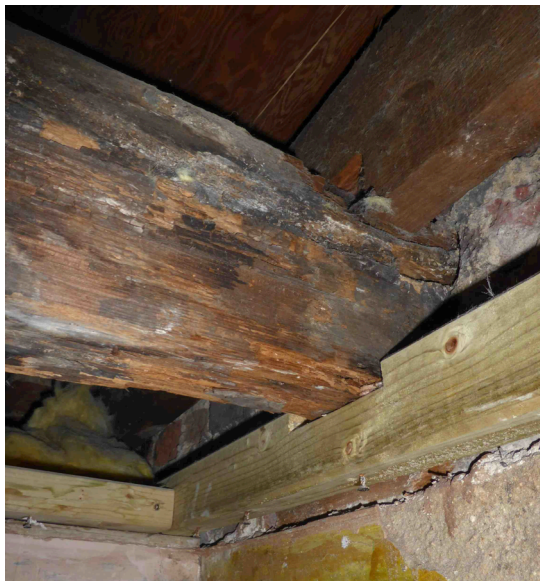
“Where the valley beam runs into the party wall, over the landing, it has significant damp related decay and will require remedial work – possibly grafting a new section of timber with a steel flitch plate to fit into the existing bearing point (which would require to be fully waterproofed), as specified by a Structural Engineer. Using steel would potentially allow for more of the original timber to be retained, however it is not a like-for-like repair and should only be considered if there were no less impactful solution. Invasive investigation needs to be undertaken in order to ascertain the least destructive and most appropriate way to repair this critical timber.” Extract from the approved Heritage Impact Assessment September 2020

Fig. 9 Underside of the valley beam at bearing point on masonry wall

The presumption is the retention of significant original fabric wherever practical. As such the use of steel bearing plates specified by a conservation-accredited structural engineer forms part of the application, using 195 x 10mm plates to create a replacement bearing as per fig. 10. This proposal results in the valley beam being retained in situ in its existing state with a structural bearing reinstated and the load of the roof shared to the purlins.

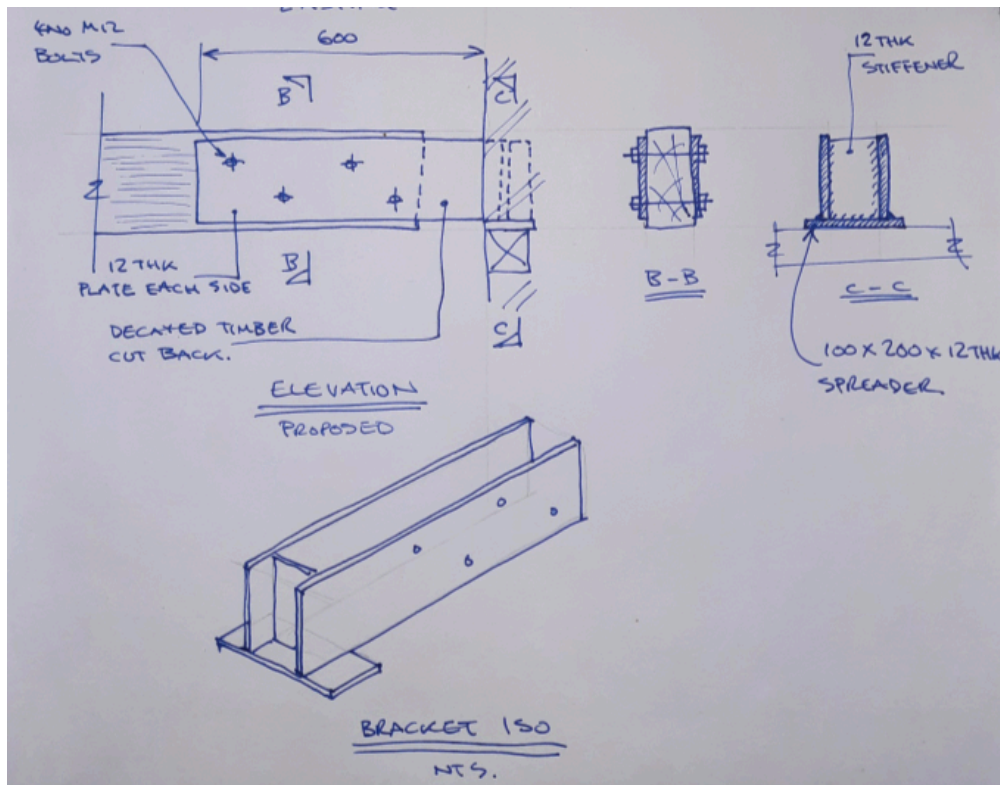
Fig. 10 The Morton Partnership: design for steel bearing plates to replace decayed timber into existing masonry wall.

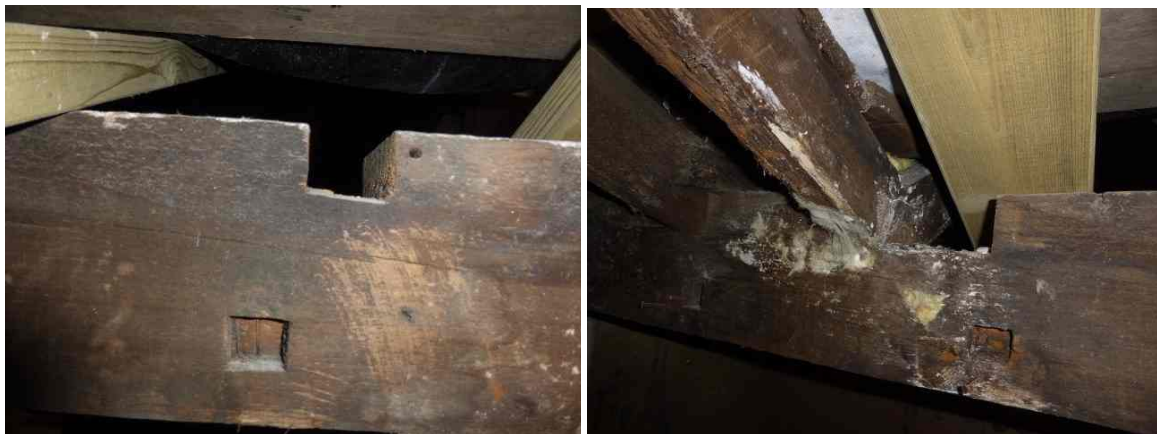
On removal of the inset terrace structure it has become evident that in addition to its poor bearing the valley beam has also been deeply notched along its length on both its upper and lower surfaces (Figs. 11 & 12). The notching on the top surface of the beam frequently aligns with original mortices cut into the beam to take the original ceiling joists, reducing the effective structural depth of the beam that supports half the weight of the roof.

Figs. 11 - 12 Notching revealed in opening up compromising integrity of the valley beam

Cladding of the beam on both sides with steel plates was initially considered as a means to strengthen it. Constructibility issues (requiring all other timbers which rely upon this beam to be moved), added to the amount of interference with the beam itself (with numerous through-bolts required) has, on balance, been considered to be too great an intervention.

The decision has therefore been made to improve additional support elsewhere to enable the valley beam, the most important structural timber in the house, to remain in its current condition, apart from reinstating its bearing.

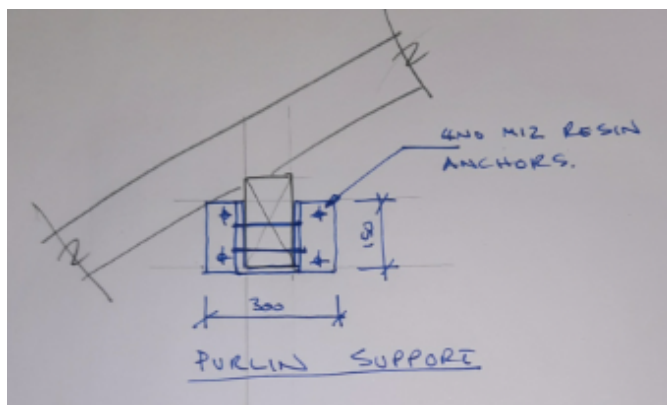
Fig. 13 The Morton Partnership: design for steel bracket for the reinstated purlins

The reinstatement of the purlins cut through during the terrace installation in 1969 forms part of the consented works to the original roof. These purlins will be connected to the masonry walls using steel supporting brackets (fig. 13) as the original purlins were not bearing into the masonry walls, so no ledge or pocket is available to give support and padstones would otherwise need to be cut into the walls which is considered to be a greater intervention. It is important to gain bearing at either end of the purlins to alleviate loading of the damaged valley beam. These brackets will not be visible, with lime plaster covering the plates.

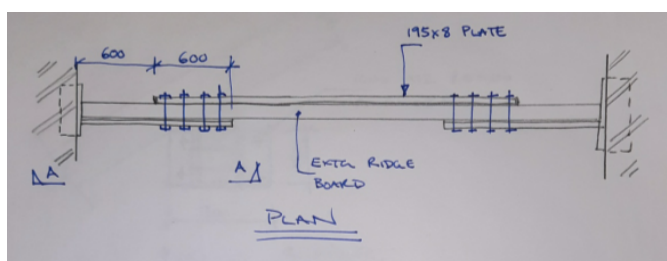
Fig. 14 The Morton Partnership: ridge beam stiffening splints

Retaining the valley beam in situ without strengthening requires the two ridge beams to be provided with additional stiffening. The plan view of the ridge beam stiffening shows the use of three steel 'splints' per ridge, again the original ridges have no bearing onto the wall, rather they provide a connection from pitch to pitch and effectively pass the majority of the roof weight onto the valley beam, which as already noted is compromised (Figs 14, 15). The steel bearing plate requires only a horizontal mortar joint to be opened up for the lateral plate to slide in, allowing the bricks to remain undisturbed.

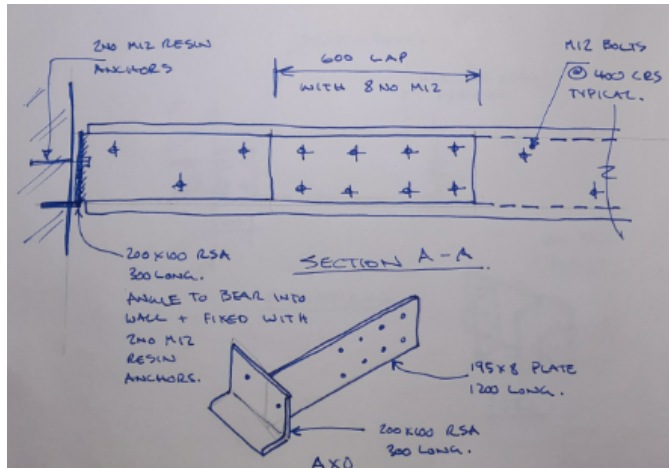
Fig. 15 The Morton Partnership: plate reinforcement plan and end detail with integral bearing plates

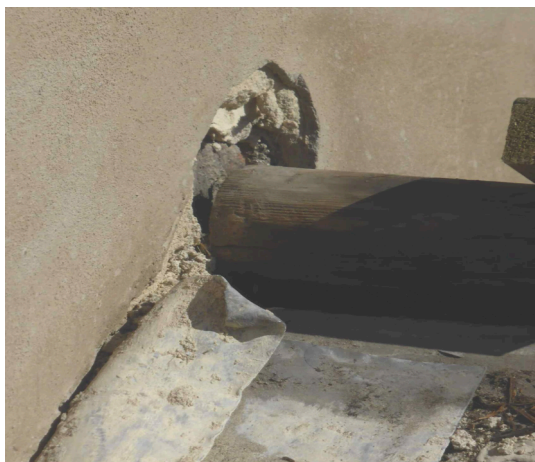
The consented scheme proposes the roof ridges to be capped with clay ridge tiles. However the approved removal of the terrace has revealed original hand planed timber rolls for securing lead ridges that were formerly concealed within the terrace parapet cladding.

Fig. 16 Original timber lead roll adjacent to party wall uncovered following removal of the terrace

The original pitched roof has a considered significance of 1, thus the discovery of the original ridge rolls in good condition provides an opportunity to reinstate the lead covering along both ridges (fig. 16). The returning of the lead ridges in addition to the original roof form and materiality is considered to provide an enhanced significance for the roofscape.
