*79 Guilford Street, WC1N 1DF*

*Rev-A*

*May 2021*

*Listed Building Consent and Non-Material Amendment Application for Roof Structure and Layout and Front and Rear Wall Structural Works.*

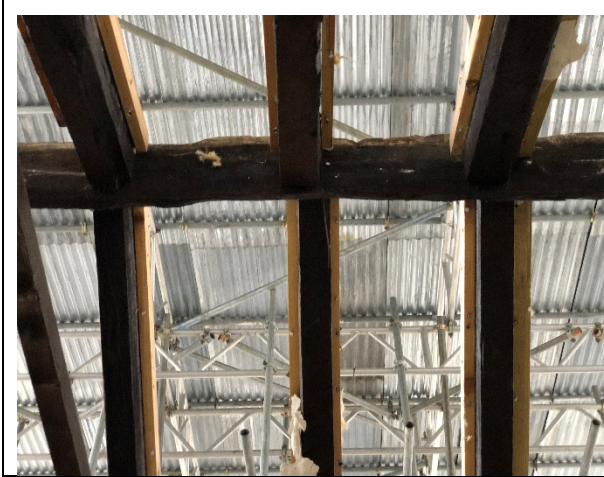
Ridge beam as viewed from below. Note: beam is very thin and has decayed from the top.

- The ridge boards to both sections of roof were small and were in a poor condition.
- A few of the rafters to the front pitch appeared to have been fire damaged in the past.

1. Install a ridge beam to the front and rear sections of the roof and physically fix all rafters to these, to prevent further roof spread.
2. New steelwork is to be installed at the 'knee' between the pitched and flat roof sections of the roof, to adequately support both the inclined members and flat roof joists.

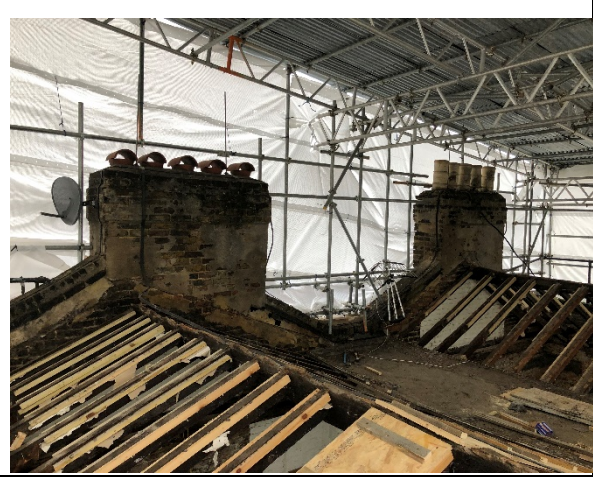
View across roof. Note condition of ridge beam and evidence of previous unsuccessful strengthening measures.

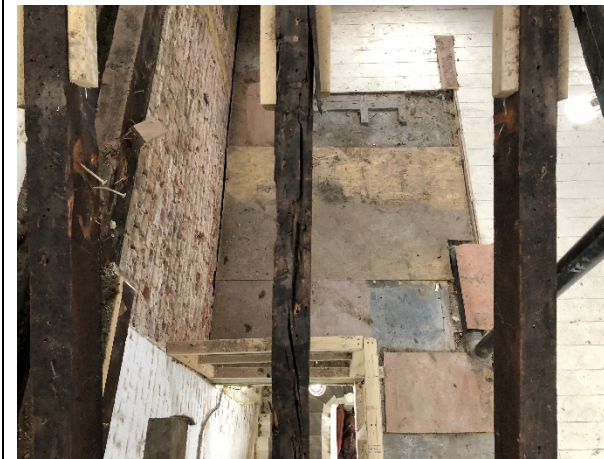
View of rafter with severe cracking.

5. For these works to be carried out, it is likely that the rear section of roof will need to be taken down. As the rafters are not original and in a poor condition, we would suggest that a number of the rafters are beyond repair and should be replaced when the rear section of roof is rebuilt.

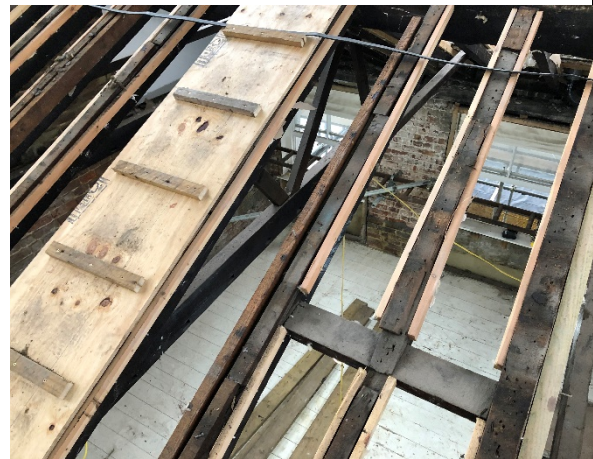
Example of timbers that have been cut into shorter lengths and then fixed back together.

- The ends of a number of these rafters were rotten.
- A number of the existing rafters in the front section of the roof had been cut and spliced together with timber battens screwed to the side of the joists.

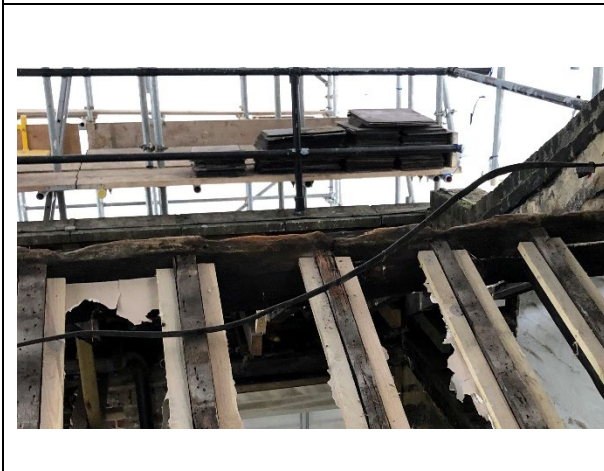
View of ridge beam viewed from roof level.
