**Front Elevation of Lower Ground Floor, 42 Parkhill Road (see diagram 100 - 101 A)**

**Rear Elevation of Lower Ground Floor, 42 Parkhill Road (see diagram 120 - 121 A)**

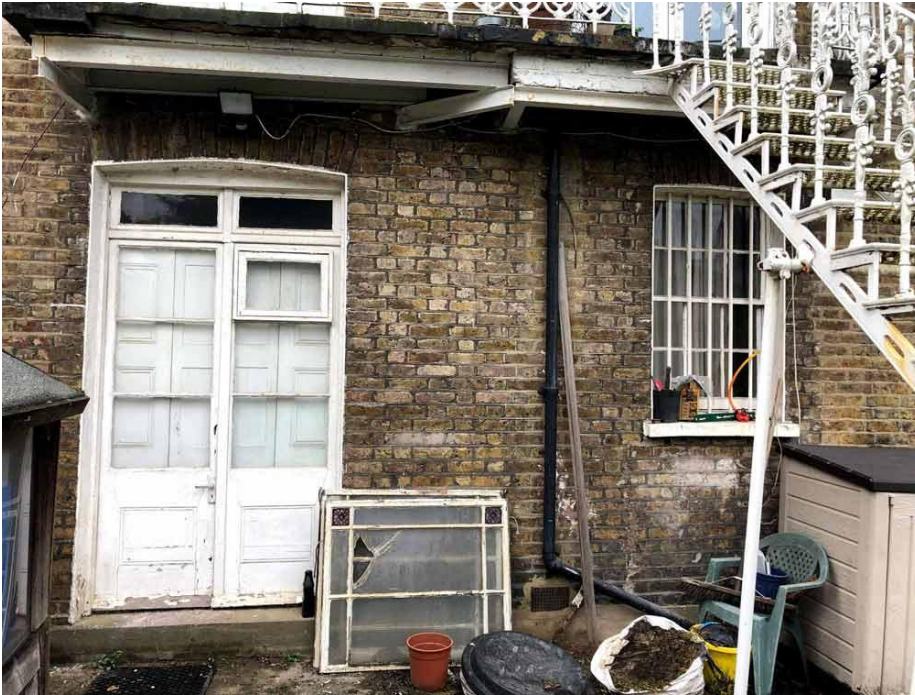
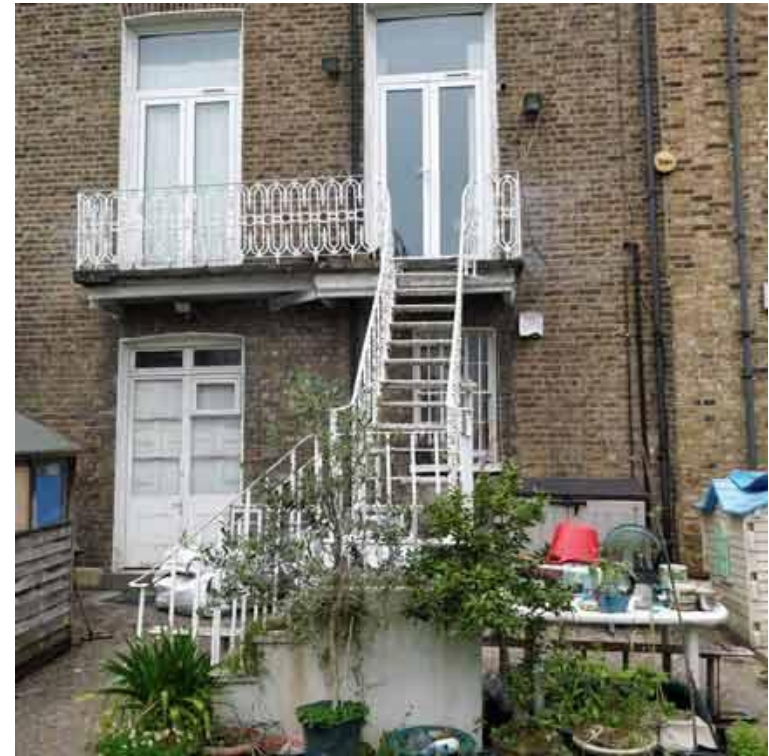
- Existing windows in poor repair

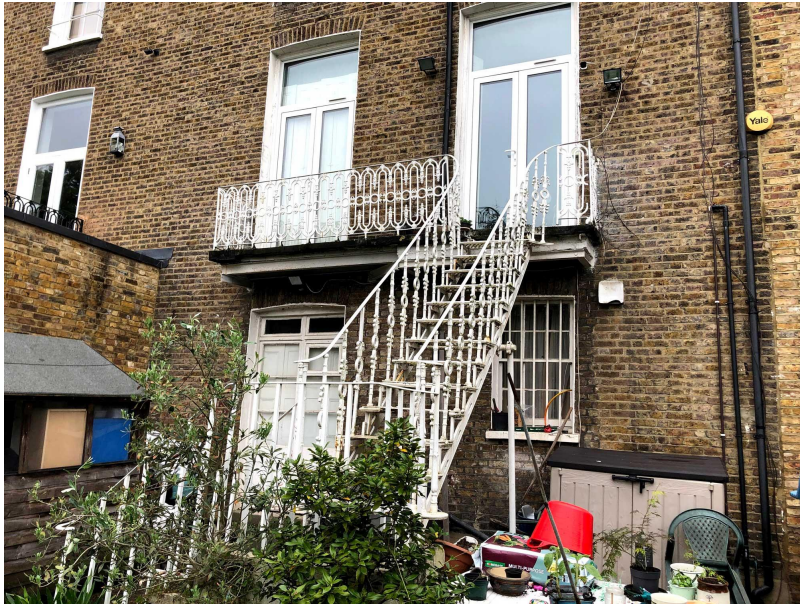
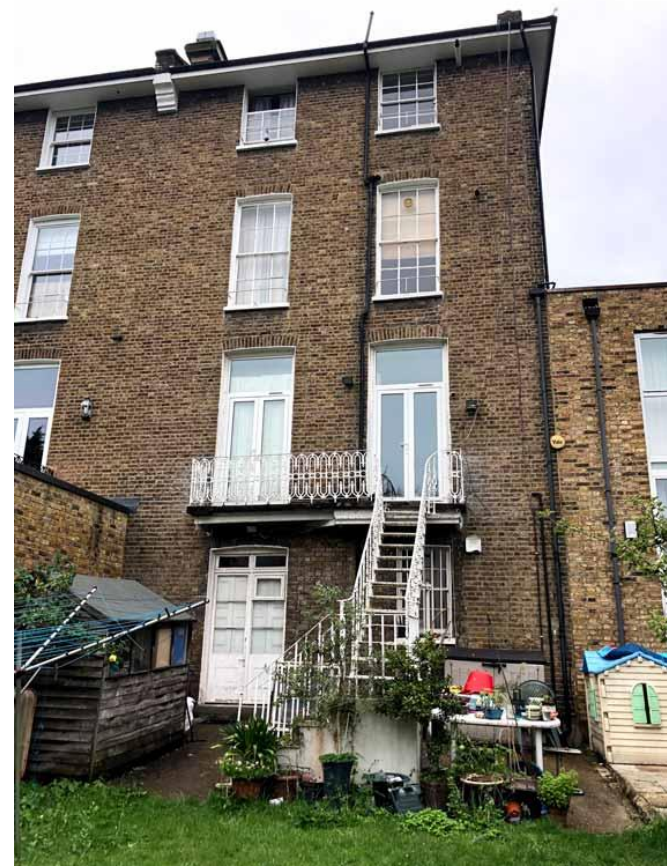
- Existing right hand window out of alignment with those above
