Landmark Trees

ARBORICULTURAL IMPACT ASSESSMENT REPORT FOR:

39a Priory Terrace
London
NW6 4DG

Ref: SHH/39APT/AIA/01

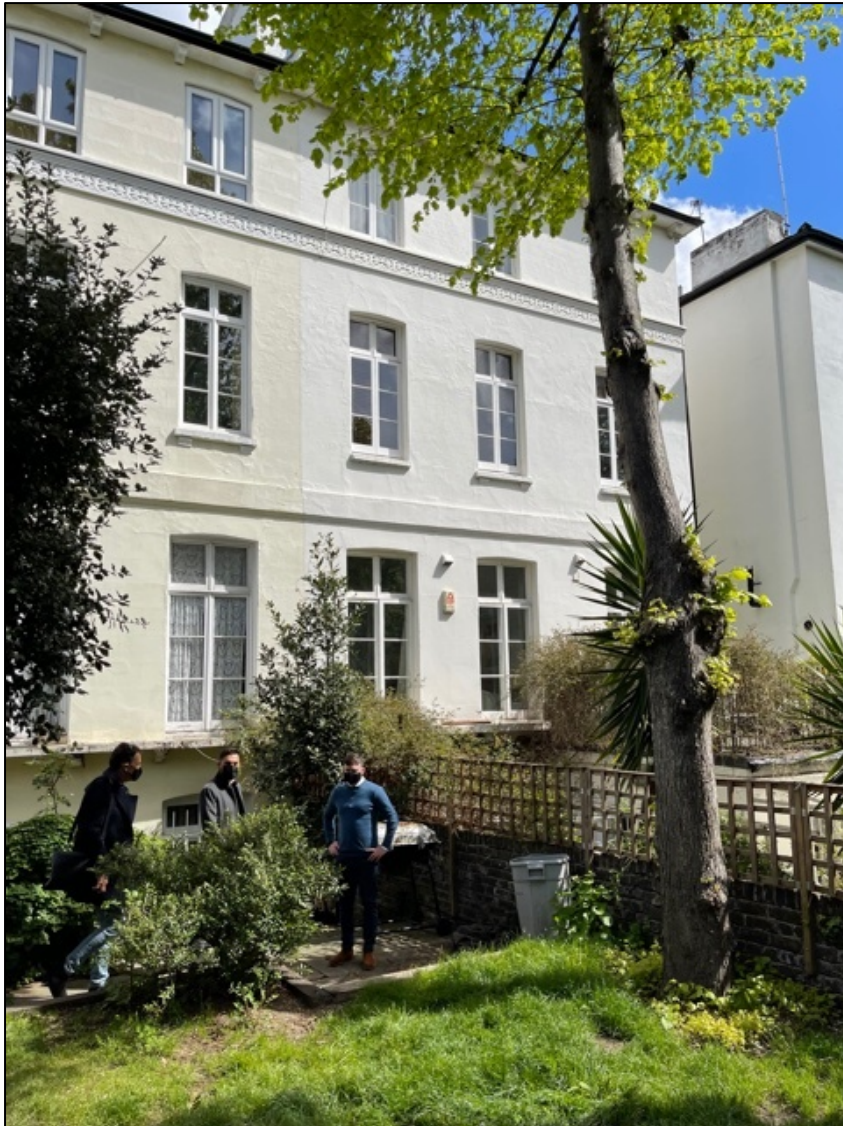
Photograph 2: Existing rear elevation with T1 visible to right

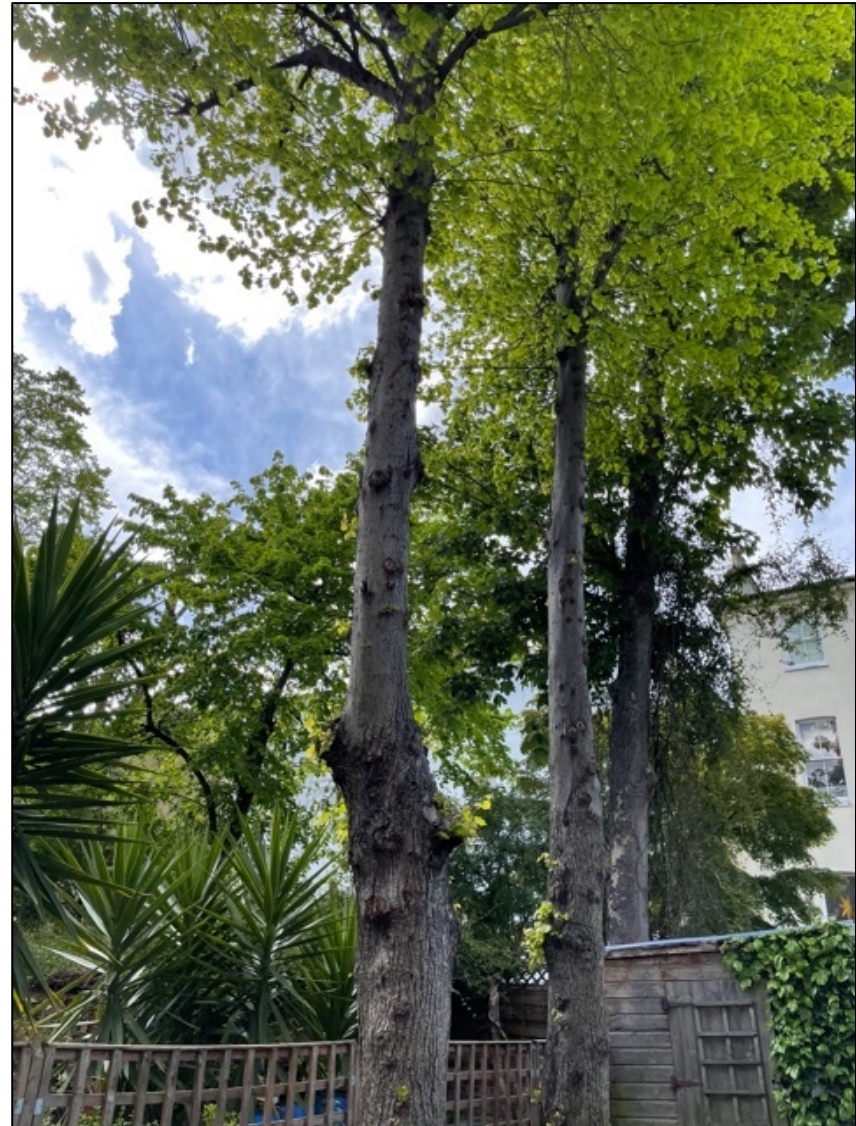
Photograph 3: T1, T2 and T3

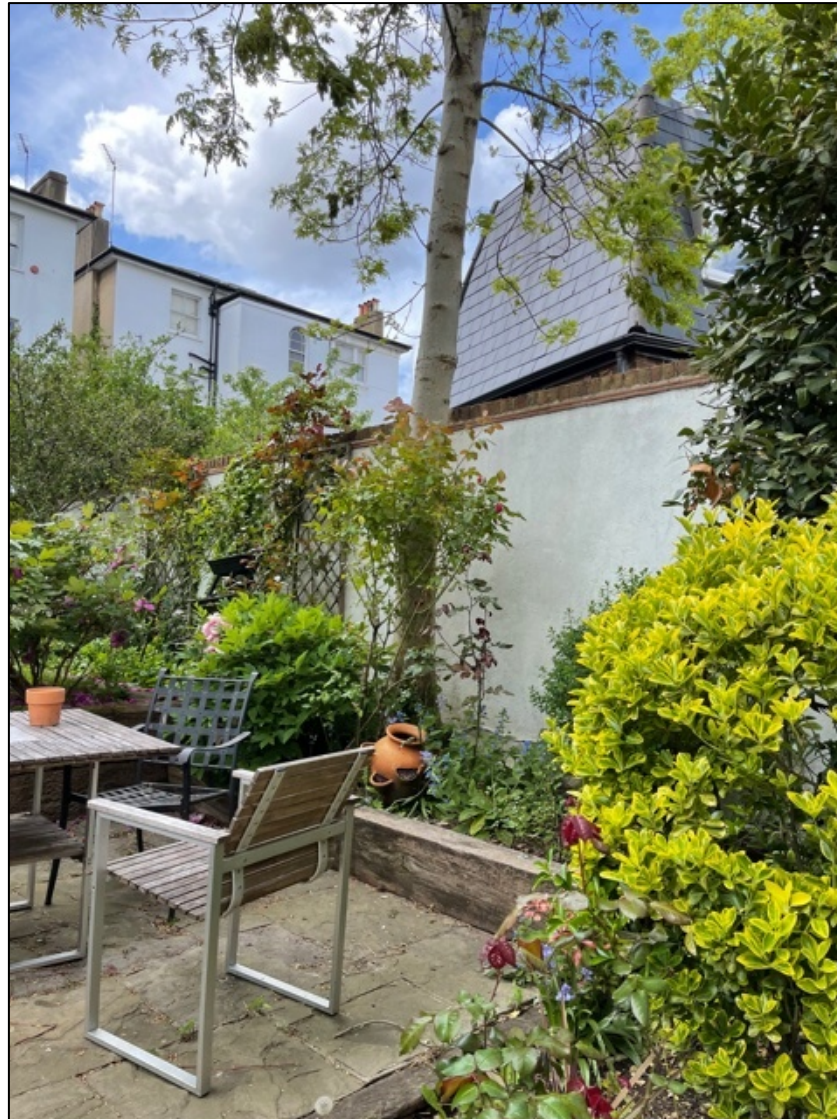
Photograph 4: Low quality ash T4

Tree No.	English Name	B.S. Cat	Height	Ground Clearance	Crown Spread	Recommended Works	Comments/ Reasons
4	Ash, Common	C	11	2.5	3333	Fell	A well formed tree but growing against boundary wall. Limited future potential To facilitate development
5	Oak, Holm	C	4	1.5	1111	Fell	To facilitate development

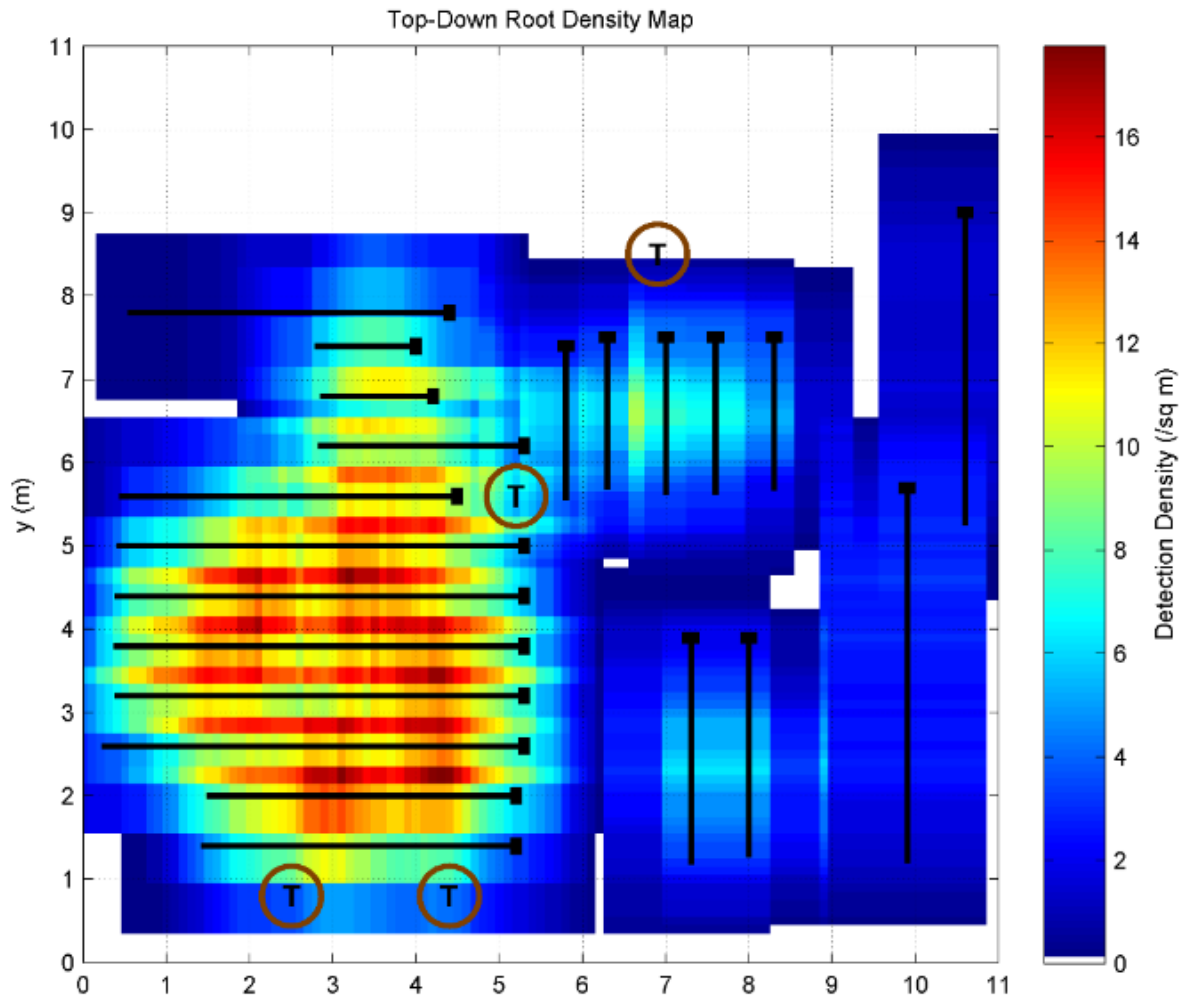
a) Top Down Root Density Map

The Top Down Root Density Map details areas of the scan that show the most root detections across the whole scan area. Areas of higher density (16 detections per M^2) appear in red, with areas of lower root density (0-2 detections per M^2) appearing in blue. Detections refer to individual root detections and do not relate to root size or amount of root biomass, therefore it is typically expected to see higher densities further away from the tree.

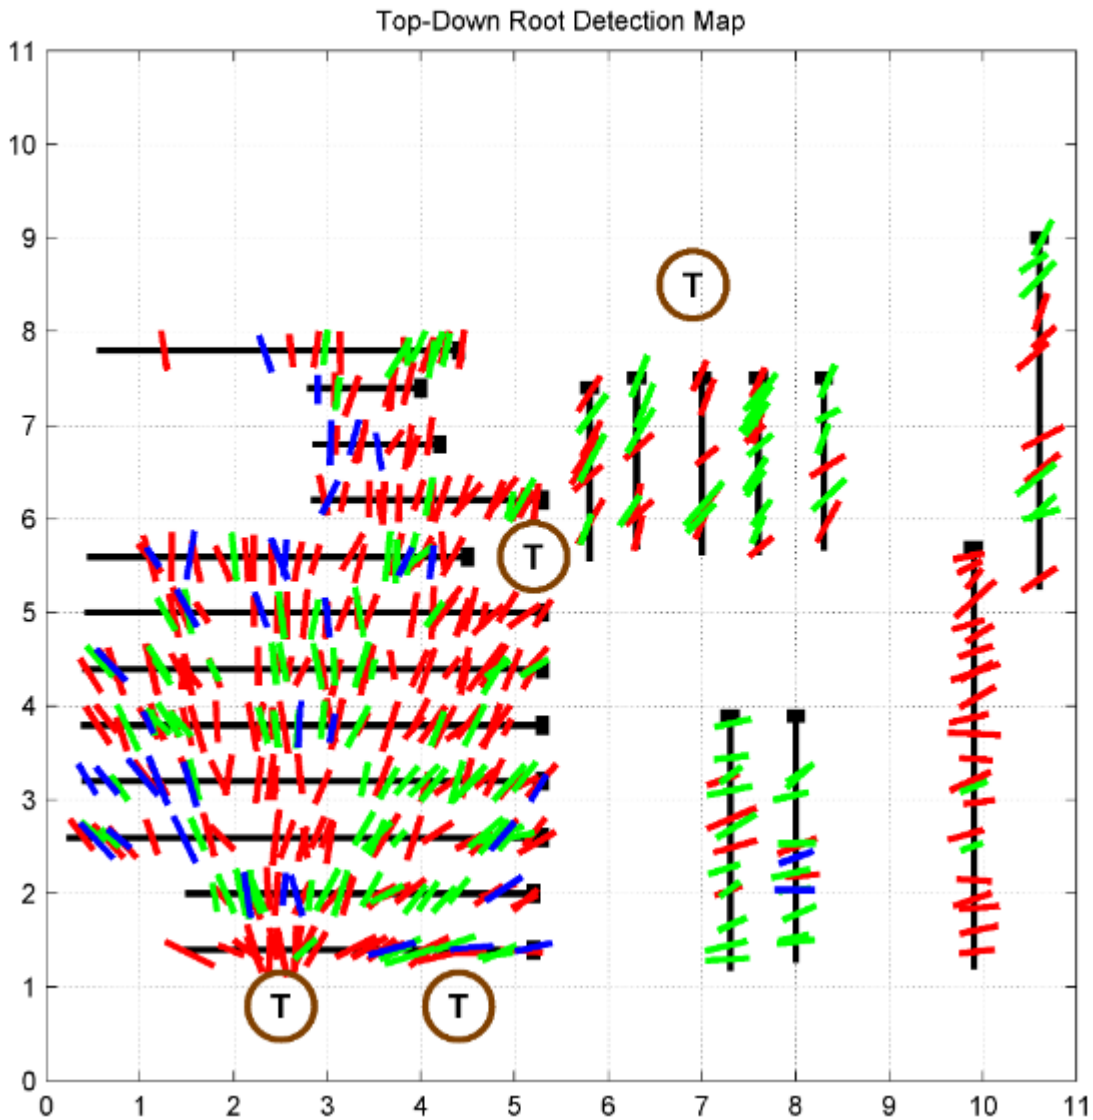
b) Top Down Root Detection Map

The Top Down Root Detection Map plots the number and location of detected roots within each scan line. Each confirmed detection is marked with a line that dictates the estimated direction of the root relative to the other root markers. The number of detections across all scan lines shows a high density of roots across the whole area. There are a total of 598 detections across the whole site, averaging 8.36 root detections per linear meter.

The Root detections are colour coded by depth, Red 0-25cm Depth, Green 25-55cm Depth, Blue 55 and deeper.

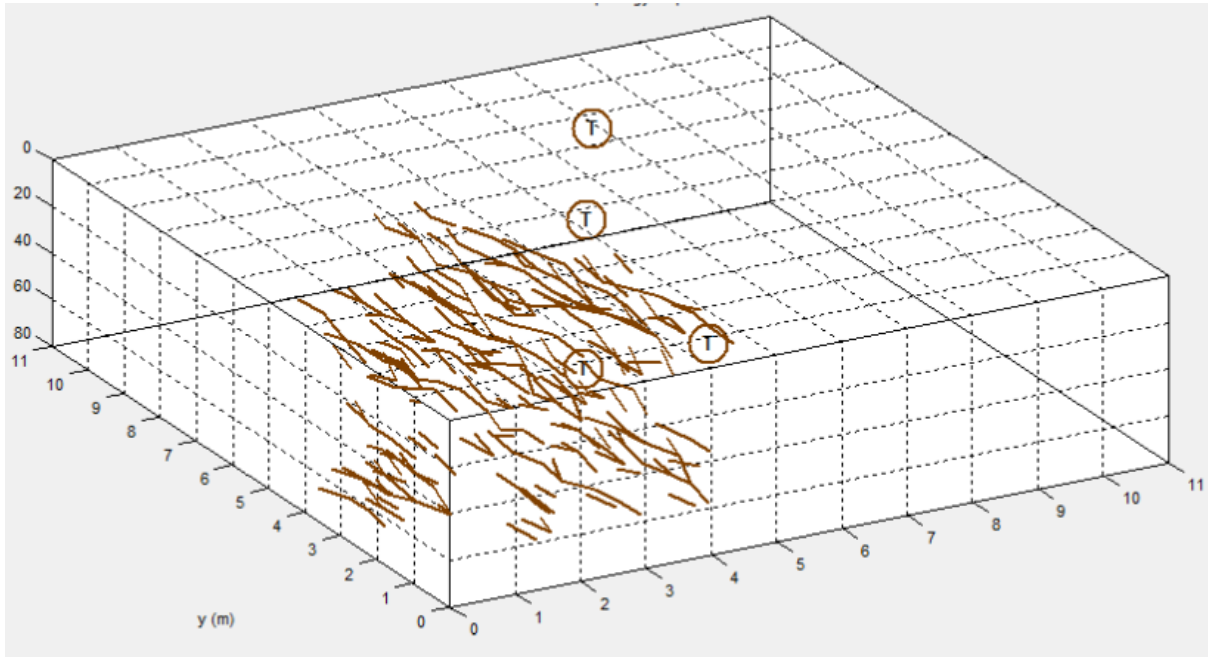
i) Root Morphology Map of Scan Lines G1-12

The Root Morphology Map is a computer-generated map of the tree's rooting system based on the detection points as detailed above. The software links the data points found on the scan lines with each other relative to the tree's location.

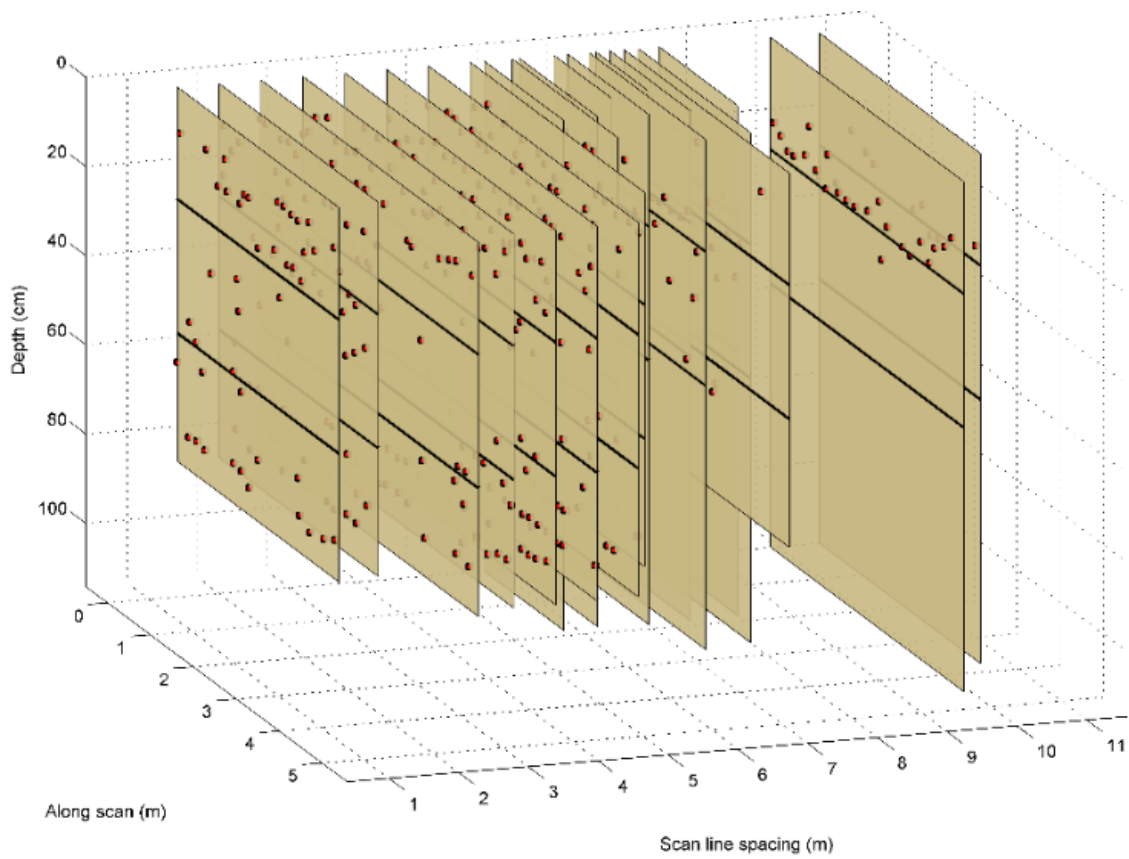
d) Trench View

The Trench View graphics depict a virtual “slice” through the soil along the length of the scan line. The points where the roots are detected are marked with a red dot. The horizontal black lines show the analysis zones that have been created to offer insight into the depths of soil that the trees are mostly rooting.
