Design and Access Statement

66a Fortress Road, NW5 2HG
Garden wall rebuild on Grade II listed property

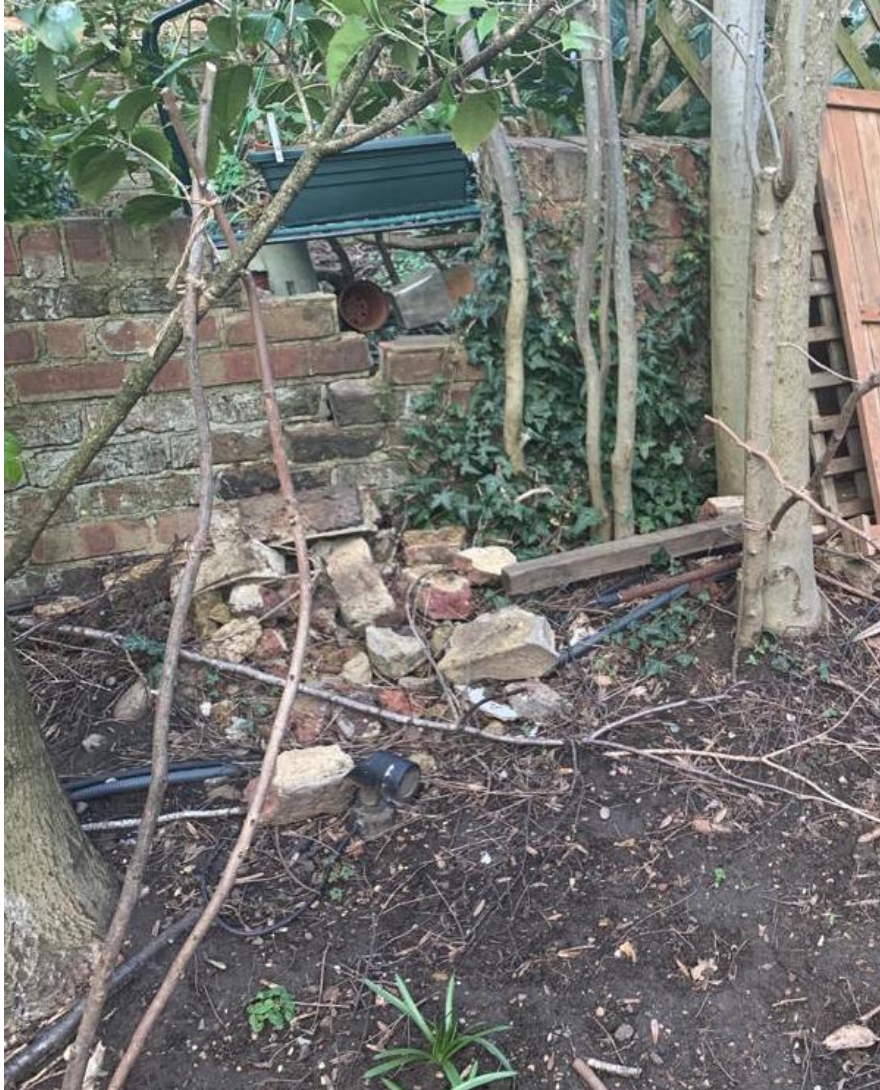
Section of wall cracked / crumbling due to tree roots nearby.

The feature is a brick garden wall 9 courses tall. It appears to be at least 100 years old, made of red brick. It sits on the boundary line on the north side of the property. The affected section is approximately 4-5m in length. The wall has begun to crack and tilt due to the roots of an adjacent set of trees. One section (see photo) has fallen in. It would not be safe to leave it as it is.

The gardens in this Grade II listed terrace all have similar brick walls as boundary walls. My plan is to take down, reinforce, and replace the affected section in the same style as the existing wall, and a specialist has been found to conduct the work. No buildings are adjacent to the walls.

The wall can be seen in the Figure above. It is a red brick garden wall, single skin, 9 courses tall, along the northern boundary of the property. Only the low section (approximately 4-5m long), which is in the middle of the garden next to the trees, needs repair. The existing design as seen in the photo will be replicated in the replacement, with appropriate reinforcement to ensure future safety.
