/ APPENDIX G
// HEYNE TILLET STEEL
STRUCTURAL SURVEY

Grange Central Saint Martins – Site Visit Report No.4

This report summarises the findings of the structural condition survey completed by HTS in the week commencing 17.02.2020. It discusses elements in obviously poor condition or where further investigations are required. A location plan can be found attached.

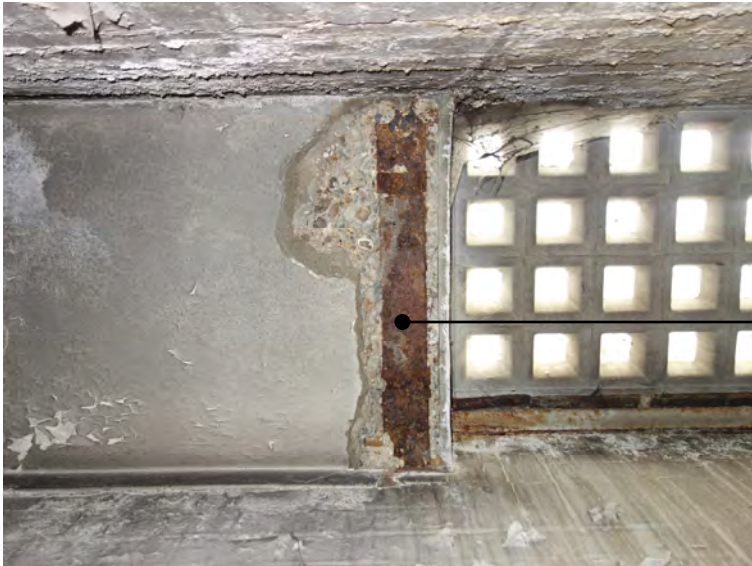
B.1 Corroded steel joist trimming the edge of the pavement light.

Clean and reinstate cover.

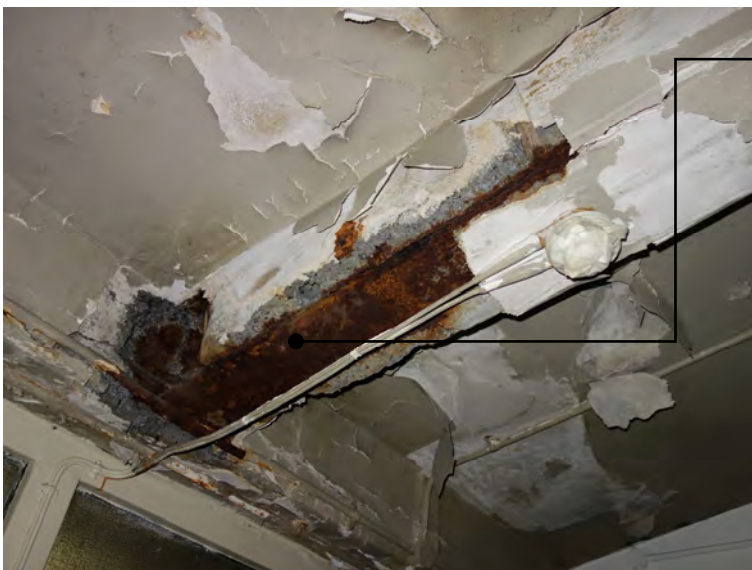
B.2 A beam supporting the underside of the lecture theatre is heavily corroded.

Cover to full length of beam to be removed to determine corroded length.

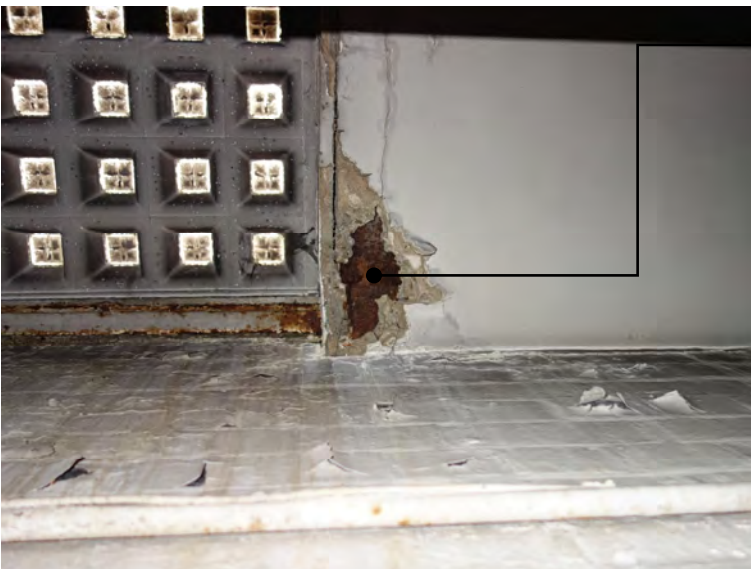
B.3 Corroded steel joist trimming the edge of the pavement light.

Expose full length of joist, clean and reinstate cover.

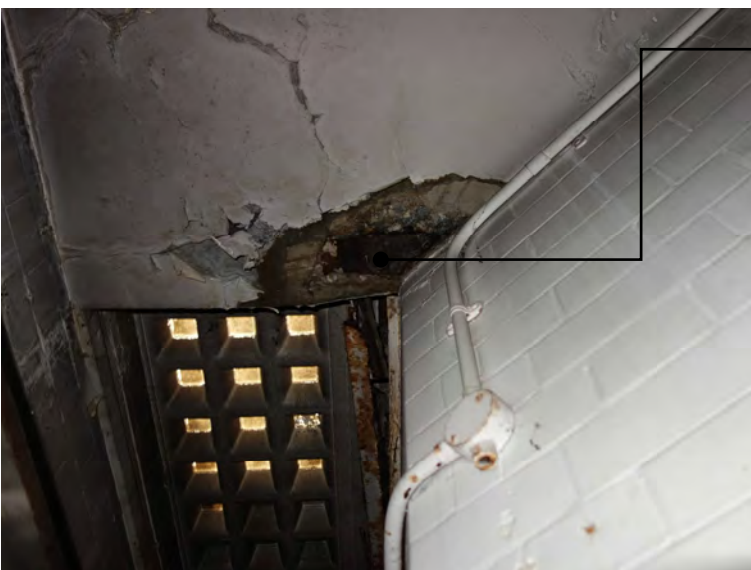
B.4 Corroded steel joist trimming the edge of the pavement light.

Expose full length of joist, clean and reinstate cover.

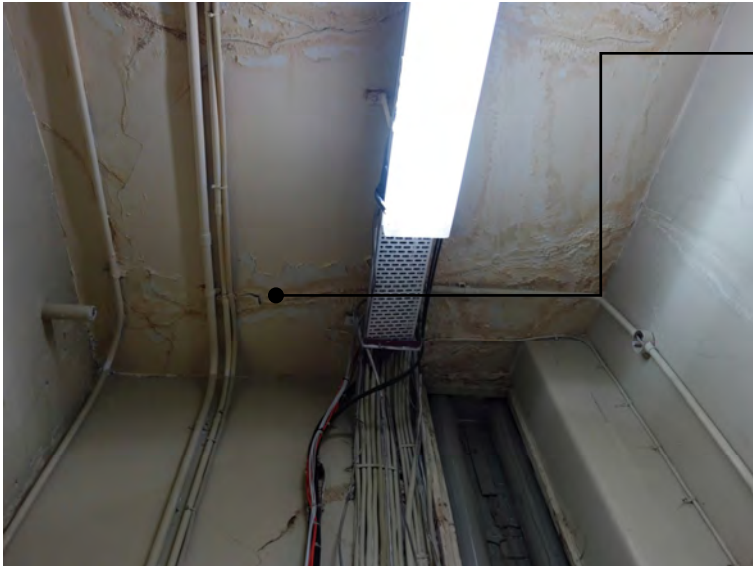
B.5 Heavy water ingress noticeable at high level with significant cracking along assumed length of joists.

Remove cover to joists in order to determine extent of corrosion.

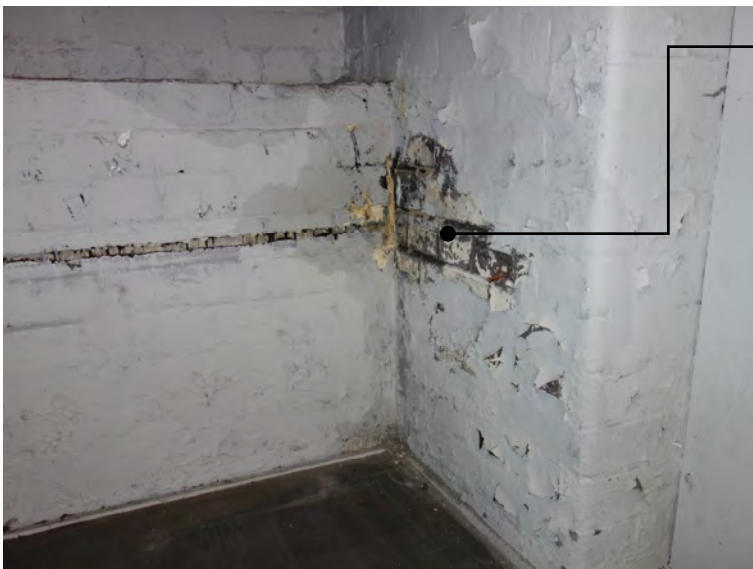
B.6 Mortar has disintegrated between bricks.

Repoint masonry.

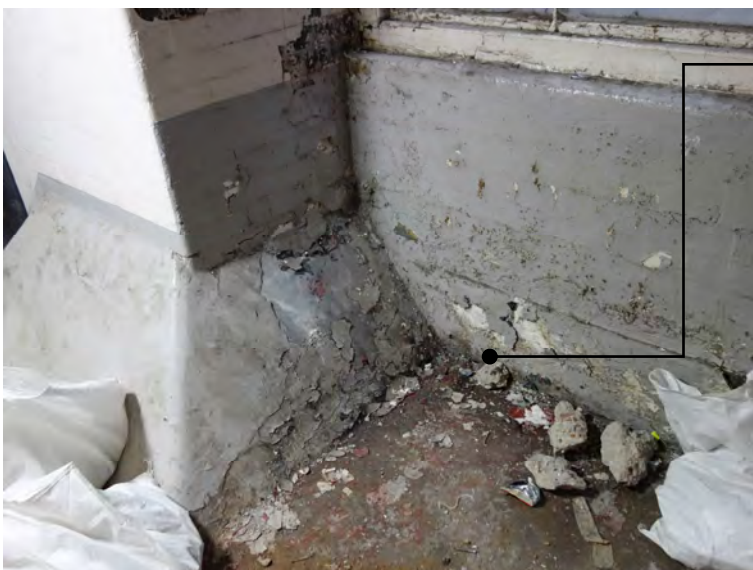
B.7 Mould and damp is apparent around the corbelling and against the masonry wall.

Remove area of paint to determine extent of damage to masonry.

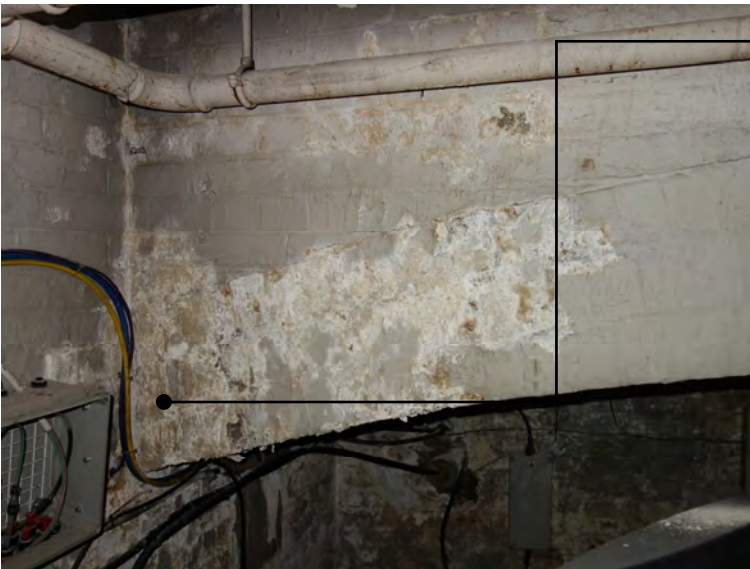
B.9 Water ingress and significant damp found in pavement vault.

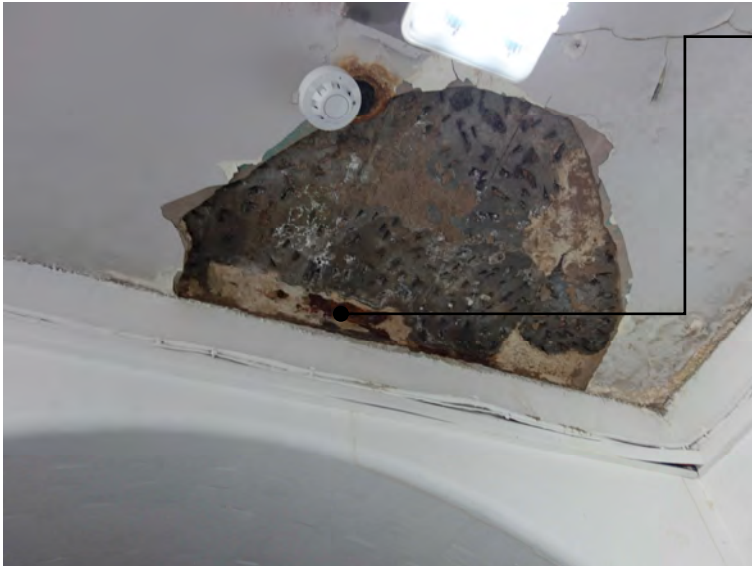
B.11 Corrosion to the joist is apparent.

Remove cover to length of joist to determine extent of corrosion.

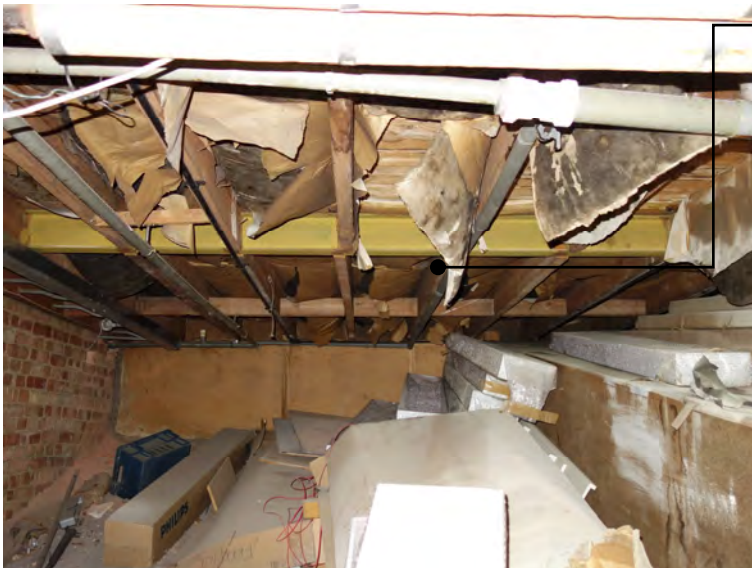
LG.1 Joists in the floor structure over the historic lecture theatre appear to have buckled/warped

As the joists are to be removed in the proposed scheme, it is recommended that this floor is removed as soon as possible.

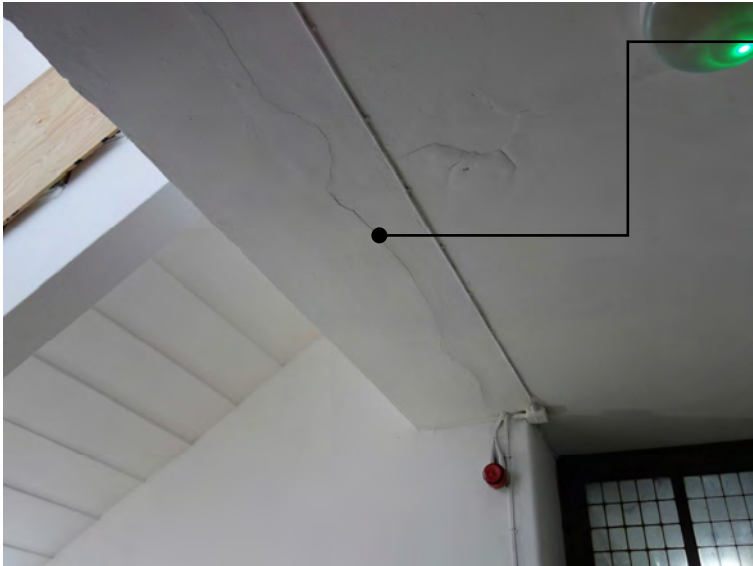
G.2 Cracking is evident to the underside of the beam supporting the stair.

Remove plaster and concrete cover to determine extent of corrosion to steel beam within.

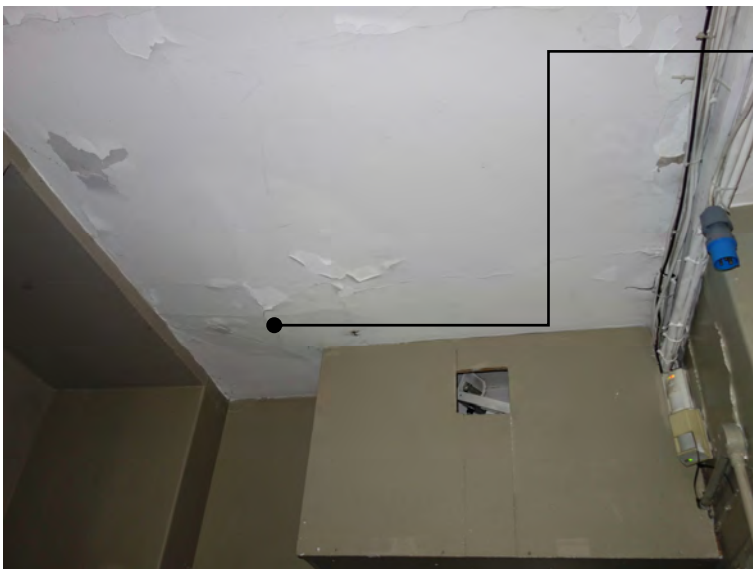
G.3 Water ingress noticeable at high level.

Remove cover to joists in order to determine extent of corrosion.

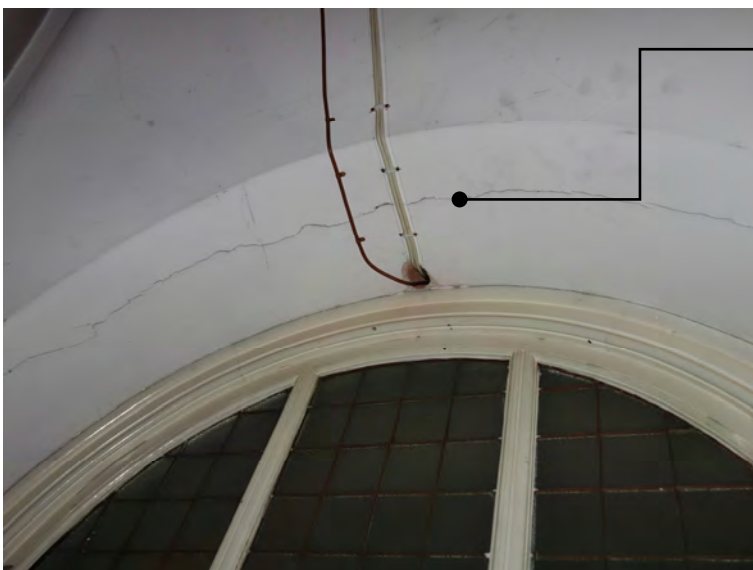
G.4 Cracking is evident on the underside of the arch.

Remove plaster to determine if cracking extends to the structure above.

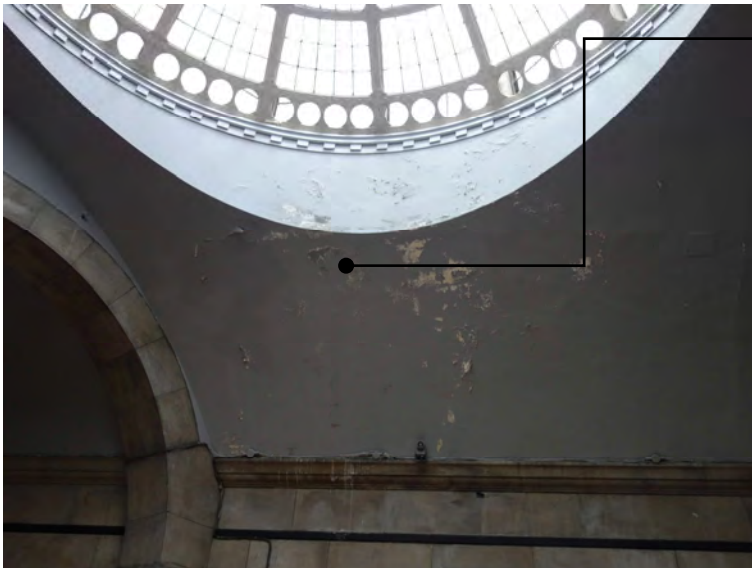
G.5 Water ingress noticeable at high level.

Remove cover to steel in order to determine extent of corrosion.

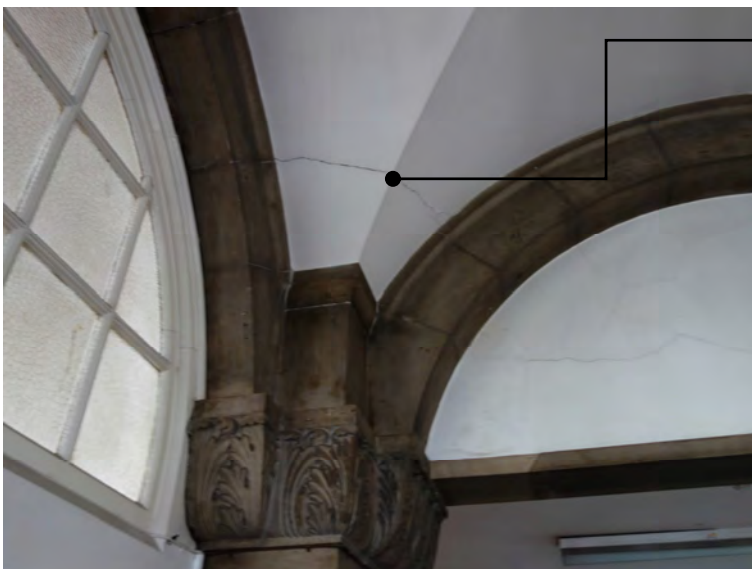
1.1 Cracking in plaster as base of arch.

Remove plaster to determine if cracking extends to the structure within.

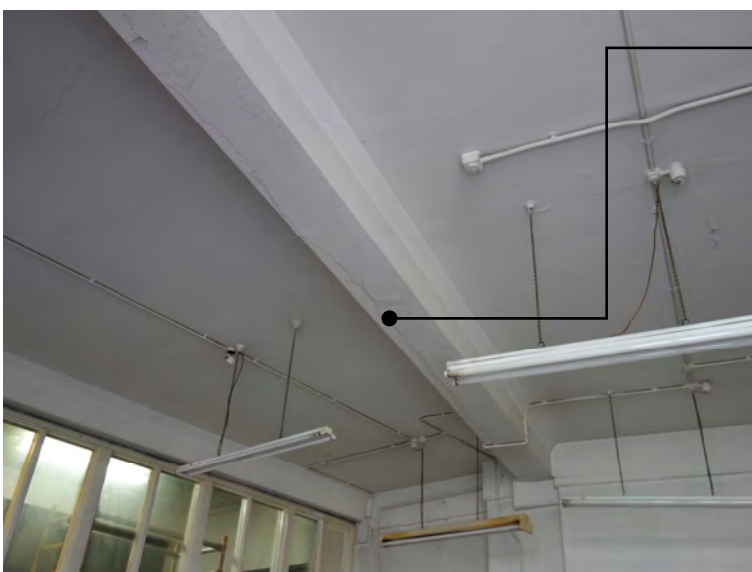
1.2 Cracking can be seen along the length of the beam.

Remove plaster and cover to the beam to determine the extent of corrosion within.

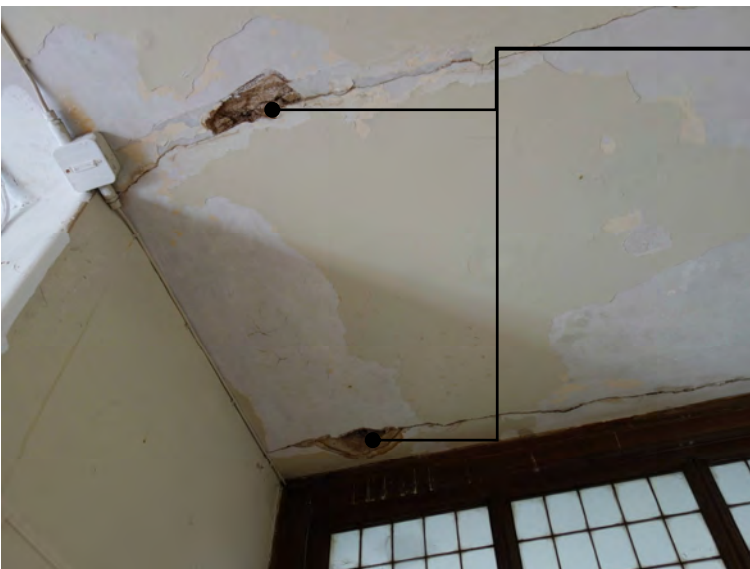
1.4 Significant cracking can be seen in assumed joist locations.

Remove plaster and cover to determine extent of corrosion to the joists.

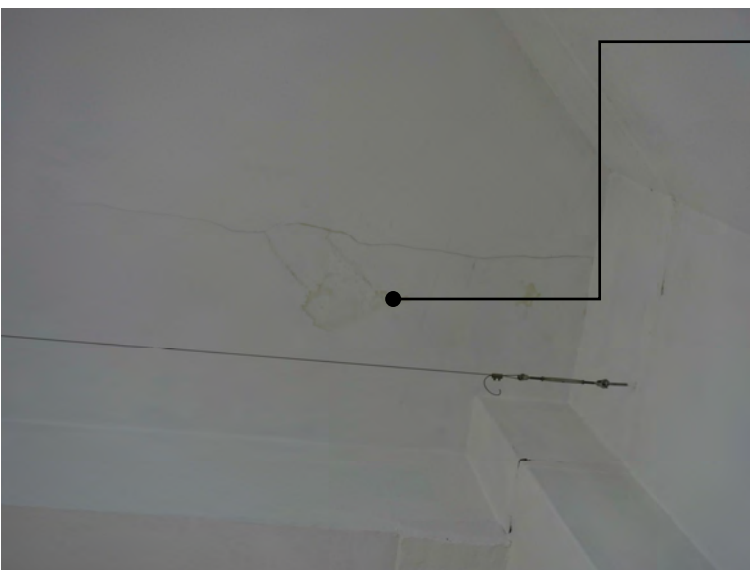
1.5 Water ingress noticeable at high level.

Remove cover to joists in order to determine extent of corrosion.

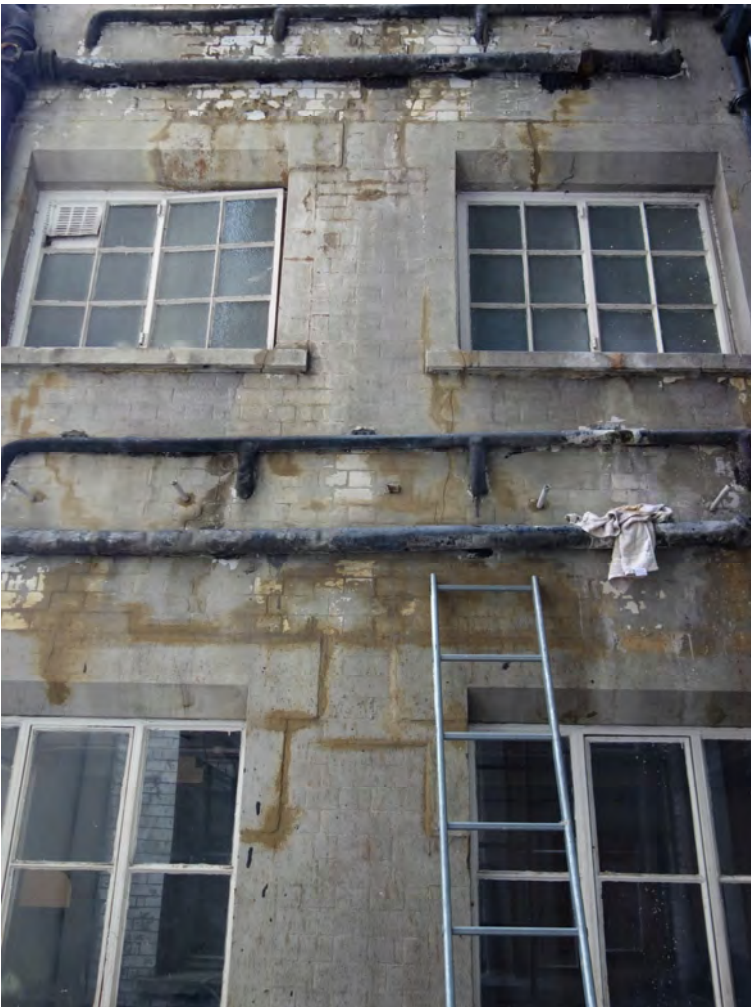
1.7 Water ingress in the masonry is apparent externally.

Review cause of water ingress, assumed to be the drainage, and fix to allow the wall to dry out.

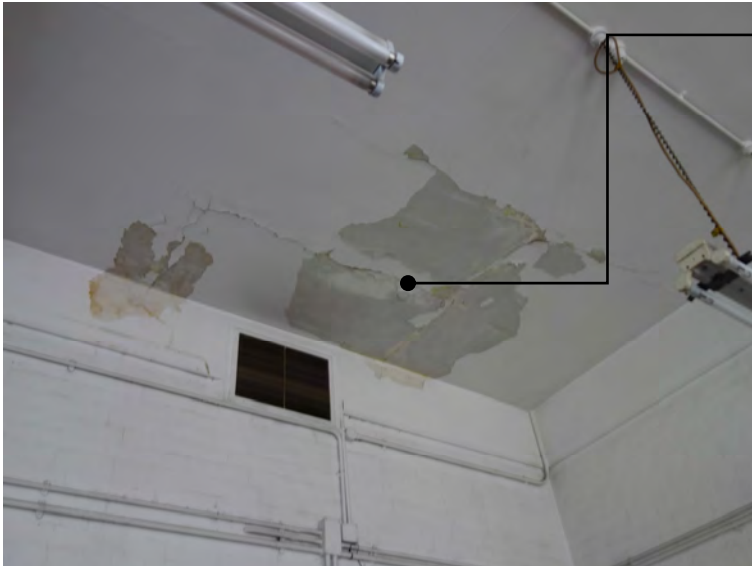
1.8 Water ingress noticeable at high level.

Remove cover to joists in order to determine extent of corrosion.

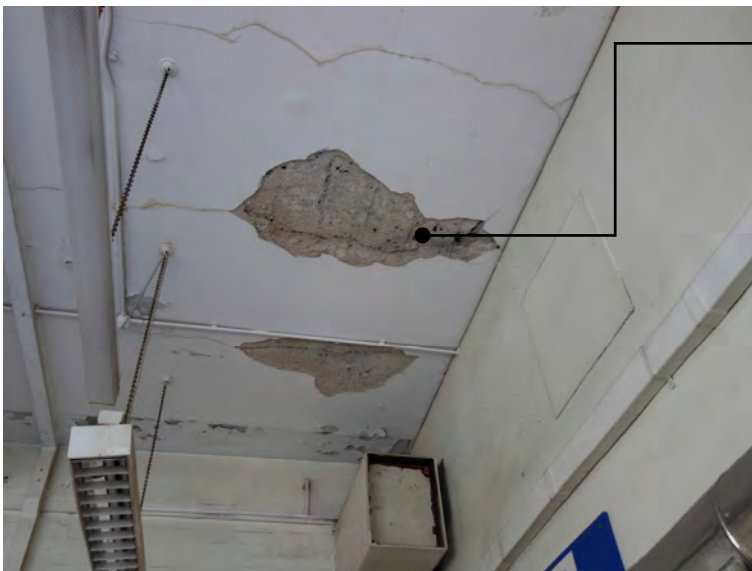
1.9 Cracking apparent in assumed joist locations.

Remove cover to joists in order to determine extent of corrosion.

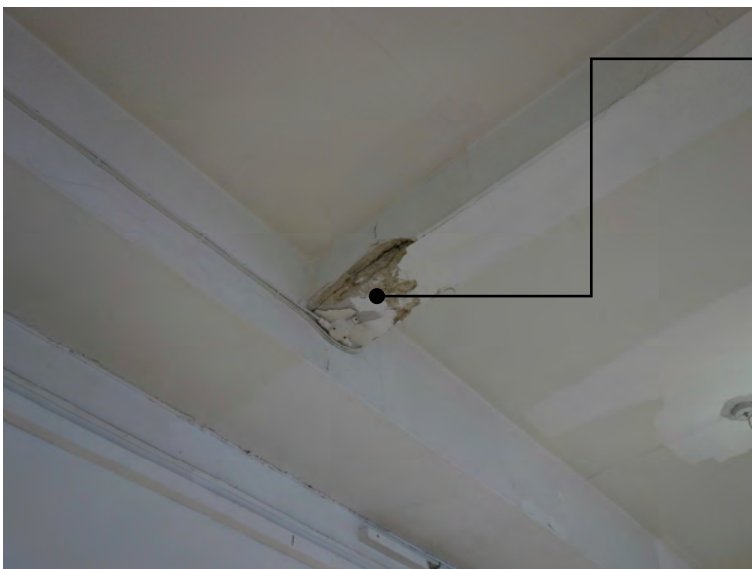
2.1 Disintegration of the plaster is apparent at the end of the secondary beam.

Remove plaster encasement to the beam to determine extent of corrosion to steel within.

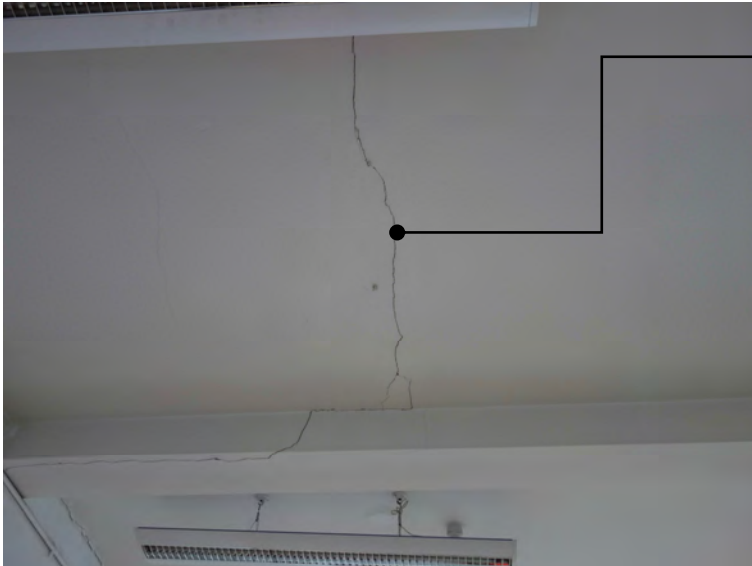
2.2 Cracking in an assumed joist location continues down the supporting beam.

Remove cover to joists in order to determine extent of corrosion.

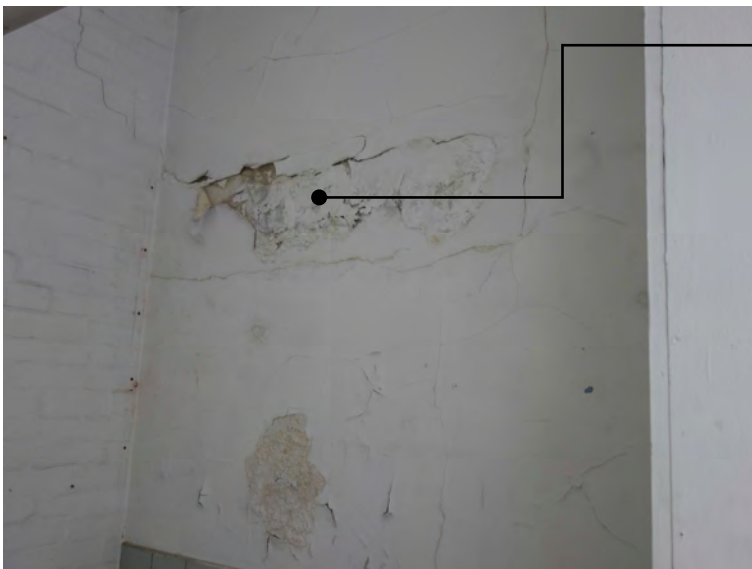
2.3 Water ingress apparent in the masonry wall.

Remove finishes to determine the state of the masonry within.

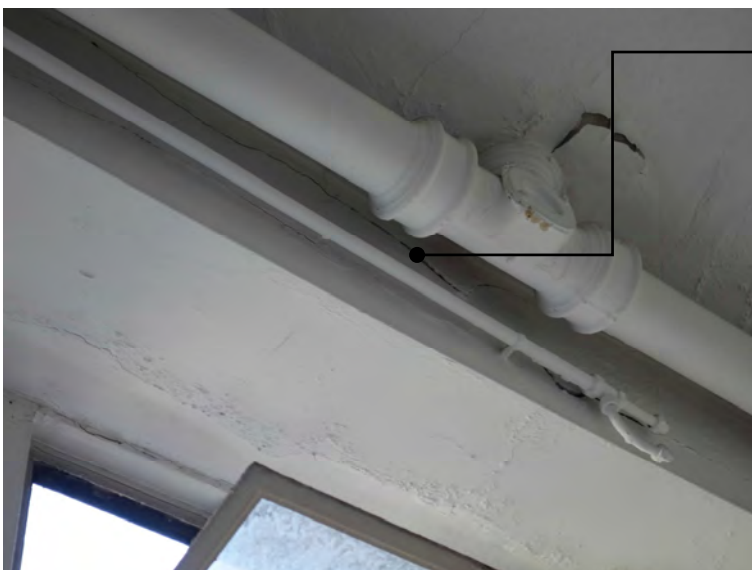
2.4 Water ingress and cracking in lintel can be seen,

Remove finishes to lintel to determine extent of corrosion.

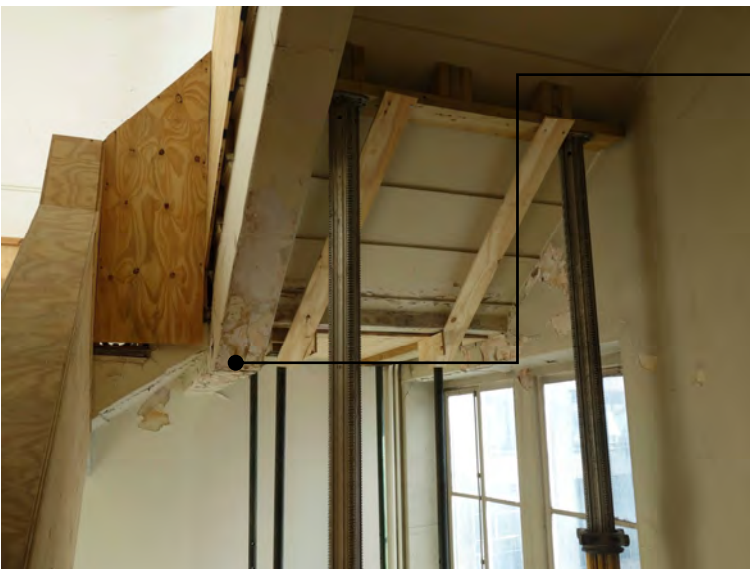
2.6 Water ingress and cracking is apparent along the beams supporting the stair and within the wall above the window.

Remove the finishes and concrete cover to determine the severity of the corrosion.

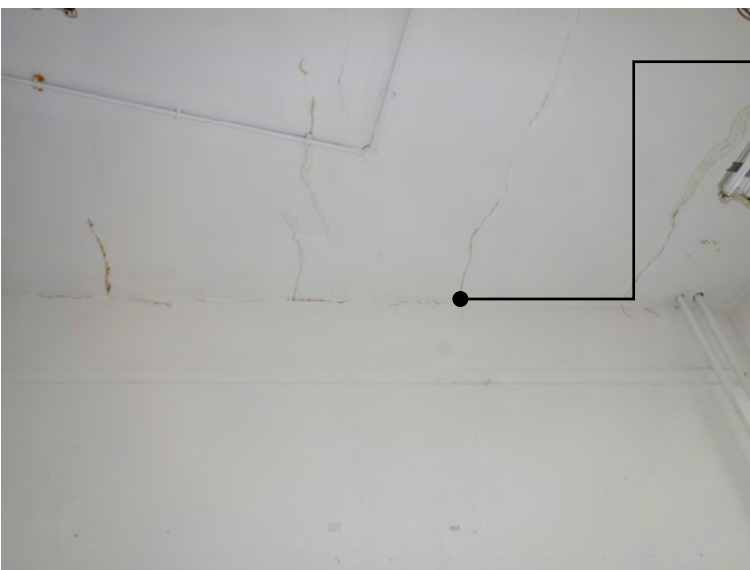
2.7 Cracking and possible signs of corrosion apparent at end of assumed joist locations.

Remove finishes and cover to joists to determine extent of corrosion to joists.

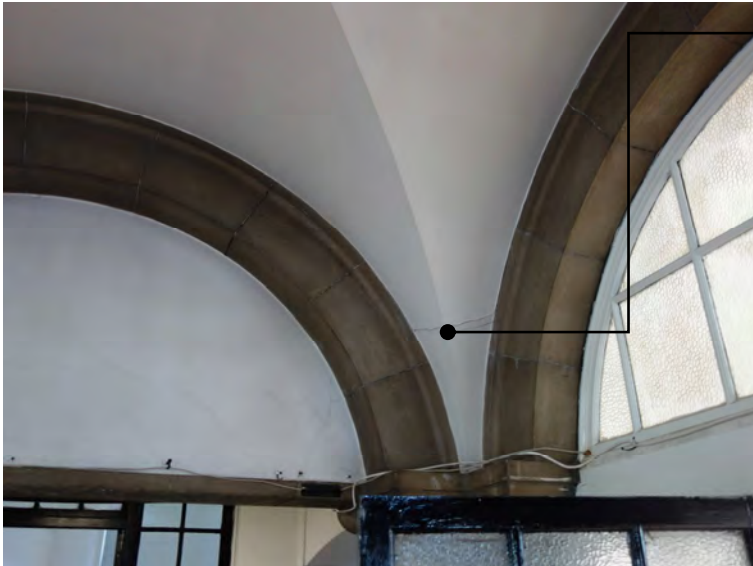
2.8 Cracking in plaster as base of arch.

Remove plaster to determine if cracking extends to the structure within.

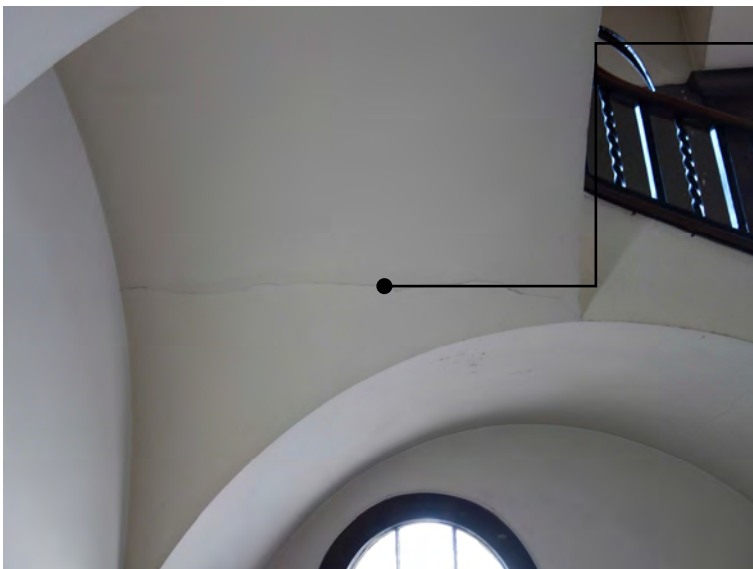
2.9 Cracking at the base of the stair arches can be seen.

Remove plaster to determine if cracking extends to the structure within.

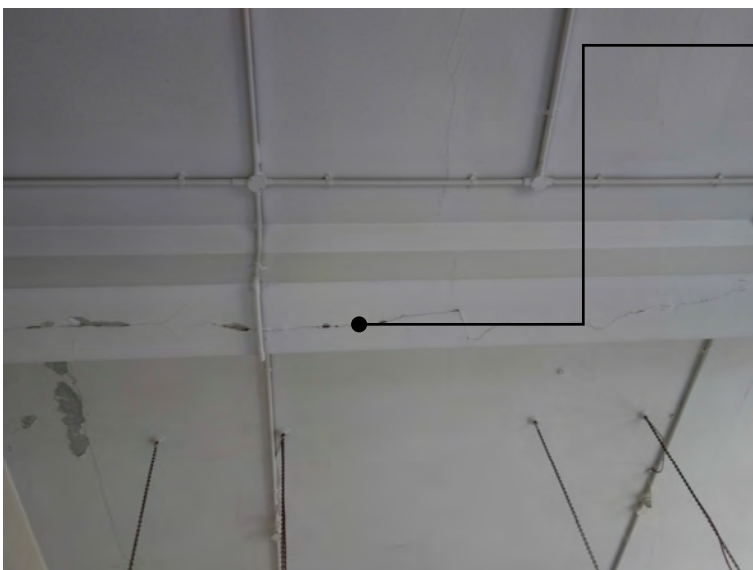
2.10 Cracking to the plaster to the underside of the beam.

Remove plaster and cover to the beam to determine the extent of corrosion within.

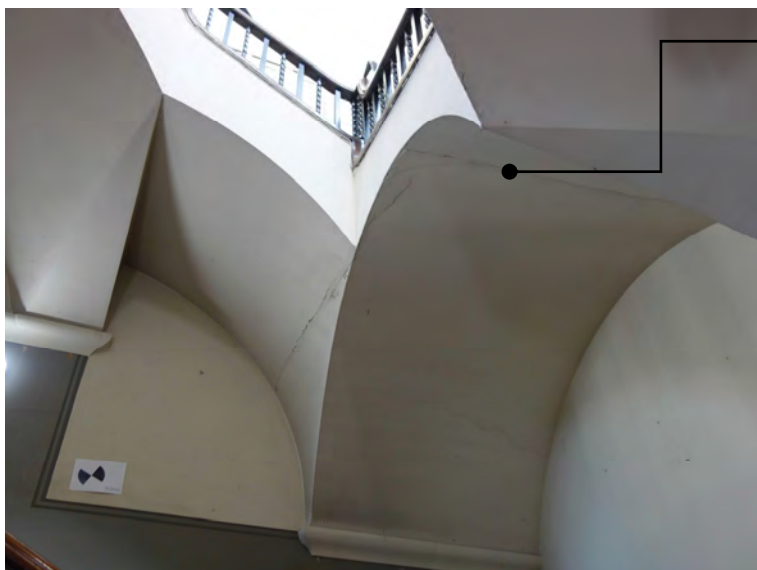
3.1 Cracking at the base of the stair arches can be seen.

Remove plaster to determine if cracking extends to the structure within.

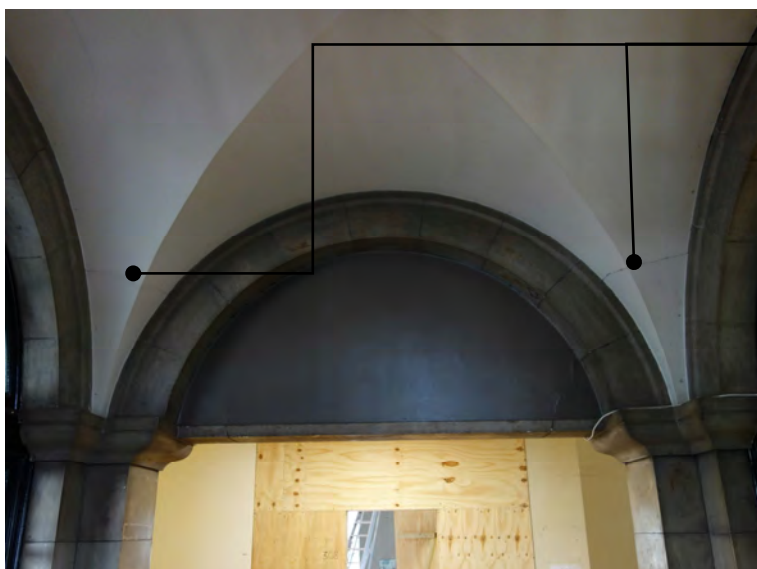
3.2 Cracking in plaster as base of arch.

Remove plaster to determine if cracking extends to the structure within.

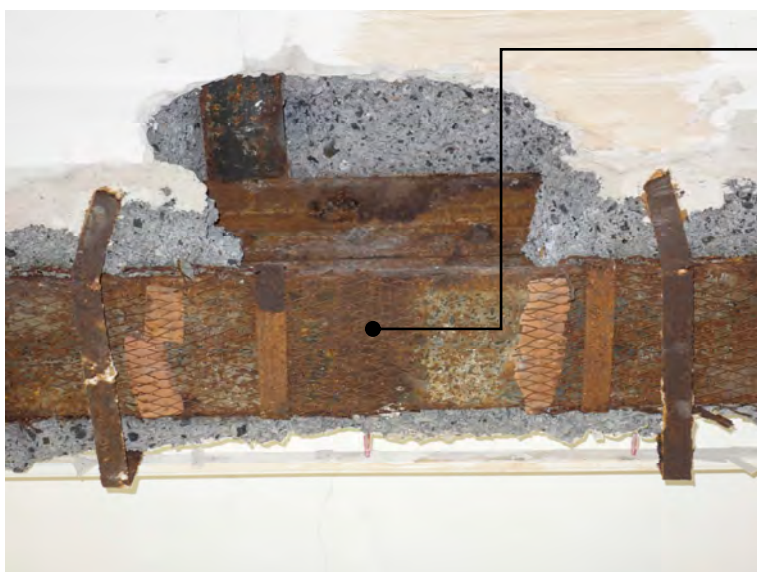
3.3 Light corrosion to beam.

Clean beam and reinstate cover.

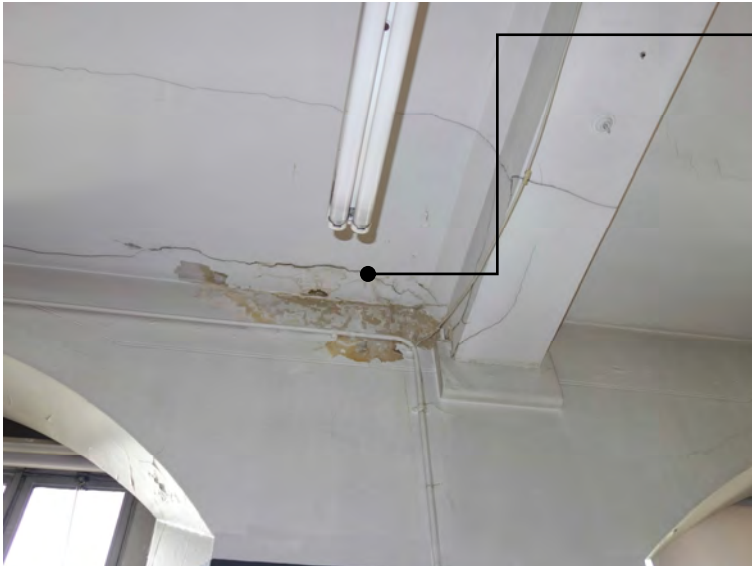
3.4 Cracking along the joist adjacent to the wall can be seen.

Remove finishes and cover to the steel to determine extent of corrosion within.

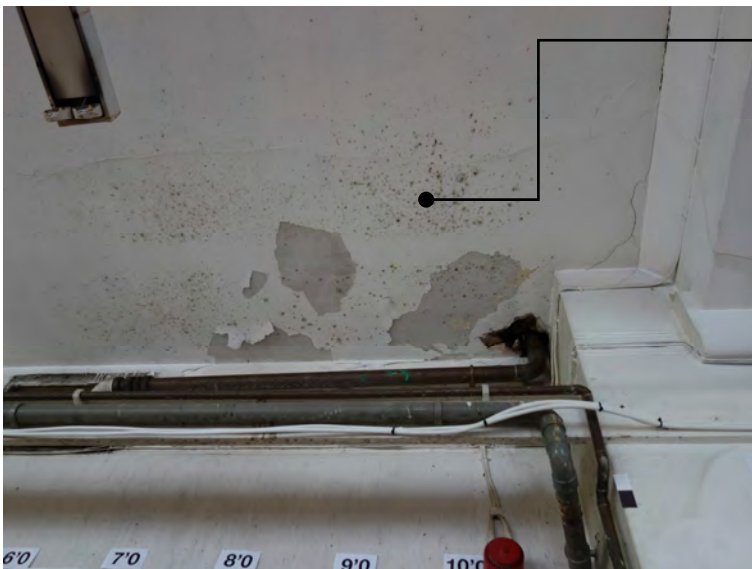
3.5 Mould on the ceiling indicates moisture within the slab.

Remove plaster to determine condition of structure within.

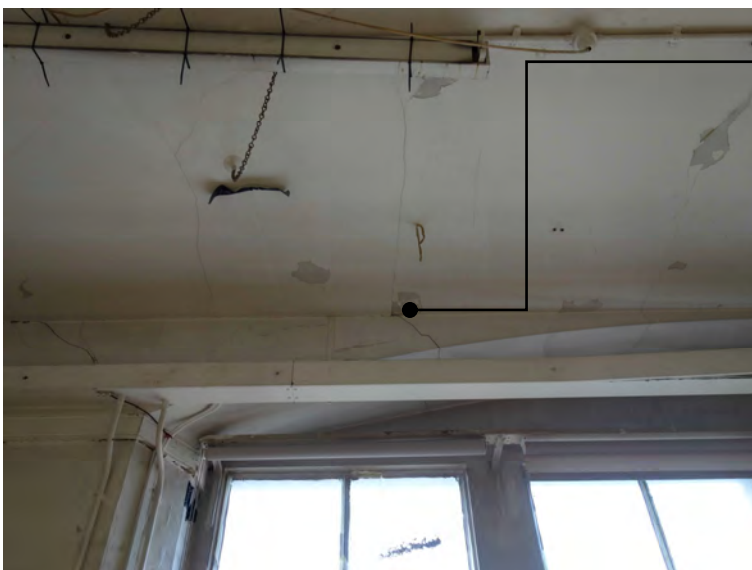
3.6 Cracking to the plaster beneath the steel joists extends into the window arch.

Remove finishes to the base of the arch to determine if cracking extends to the structure within.

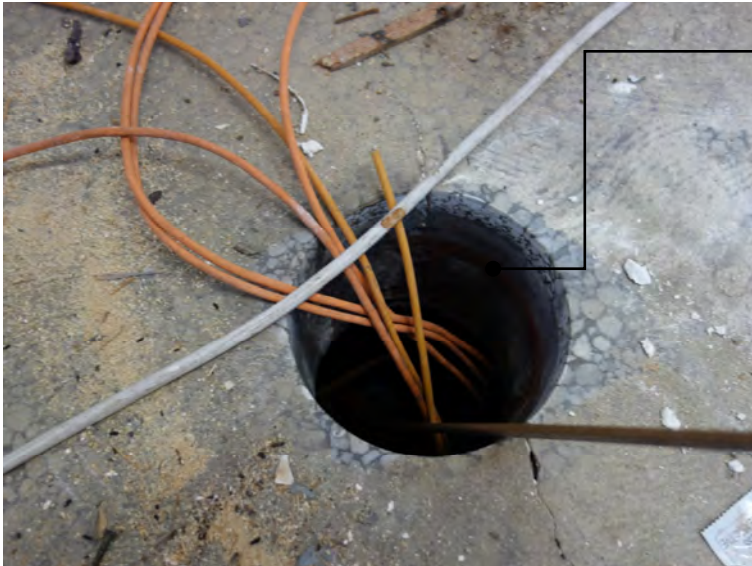
3.7 A hole has been core drilled through the slab, cutting through one of the steel joists.

Temporarily prop each side of the cut joist to the slab below (within the service void).

Permanent repair required.

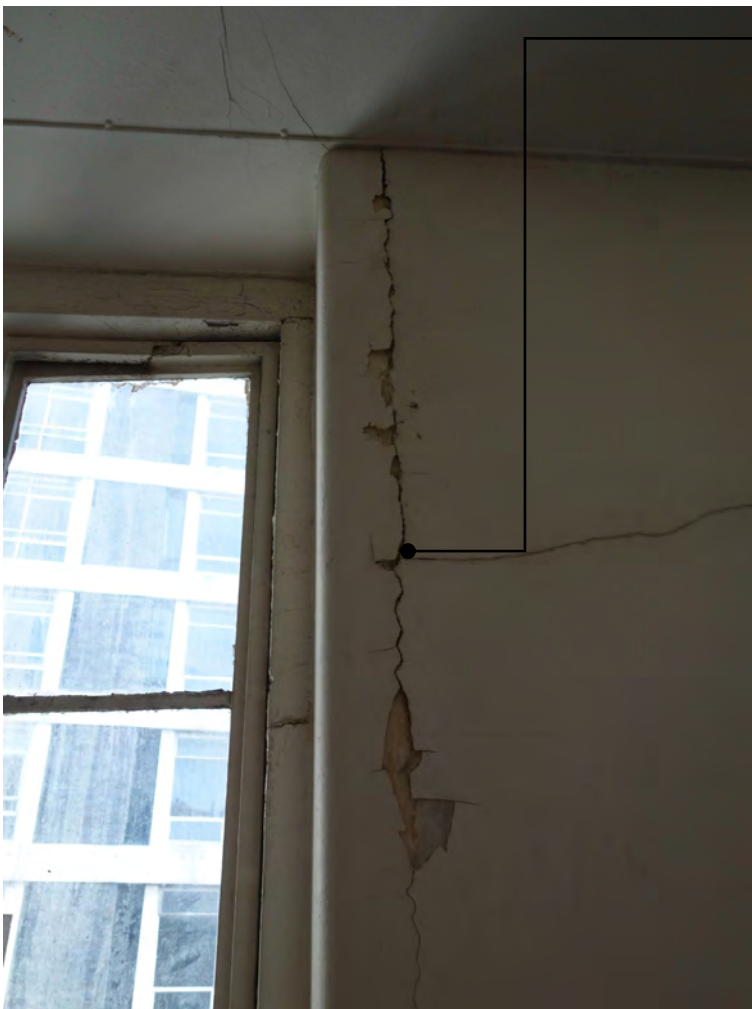
3.8 Significant cracking to masonry adjacent to the window.

Remove finishes to the masonry to determine if cracking extends to the masonry behind.

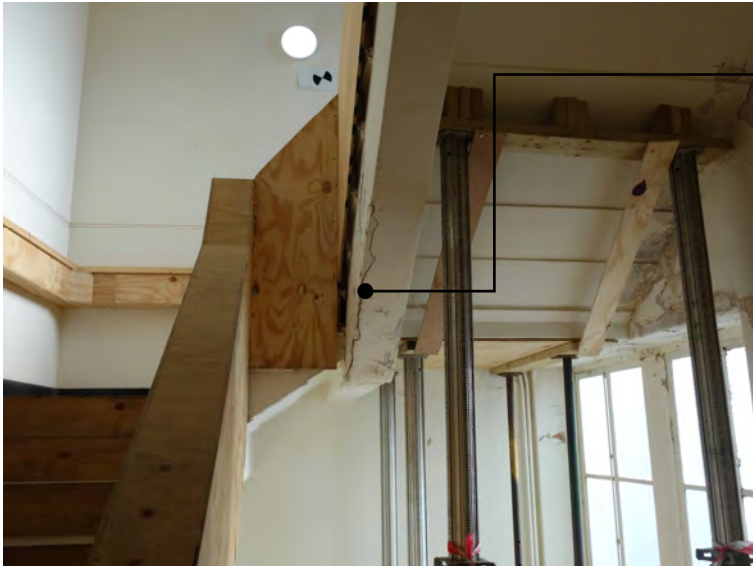
3.9 Water ingress and cracking is apparent along the beams supporting the stair and within the wall above the window.

Remove the finishes and concrete cover to determine the severity of the corrosion.

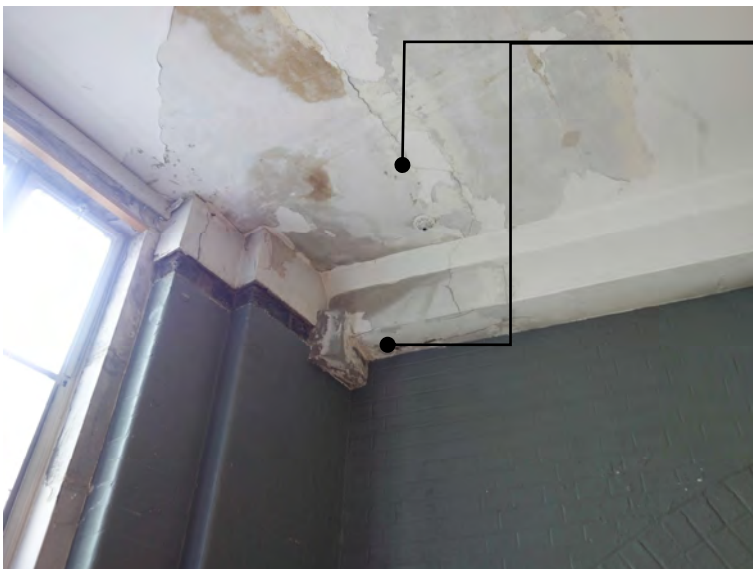
3.10 Water ingress apparent at end of primary beam and within slab.

Remove finishes and cover to beam and slab joists to determine extent of corrosion within.

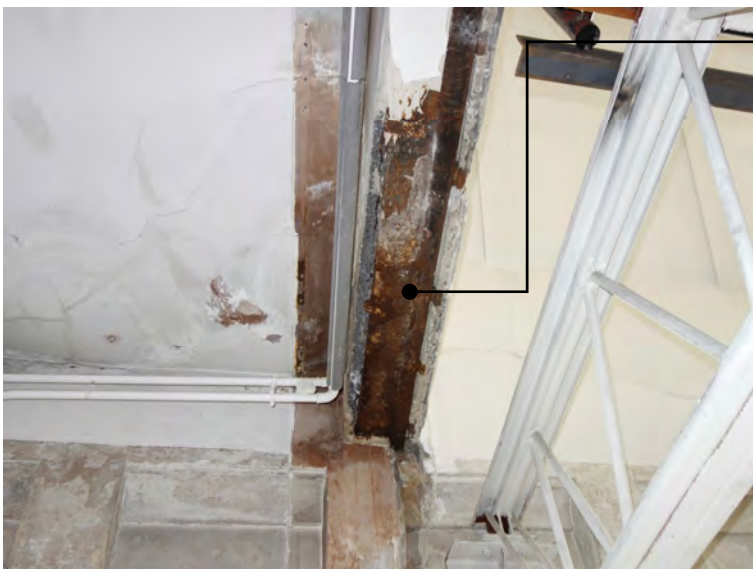
4.1 Exposed steelwork shows signs of heavy corrosion.

Remove plaster to underside of entire beam to determine the extent of corrosion.

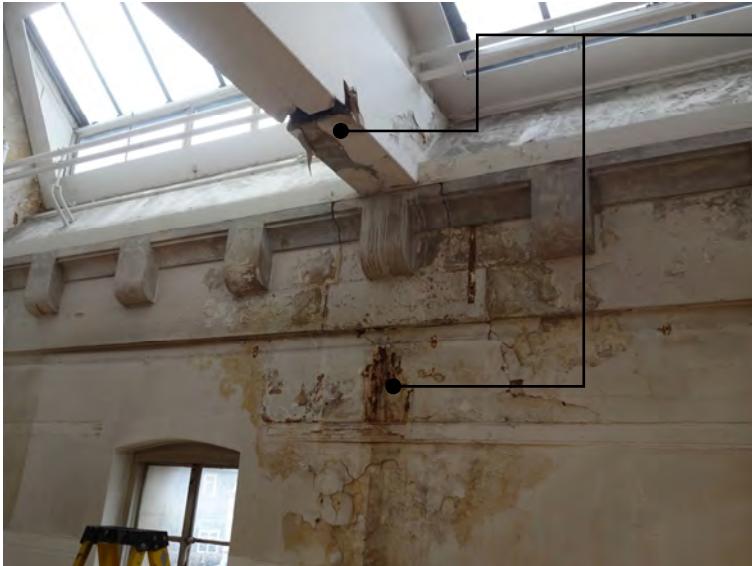
4.2 Corrosion to steelwork and water ingress on the wall is apparent.

Remove plaster and underside of concrete encasement to the length of the steelwork to determine the extent of corrosion.

Remove plaster to the wall to determine the damage to the structure within.

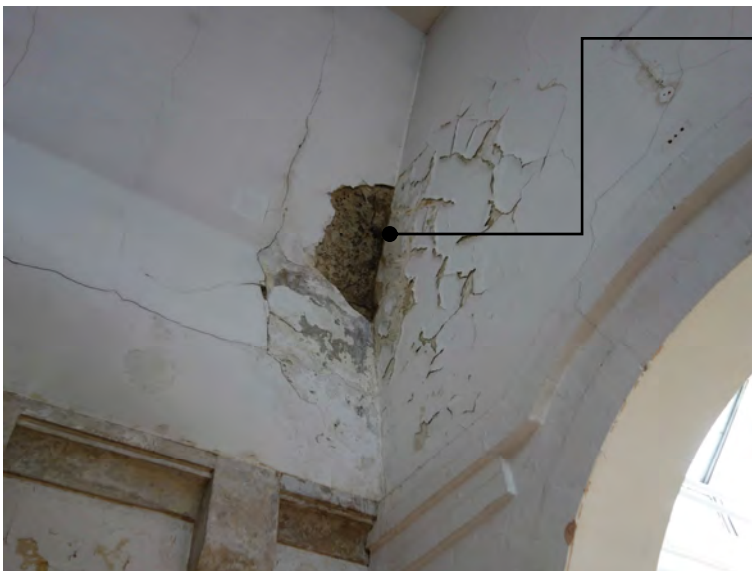
4.3 Damage to the plaster from water ingress is apparent.

Remove plaster to determine extent of damage to structure within.

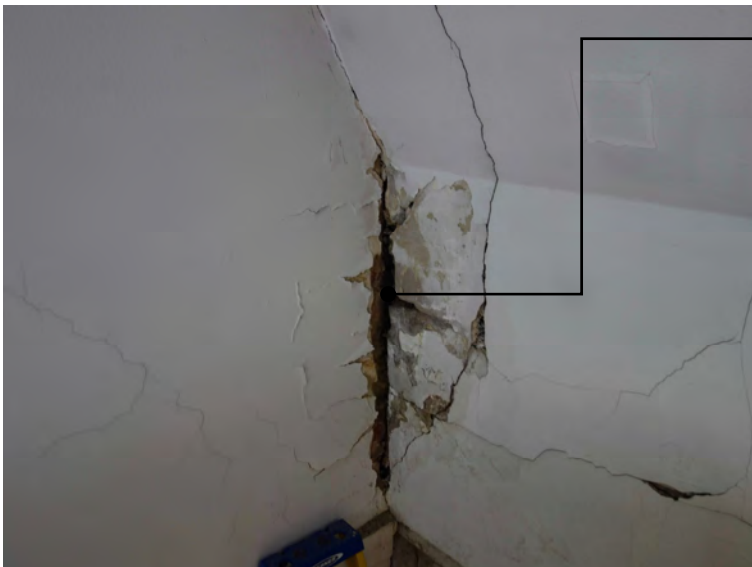
4.4 Damage to the plaster from water ingress is apparent.

Remove plaster to determine extent of damage to structure within.

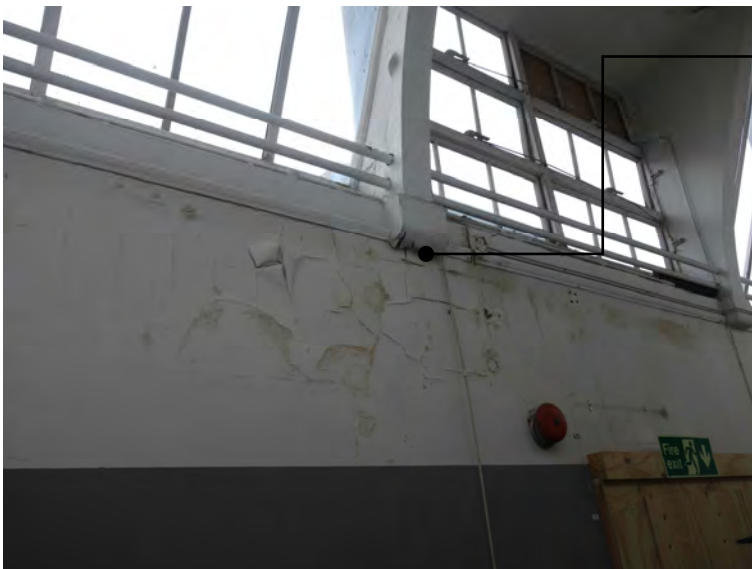
4.6 Damage to the plaster below the high-level windows indicating water ingress.

Remove plaster to determine extent of damage to structure within.

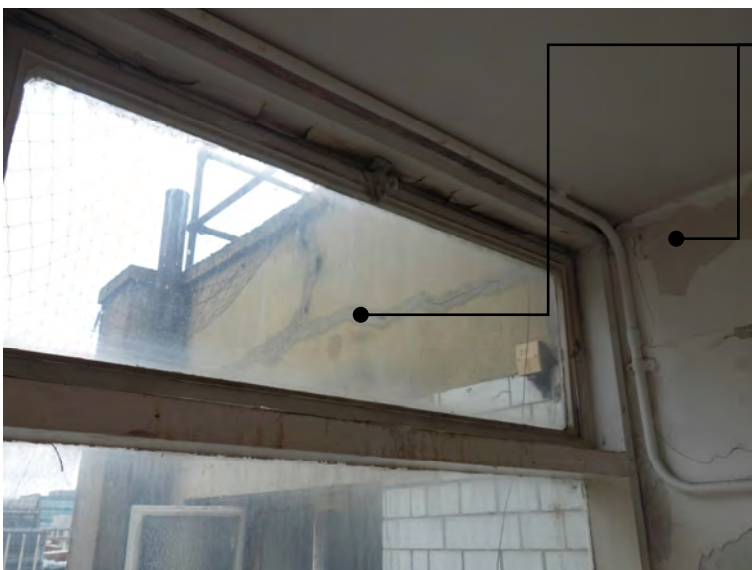
4.7 Cracking in the wall internally continues externally.

Remove plaster to expose extent of damage to the structure within.

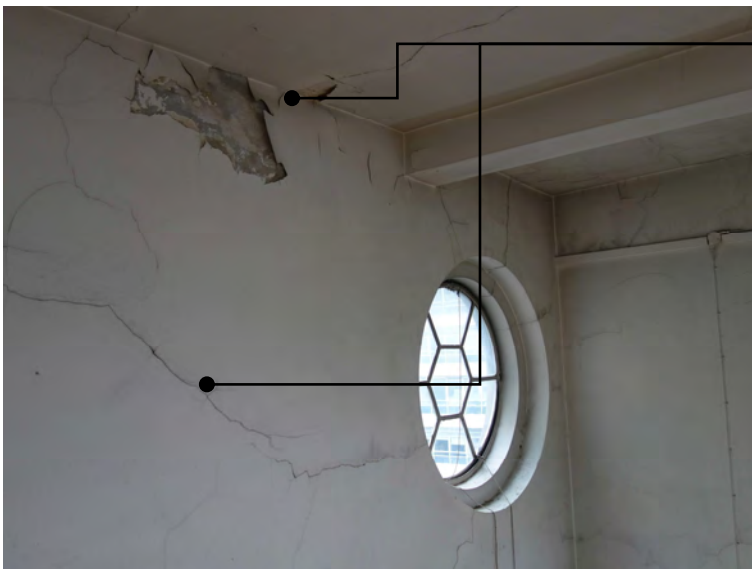
4.9 Numerous cracks are evident in the walls around the stairwell.

Remove small areas of plaster around cracking to determine extent of cracking to masonry behind.

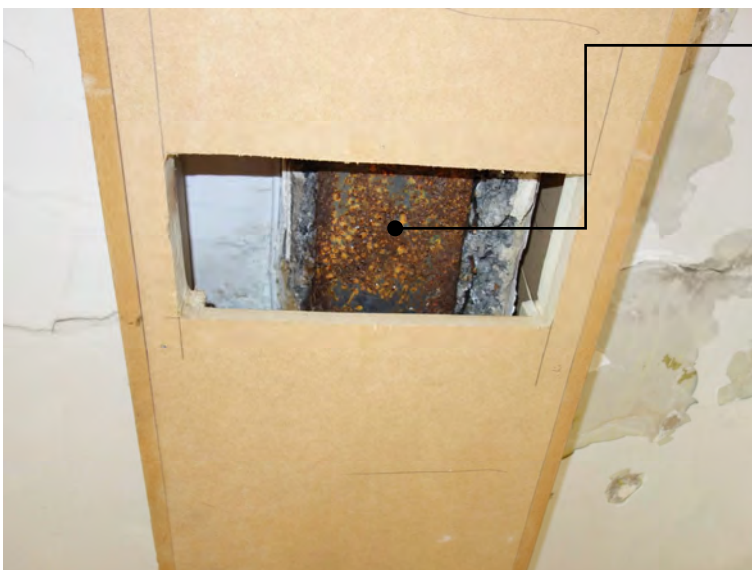
4.10 Light corrosion can be seen to the steelwork over the top of the stair.

Clean corroded steel and reinstate concrete cover.
