/ APPENDIX G
// HEYNE TILLET STEEL
STRUCTURAL SURVEY

Grange Central Saint Martins – Site Visit Report No.4

This report summarises the findings of the structural condition survey completed by HTS in the week commencing 17.02.2020. It discusses elements in obviously poor condition or where further investigations are required. A location plan can be found attached.

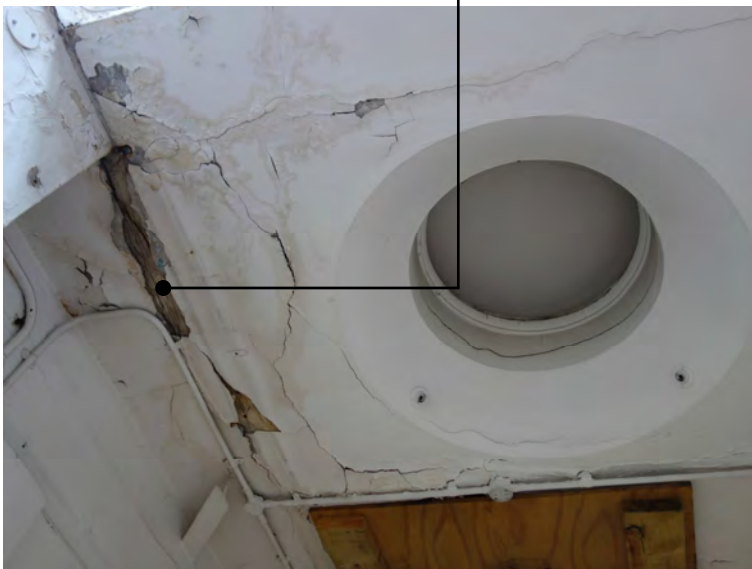
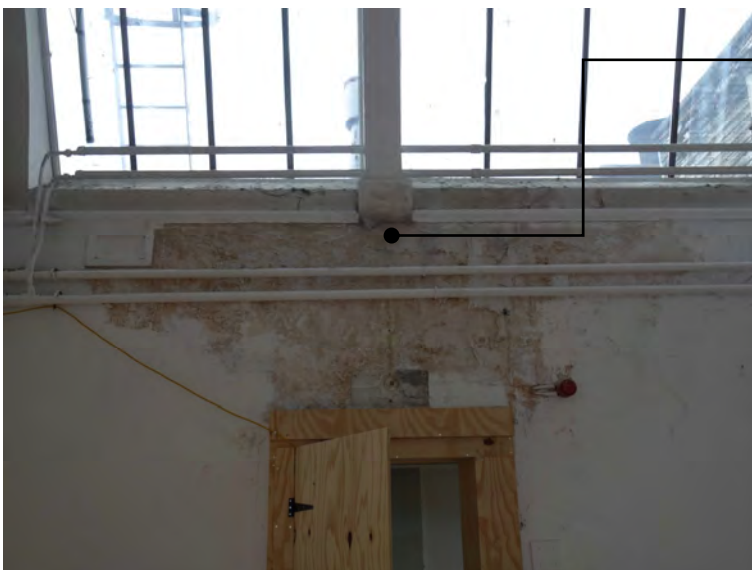
4.12 Damage to the plaster below the high-level windows indicating water ingress.

Remove plaster to determine extent of damage to structure within.

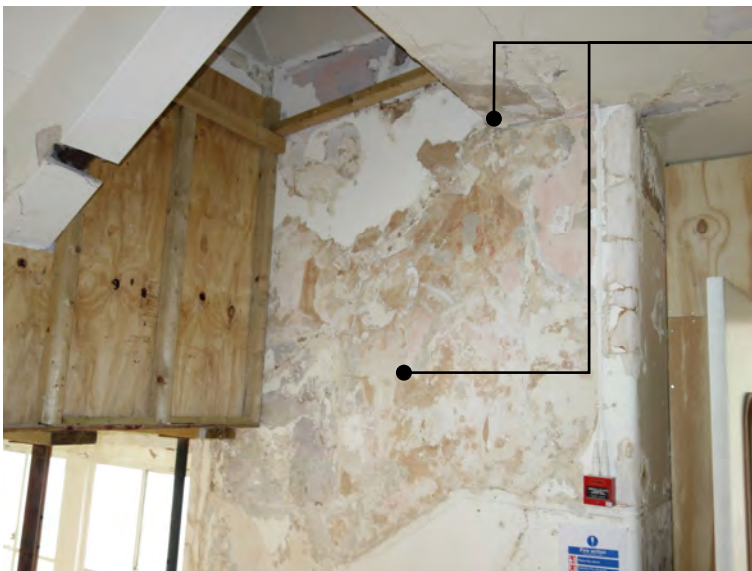
4.14 Heavy water damage apparent to plaster on the wall.

Remove plaster and concrete cover to beam at connection to wall to determine extent of corrosion to steelwork within.

Remove plaster to determine extent of damage to masonry.

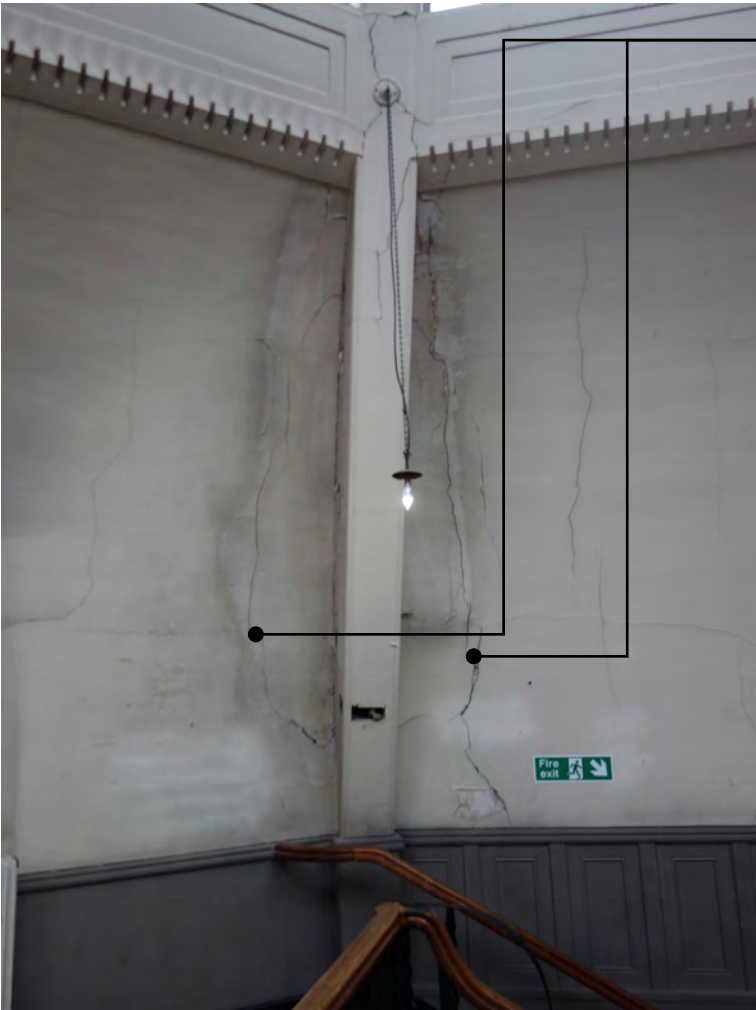
5.1 Cracking to plaster to dome structure, either side of steelwork.

Remove plaster finishes to determine extent of damage to structure within.

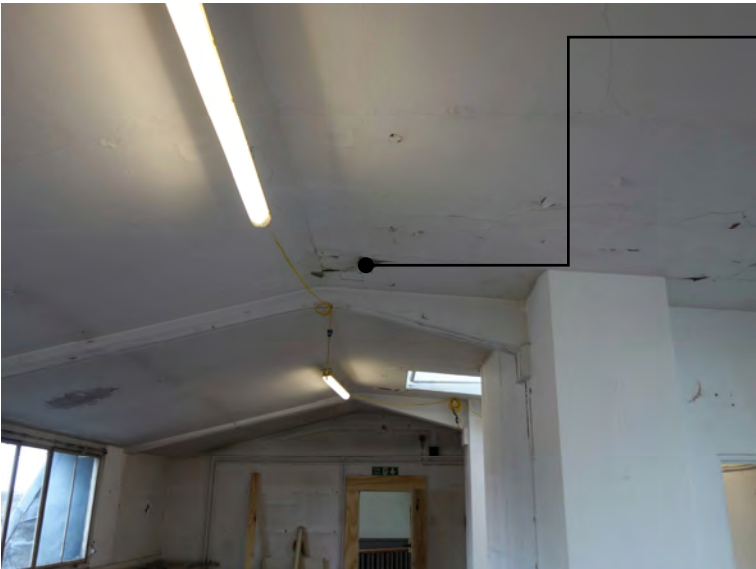
5.2 Cracking apparent in the plaster covering the structure.

Remove plaster finishes to determine extent of damage to structure above.

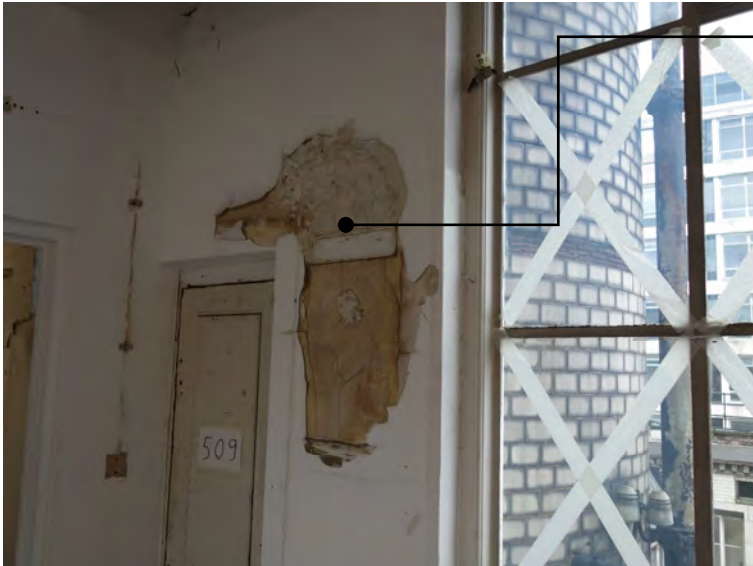
5.3 Plaster swelling seen in wall indicating water ingress.

Remove plaster in the wall to determine extent of damage to structure behind.

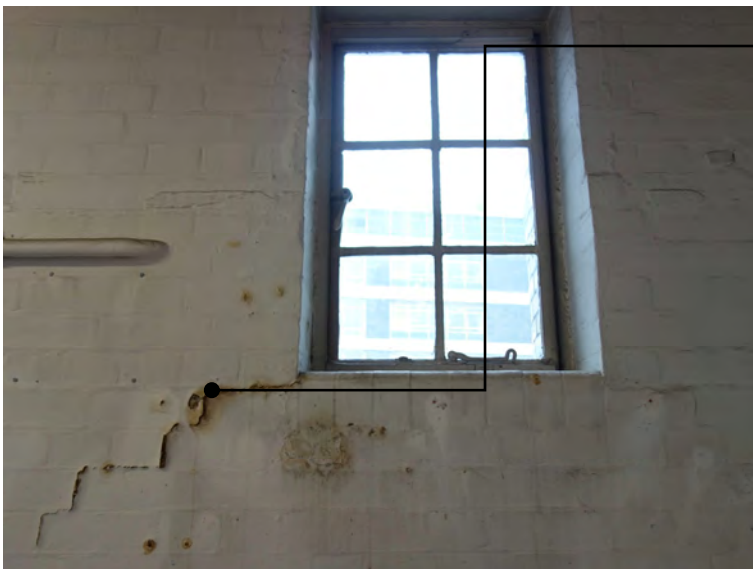
5.4 Large crack to the plaster at the corner of the window.

Remove plaster in the wall to determine extent of damage to structure behind.

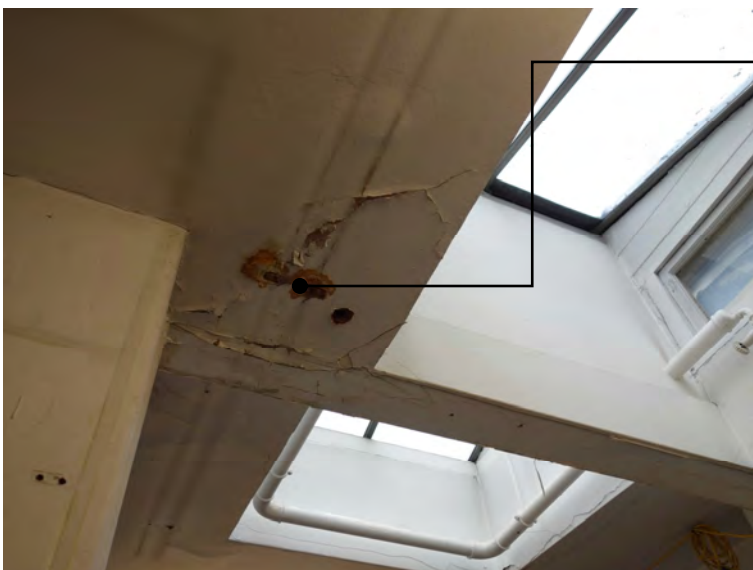
5.5 Rust stains can be seen on the ceiling below an assumed steel joist location.

Remove plaster and concrete cover to determine the extent of corrosion to the joist within.

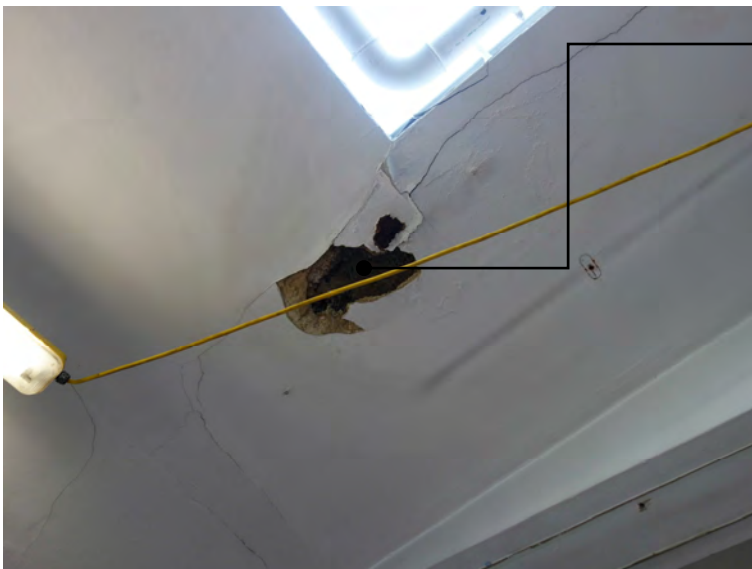
5.7 A portion of the clinker concrete slab appears to have been removed.

Repair concrete slab according to HTS specification.

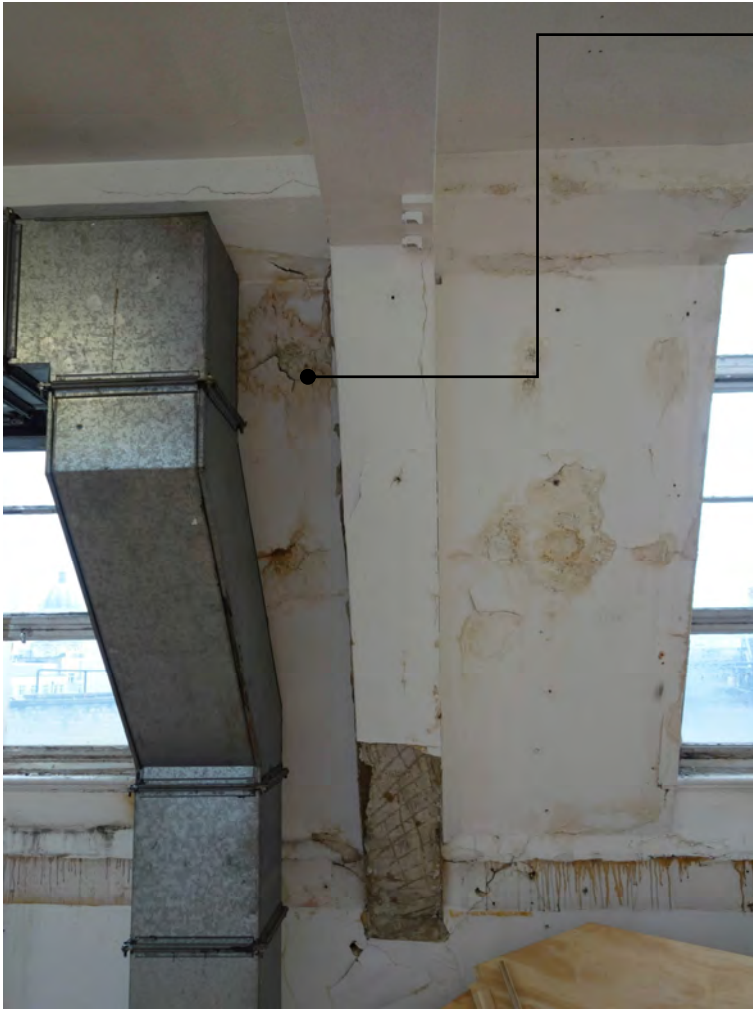
5.8 Plaster swelling seen in wall indicating water ingress.

Remove plaster in the wall to determine extent of damage to structure and corrosion to steel behind.

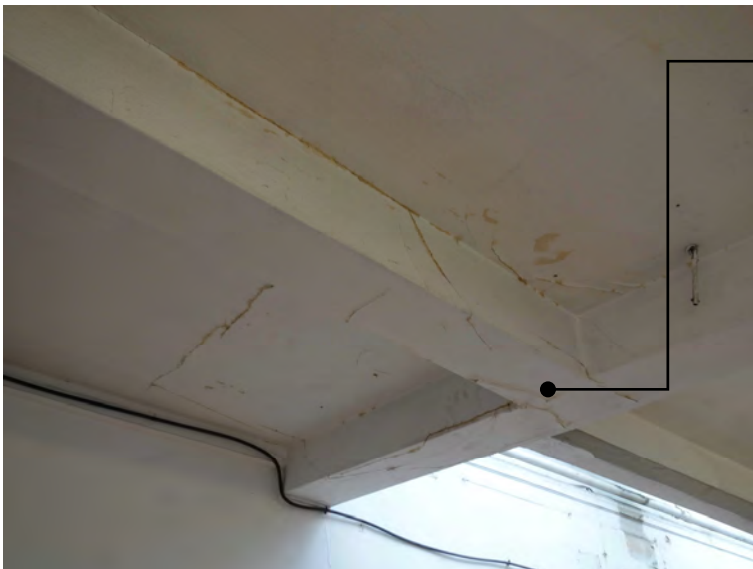
5.9 Water ingress and signs of corrosion apparent on plaster surrounding steel downstand beams.

Remove plaster and concrete cover to determine the extent of corrosion to the beams within.

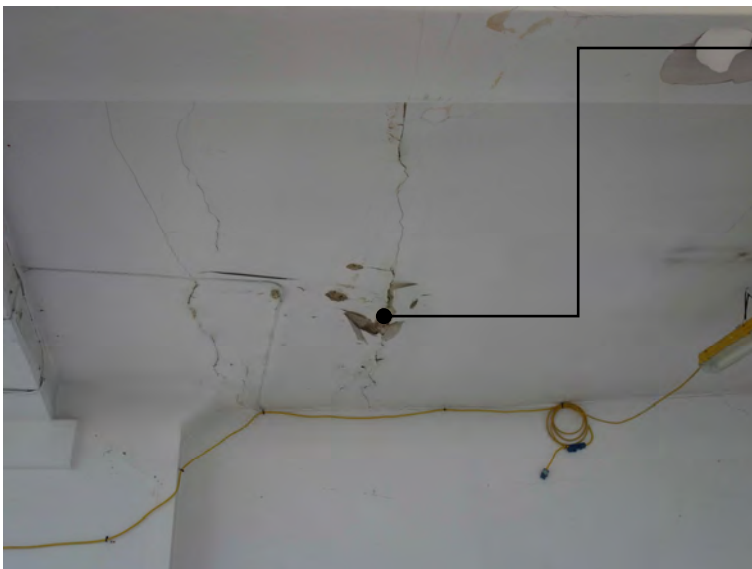
5.11 A large crack is evident beneath an assumed joist location.

Remove plaster and concrete cover to joist to determine the extent of corrosion within.

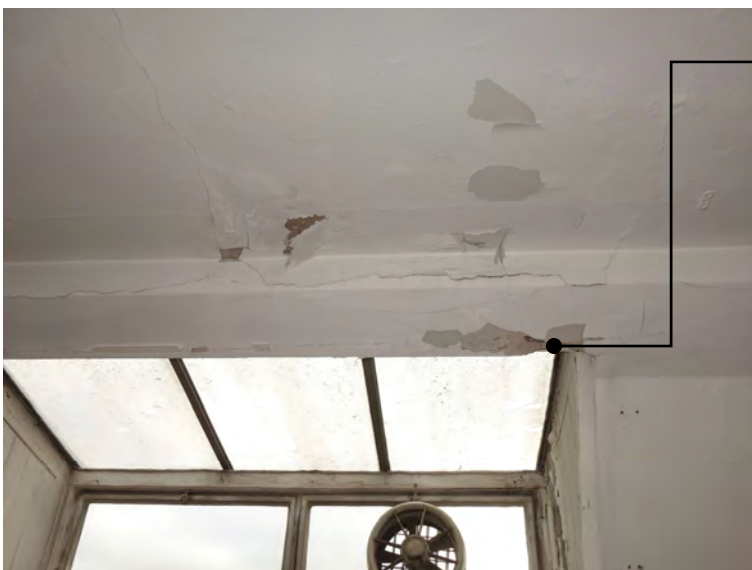
5.12 Cracking can be seen to the bottom of the steel beam running across the roof lights.

Remove plaster and concrete cover to determine the extent of corrosion to the beam within.

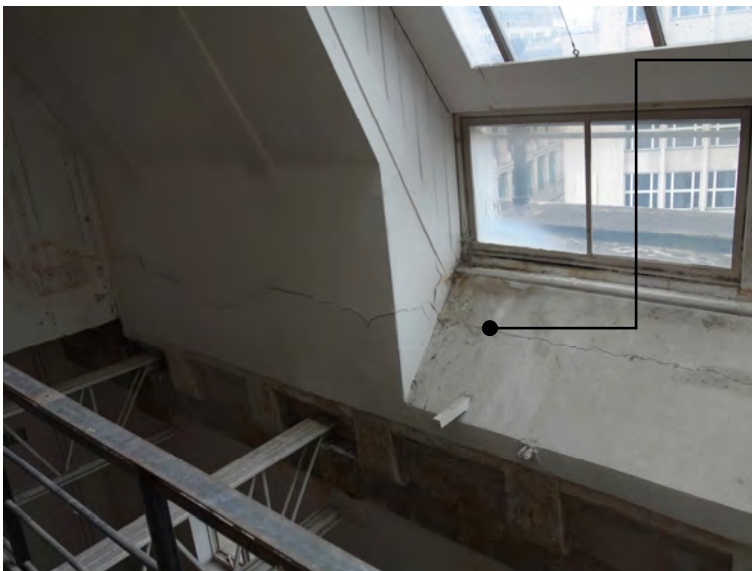
5.14 Cracking along the length of the window and the adjacent section of wall is evident.

Remove the plaster finish to determine extent of damage to structure within.

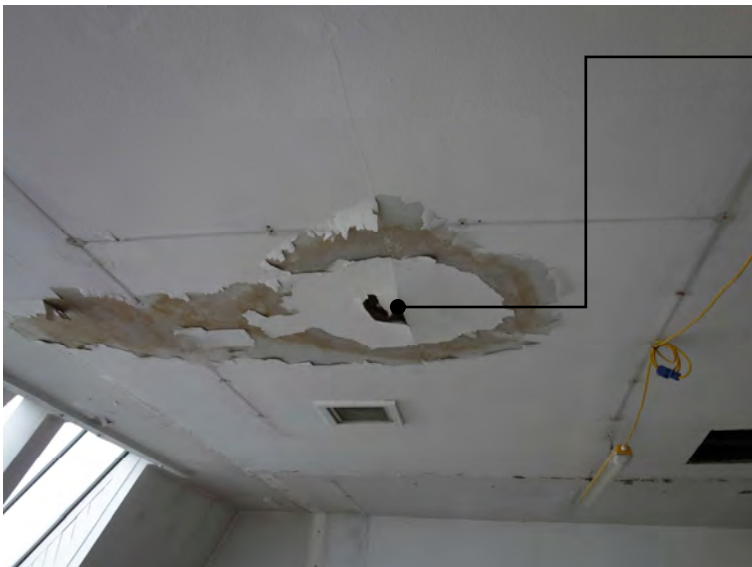
5.15 Water damage and staining to the suspended ceiling suggests water ingress through the structure above.

Remove section of damaged suspended ceiling to allow inspection of the structure above.

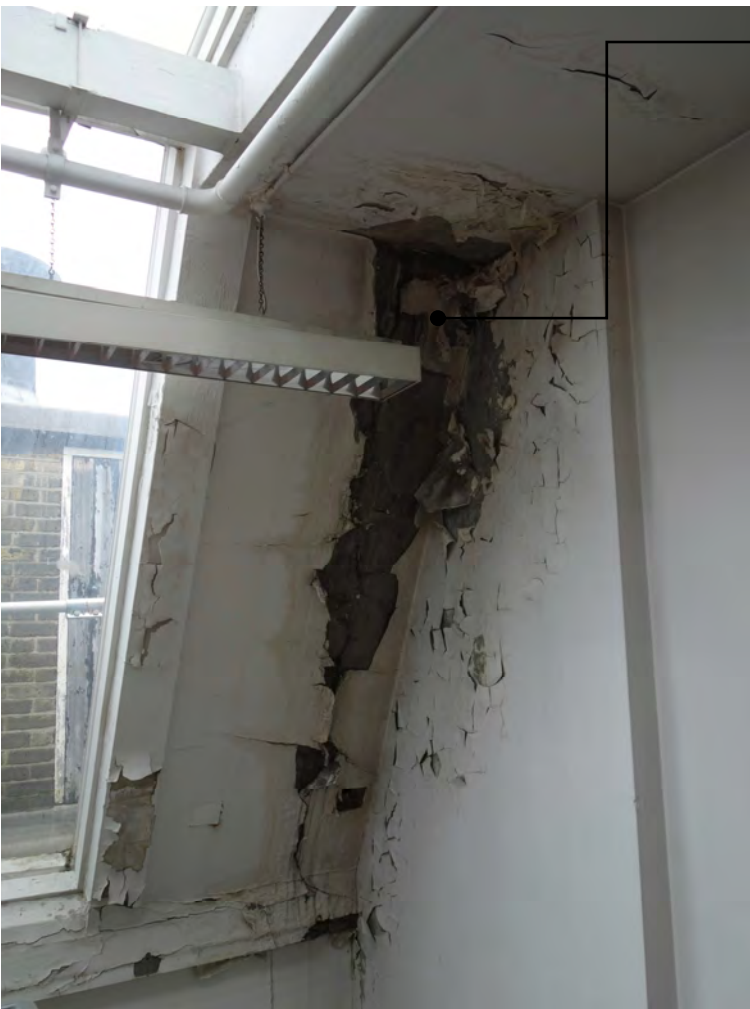
5.17 Water ingress and damage to plaster apparent in mansard and roof slab.

Remove plaster and concrete cover to one joist in the mansard and one in the slab to determine the extent of corrosion to the steelwork within.

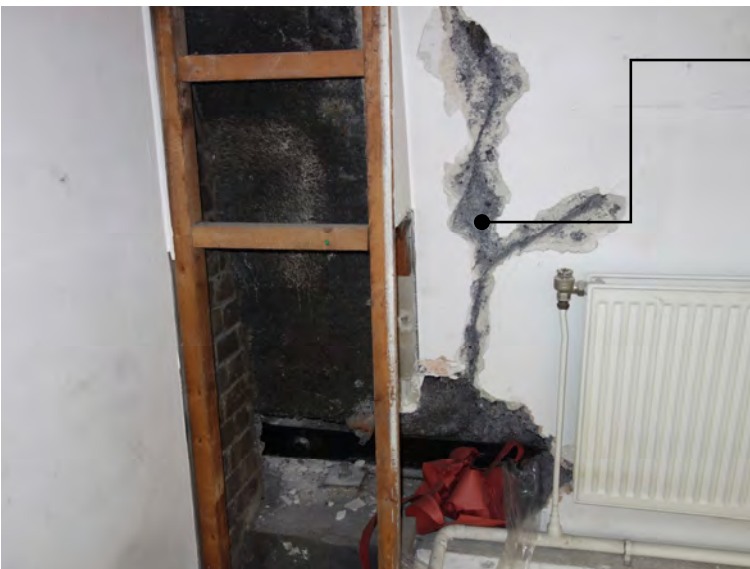
5.19 An area of clinker concrete has been removed exposing the steelwork within.

Reinstate concrete cover according to HTS specification.

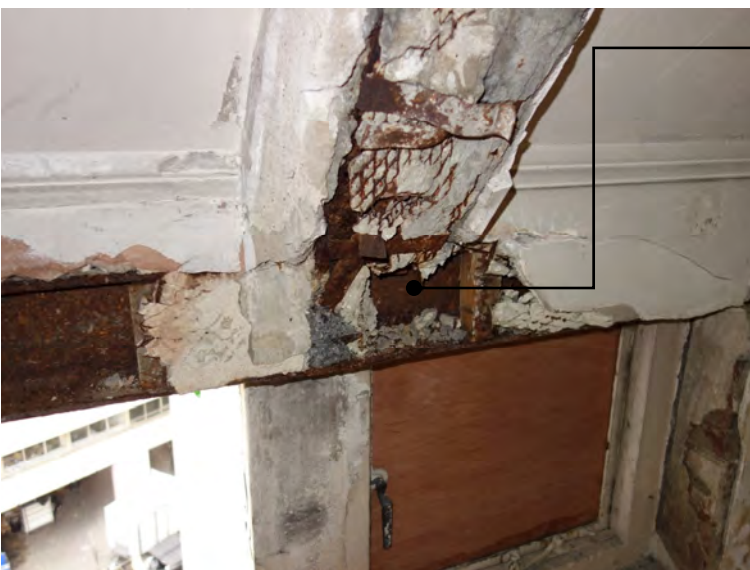
5.20 Heavy corrosion and delamination apparent on steelwork.

Remove plaster and concrete encasement to entire beam and mansard column to determine extent of steel repair required.

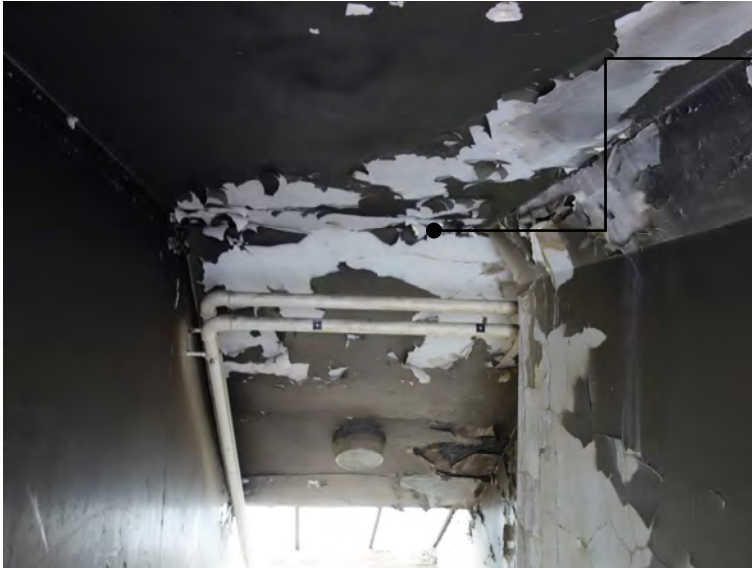
R.1 Disintegration of plaster to the ceiling of the roof entrance, suggesting water damage to the roof.

Remove plaster finishes to determine extent of water ingress and damage to structure within.
