TYBALDS ESTATE CAMDEN LONDON WC1N 3PF

PRELIMINARY ARBORICULTURAL ASSESSMENT

Report No: RT-MME-154667-01 Rev A

Date: April 2021 Revised: June 2021

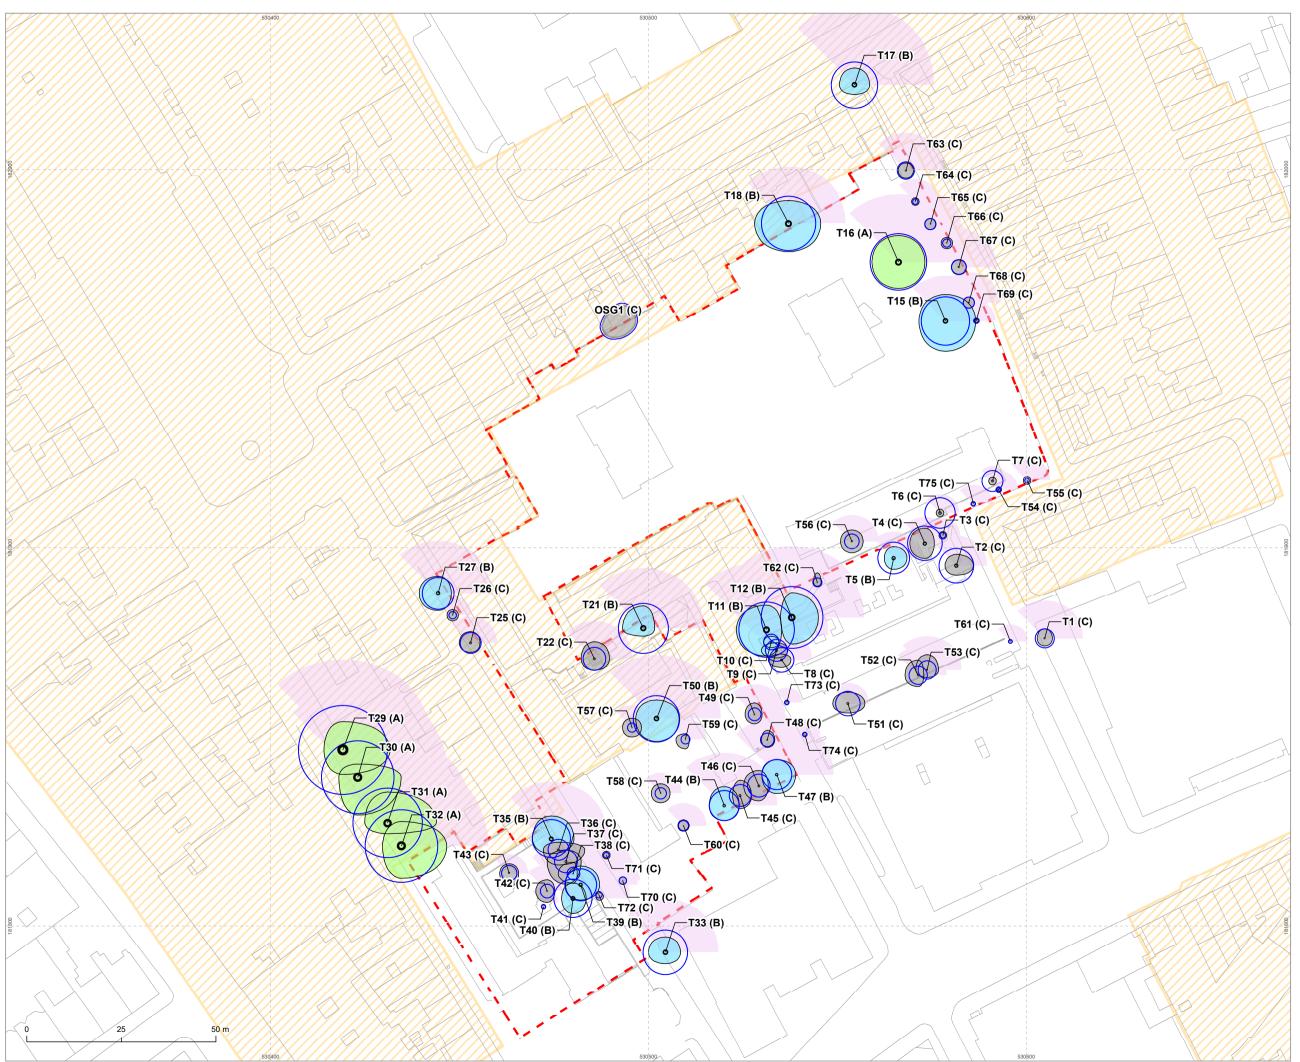
The existing canopy spreads and indicative shade patterns of the assessed trees are shown on the Tree Survey Plan (C154667-01-01). Whilst larger, more mature trees offer significant value in term of their contribution to the future site use and are unlikely to grow much larger, the future crown spreads of younger trees will need to be fully considered when designing any built development nearby.

Initial Root Protection Areas (RPAs) for the trees have been plotted onto the Tree Survey Plan as circles, with the tree located centrally on the main stem, extending to encompass the area of ground, and thus the root-able soil volume, required for protection.
