**TREE PROTECTION &
CONSTRUCTION METHOD STATEMENT
FOR REDEVELOPMENT OF
KINGS CROSS COMMUNITY HUB
51 ARGYLE ST,
LONDON
WC1H 8EF**

ARBORICULTURAL SOLUTIONS LLP

ORIGINAL – DECEMBER 2020.

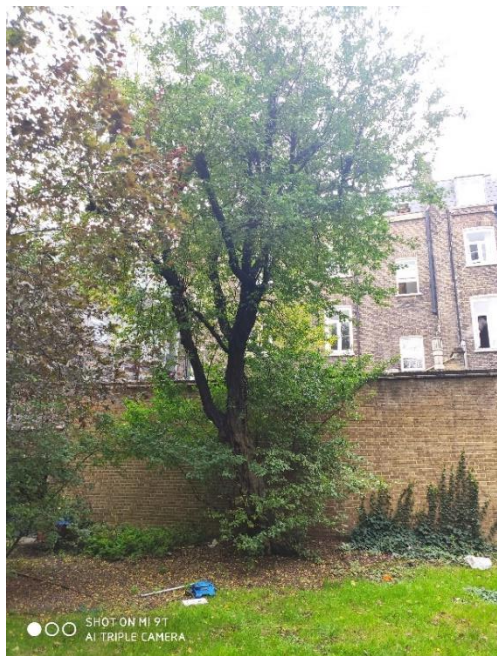
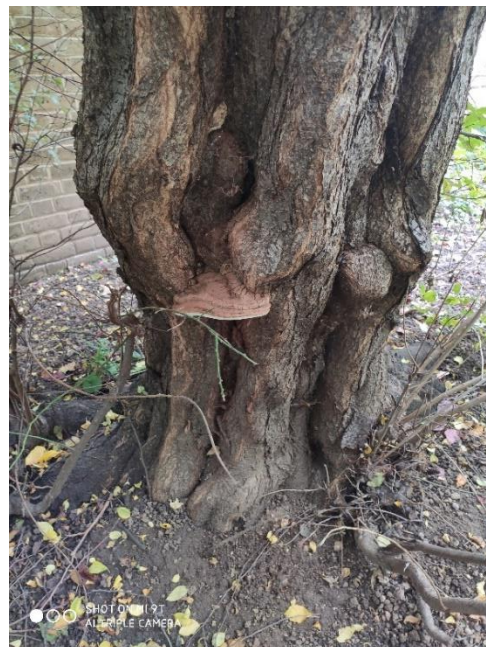
5.4.1. Tree 1 has been categorised as U (Trees unsuitable for retention) as it has a fungal bracket of *Ganoderma* on the trunk and is in such a condition that it cannot realistically be retained in the context of the current land use for longer than 10 years.

Photographs 1 and 2 showing tree 1 (Cherry Plum) and fungal bracket on trunk.

- Trees 1 (Cherry Plum), 5 and 6 (Purple-leaf Plum) and tree 9 (Downy Birch) will require removal to facilitate the redevelopment.
- Trees 3 (Downy Birch), 4 (Italian Alder), 7 and 8 (Fastigate Hornbeam) are outside the proposed construction area. These trees will be protected and retained.
- Trees 2 (Purple-leaf Plum) and 10 (Downy Birch) are within the construction area. These trees will be retained and will require special precautions (refer to 8.1 Tree Protection Method Statement) to minimise the risk of damage to the roots.

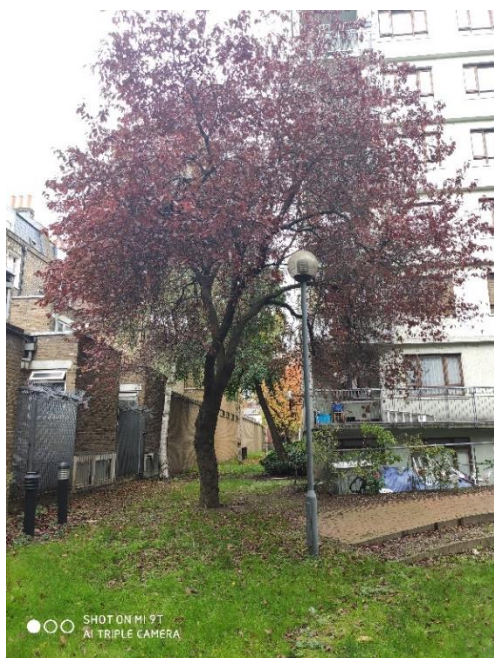
5.4.2. Trees 2 to 6 are considered to be of low category reflecting their small size and restricted amenity value. These trees are growing at the rear of the existing Community Centre building and so are of restricted public amenity value (refer to photographs 3 to 6 below).

Photograph 3 showing tree 2.

6.1.6. Trees 2 & 10 will be protected and retained. The circular representation of the root protection areas extends into the proposed construction areas. the basement excavations encroach slightly into the RPA of Tree 2 (Purple-leaf Plum). This is a very minor incursion and is unlikely to have a significant impact on the stability or health of the tree. In addition, new paving is proposed over approximately 25% of the area of the RPA. This will need to be of porous permeable design laid on a 'minimal dig' base to prevent damage to the rooting zone.

8.4.2. Before any basement or foundation excavation works commence the outline of the basement within the RPA of tree 2 will be carefully excavated by hand and any roots crossing into the footprint of the basement cleanly cut before the excavation works commence.

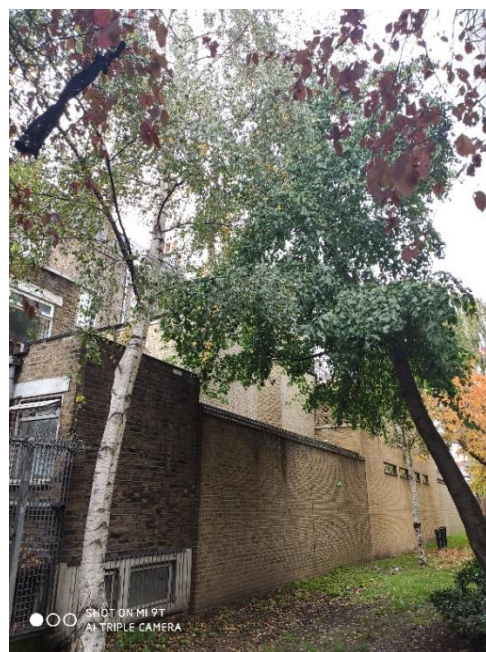
Photograph 4 showing trees 3 and 4.

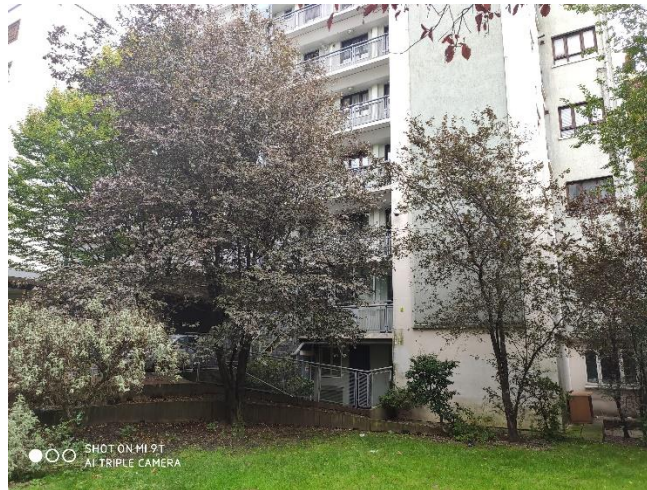
Photograph 5 showing trees 5 and 6.

6.1.5. The basement excavation extends into the west side of the RPA of tree 5 and in addition, the tree is located within the proposed garden area. Plum trees are recognised by a number of authorities as being shallow to moderately deep rooted on clay soils. Excavations within the RPA may lead to significant root damage or loss and result in a decline in the health of the tree concerned. Plum trees (*Prunus* species) are vulnerable to infection by *Ganoderma* as the infection is considered to be associated with root damage and severance. As with any fungal species that causes root and butt rot in living trees, decay by *Ganoderma* can cause mechanical failure of the stem base or root plate.

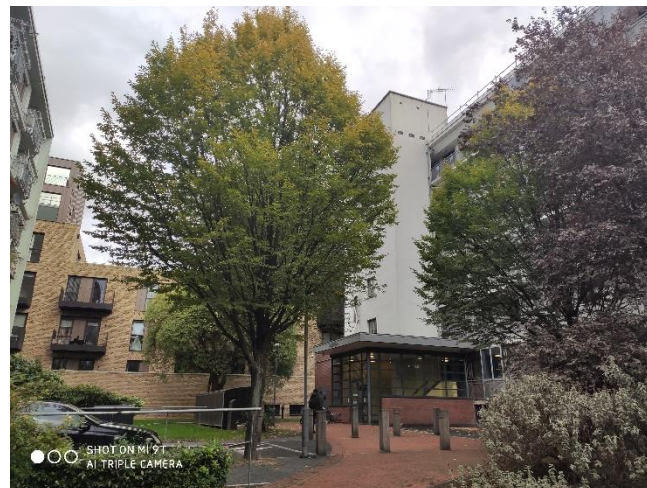
5.4.3. Trees 7, 8 and 10 have been categorised as B2. Trees 7 and 8 are in good condition and of long-term potential and tree 10 is a prominent tree at the front of the buildings (refer to photographs 6 and 7 below).

Photograph 6 showing tree 5 to right of tree 7 at centre.

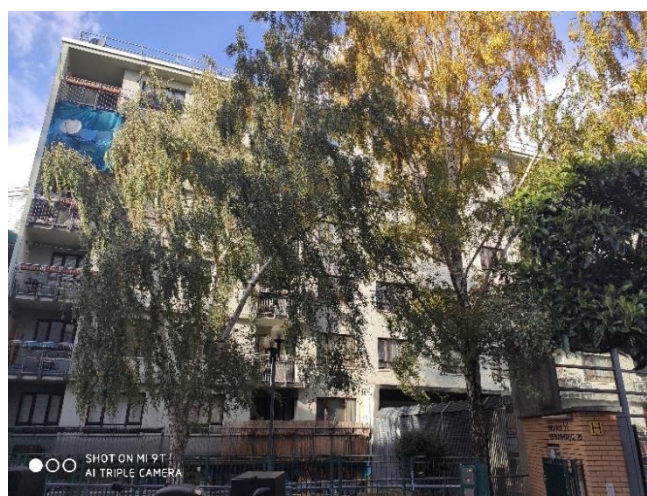
Photograph 7 showing trees 9 and 10 at the front of the building.

6.1.7. Tree 10 (Downy Birch) is located at the front of the property within the existing stepped and ramped access to the building and the. There are several elements of hard landscaping and hard surfacing making the prediction of the root locations difficult. The existing ground level slopes downward towards the existing building and the encroachment within the RPA to create the lower ground level patio area is less than 15% of the RPA. Birch trees tend to be shallow rooted and intolerant of root damage so any works within the RPA will require careful
