DESIGN AND ACCESS STATEMENT

CAPITAL WORKS PLANNING

ACTON STREET

CAMDEN

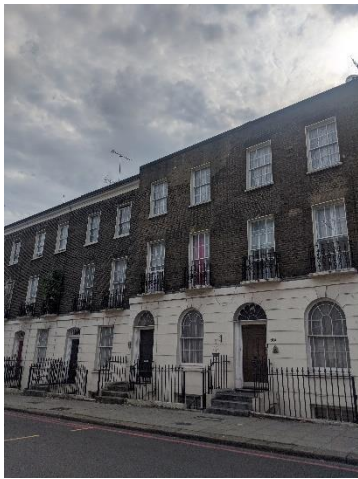
The external painted elements including windows, cills and cornice details on both the front and rear elevation have deteriorated over time with visible cracks evident. These elements are painted in magnolia and white. The brickwork also has visible damage, and they are in poor condition in some areas of the buildings. The proposed work includes for these to be repaired. Currently, both the yellow stock brickwork to upper storey's and the stucco render are affected by how busy the road is, with a layer of soot having discoloured the bricks and render over the years.

Figure 2: Existing painted section on front elevation

It is proposed that all previously painted surfaces will be improved by redecorating with a magnolia and white colour in a suitable paint considering the materials (as below). Where necessary we will be carrying out masonry repairs to brickwork and rendered sections to prevent further deterioration, which will be completed by a specialist contractor. Mortar repairs will be completed in accordance with the below material list, to ensure suitability for the scenario to be used.

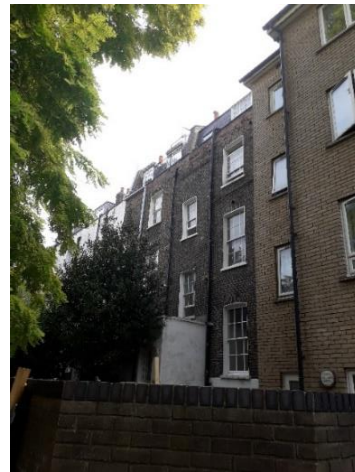
Figure 3: Existing brickwork sections on rear elevation

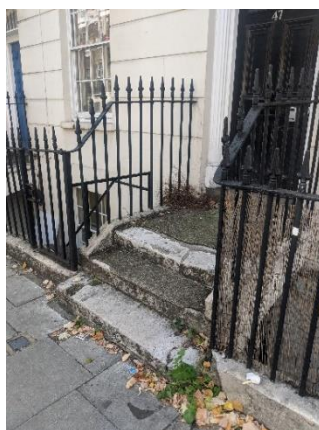
Figure 4: Existing front entrance steps

The properties currently have front entrance steps constructed up to the ground floor entrance that requires waterproofing. They are in very poor condition with visible cracks and splits. Where required, it is proposed to cover the front steps with a Prokol liquid applied coating waterproof covering. Any non-breathable coating currently applied would be removed and the steps prepared in line with manufacturer's recommendations to receive the waterproof covering.
