79 Guilford Street, WC1N 1DF

September 2021

Revision A

Listed Building Consent Application for Works at 79 Guilford Street, WC1N

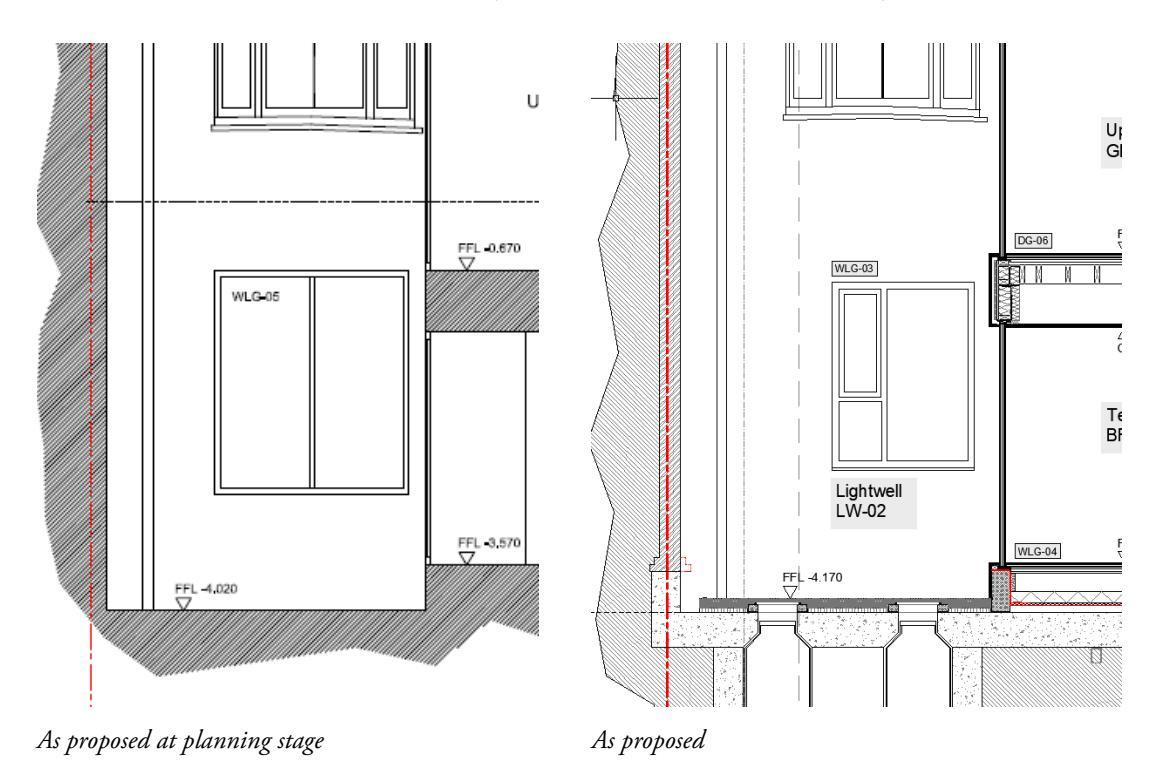
At planning stage the architectural drawings detailed the widening of the lower ground floor rear double door opening to form a large, modern window. It has now been decided that the opening does not need to be enlarged and it is proposed the opening be retaining and made good, and a new modern aluminium framed window is installed which follows the same logic as the previously approved drawings.

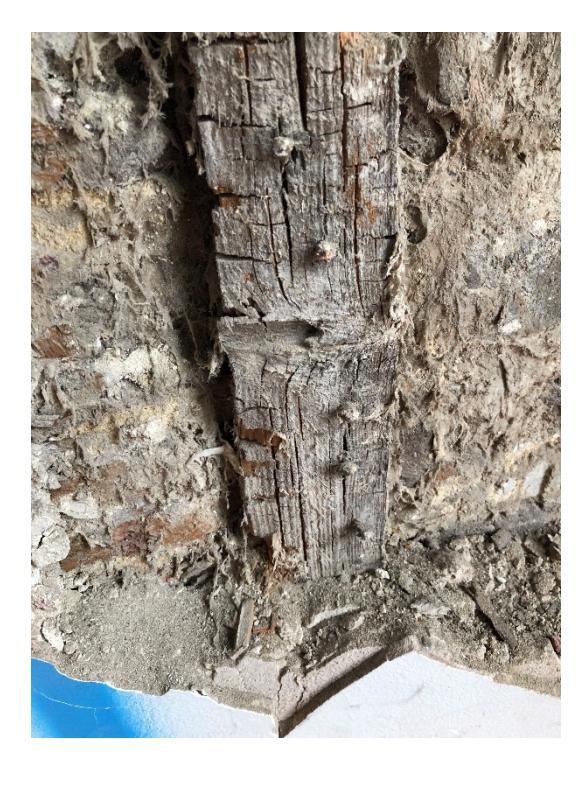
During early stage construction a leak was discovered on the staircase. To avoid further damage opening up work took place to expose the pipework. Holes were cut at ground-first floor and first-second floor winder levels, through previously inserted plasterboard and gypsum render which was likely installed during the 2012/13 refurbishment works when an internal RWP was installed. In so doing some areas of dry rot have been found, with some timber studs crumbling away. Finally, as detailed in a separate LBC application, the existing rear wall needs to be tied back into the party walls of the building and access will be required to allow this work to take place.

Image of dry rot on studs

In tandem with this the clients seek to improve the performance of the building and have an ambition to meet Enerphit standards. In order to do so the airtightness and thermal performance of the building needs to be improved. The applicant therefore seeks to strip back the remaining non-original plasterboard, render the external walls with a lime-based insulative product. Timber studs would be inspected for any further signs of rot and replaced with new where required. Finally, new lath and lime plaster would be reinstated, replacing the non-original and/or gypsum skimmed plaster in place currently.

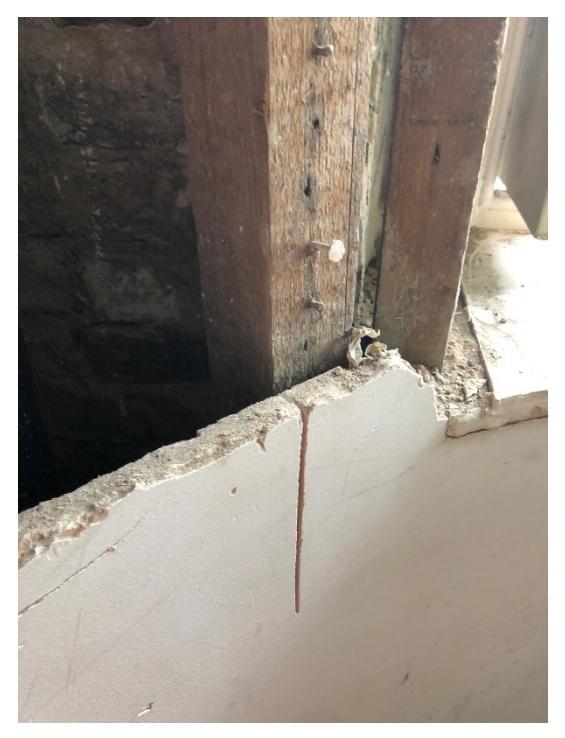
Image of plasterboard lining

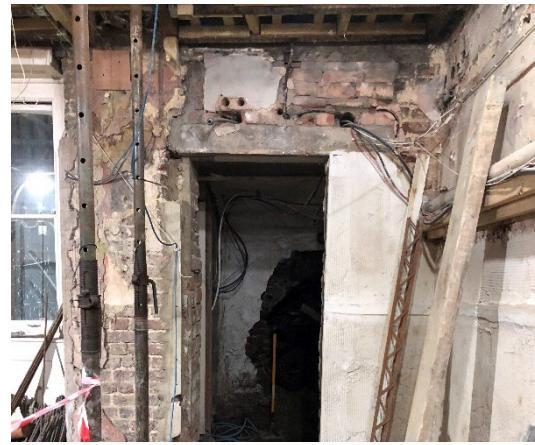
The applicant also seeks permission to repair the structure above the entrance door to the basement, the lintel of which currently has only 50mm of bearing. Concurrently they propose to remove a non-original nib, widening the door and improving access via the porch. They concurrently intend to re-support the brick arch

Image of door opening proposed to be widened

of the crossover by installing concrete lintels and generally improve the state of the brickwork in this area. This is thought of as an improvement to the building.

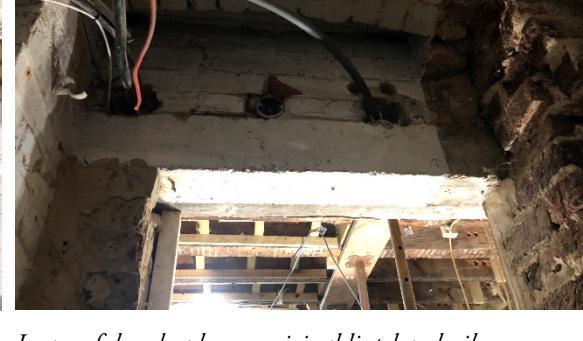
Image of door head, non-original lintel and nib

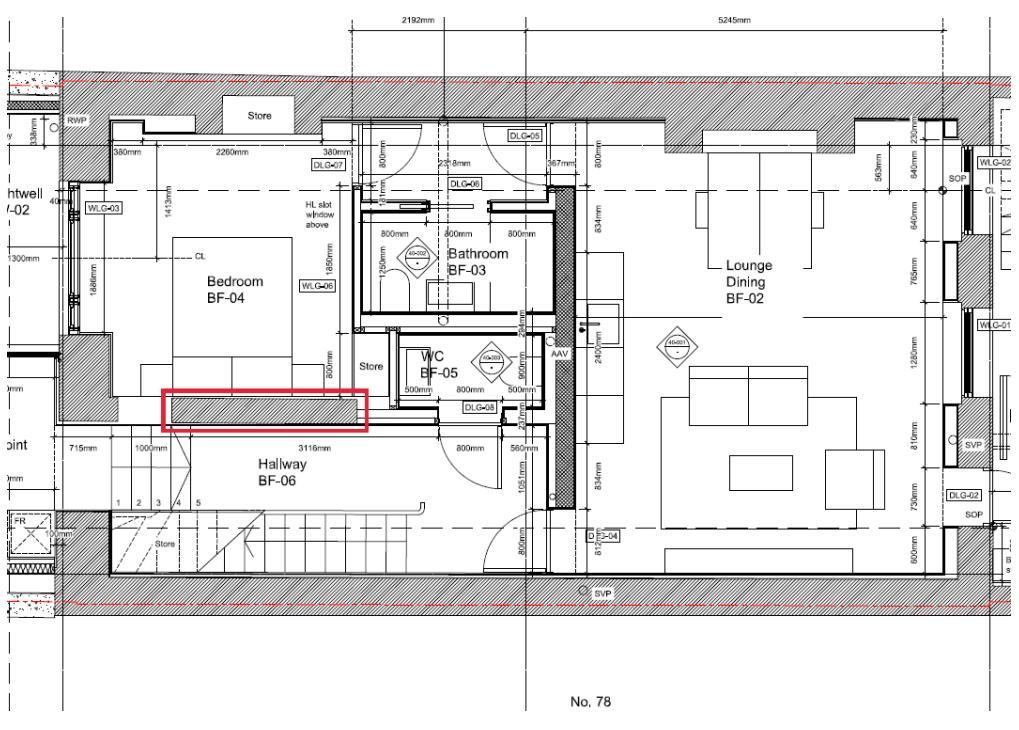
In the consented scheme, the original wall in the basement was proposed to be retained. Originally it was thought this was an original stock brick wall but it was later discovered to be made of part blockwork, part engineering brick and some original bricks. The wall was not restrained at its head and was unstable. As such the wall was removed. The original bricks have been used to make good other walls that were damaged under previous ownership. As such it is now proposed this wall be rebuilt using blockwork.

Removed wall outlined in red
