ARBORICULTURAL IMPACT ASSESSMENT REPORT FOR:

5 The Grove
Highgate
London
N6 6JU

Ref: TSS/5TGV/AIA/01b

Date: 20th August 2021

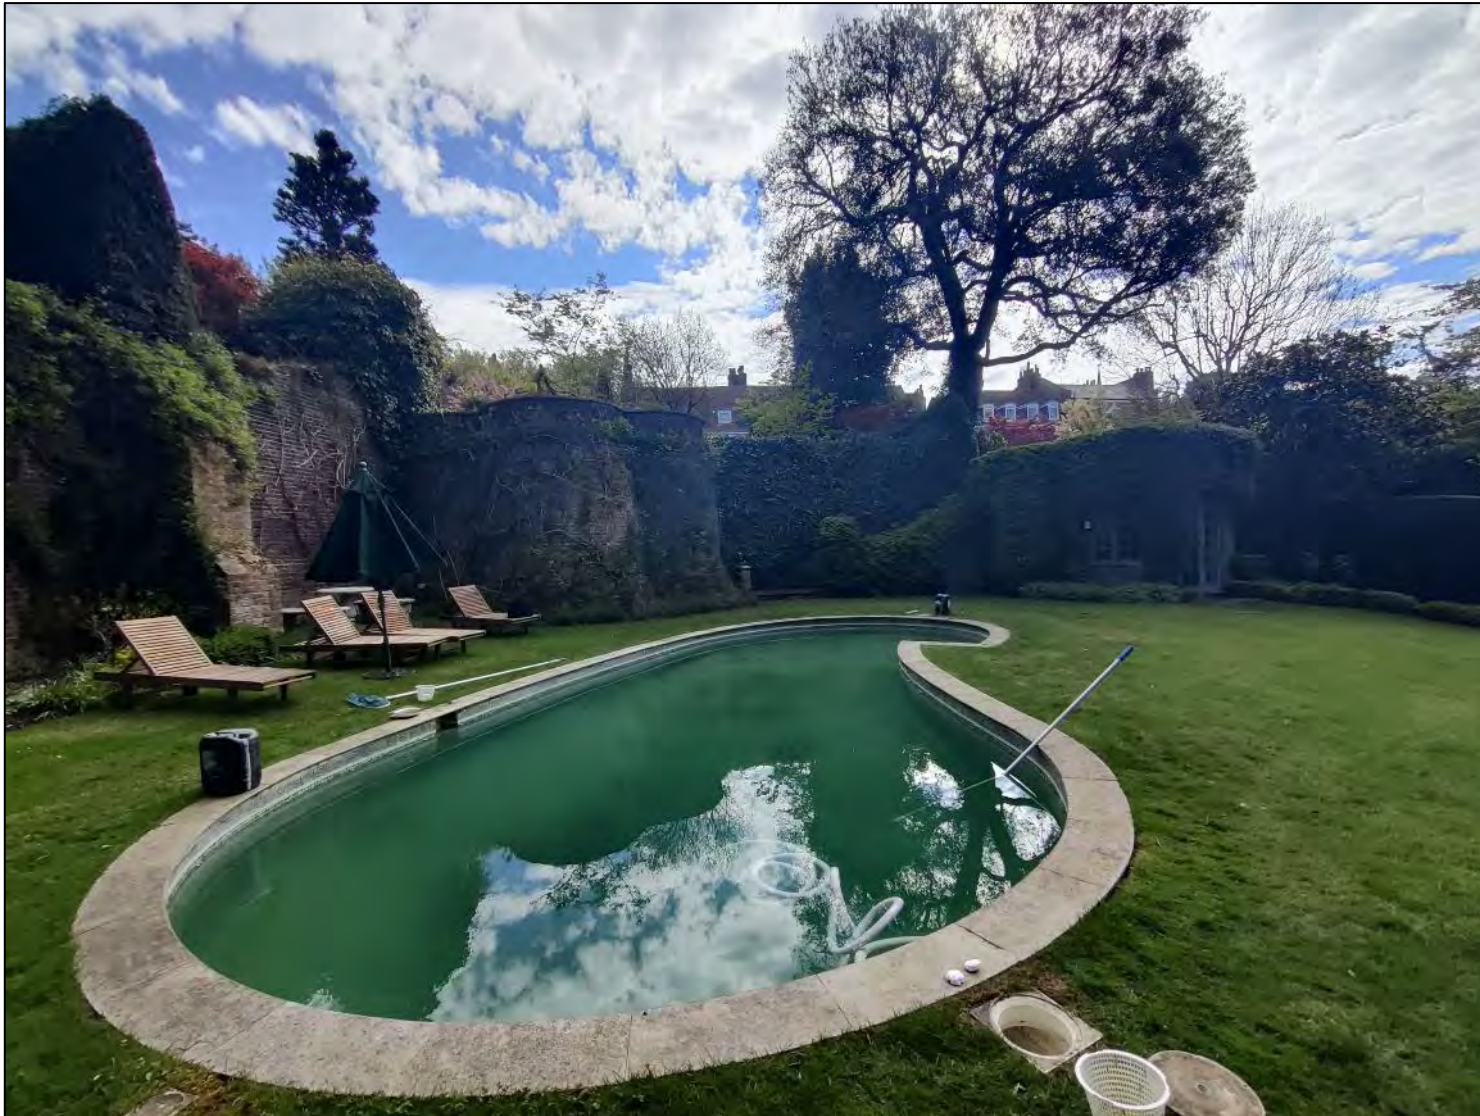
Photograph 2: Existing lower garden arrangement with T12 visible to rear set above existing summerhouse

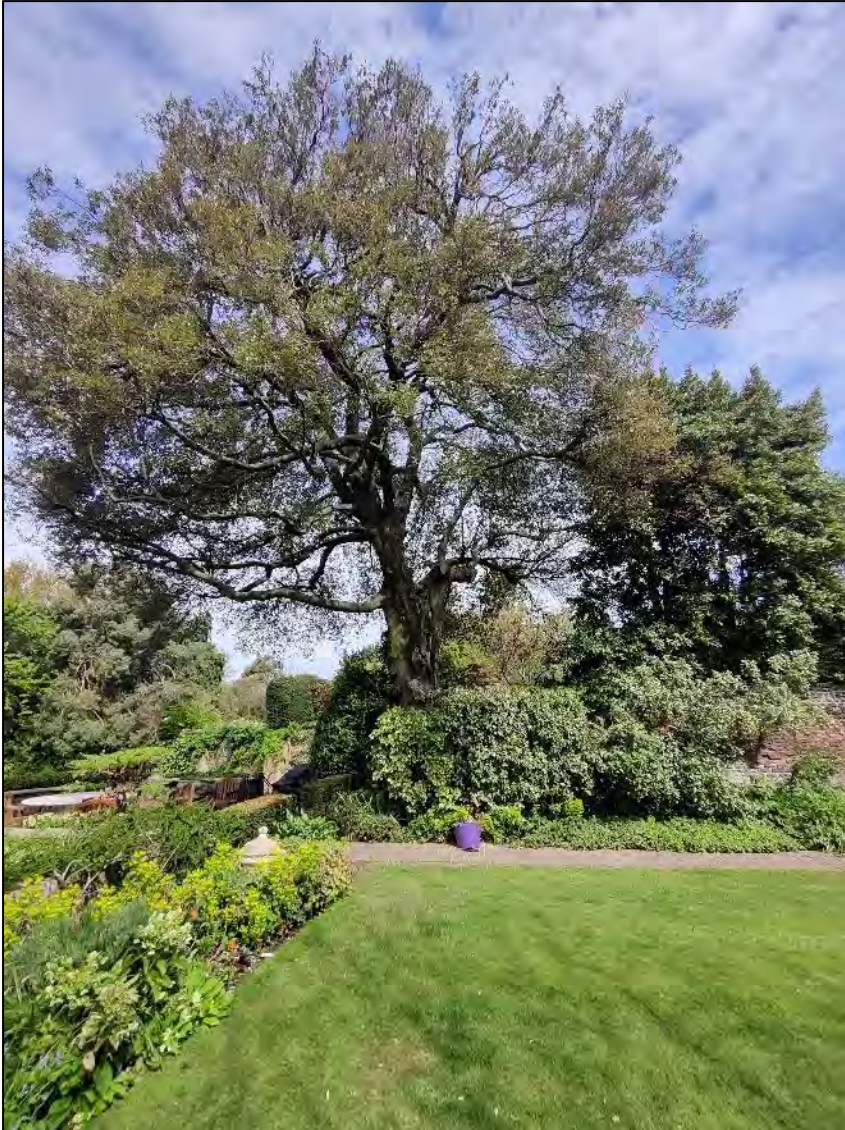
Photograph 3: Holm oak T12 growing at roof level of summerhouse to left

- 6.1.3 Further impacts to retained trees comprise the encroachments of the RPA of T1 by the new pergola and terrace beneath it by 4% and the RPA of T12 by the side extensions to the summerhouse, again by 4%. It will of course be noted that the encroachments to the RPA of T12 occur approximately 3m below the level of the tree beyond a retaining wall. New footpaths are also proposed within the RPAs of T's 1, 2, 12, 17 and 20.

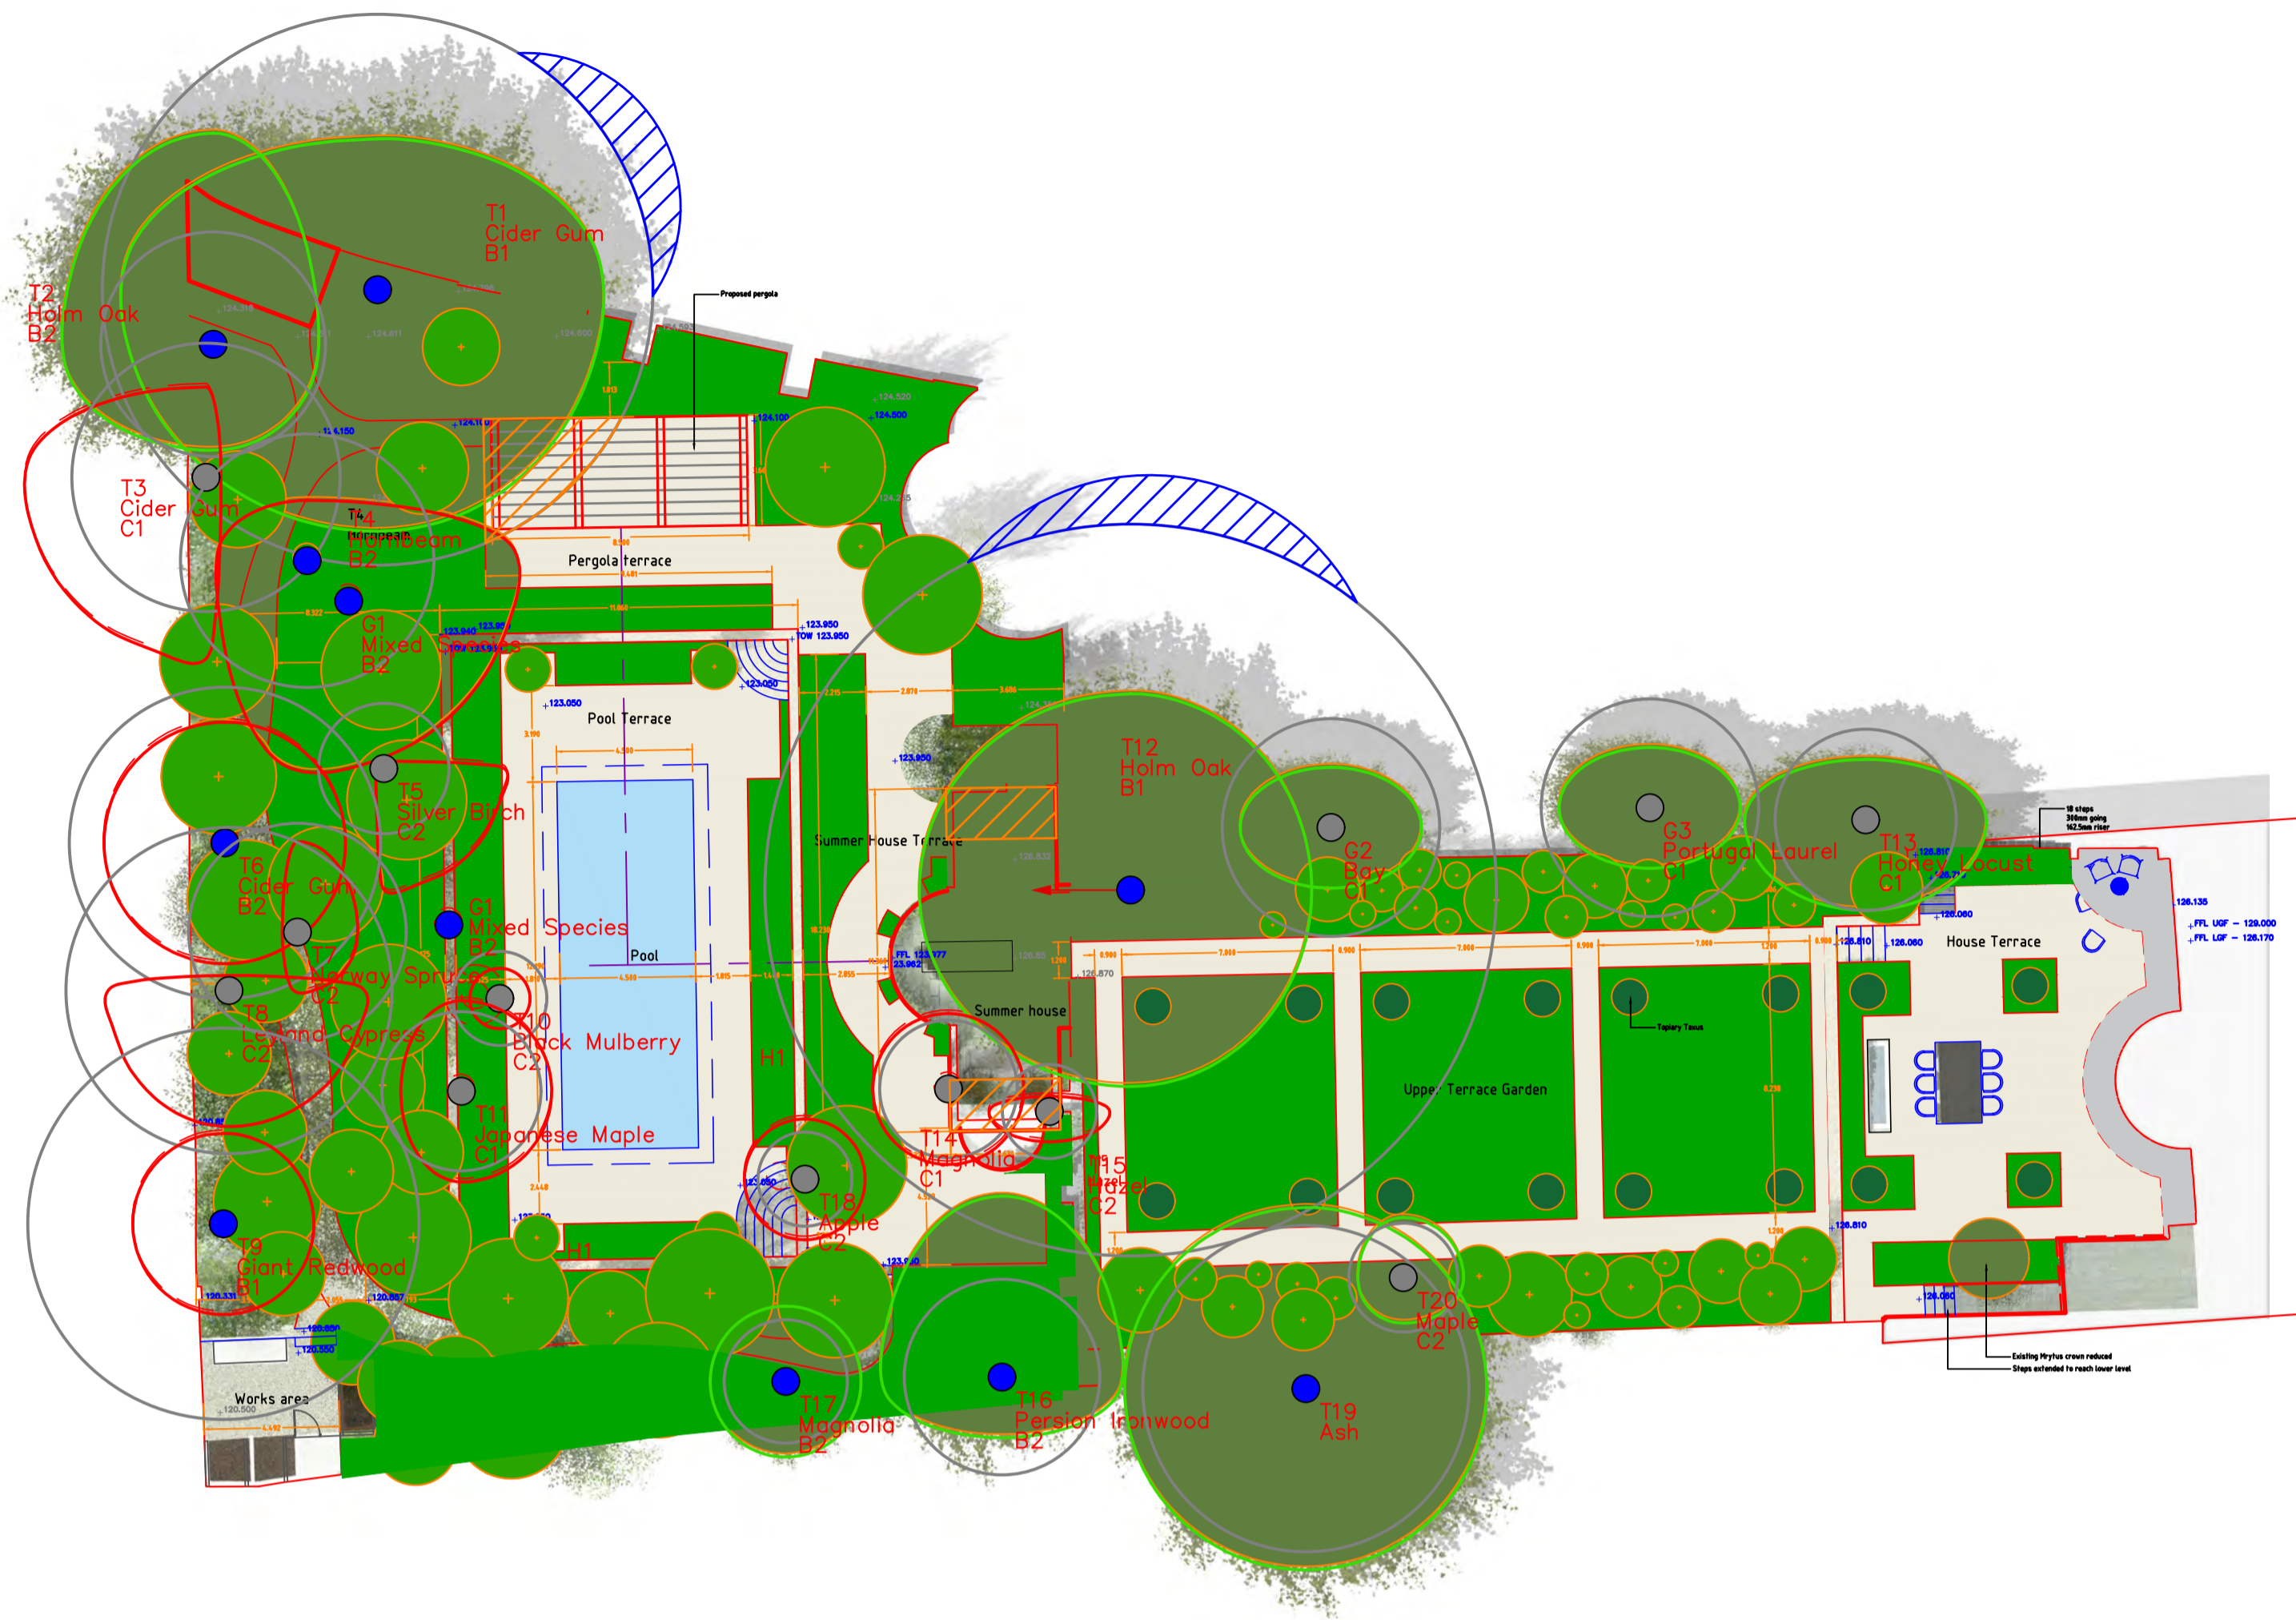
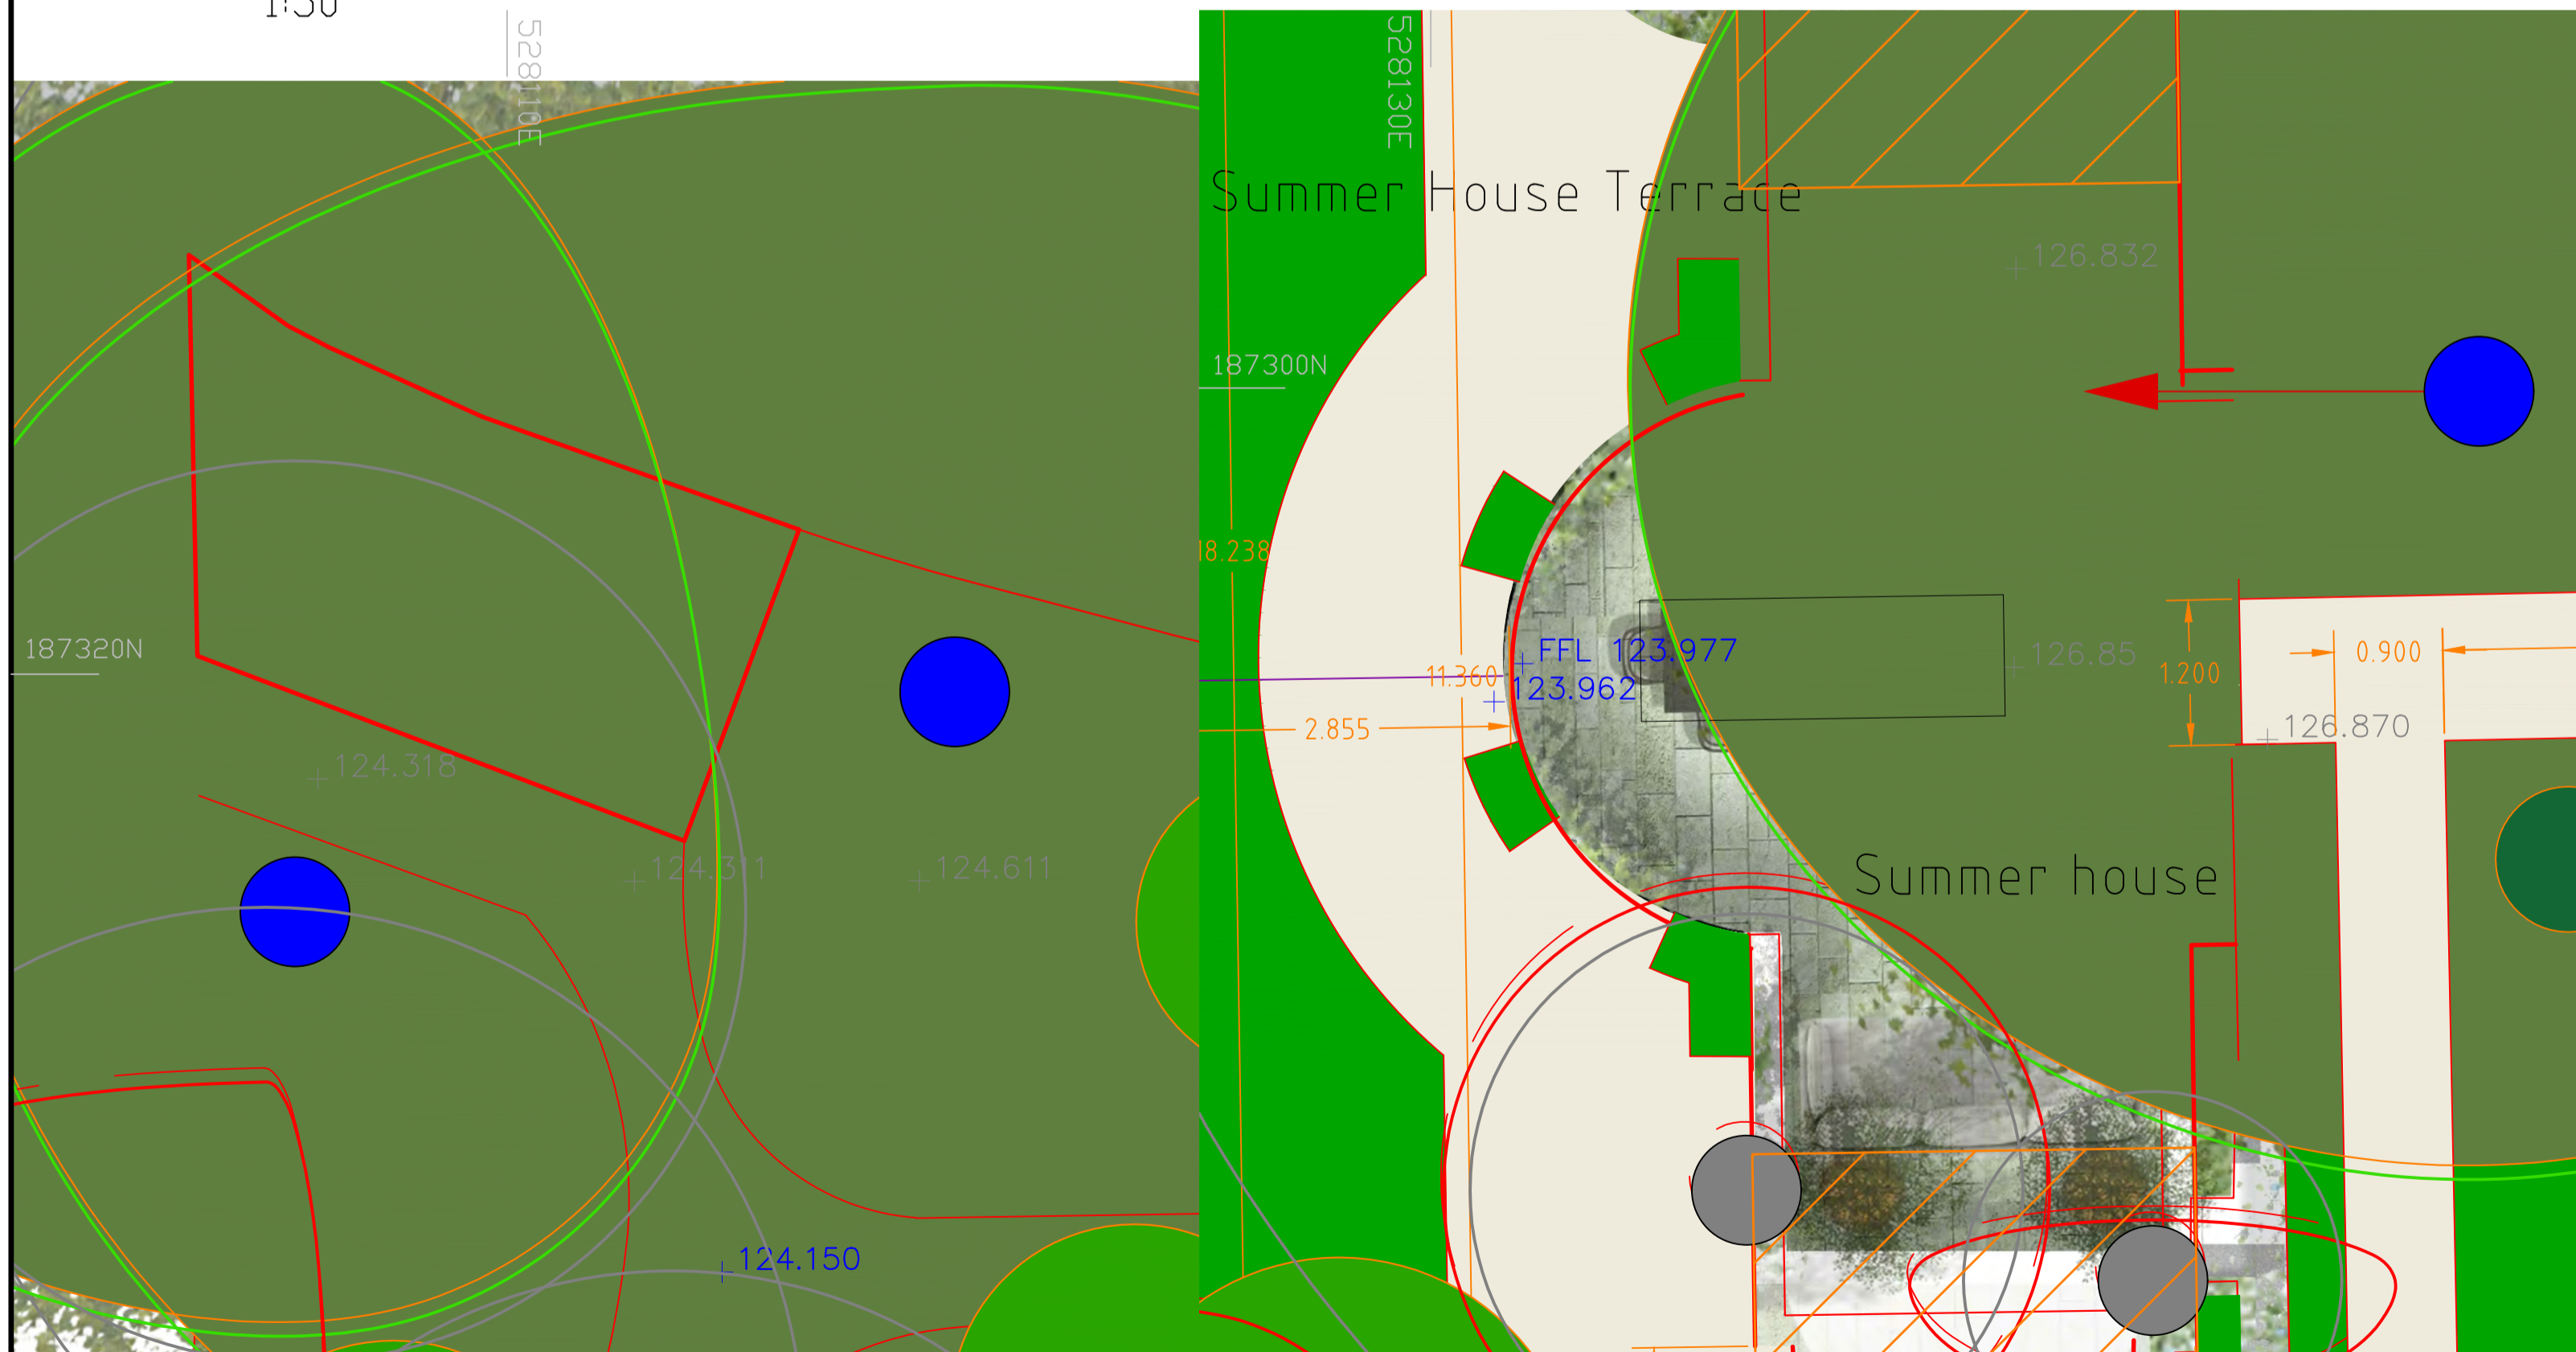
ARBORICULTURAL IMPACT ASSESSMENT PLAN (S)

- 6.1.8 As per BS5837 recommendations (at 5.3.a), the above assessment demonstrates that the tree(s) can remain viable and as per the equivalent hatching in Plan 2 of the Appendices that the area(s) lost to encroachment can be compensated for elsewhere. The guide also recommends (at 5.3.b) the arboriculturalist propose a series of mitigation measures (to improve the soil environment that is used by the tree for growth). These are provided at 6.3 below.
