Design and Access Statement

Drawing No: 052/2-DAS-00
Date: August 2021
Revision: -

Project: 125 Albert Street

125 Albert Street
Camden Town
London NW1 7NB

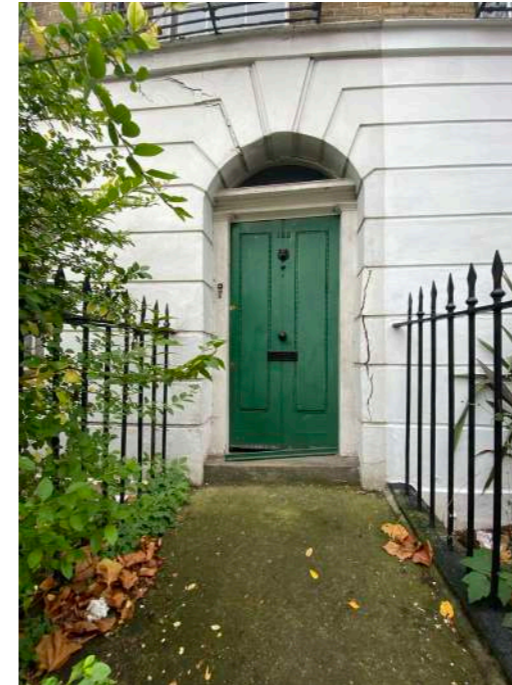
125 Albert Street is an early Victorian 3 storey mid terrace property, with brick and stucco. The brick to the front elevation is pitted, which may be from abrasive work to remove previous paintwork. There are substantial cracks to the stucco and there is visually apparent movement at the door arch, threshold, window lintels and cills. There have been a number of alterations to the property, including rebuilding of partial front and rear elevations, re-built outrigger and internal reconfiguration to ground and second floor. The original plan form to the main building has predominantly been retained. The building is north-east facing on a long narrow plot. 125 Albert Street was built circa 1845 as part of 9 properties from 123 - 139 Albert Street. The Jewish Museum has amalgamated no. 129-131.

Existing Entrance and Stucco showing cracking

The cracked stucco to the front elevation will be made good.

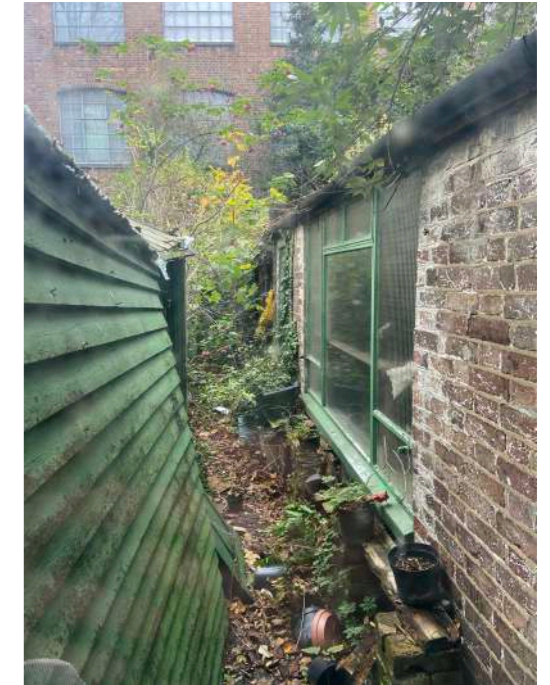
Existing C20 Outrigger and Timber Outbuilding

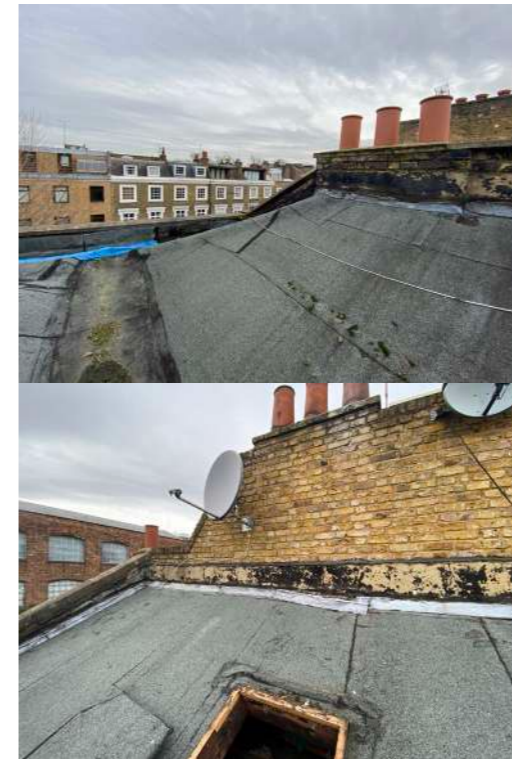
The roof has felt burnt onto slate with failing lead and felt upstands and gutters, which has been the origin of significant historic water damage to the inside of the building.

Existing Felt Roof

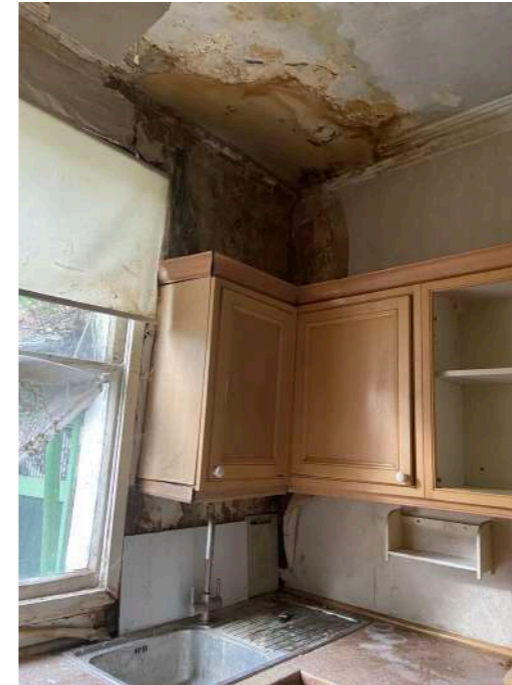
Existing Ground Floor cornice and historic water damage

There is original cornicing present to the ground and first floor hall and reception rooms, which will be retained and restored by a plaster specialist. There are a number of areas which have significant damage from historic water damage, flues, pipes, etc.. where cornicing is missing, replica cornicing will be applied using traditional materials.

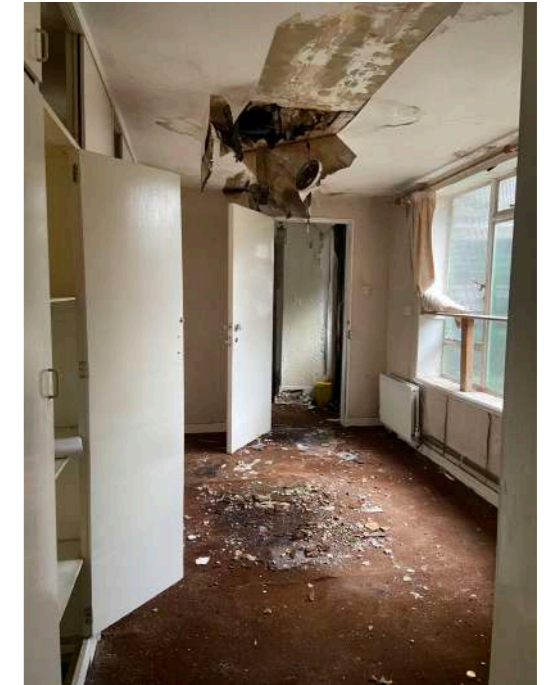
Existing C20 Outrigger

The rear ground floor extension will replace the existing C20 outrigger. The materials proposed are sympathetic to the original building, whilst providing a clear distinction between the original and proposed. The addition replacing the existing outrigger will be mainly brick with traditional style windows. The line of this element will be more in line with the original outrigger prior to the new boundary lines being established. More information on the change in boundary lines can be found within the Heritage Statement. The element of extension adjacent to the outrigger will be more transparent through the use of a large glazed door and fully glazed roof. The scale of this area is also reduced to ensure it is subservient to the "outrigger" element of the extension. The original brick work to the rear elevation will be cleaned, repointed and expressed within the proposed internal space. The extension will house the kitchen, re-establishing the original location of the kitchen. Modest modifications to the original building to allow access to the extension are proposed. The rear window cill will be lowered to allow access to the reinstaed kitchen location, with the nibs of the cills retained to express the original window opening.

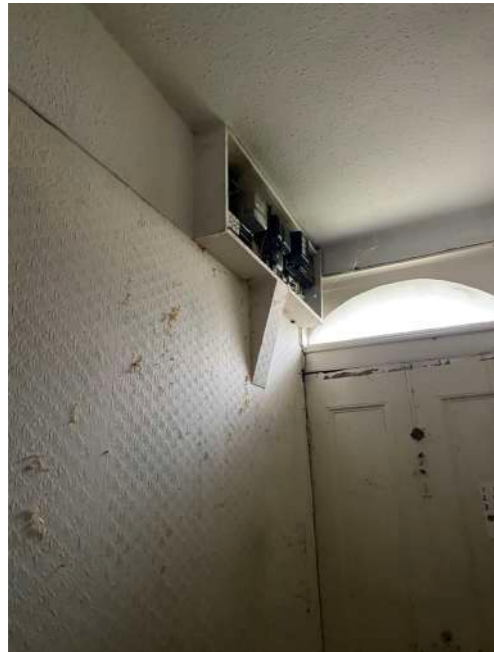
Hallway - showing timber door and fanlight. Note, no cornice to Hallway

There is no cornicing to the entrance hallway. A new cornice, in keeping with the period of the property, is proposed to the front area of Hallway, defined by the downstand. The existing floor slopes to the doorway, the existing floorboards will be lifted and the existing joists inspected with additional joists installed to level the floor. The existing floorboards will be reinstated following remedial works. The floor to the hallway will be finished with encaustic tiles, in keeping with the period of the property. The original opening between Hallway and front Living Room will be reinstated.

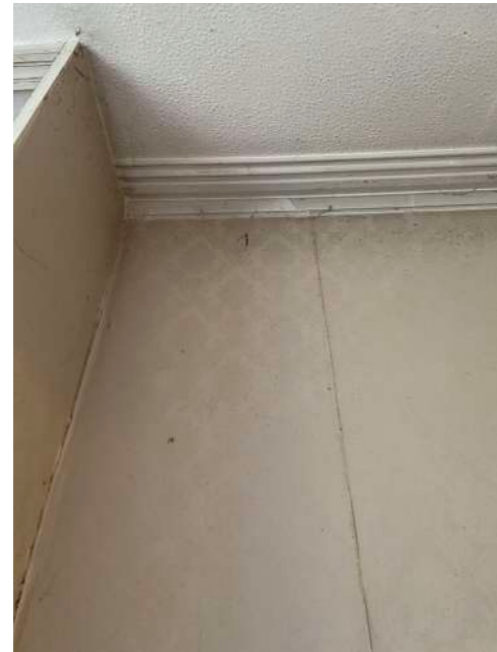
Front Reception Room - cornice and existing in-built joinery cutting through cornice

The cornice to the front Living Room is in relatively good condition and will be protected during works and re-decorated. There is some in-built floor to ceiling joinery to the alcoves on both sides of the chimney breast. The joinery will be removed to reinstate the original proportions of the room, any remedial works to the cornice will be undertaken to these areas. The floor to this area slopes to the front of the property. The floorboards will be lifted and the existing joists inspected to identify the issue, additional joists will be added to the floor void to re-level the floor where required. All existing floorboards will be reinstated and a floating timber floor will be installed over. The existing reproduction window will be replaced with a new timber sash single glazed window with detailing of the correct period.

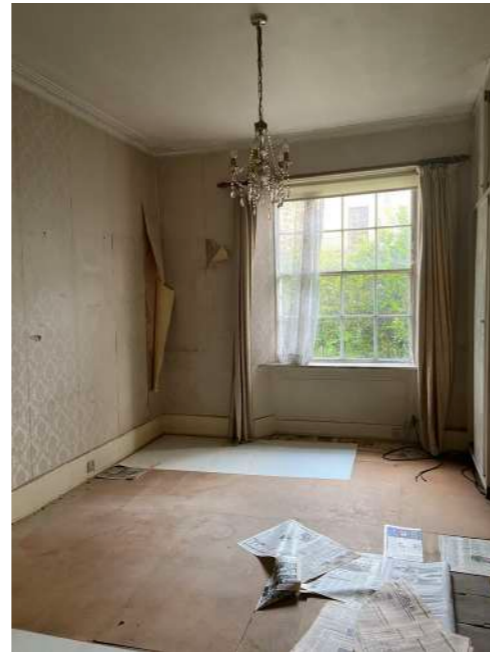
Front Reception Room - significant sloping floor, replacement windows and original doorway

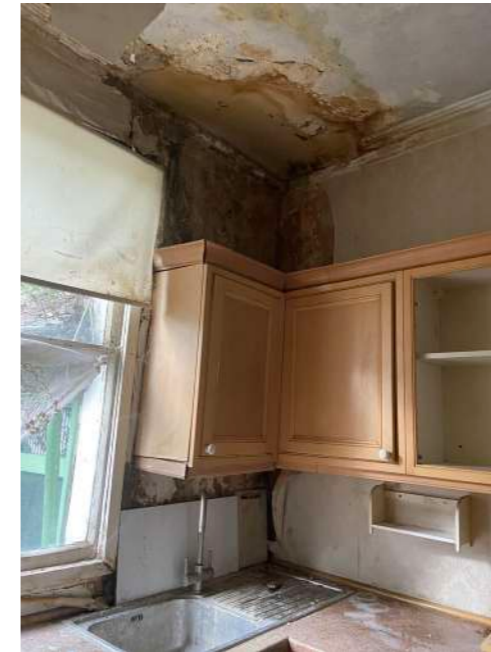
Rear Reception Room - significant damage to existing cornice from historical water damage

The rear room, currently housing the kitchen has an original cornice, the majority of which is in relatively good condition. There is significant damage to the cornice to the rear elevation from historic water damage and also installation of a boiler. A plaster specialist will be engaged with to undertake remedial works and reproduce cornice to the missing areas. The existing kitchen units will be removed and the original proportions of the room returned. The floorboards will be lifted and the existing joists inspected, additional joists will be added to the floor void, if required. All existing floorboards will be reinstated and a floating timber floor will be installed over.

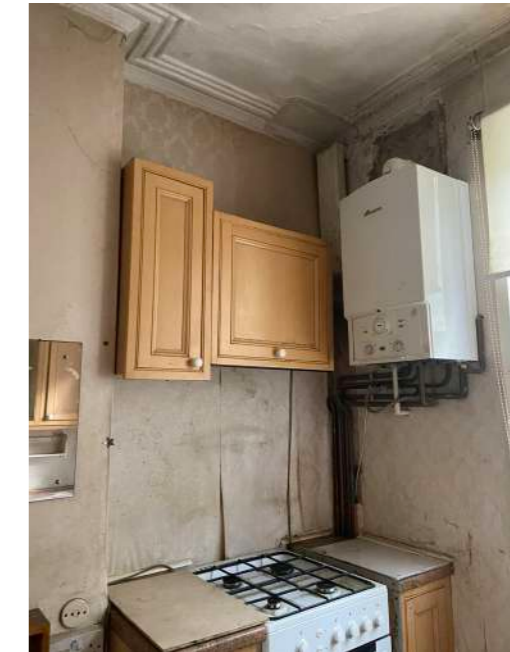
Rear Reception Room - significant damage to existing cornice, pipework and boiler/flue outlets

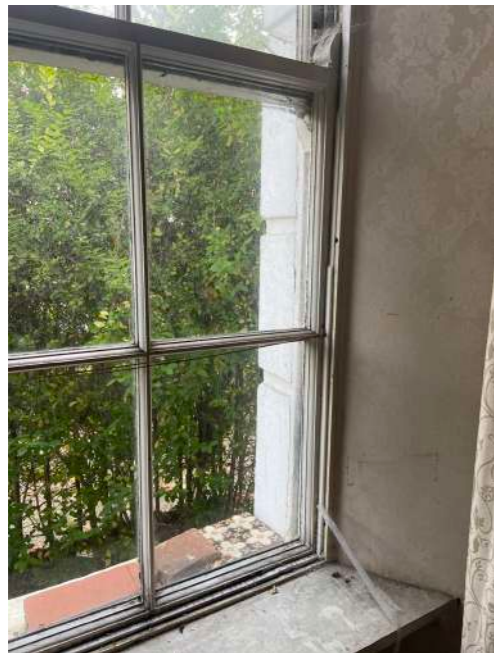
Front Reception Room - single glazed replacement sash windows, style not in keeping with property period

It is proposed to replace the all reproduction timber sash windows with new single glazed timber sash windows, with detailing which reflects the building period. Detailing will match the original sash window present on the first floor landing.

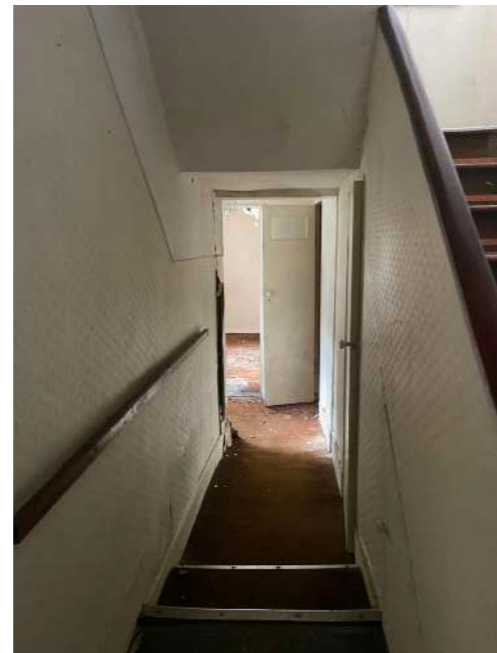
Hallway/Stairs - Original stairs with boarding to handrails, to be returned to original detail

The original staircase will be refurbished, including the removal of the existing boarding to both sides of the balusters. It is assumed the original balusters are present underneath the existing panelling, any missing balusters will be replaced with like for like.

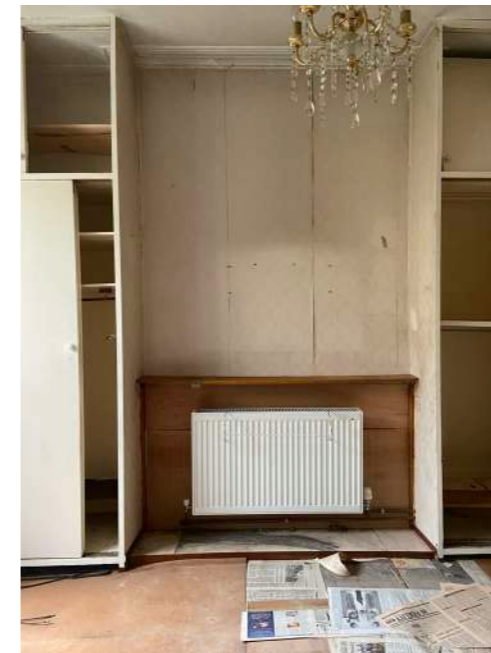
Front Reception Room - showing in-built joinery, chimney breasts present to all main rooms, no fireplaces present

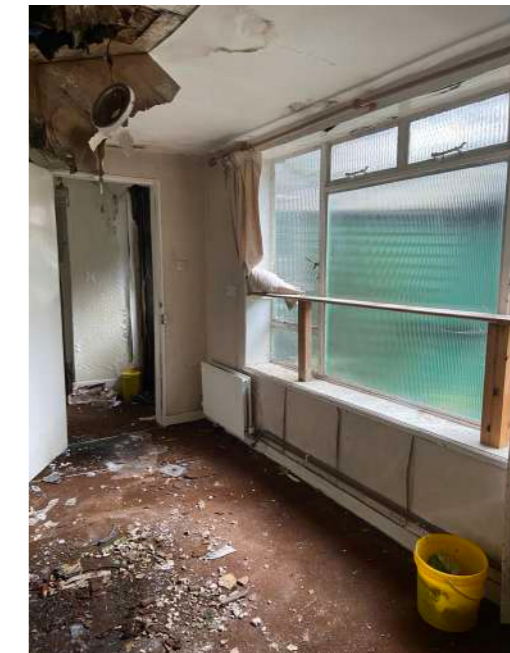
Outrigger - 20th Century Outrigger in complete disrepair

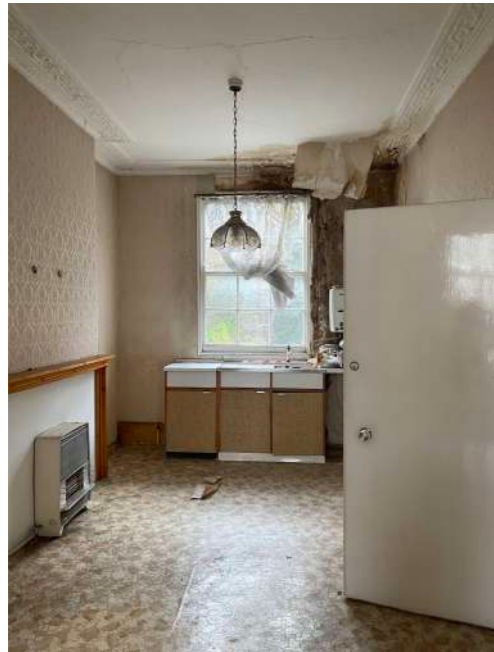
Rear Room - damaged cornice from historic water damage, original doors overlaid and chimney

To the rear room, a new shower/washroom will be located, which will be completely reversible. The room also enjoys its original cornice, the majority of which is in relatively good condition. There is significant damage to the cornice to the rear elevation from historic water damage. A plaster specialist will be engaged with to undertake remedial works and reproduce cornice to the missing areas. The floorboards will be lifted and the existing joists inspected to identify any issue, additional joists will be added to the floor void to re-level the floor where required. All existing floorboards will be reinstated and a floating timber floor will be installed over.

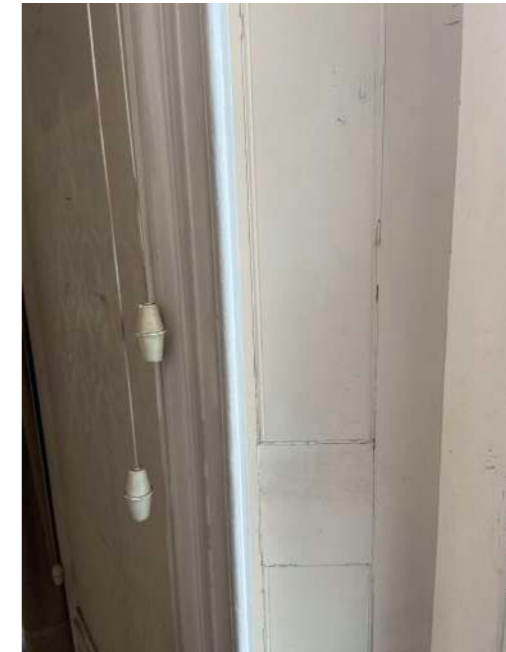
Front Room - original panelling and architrave to front windows - windows are replacement

The cornice to the front room is in relatively good condition and will be protected during works and redecorated. There is some in-built floor to ceiling joinery to the alcoves on both sides of the chimney breast. The joinery will be removed to reinstate the original proportions of the room, any remedial works to the cornice will be undertaken to these areas. The floor to this area slopes to the front of the property. The floorboards will be lifted and the existing joists inspected to identify any issue, additional joists will be added to the floor void to re-level the floor where required. All existing floorboards will be reinstated and a floating timber floor will be installed over. The existing reproduction window will be replaced with a new timber sash single glazed window with detailing of the correct period. The original timber panel door and architrave to the room will be made-good and re-decorated. The original concertina doors and architraves between the main rooms will also be made-good and redecorated. The existing concertina doors will be operational and will work with the proposed layout. The original window panelling and window architrave will be retained, protected, made-good where required and redecorated.

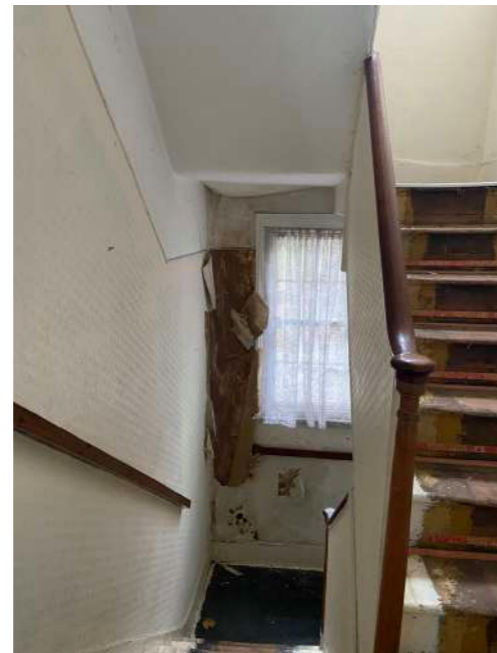
First Floor Landing - looking down to original window. Original stairs with cladding to balusters

To the first floor landing the only original sash window is located, though the glass appears to be replacement. This window and opening will be inspected, protected with any remedial works undertaken. The stair balusters will be reinstated with the cladding over removed and any remedial works required undertaken.

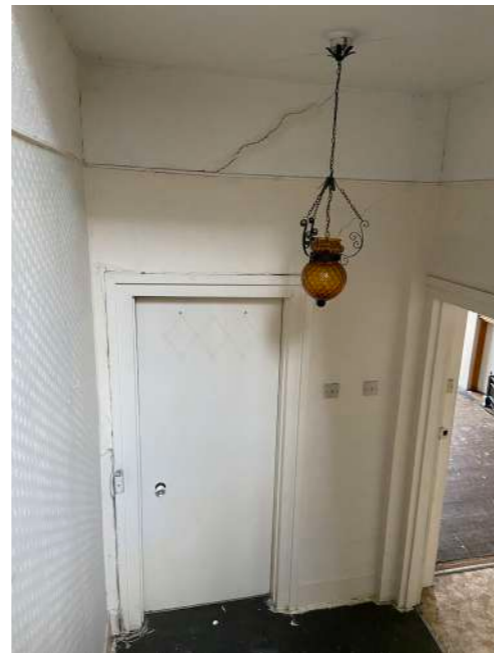
First Floor Landing - looking down to first floor level, significant cracking apparent

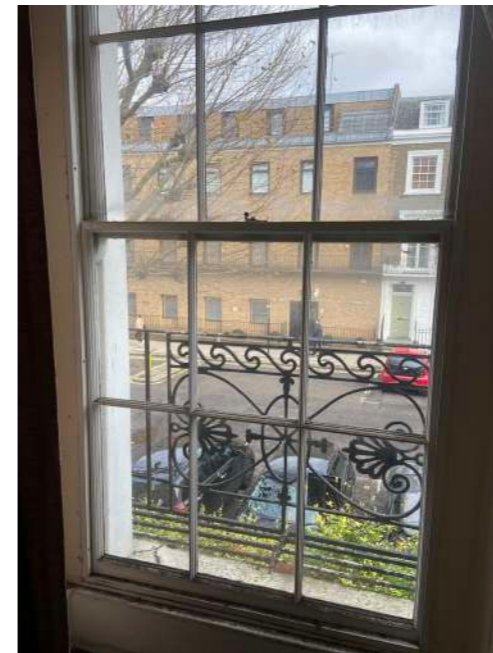
Front Room - showing replacement windows and external balconies

It is proposed to replace the front and rear reproduction timber sash windows with new single glazed timber sash windows, with detailing which reflects the building period.

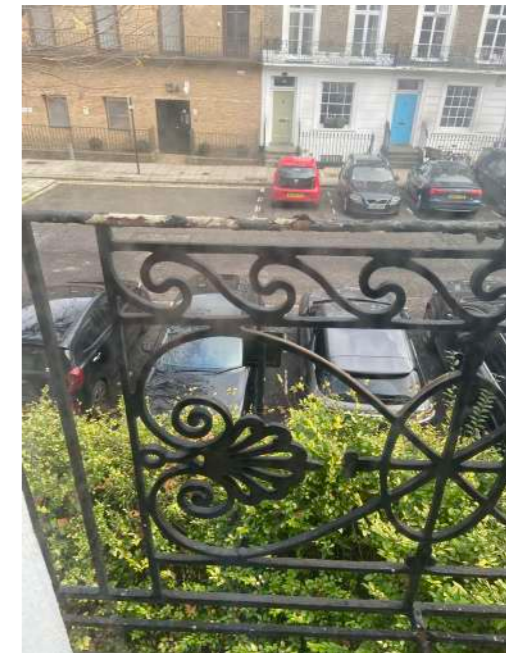
Front Room - view out to metal balconies requiring repair and making good

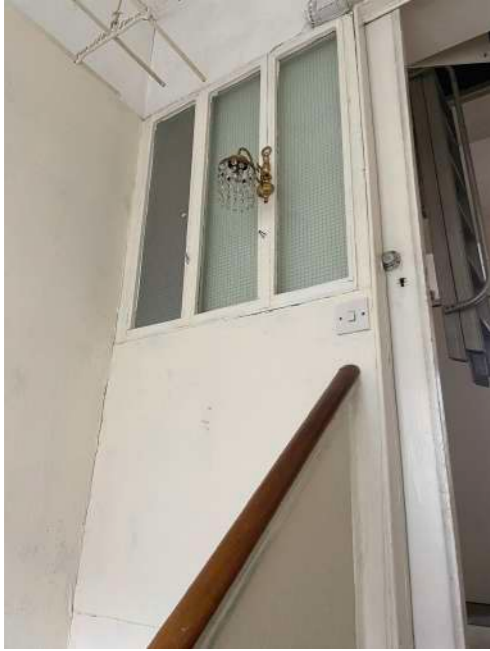
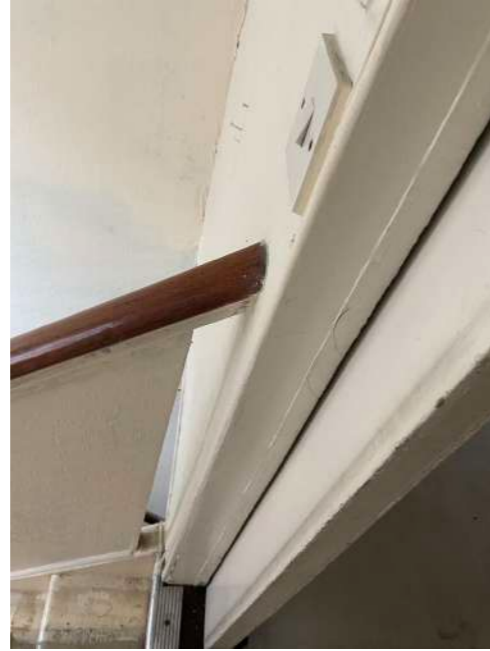
Stairs/Landing - looking up to Second Floor, original handrail removed to allow for partition

The stair balusters will be reinstated with the cladding over removed and any remedial works required undertaken. As stated in Section 3, the return balustrade has been removed to make way for the glazed and solid partition which has installed to create an inner room. It is proposed to remove this partition and create a new staircase to lead to the proposed mansard roof extension over. This stairs will be fully enclosed and in a more modern style to indicate the modern intervention.

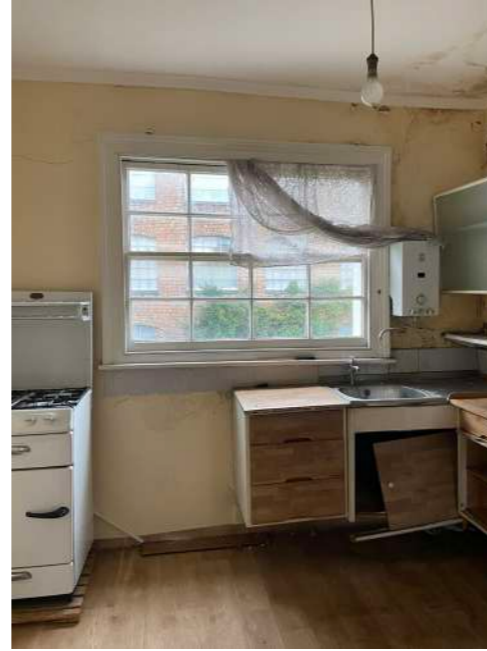
Rear Room - view to rear showing rebuilt facade and window and water damage to ceiling

The window openings to the rear will be modified to reflect the original sizes. It is proposed to replace the front and rear reproduction timber sash windows with new single glazed timber sash windows, with detailing which reflects the building period.

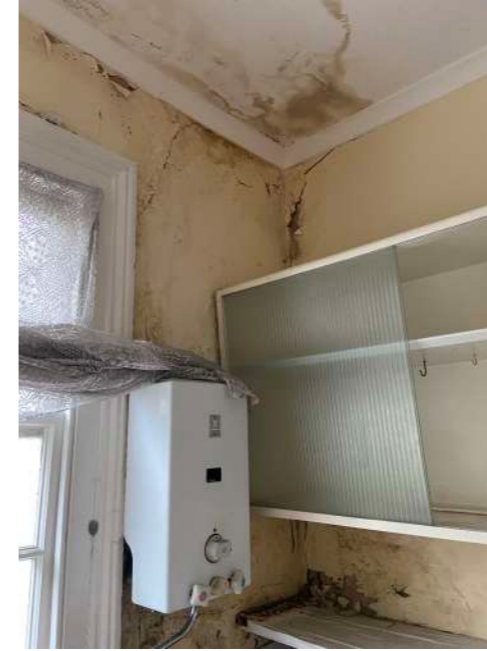
Rear Room - view to rear showing water damage to ceiling and modern cornice

Modern, low-grade cornicing is present in both rooms. These will be removed. The floorboards will be lifted and the existing joists inspected to identify any issue, additional joists will be added to the floor void, where required. All existing floorboards will be reinstated and a floating timber floor will be installed over.

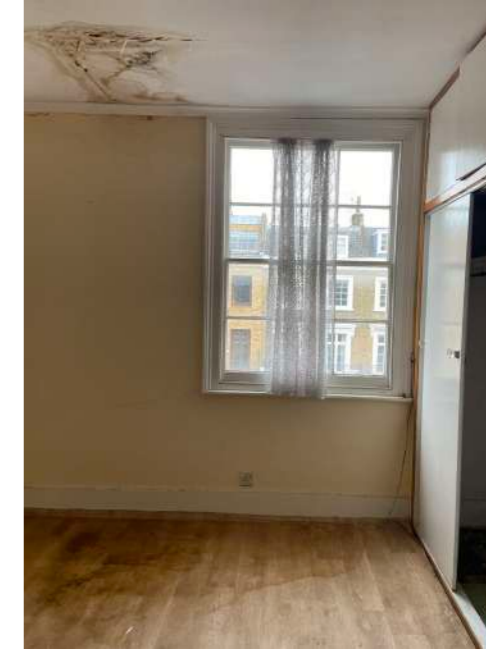
Front Room - view to front, showing water damage and modern cornice

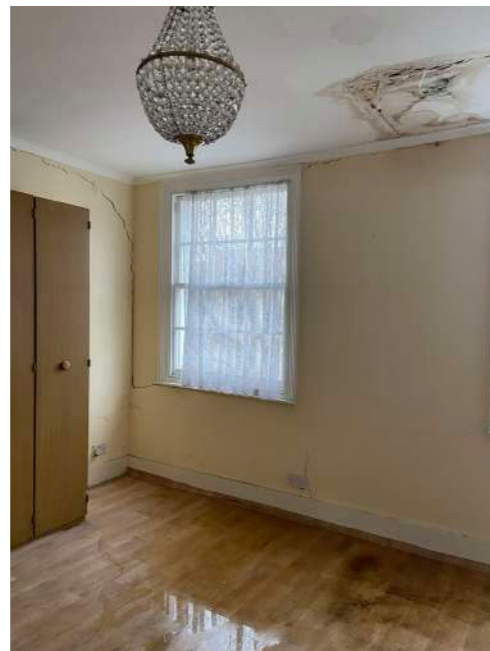
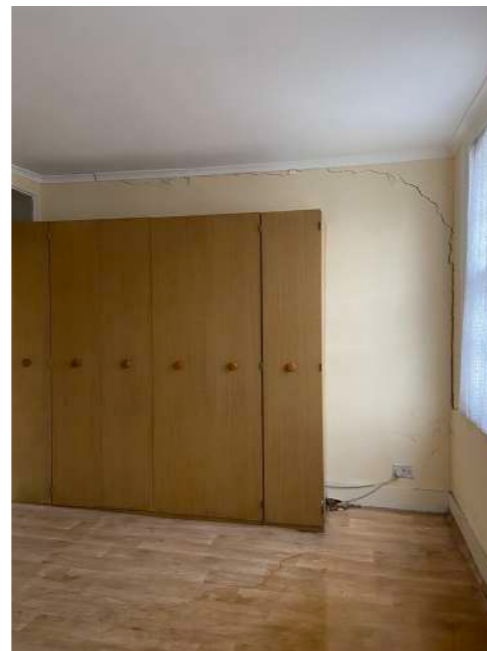
Front Room - showing significant cracking, adjacent to No. 127 Albert Street

Front Room - showing significant cracking, adjacent to No. 127 Albert Street and historic water

Front Room - showing significant cracking, adj. to No. 127 Albert Street and historic water damage and partition to left hand side

The inner room will be removed and the original room proportions to the front room returned. There is evidence of historical water damage to the ceilings and floor. This is from a failing, inadequate felt roof, failing lead guttering and flashings and blocked rear gutter. There is also cracking evident to the front elevation/party wall which will be inspected and remedied during the works.

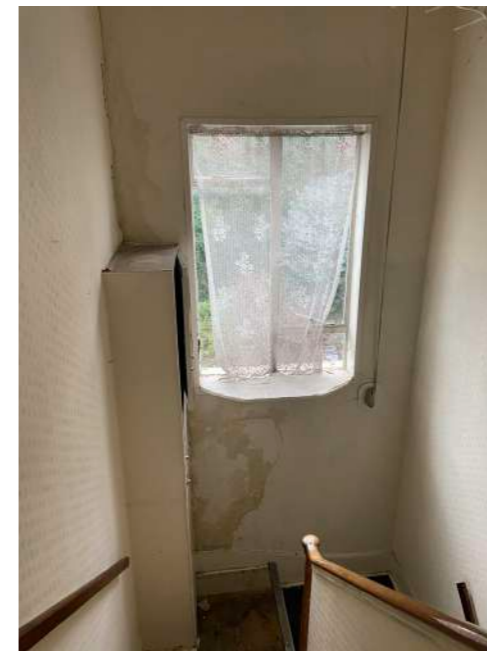
Stairs - looking down to 20th Century metal window and cupboard

The second floor landing window is a metal frame casement window in an opening which does not relate to the period of the property and with a concrete lintel. This will be replaced with a traditional style sash window with single glazing to match the period of the property and the original window to the landing below.

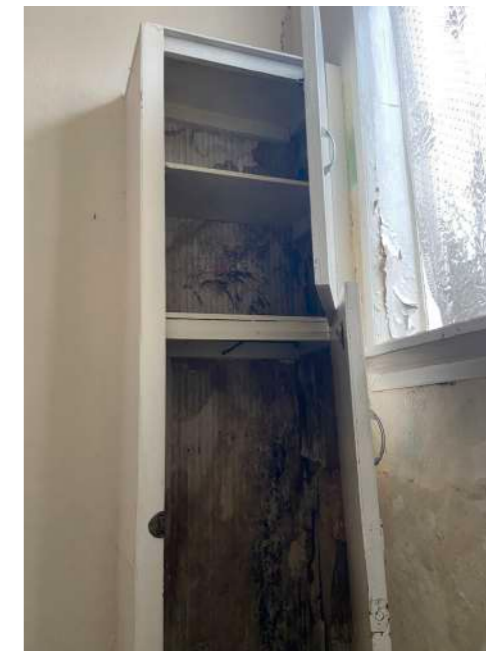
Stairs - later addition cupboard to stair return, showing historic water damage
