# MORS+HARTE ARCHITECTS

## Design and Access Statement

Drawing No: 052/1-DAS-00  
Date: August 2021  
Revision: -

**Project: 125 Albert Street**

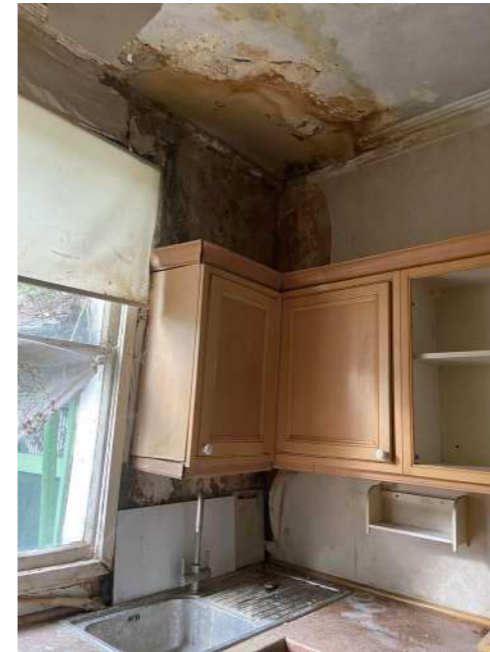
*Rear Reception Room - significant damage to existing cornice from historical water damage*

The rear room, currently housing the kitchen has an original cornice, the majority of which is in relatively good condition. There is significant damage to the cornice to the rear elevation from historic water damage and also installation of a boiler. A plaster specialist will be engaged with to undertake remedial works and reproduce cornice to the missing areas. The existing kitchen units will be removed and the original proportions of the room returned. The floorboards will be lifted and the existing joists inspected, additional joists will be added to the floor void, if required. All existing floorboards will be reinstated and a floating timber floor will be installed over.

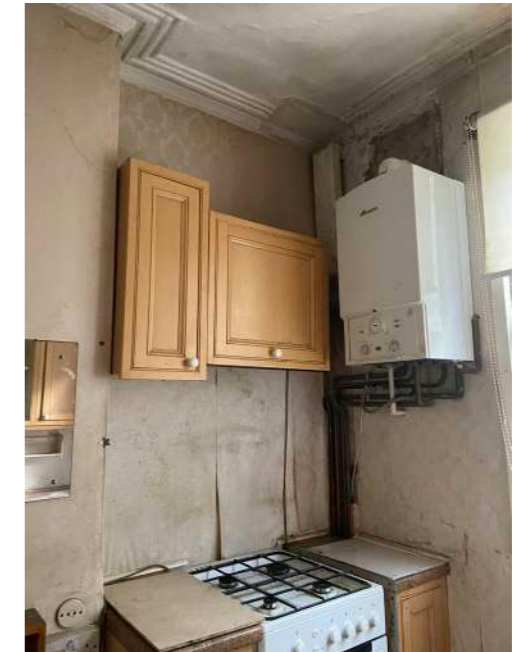
*Rear Reception Room - significant damage to existing cornice, pipework and boiler/flue outlets*

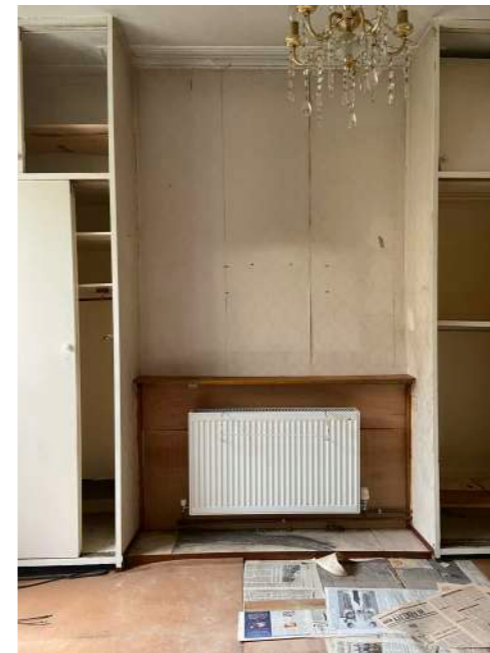
*Front Reception Room - showing in-built joinery, chimney breasts present to all main rooms, no fireplaces present*

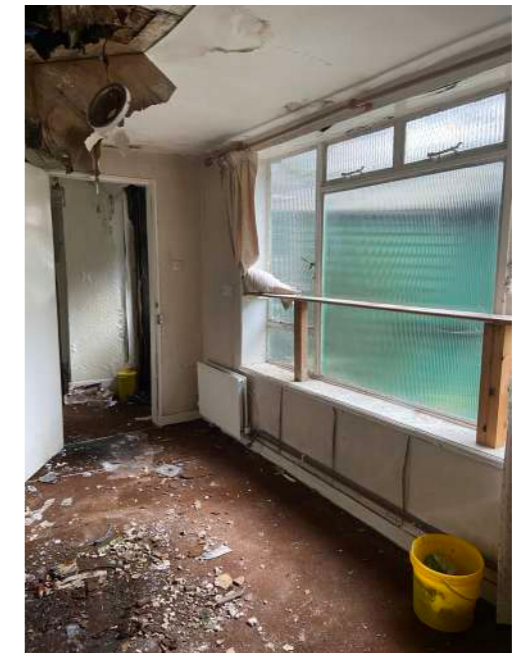
*Outrigger - 20th Century Outrigger in complete disrepair*

The rear ground floor extension will replace the existing C20 outrigger. The materials proposed are sympathetic to the original building, whilst providing a clear distinction between the original and proposed. The addition replacing the existing outrigger will be mainly brick with traditional style windows. The line of this element will be more in line with the original outrigger prior to the new boundary lines being established. More information on the change in boundary lines can be found within the Heritage Statement. The element of extension adjacent to the outrigger will be more transparent through the use of a large glazed door and fully glazed roof. The scale of this area is also reduced to ensure it is subservient to the "outrigger" element of the extension. The original brick work to the rear elevation will be cleaned, repointed and expressed within the proposed internal space. The extension will house the kitchen, re-establishing the original location of the kitchen. Modest modifications to the original building to allow access to the extension are proposed. The rear window cill will be lowered to allow access to the reinstaed kitchen location, with the nibs of the cills retained to express the original window opening.

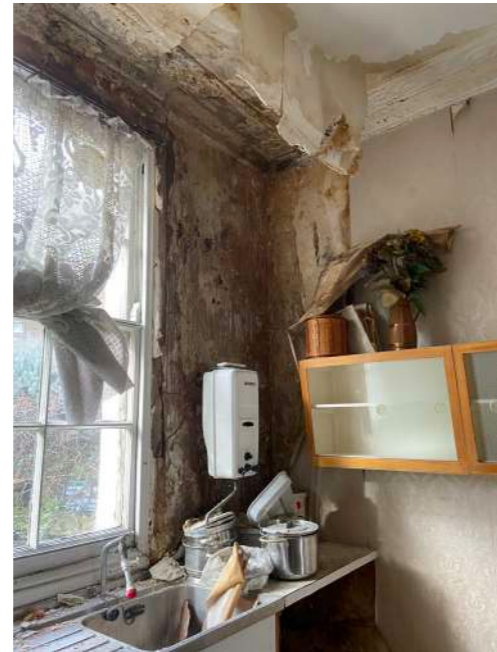
*Rear Room - damaged cornice from historic water damage*

To the rear room, a new shower/washroom will be located, which will be completely reversible. The room also enjoys its original cornice, the majority of which is in relatively good condition. There is significant damage to the cornice to the rear elevation from historic water damage. A plaster specialist will be engaged with to undertake remedial works and reproduce cornice to the missing areas. The floorboards will be lifted and the existing joists inspected to identify any issue, additional joists will be added to the floor void to re-level the floor where required. All existing floorboards will be reinstated and a floating timber floor will be installed over.

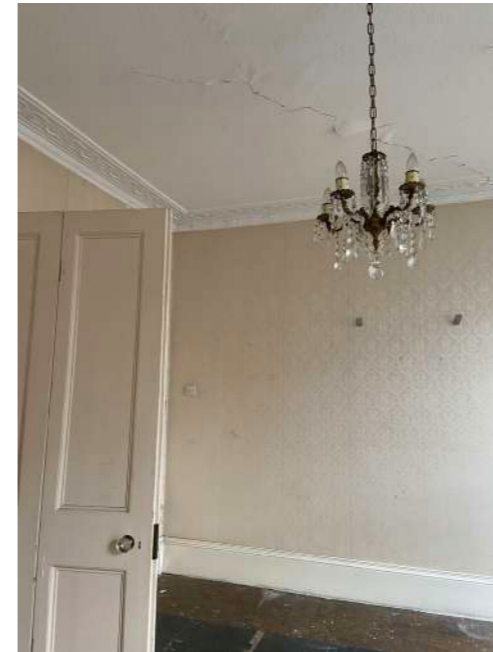
*Front Room - significant cracking to ceiling and sloping to floor*

All walls and ceilings have been covered with paper which shows signs of historical cracking. During the works all walls will be stripped of wall coverings and plaster inspected, with remedial works undertaken to remedy. All materials used will be in keeping with the existing materials.

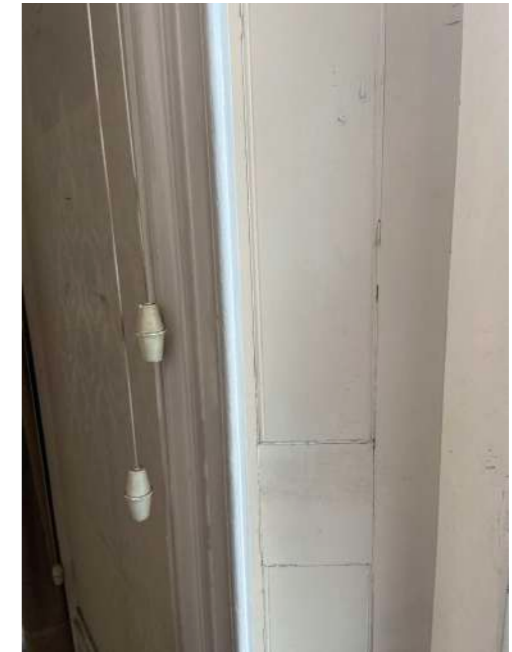
*Front Room - original panelling and architrave to front windows - windows are replacement*

It is proposed to replace the front and rear reproduction timber sash windows with new single glazed timber sash windows, with detailing which reflects the building period.

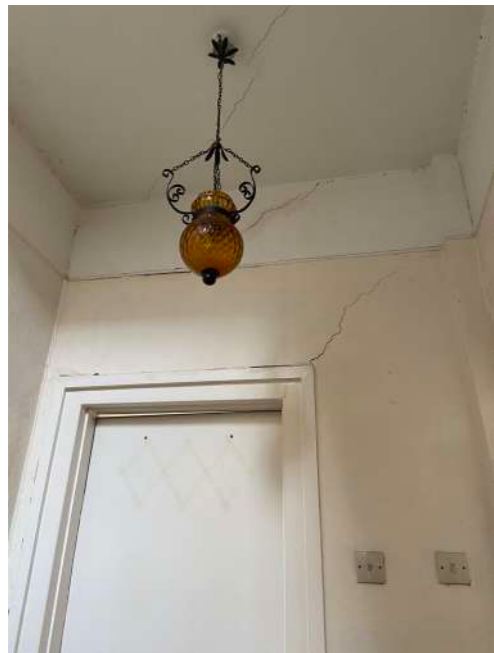
*First Floor Landing - significant cracking to walls and ceiling*

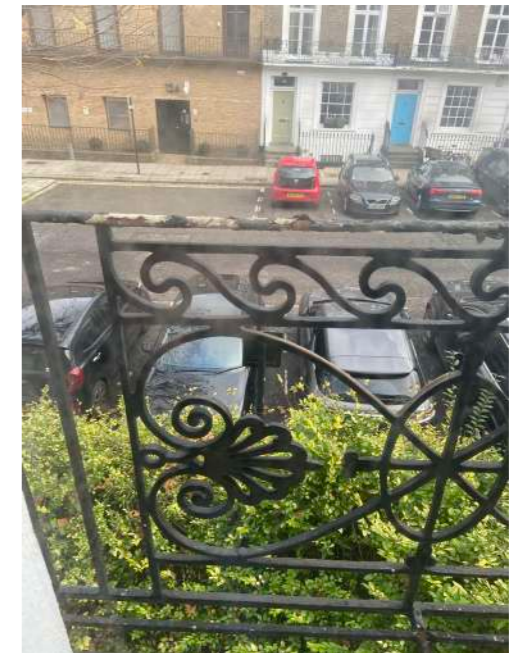
*Front Room - view out to metal balconies requiring repair and making good*

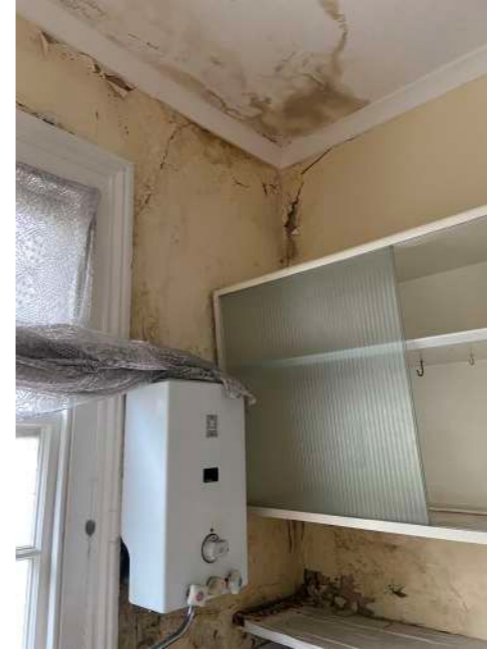
*Rear Room - view to rear showing water damage to ceiling and modern cornice*

Modern, low-grade corncicing is present in both rooms. These will be removed. The floorboards will be lifted and the existing joists inspected to identify any issue, additional joists will be added to the floor void, where required. All existing floorboards will be reinstated and a floating timber floor will be installed over.

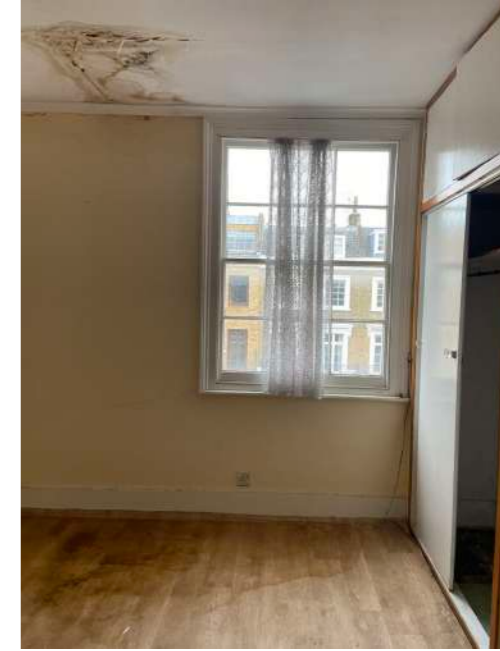
*Front Room - view to front, showing water damage and modern cornice*

The inner room will be removed and the original room proportions to the front room returned. There is evidence of historical water damage to the ceilings and floor. This is from a failing, inadequate felt roof, failing lead guttering and flashings and blocked rear gutter. There is also cracking evident to the front elevation/party wall which will be inspected and remedied during the works.

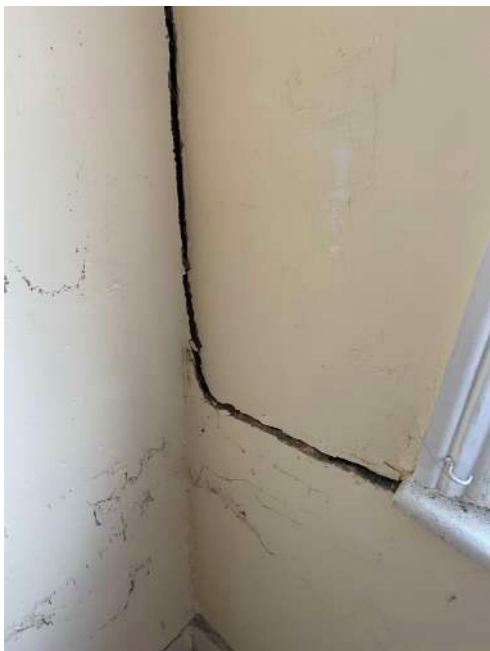
*Front Room - showing significant cracking, adjacent to No. 127 Albert Street*

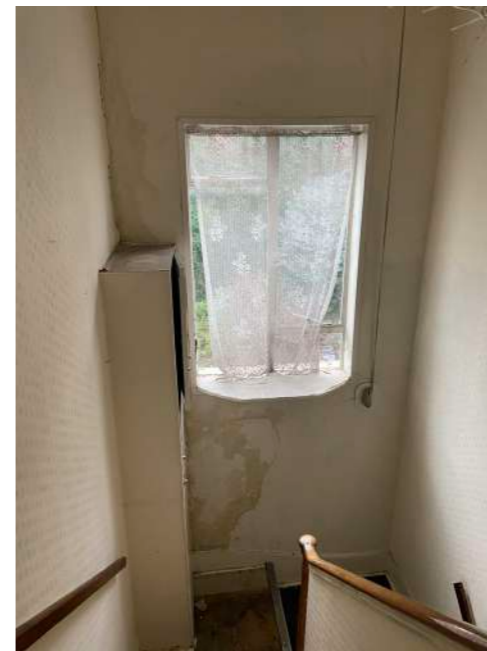
*Stairs - looking down to 20th Century metal window and cupboard*

The second floor landing window is a metal frame casement window in an opening which does not relate to the period of the property and with a concrete lintel. This will be replaced with a traditional style sash window with single glazing to match the period of the property and the original window to the landing below.

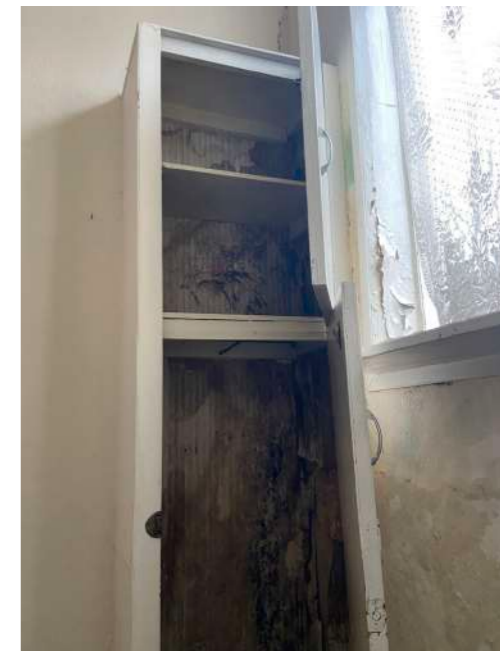
*Stairs - later addition cupboard to stair return, showing historic water damage*
