**Rosslyn Hill Unitarian Chapel  
3 Pilgrims Place  
London  
NW3 1NG**

**Proposed Renewal of Slate Roof Coverings &  
Miscellaneous External Repairs to the Church Building**

**Design & Access**

October 2021

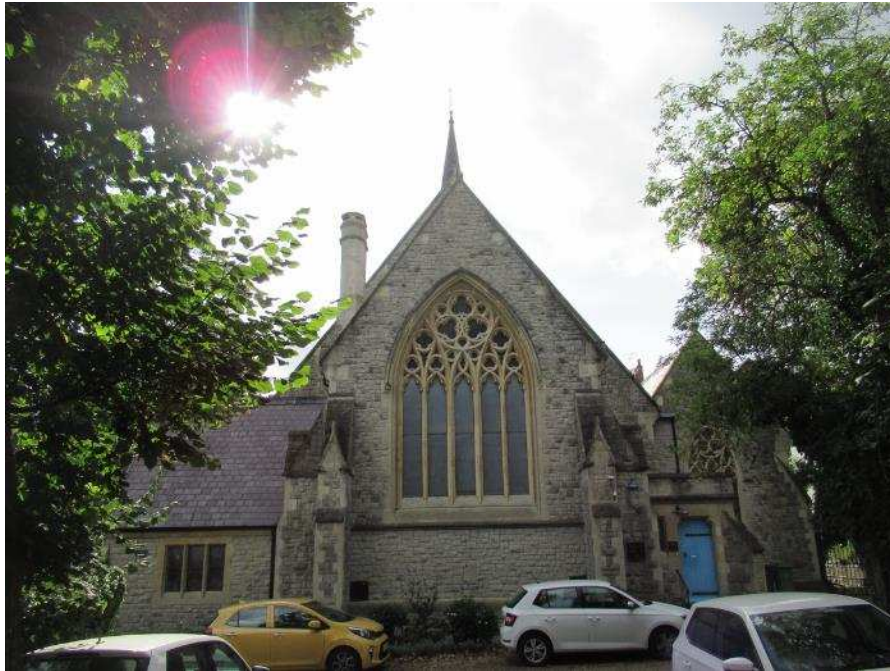
Photoplate 1 – View of east elevation

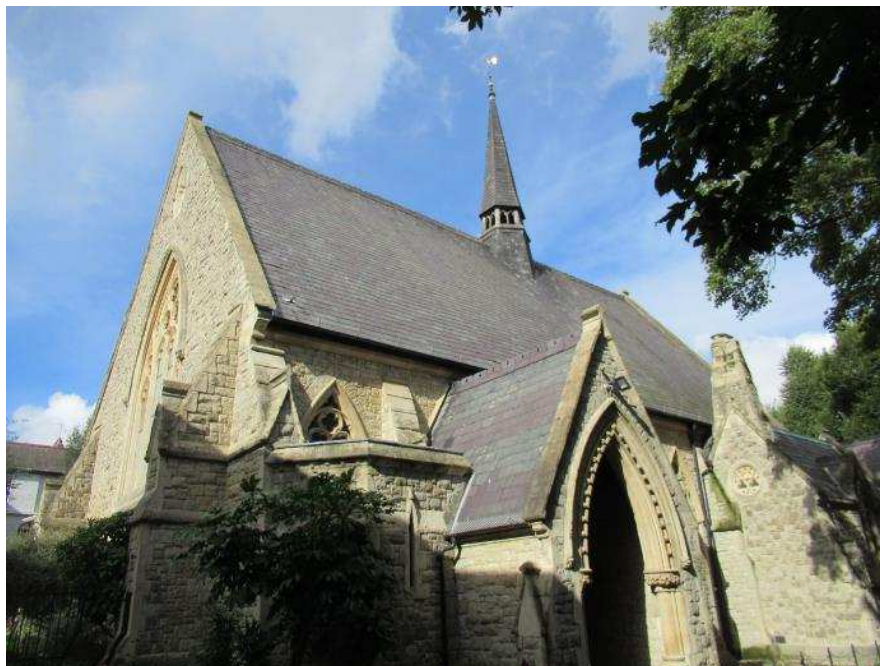
Photoplate 2 – View of south elevation, west end

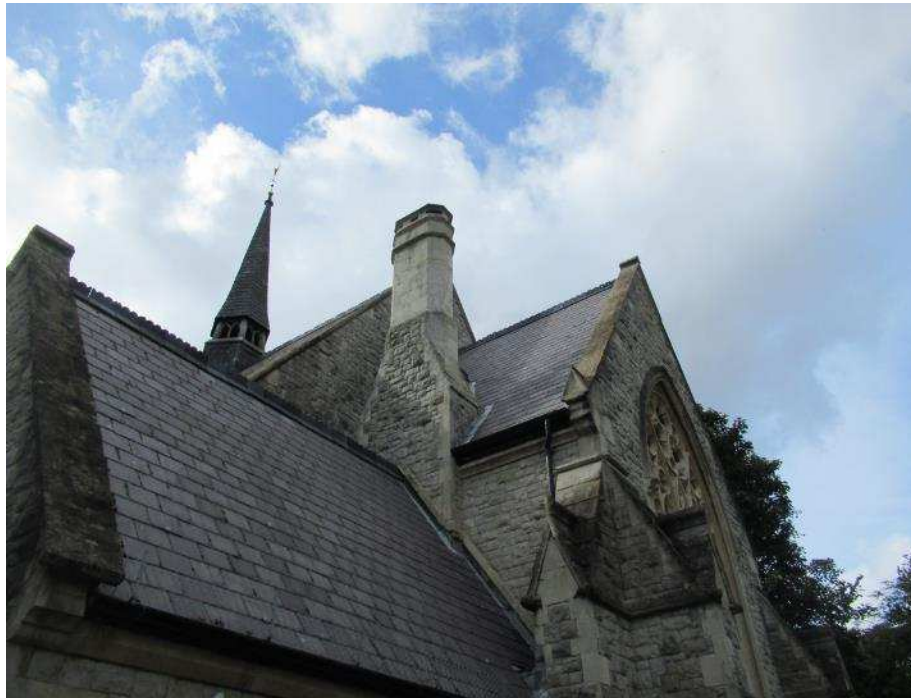
Photoplate 3 – View of south elevation, east end

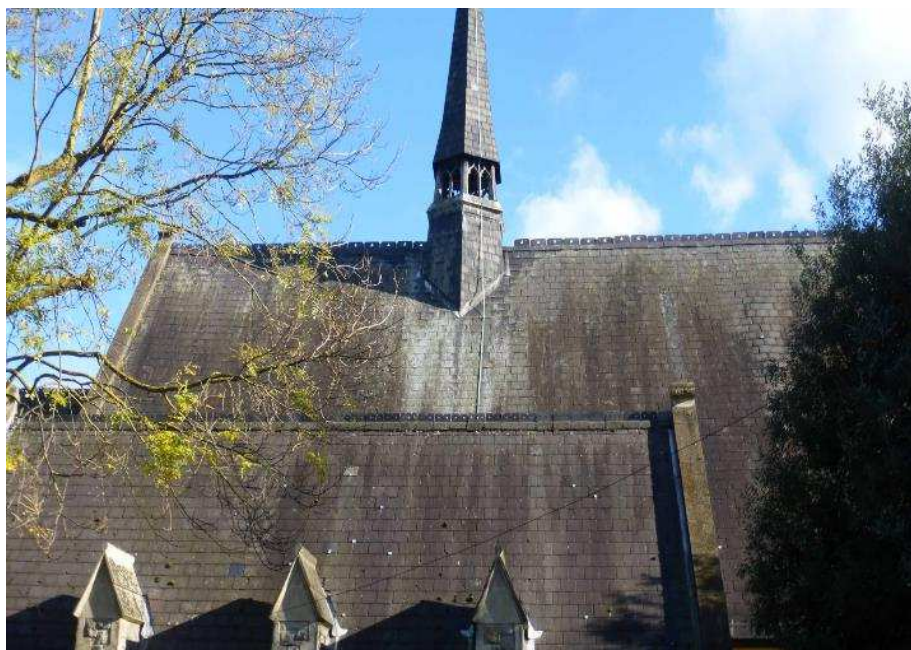
Photoplate 4 – View of north elevation roof slopes

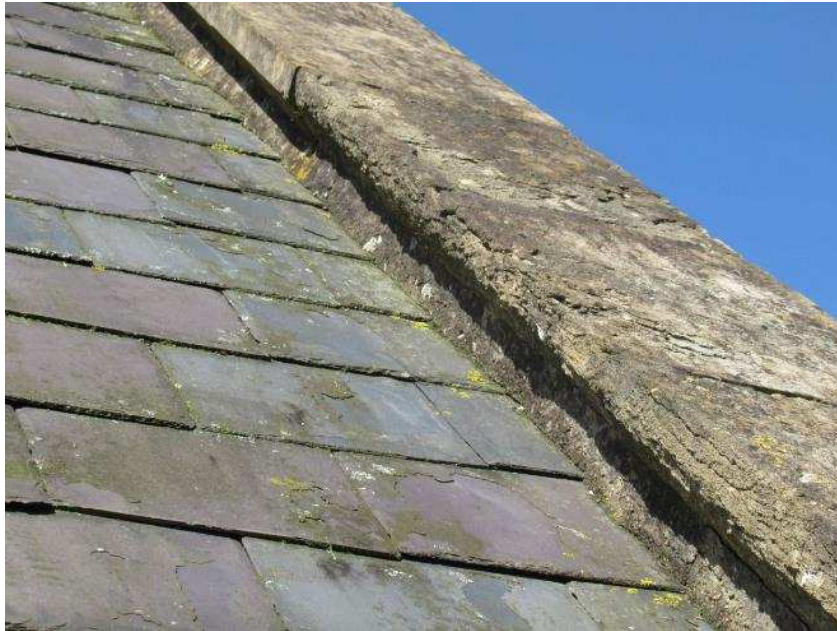
The east and west gables to the Nave roof are weathered with stone copings. The stones are in the main in good condition, however there are approximately 3 linear meters of heavily weathered and spalling stone with loss of profile to the drip detail to the east gable and approximately 2 linear meters of weathered stone with loss of profile to the drip detail to the west gable.

Following the survey, it was decided to apply for Listed Building Consent to replace the Nave and Chancel slate roof coverings, rather than continue with on-going water ingress issues and localised repairs, and to replace the defective stone copings with new Bath stone copings of matching detail and profile.

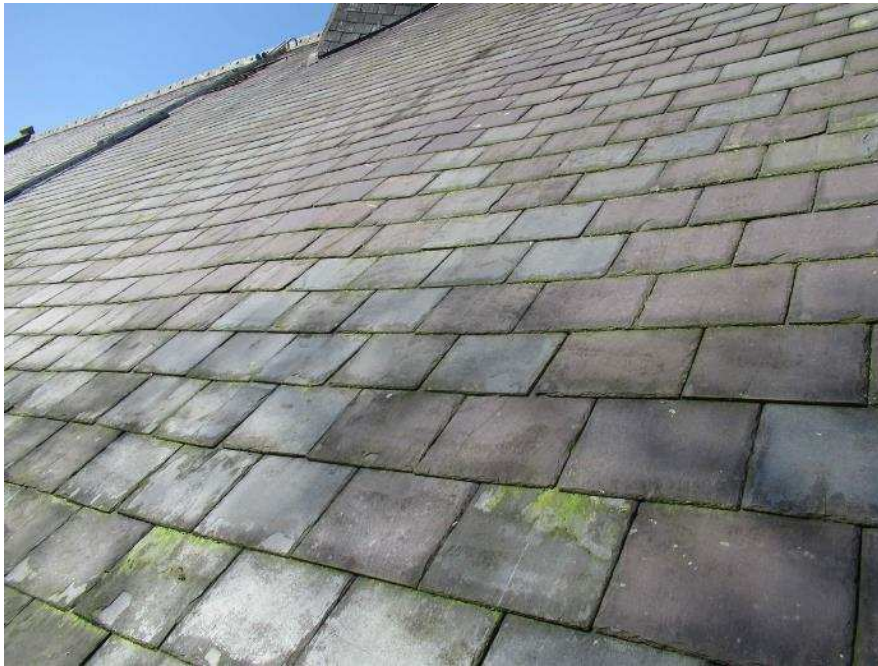
The existing slates are all natural and have a varied colouration of blue/grey and darker purple shad.

Photoplate 5 – View slate covering and variety of colours

The replacement slates are proposed as Cembrit Glendyne natural slate, of their best roofing slate specification, free from pyrite and metallic inclusions. The slates would be 508mm long x 254mm wide, and fixed with copper clout nails. These slates are of a blue/grey colour finish with vertical grain, as depicted on the image below.
