# KNAPP HICKS & PARTNERS LTD

37740A/L/001A/DALC/dalc  
4<sup>th</sup> November 2021

**RE: COMMUNAL STAIRCASE TO 4 HANDEL STREET, LONDON,  
WC1N 1PB.**

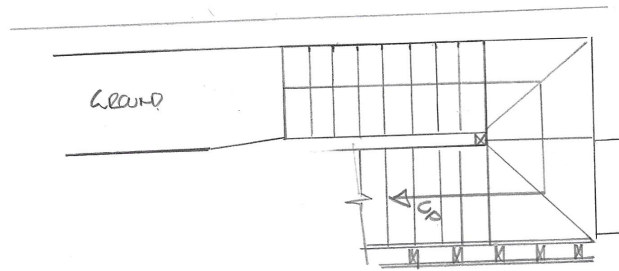
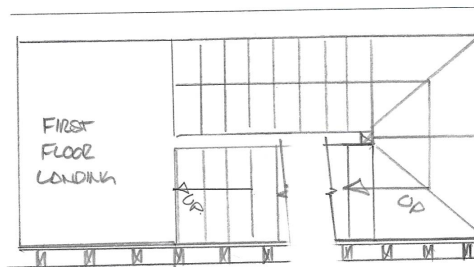
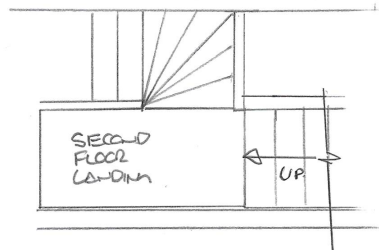
Arrangement of  
Stairs.  
4 Handel Street  
London

The staircase comprises four straight flights with 180 degree winders at half landing level. At the left and rear of the stairs the supporting walls were masonry. At the right side of the stairs there was a hollow sound when the wall was knocked suggesting timber stud construction.

It was possible to view the structure to the straight flights as the finishes to the underside of the flight from First Floor to Second Floor had been partially removed to carry out an asbestos survey. We viewed twin 100x50 stringers located below the treads. A basic arrangement has been sketched on the plan drawing appended to the report. At First and Second Floor, the stringers will be connected directly to the timber floor joist spanning across the landings. At the ends with the winder treads the support arrangement was not clear as the structure is completely obscured by the plaster finishes on the underside. The plaster finish on the underside of the winder treads is a complex helix shape, which would preclude any of the supporting elements being single straight lengths of timber spanning wall to wall. It is thought therefore that there may be either cantilever timber elements, or jointed sections providing support.
