BS5837 Arboricultural Report,

Arboricultural Impact Assessment

and Method Statement

2 Millfield Lane, London, N6 6JP

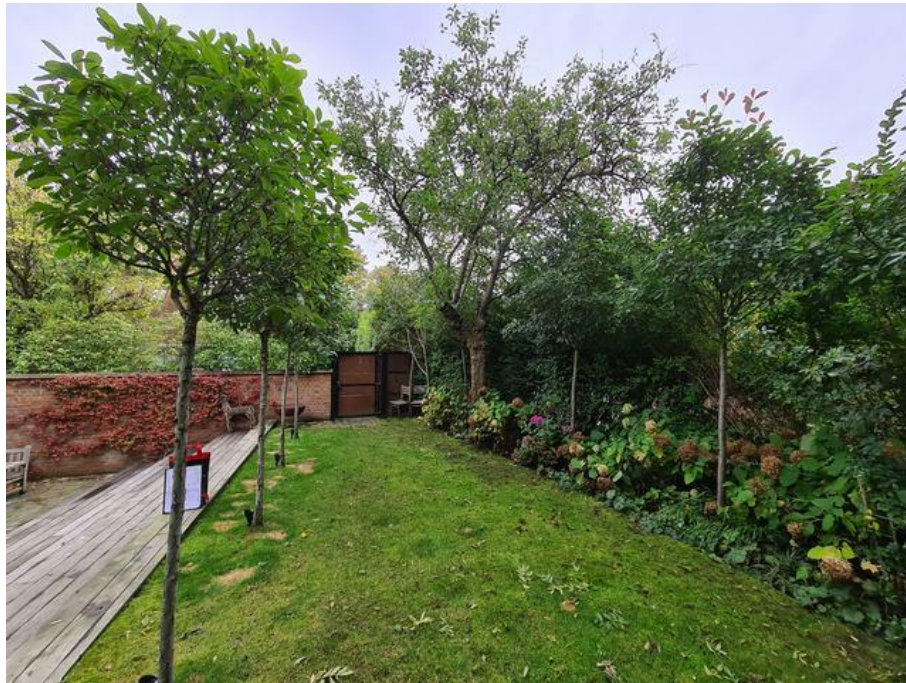
Image 1 T01 an apple tree amongst G08 the Red Robin trees.

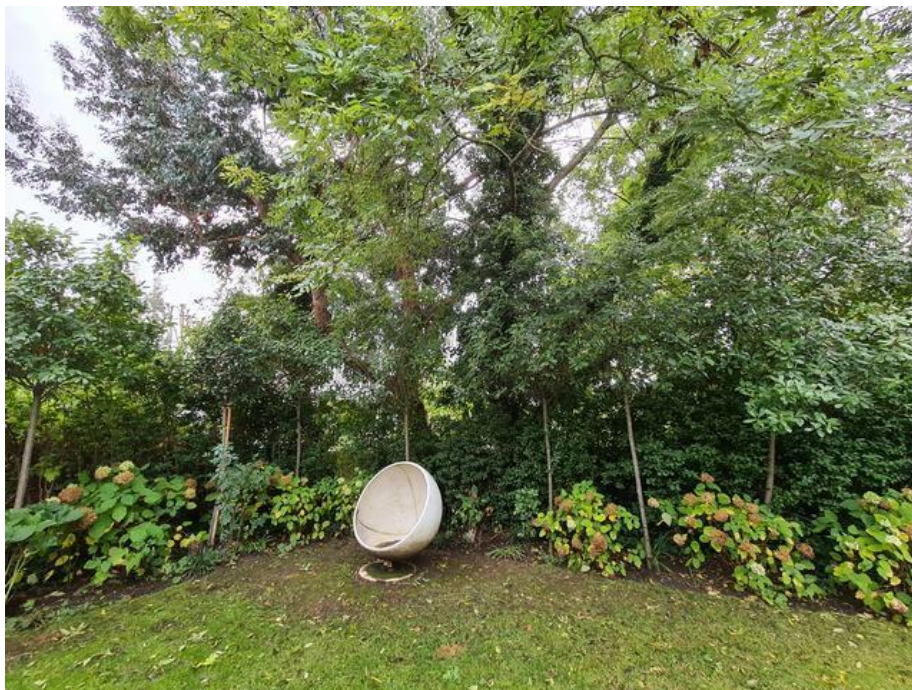
Image 2 T02 and T04 both ash trees with the eucalyptus tree T03 at their rear.

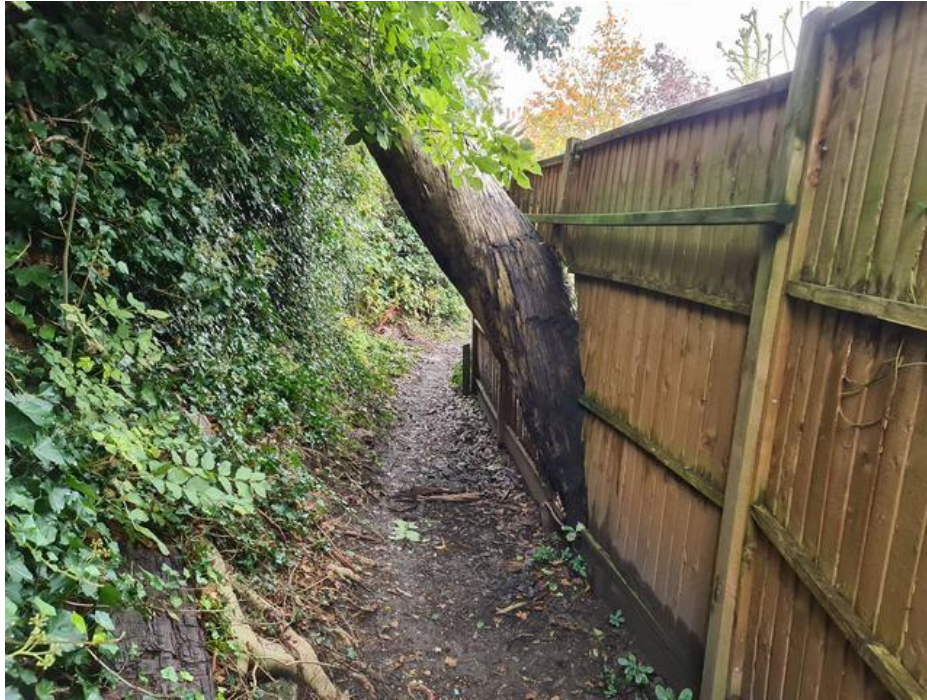
Image 3 Trunk of T03 a eucalyptus tree growing through eh fence and across the path.

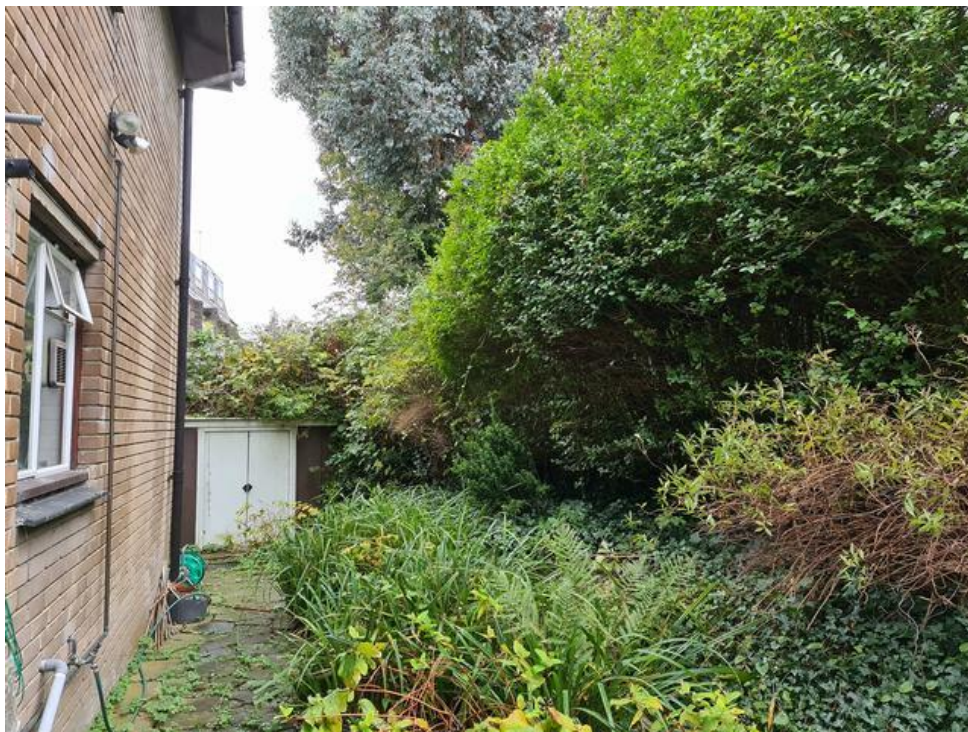
Image 4 Existing building at a lower level that T02 to T04, with T03's crown visible

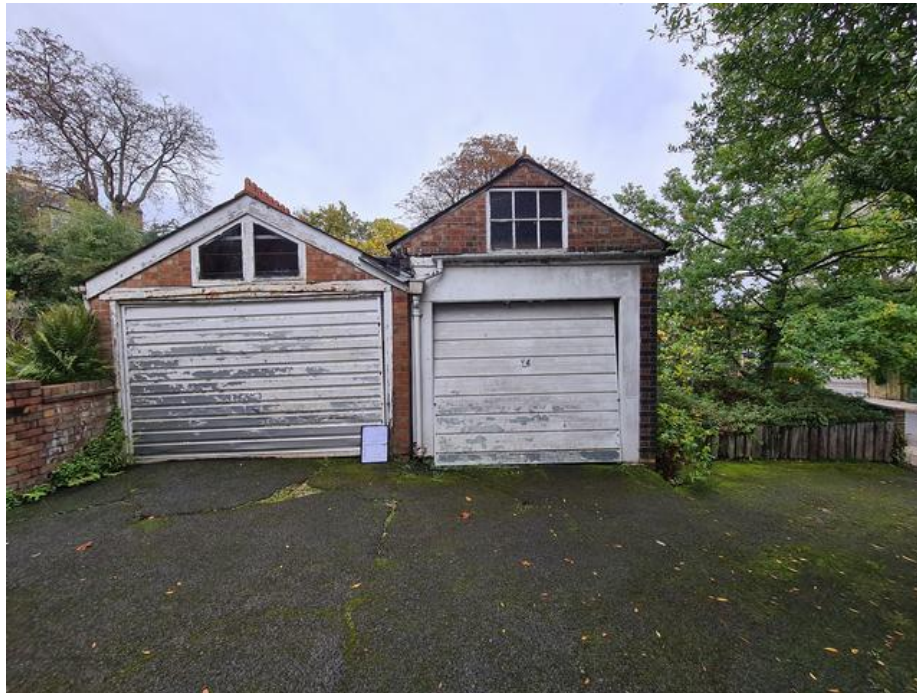
Image 5 T05 a small oak tree to right of the existing garages.

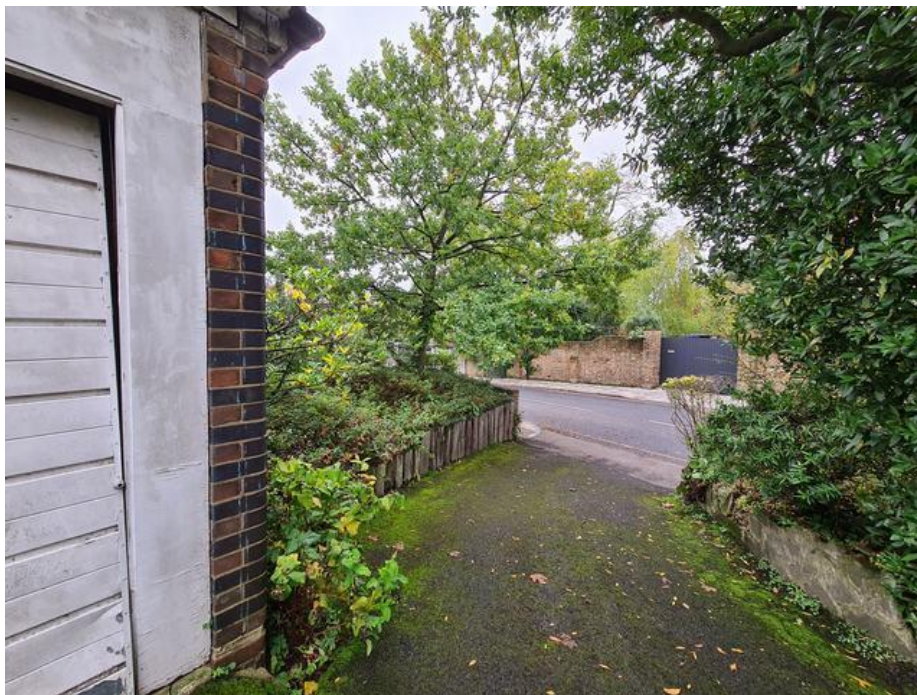
Image 6 T05 the small oak tree in a raised bed adjacent to current drive.

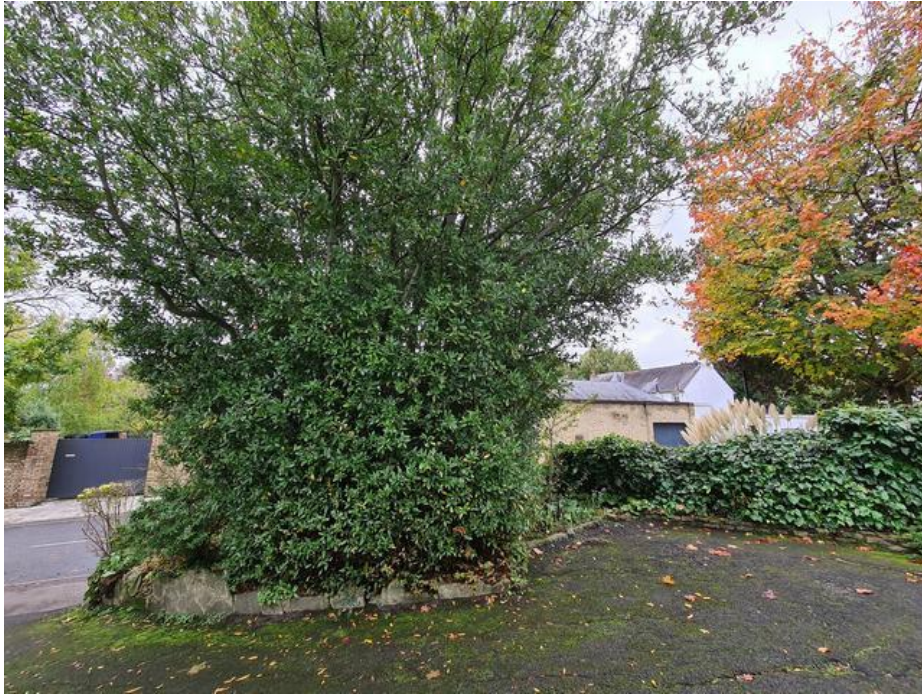
Image 7 T07 a multi stemmed Portuguese laurel bush that is to be removed.

- 12.1** Tree works (see schedule at Appendix VII) will be undertaken in one phase, and this will be undertaken prior to any construction or demolition works and prior to the installation of any tree protection measures. All tree works are to be carried out in accordance with BS 3998 (British Standard Recommendations for Tree Work 2010) unless otherwise specified with clear justification for any deviation from the British Standard.
- 12.2** There are only two trees that are proposed for removal as part of this applications. These are T06 a bushy multi stemmed Portuguese laurel and a small cypress tree. These trees are small in size and of limited amenity value.

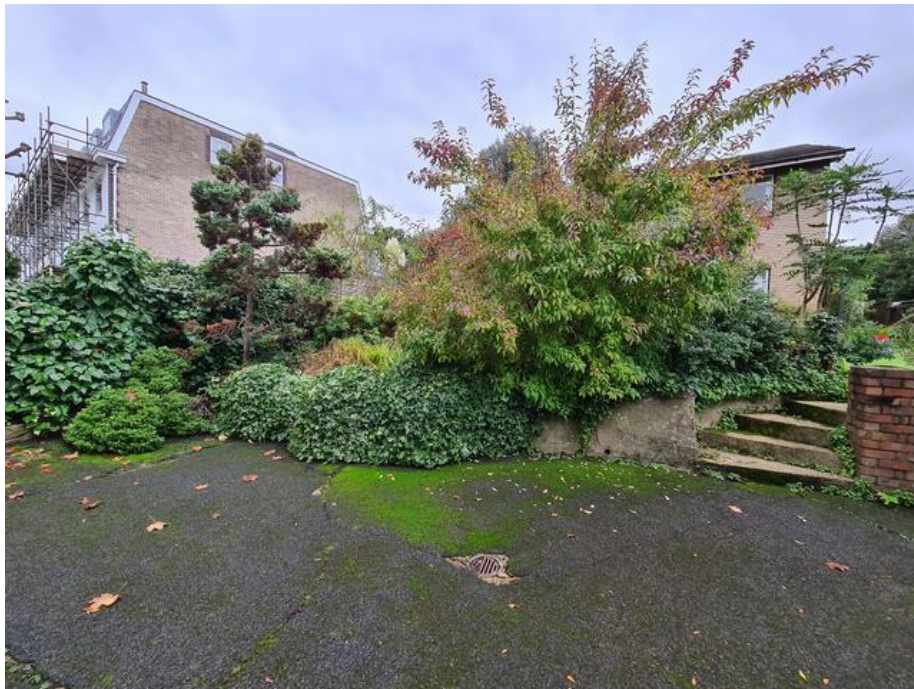
Image 8 T08 a small cypress tree to be remove along with a small shrub on the right.
