Job Number
RS100215

23a Ravenshaw Street
London
NW6 1NP

CCTV Inspection Report

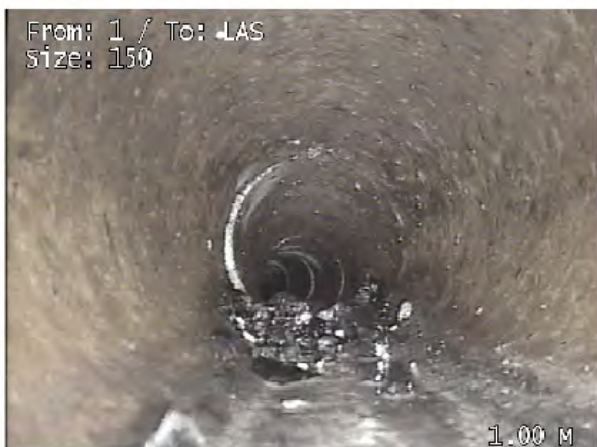
Distance (M)	Code	Observation / Remarks	Photo no.	Type / Grade
M/H Ref: 1 I/L: 1.4 metres				
0.00	ST	Start of Survey Length	1/2.jpg	Comment / 0
0.00	SN	Start node type: Manhole	1/3.jpg	Comment / 0
0.00	WL	Water level 0% height/diameter	1/4.jpg	Comment / 0
1.00	REM	Enter comment here...	1/5.jpg	Comment / 0
1.00	DER	Settled deposits coarse 15% cross-sectional area loss, Start	1/6.jpg	Service / 3
3

Settled deposits coarse 15% cross-sectional area loss, Start

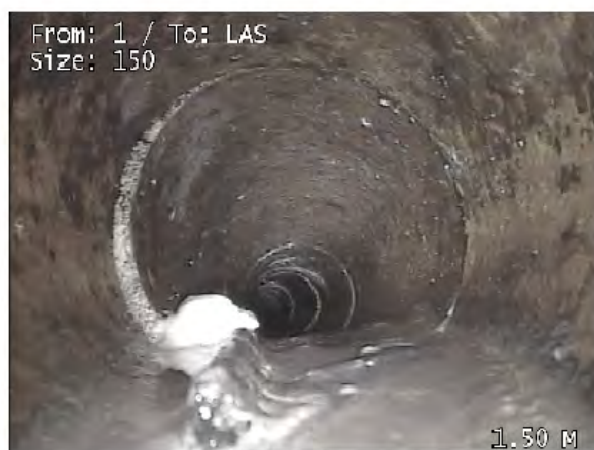
Attached deposits, encrustation at 5 o'clock 10% cross-sectional area loss

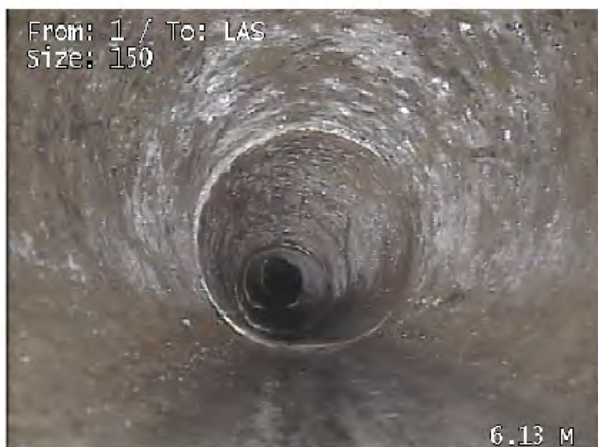
At boundary approx sewer depth 2.5

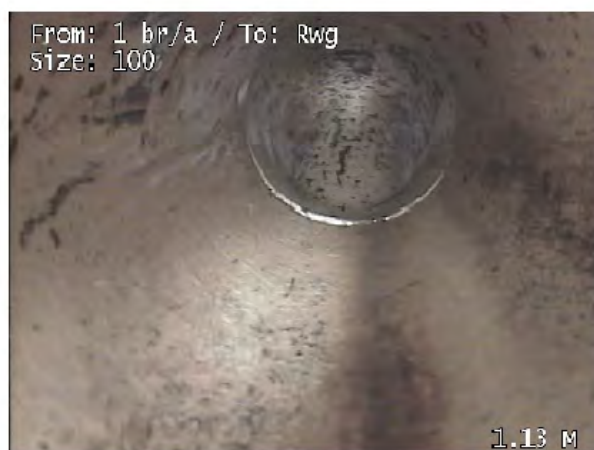
Line of drain/sewer deviates up half

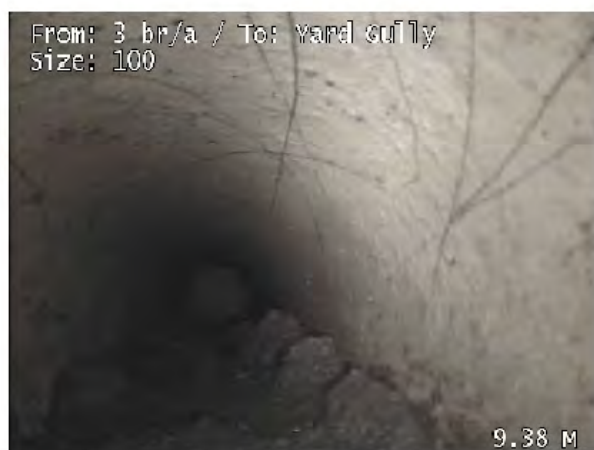
Distance (M)	Code	Observation / Remarks	Photo no.	Type / Grade
M/H Ref: 3 br/a I/L: 0.3 metres				
0.00	ST	Start of Survey Length	7/2.jpg	Comment / 0
0.00	SN	Start node type: Manhole	7/3.jpg	Comment / 0
0.00	WL	Water level 0% height/diameter	7/4.jpg	Comment / 0
9.38	DEB	Settled deposits coarse 25% cross-sectional area loss, Start	7/5.jpg	Service / 4
10.25	REM	Yard gully Reached	7/6.jpg	Comment / 0
M/H Ref: Yard Gully I/L: 0.2 metres

Settled deposits coarse 25% cross-sectional area loss, Start

HPWJ CLEAN RECOMMENDED
