16-19 Southampton Place, London WC1A 2AJ

Appendix A.1 - Gazetteer Review

9802.4 - 18 Southampton Place

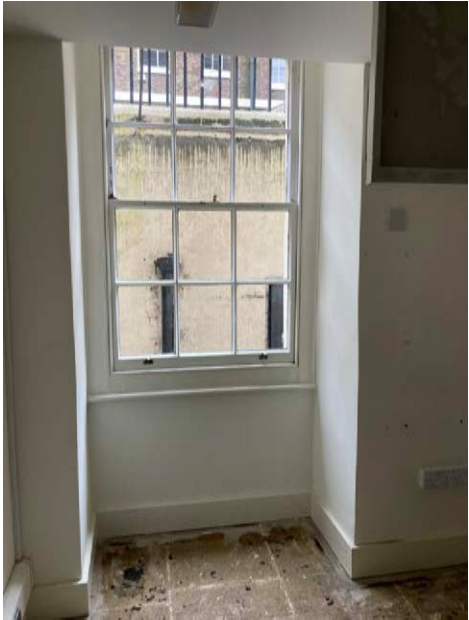
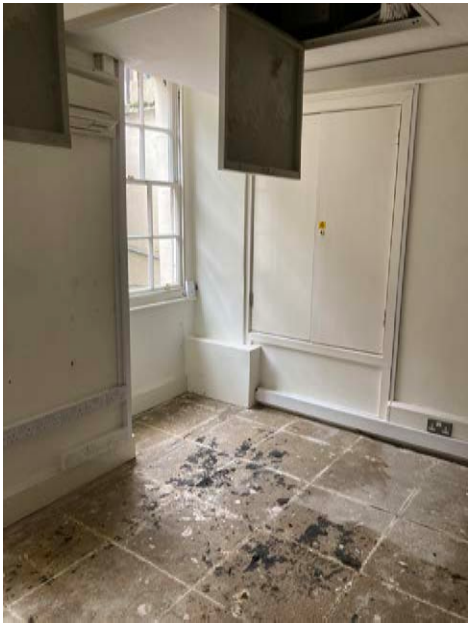
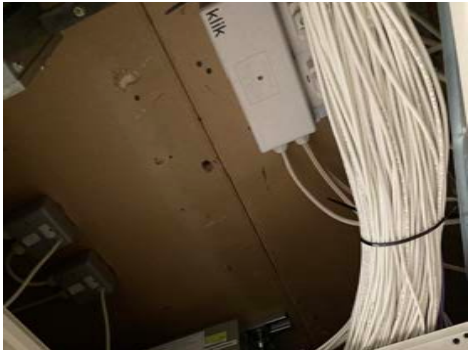
The ceiling has been replaced with a suspended ceiling, and the walls have been dry-lined.

Figure 89, Top - The windows looking out to the light well have all been replaced at some stage.
Figure 90, Middle - A general overview of the room itself. There have been substantial modern additions here.
Figure 91, Bottom - A view into the ceiling void with modern insertions.

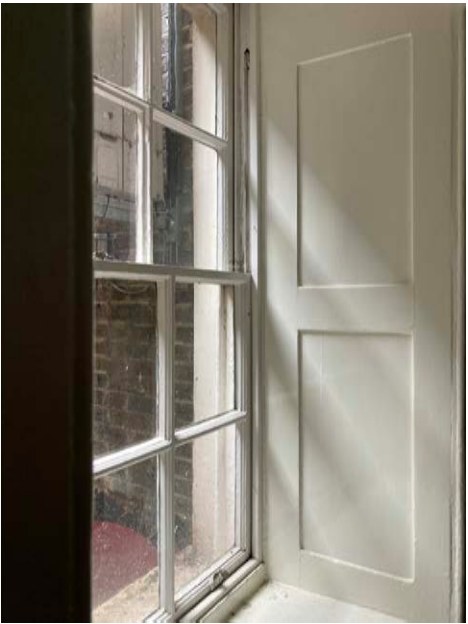
Figure 92, Top - There is an external door to the back of the building, but this is a modern insertion.
Figure 93, Bottom - The window however is historic, though some items were likely added in from elsewhere.

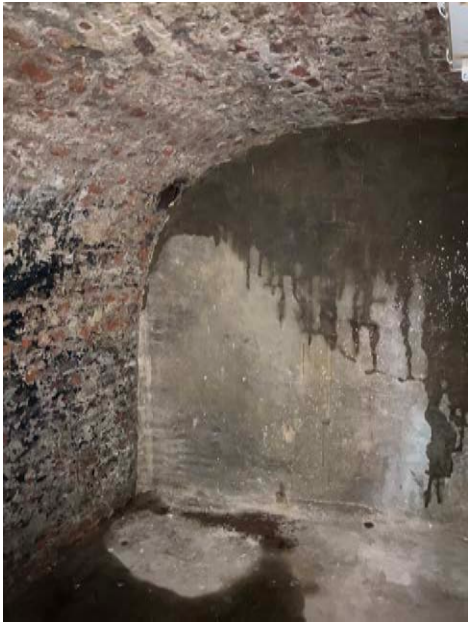
The brick vaulted coal cellar survives to the rear of the building, accessed past the rear room.

Figure 94 - The coal cellar with its brick vaulting.

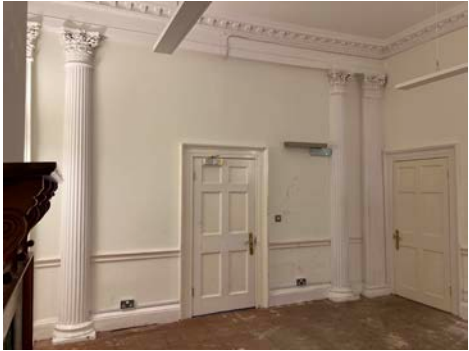
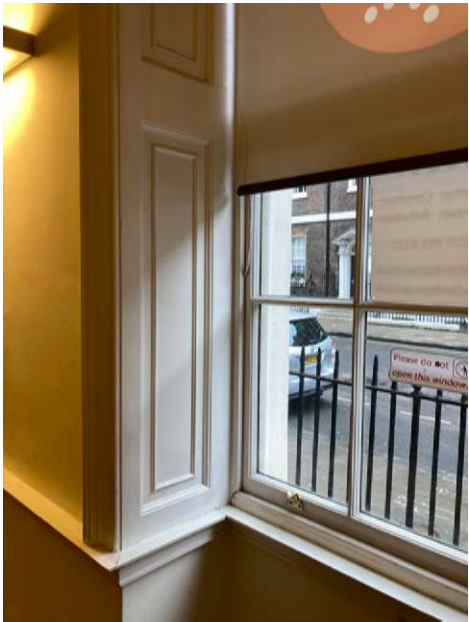
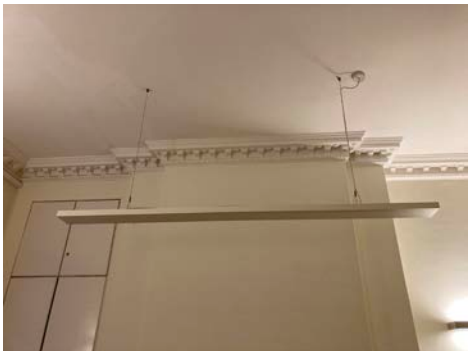
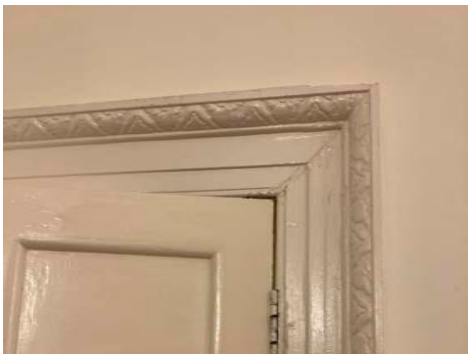
The extent of the original plaster is not known but may been extensively replaced. In this room there are also 2no. Corinthian inspired columns and 2no. Corinthian inspired pilasters which are historic, dating to the late-18th century.

The cornice is part historic, supplemented with a replacement in some areas. There is a modern inappropriate rose on the ceiling, as in the back room.

The windows are historic, with historic architraves (likely Victorian), and the shutters are likely to date to the late-18th century. The panelling shows evidence of being replaced historically.

There is an Edwardian fireplace, supplemented with Arts and Crafts or Art Nouveau tiles within marble slips.

Figure 97, Top - A general overview of the spine wall, with the Corinthian inspired late-18th century columns / pilasters.
Figure 98, Upper Middle - The shutters may have been replaced, with two different beading details to the left and right windows.
Figure 99, Lower Middle - The cracking to the ceiling seems to indicate that a plasterboard ceiling has been installed.
Figure 100, Bottom - The entrance door from the hall is historic, as is its architrave.

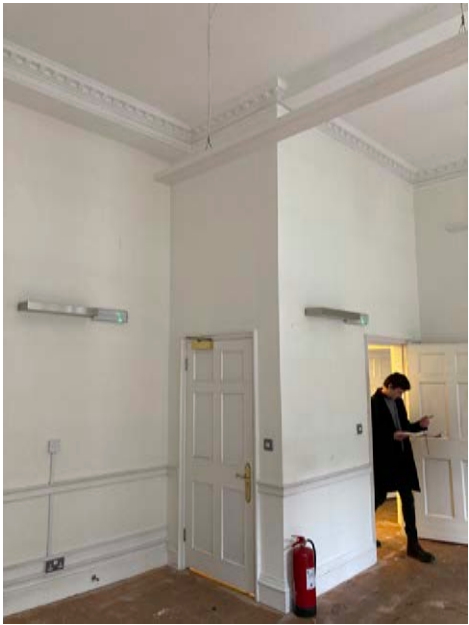
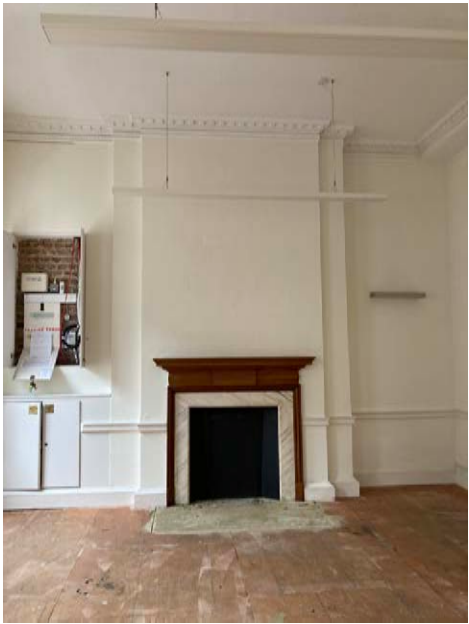
The extent of the original plaster is not known and may have been extensively replaced. A modern lobby has been inserted to the hallway and spine wall, and an opening into the spine wall has also been filled.

The windows are historic, but heavily modified. They have had their shutters removed, and have no panelling. The sashes have been replaced, along with their box frames in a traditional manner.

Figure 106, Middle - There is a modern lobby that has been inserted to the hallway.

Figure 107, Bottom - The Edwardian fireplace. As in the other photographs, modern steel beams can be seen throughout.

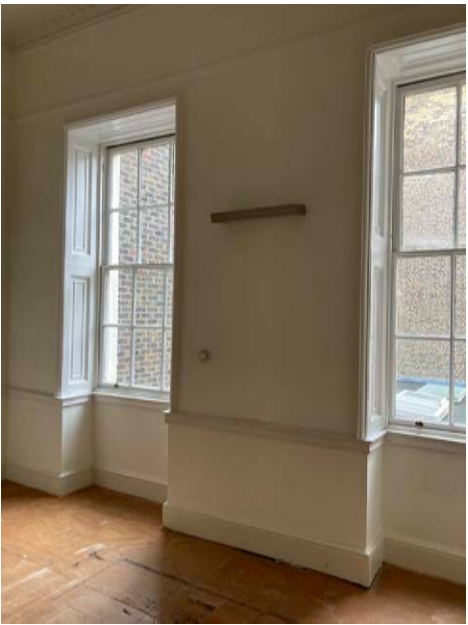
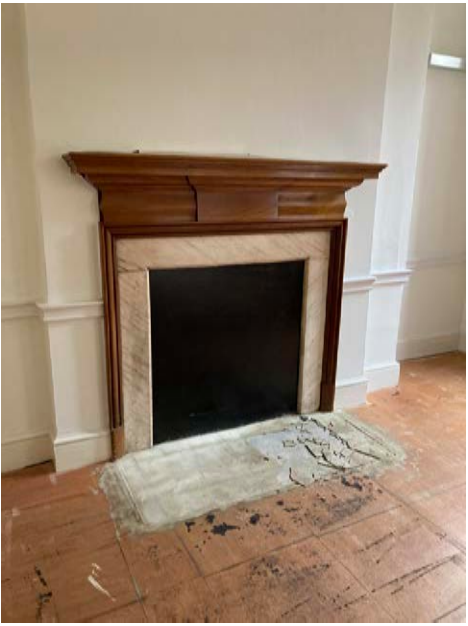
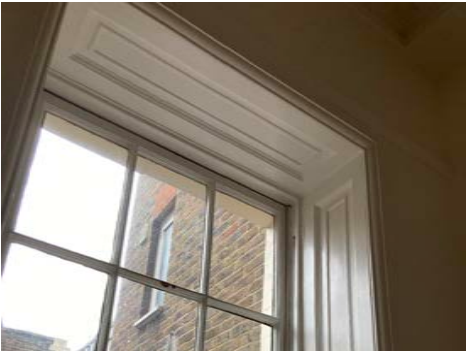
Figure 109, Middle - The Edwardian fireplace to the rear room has a damaged hearth.

Figure 110, Bottom - The soffit panels, among other window joinery, survive to the rear windows.

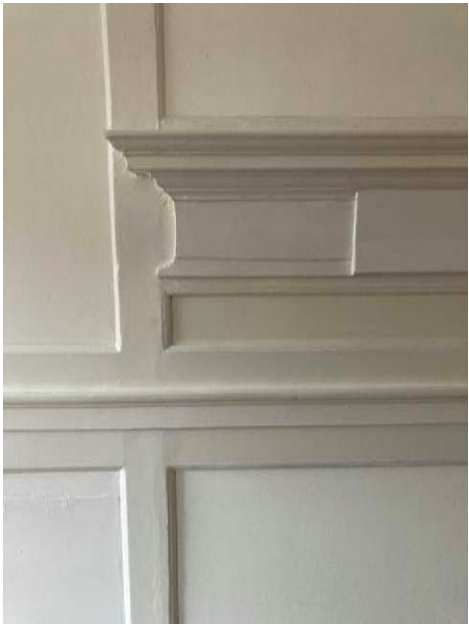
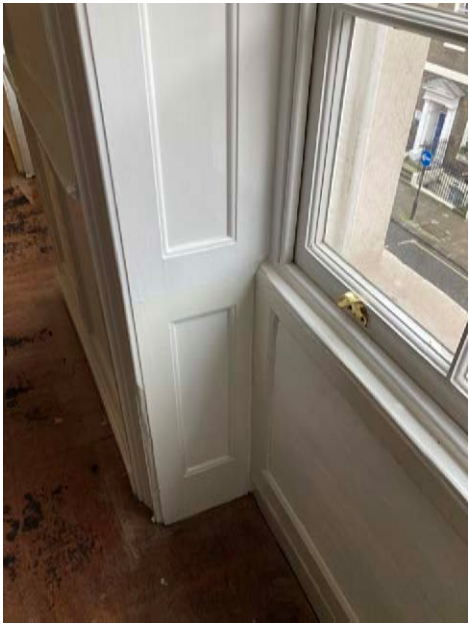
The fireplace has been filled in, though fragments of the original mantle remain in-situ.

Figure 111, Top - The cupboards here feature modern doors, and have been filled with electrical plant.
Figure 112, Middle - The fireplace mantle has been blocked up and left in-situ.
Figure 113, Bottom - The windows maintain their original shutters and panelling..

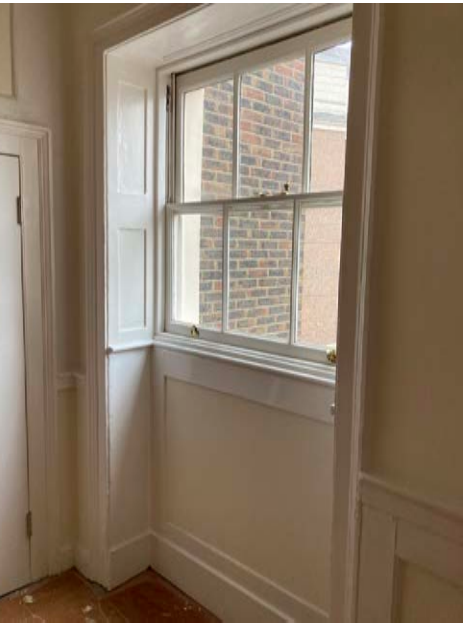
The fireplace has been filled in, though the original mantle remains in-situ.

Figure 114, Top - A general view of the room, showing the fireplace mantle left in-situ.
Figure 115, Middle - The windows retain much of their historic joinery, and the dado encircling the room is also historic.
Figure 116, Bottom - Another view of the historic windows, with their historic joinery.

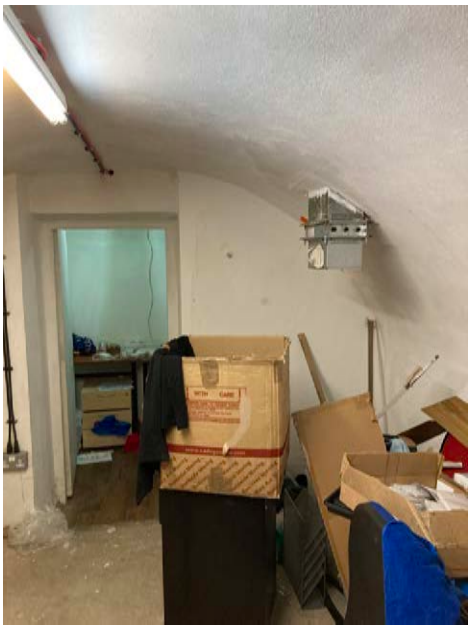
The coal cellar to 19 Southampton Place is also brick vaulted, but has been plastered with waterproof render.

Figure 120 - The coal cellar also has a subsidiary room to its rear.

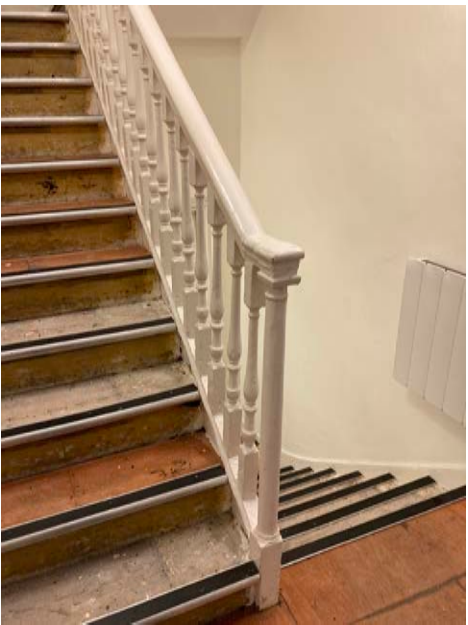
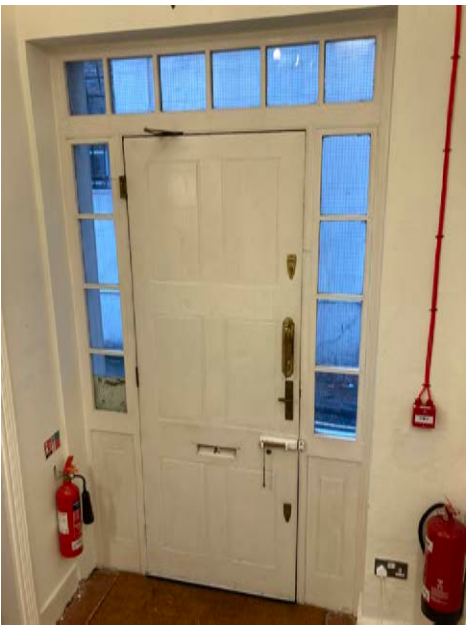
The stair itself is original until second floor level, and has painted spindles and a painted handrail. The spindles are turned until the landing between the 1st and 2nd floor, wherein they become square. Between the 2nd and 3rd floor where the additional floor has been added the stair is a newer Victorian insertion. The treads do not have scotia mouldings, and have been given modern nosing strips which have damaged the stair.

Figure 121, Top - The stair is original, though with modern nosing strips.
Figure 122, Middle - The side door is a modern addition.
Figure 123, Bottom - The original cornice is retained within the stairwell.

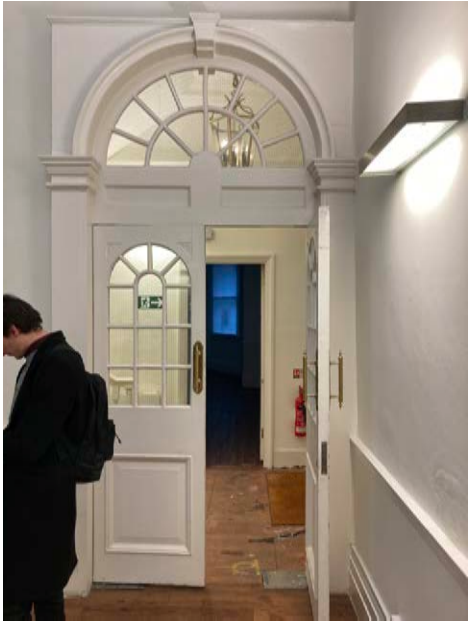
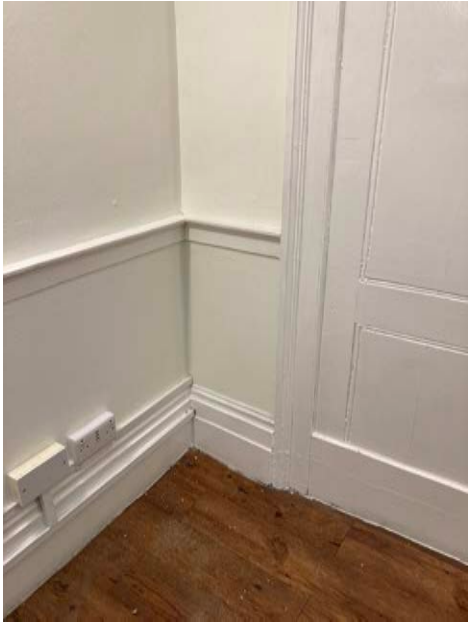
The ceiling has been replaced with plasterboard. The walls appear to retain the original plaster. The 18th century arched opening to the stairwell is original, though the doors and fanlight within are a modern addition.

The cornice appears to be historic, but may have been re-run with the replacement of the ceiling. The rose is a modern addition.

Figure 125, Middle - There is a blocked in exterior door here with fanlight, with modern additions around it.

Figure 126, Bottom - The walls, and the amount of fixing marks, highlight how much these rooms have been altered.

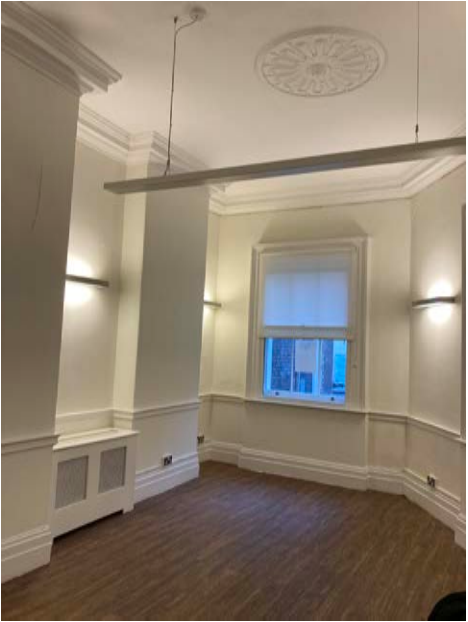
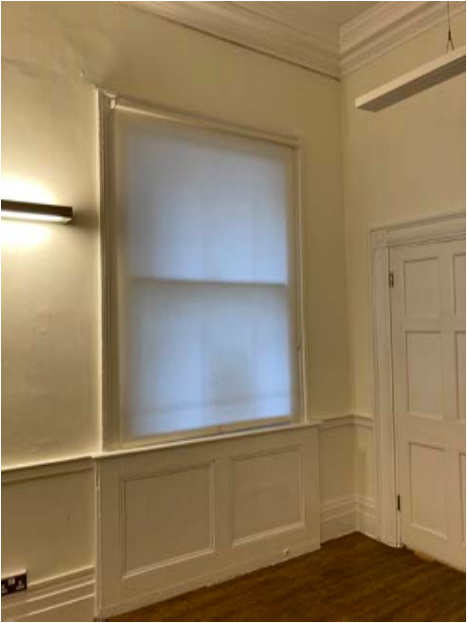
This room has been extended from its original historic plan form. The entire ceiling has been replaced with new plasterboard but the walls may retain some of their plaster finish.

Figure 128, Middle - Within the original proportions of the room are the original windows.

Figure 129, Bottom - The door to the hall has a likely 19th century architrave.

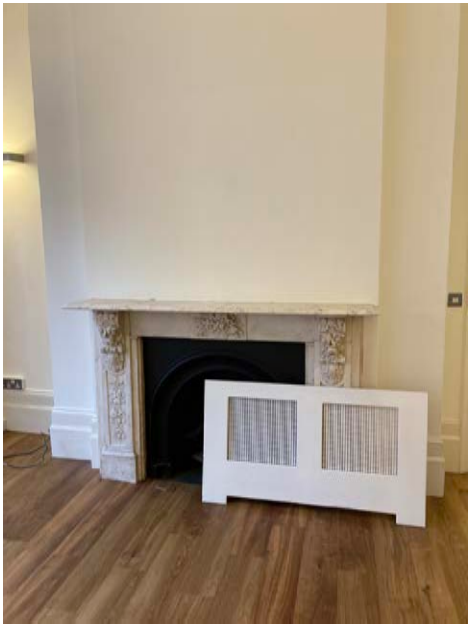
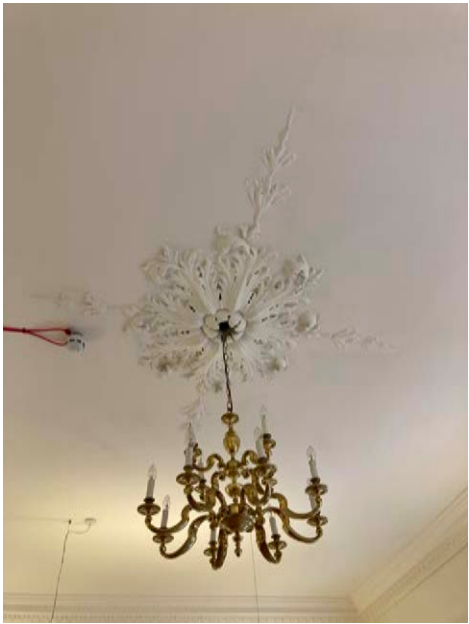
The cornice to this room is in good condition and appears to be historic. Whilst not original, there is a Victorian rose to the light fitting which is historic.

There is an impressive mid-19th century carved marble fireplace in this room which may be contemporaneous with the ceiling rose.

Figure 130, Top - A general view of the room.
Figure 131, Middle - The carved marble fireplace is a grand insertion to the room.
Figure 132, Bottom - The Victorian rose, whilst not original, is a historic addition to the room.

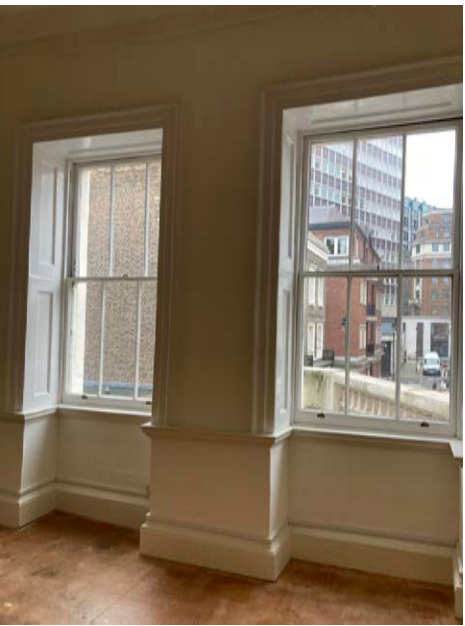
The windows are historic, and retain their original shutters and architraves, though the sashes have been replaced. This replacement, whilst overall a traditional design, is in a 3 on 3 pattern which skews the proportions, and should instead be a 6 on 6 pattern.

The fireplace has been removed from this room.

Figure 133, Top - Although the chimney breast remains to this room, the fireplace has been removed.
Figure 134, Bottom - The windows have a strange proportion with their current 3 on 3 pattern.

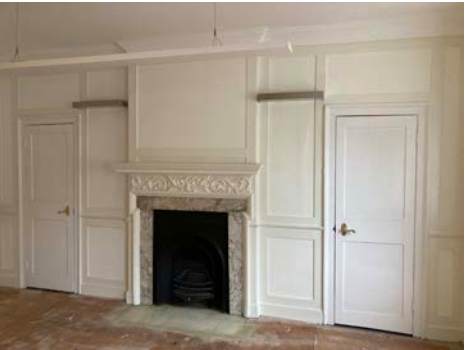
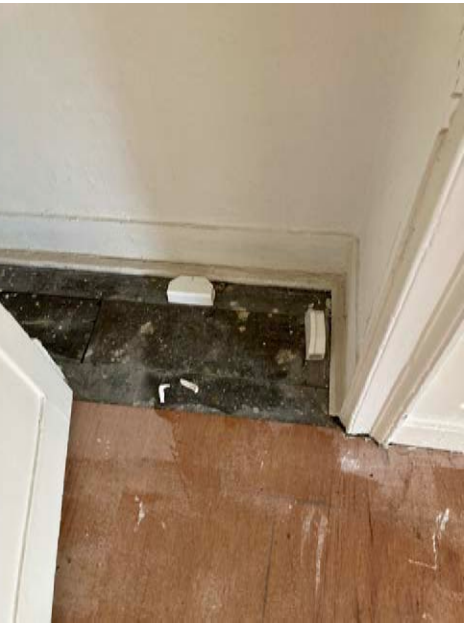
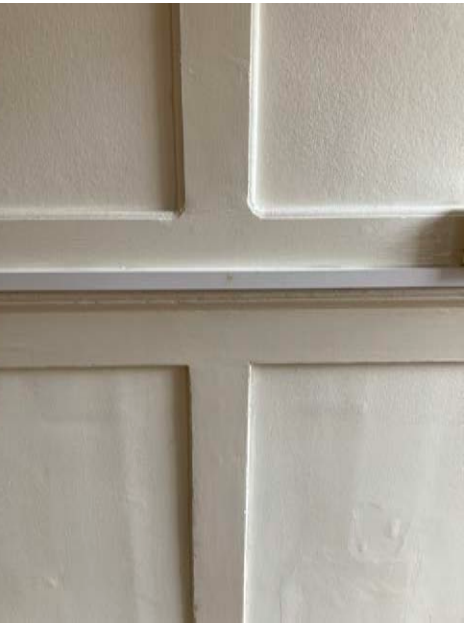
The windows are historic, though not entirely original. The window shutters have been removed and the sashes replaced, and the panelling, although old, is not 18th century. The architrave is also historic.

There is a very ornate high-status fireplace dating from the mid-18th century that has evidently been moved to this location from elsewhere. The original stone/marble hearth has also been in-filled with cement.

Figure 138, Top - A general view of the room, showing the historic cupboard doors, and the very ornate fireplace.
Figure 139, Middle - The interior of one of the cupboard voids
Figure 140, Bottom - Insensitive modern details are found throughout.

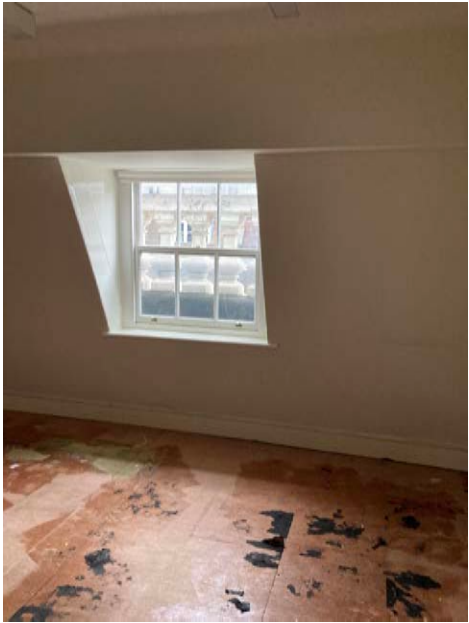
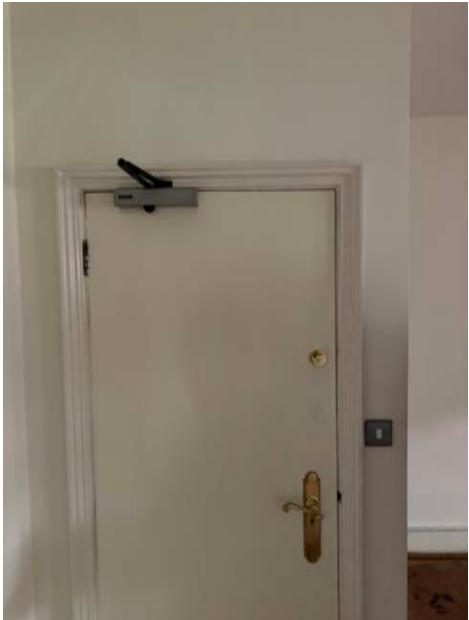
Figure 141., Top - A general view of the mansard level.

Figure 142, Bottom - The door architraves pre-date the extension, and are likely to have been moved from elsewhere.

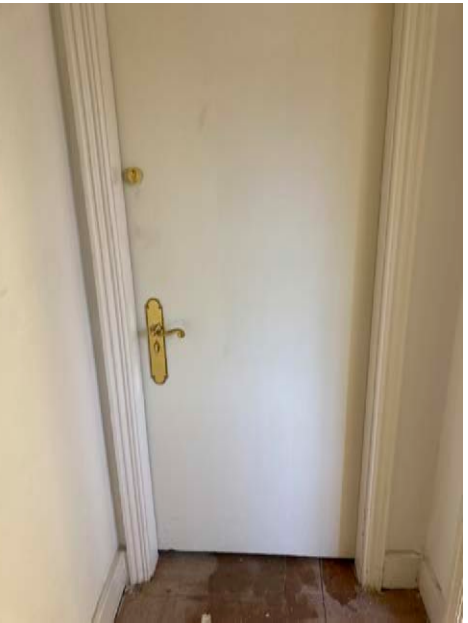
Figure 143, Top - A general view of the mansard level that was added in the Edwardian period.

Figure 144, Bottom - The door architrave might have been moved from elsewhere.
