client name  
Birkbeck University of London

project  
Gordon Square, London

drawing  
Planning - Roof Level - Scope of Work

| drawing number<br>BRK-AHR-GS-RF-DR-A-27-051 | rev<br>P05 |

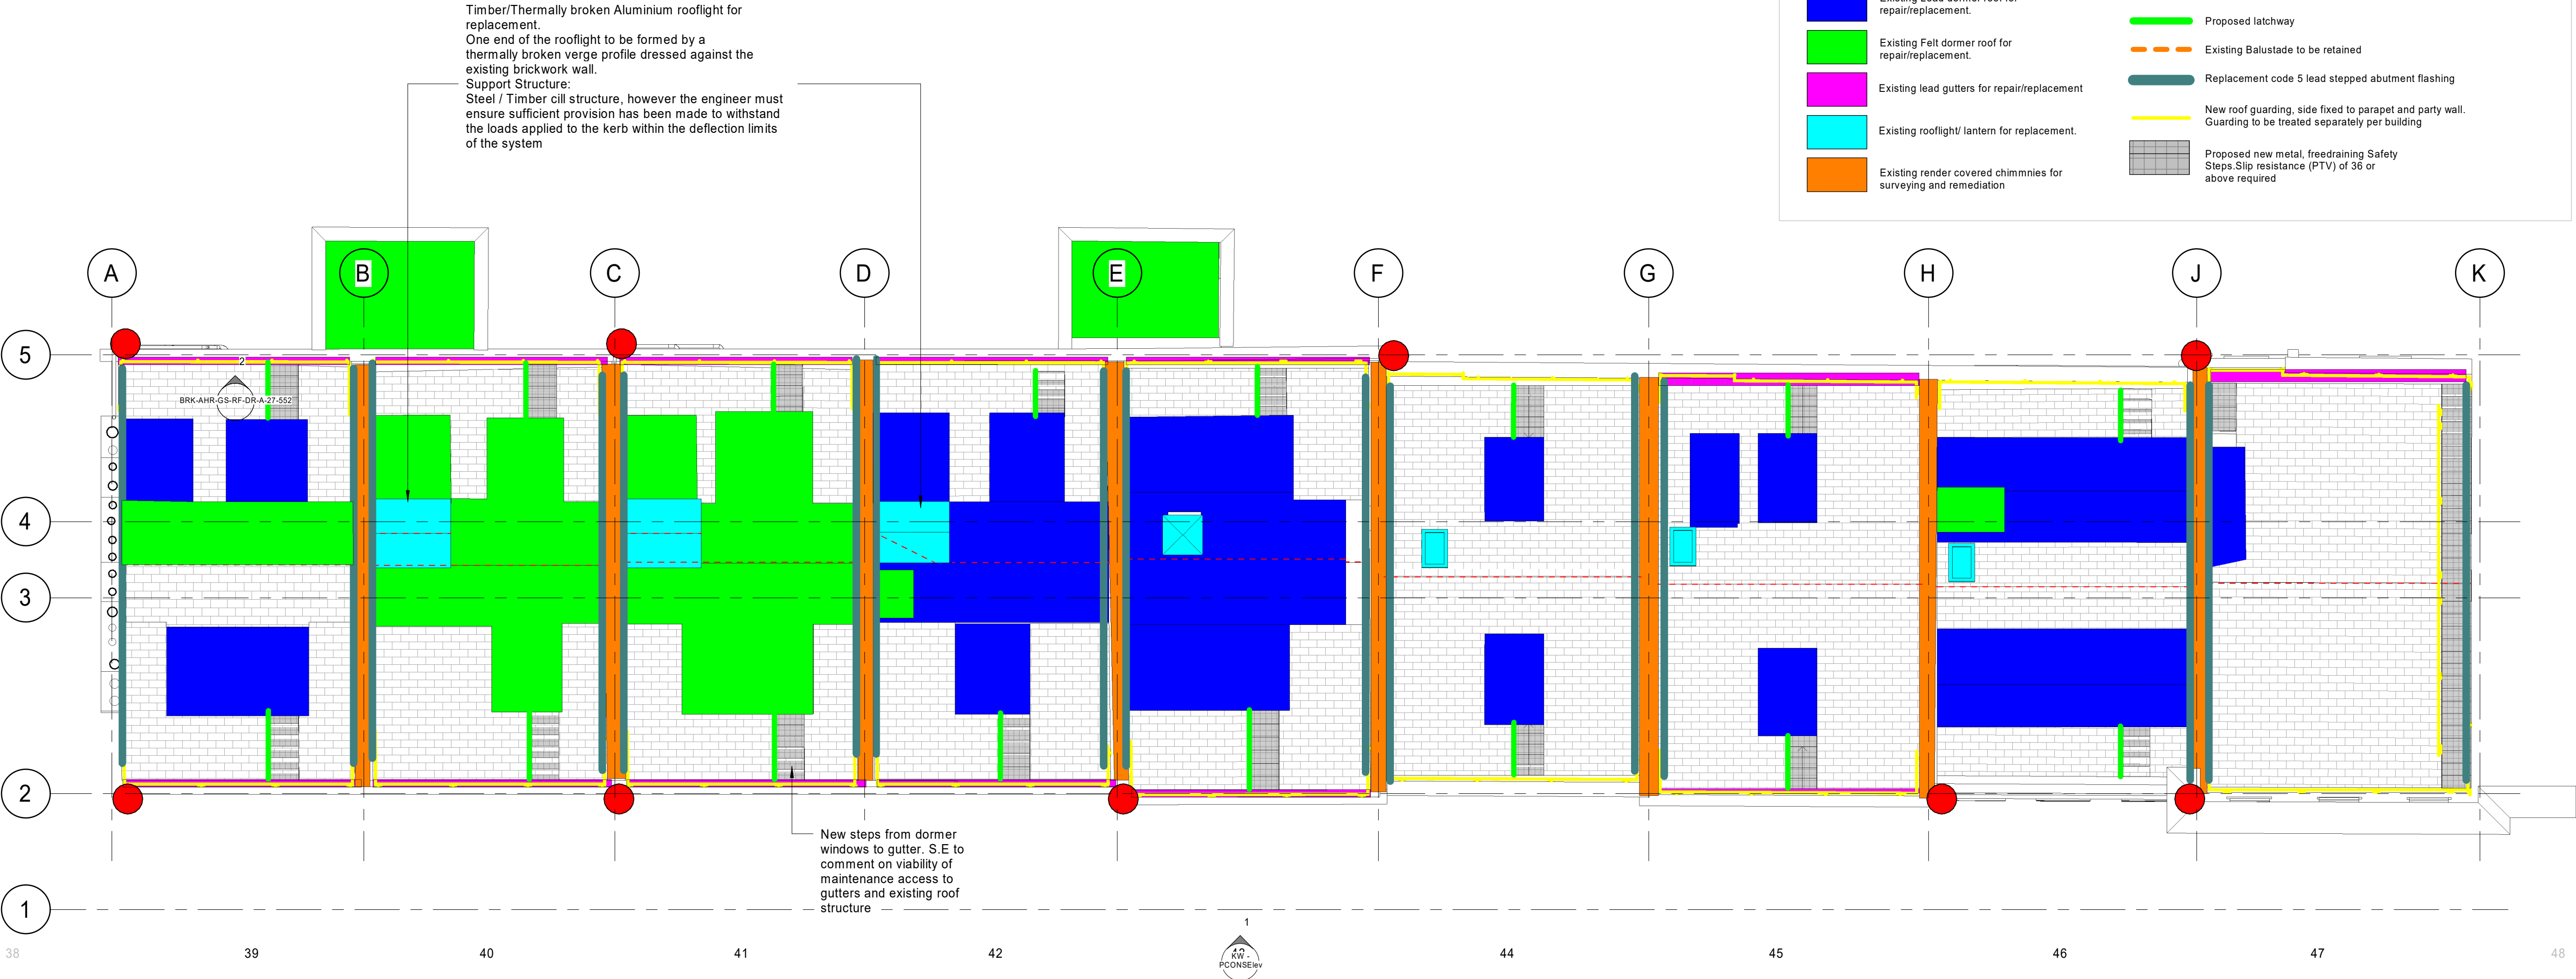
1. Planning - Upper roof scope of works  
1 : 100

Coping Stones (Coping details / Party walls): The coping stones are generally in poor condition and are attributing to the moisture ingress into the building. All coping stones to be removed, cleaned down and re-bedded, with the appropriate lead strapping and cloaking. An allowance should be made for the replacement of any damaged coping stones.

Party Walls: Areas of pointing is in poor condition. Patch repair areas of poor and failing pointing. A full inspection will be required to ascertain the quantity but Condition survey has allowed for a provisional quantity of 1m³ per wall.

3rd. dormer roofs are of a mineral felt finish. Visually this appears to be in poor condition, with some evidence of ingress internally. Recommended that intrusive survey carried out to ascertain whether moisture has penetrated the cap sheet. If whole scale repairs are required, it is envisaged that the felt system will need to be replaced.

Lead covered dormer windows. Leadwork appears to generally be in satisfactory order however there are failed and damaged flashing details prevalent through out. Renew leadwork to damaged sections. This should be subject to a further more detailed investigation and condition survey has allowed a provisional quantity of 0.5m² per unit. It may be considered beneficial to renew all lead flashing and soaker details, whilst access to the roof is available. An extra over cost should be sought for this.

Lead gutters and flashings The gutters appear to be a source of moisture penetration and should be overhauled. It was noted that some remedial works have been undertaken with a liquid system. Strip out all gutters and relime with suitably dressed coded lead in accordance with the Lead Sheet Association guidance. Inspection by qualified contractor to verify state of existing and how much material and underlay can be retained, re used and patched. Existing code 5 lead gutters and flashings to brought back to acceptable standards to Lead Association typical details.

Rainwater goods: Many rainwater outlets were missing leaf guards and exhibited a build up of detritus. Rainwater goods should be cleared, replaced where necessary (with cast iron to match existing) and leaf guards installed to all outlets.

Rooflights: Survey revealed that rooflights are beyond refurbishment and should be replaced like for like. New kerbs installed to punched opening to lift the level of existing rooflights ready for new roof level of proposed refurbished roof. Replace all waterproof junctions as part of roof recovering.

Chimneys General degradation of flaunching and pots. Allow for stripping off and resetting chimney pots on suitable flaunching.

Full survey required to roof - strip off existing tiles, put to one side those in good condition for re use, Structural Engineer to determine soundness of existing rafters and allow for replacement of 50% off existing rafters and all new battens and counterbattens.

Slate replacement roof tiles with, replacement roof underlay felt and battens/counterbattens to existing timber roof construction. Flat roof to receive localised repairs prior to new insulation and refurbishment membrane system being applied.
