JOB
18 Grove Terrace, NW5 1PH

Title	Dwg.	Rev.
EXISTING Front Elevation for Repointing	1439RP/E01

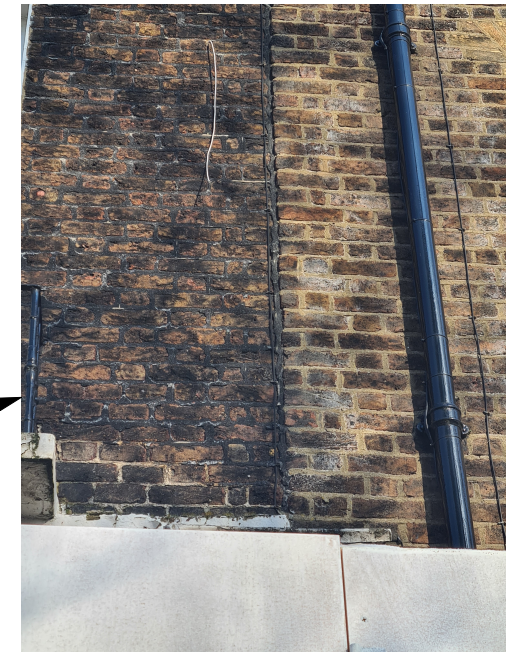
Example of poor condition grouting, many years of dirt and erosion.
