23 Gloucester Crescent

Heritage Impact Assessment of Proposed Amendments to 2021/2518/L

November 2021

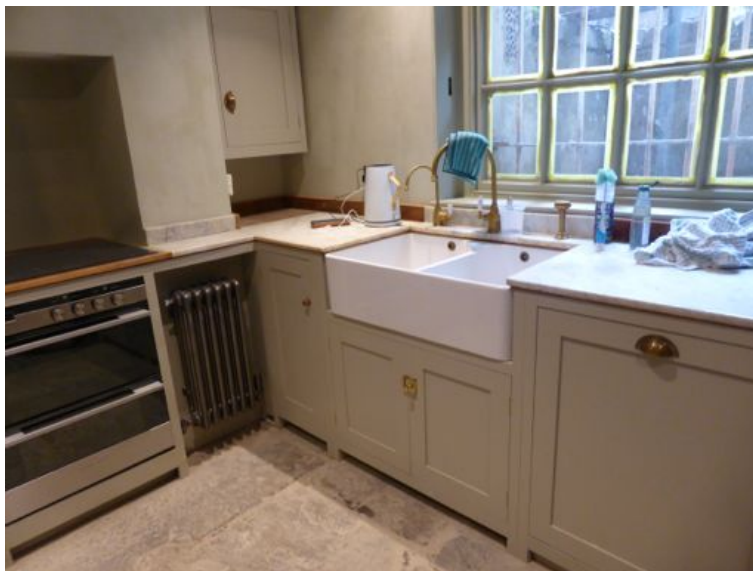
The alteration of the radiator sizing following the retention of the flagstone floor (higher BTU output was necessary to sustain normal inhabitable temperatures), required the loss of two small fixed shelves either side of the oven within the new kitchen joinery. This minor amendment to a new item of joinery is not considered detrimental to the representation of the space.

The re-use of the existing kitchen worktops from the 1969 scheme required some compromise when fitting the materials, with some of the marble unsuitable, requiring the substitution of some splashback upstands in marble to be made from the mahogany instead. The principle of re-using the original with no external material being incorporated was adhered to. Refer to drawing GC 311A.

Fig. 1 Kitchen showing radiator without shelf above, note marble and mahogany worktop/splashbacks.

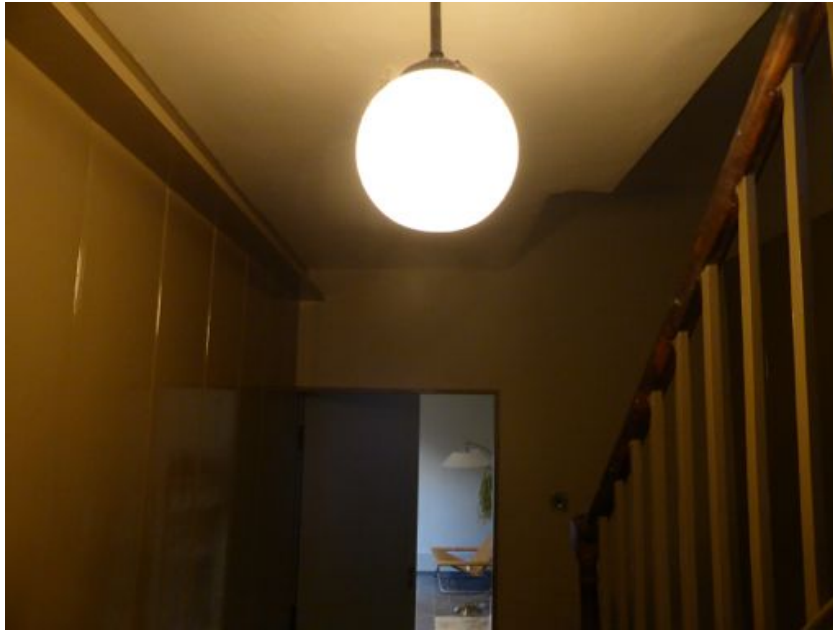
The incorporation of the 1969 RSJ back into the reinstated dividing wall between the kitchen and stair required its misalignment to be accounted for. A high level shelf (Fig.2) just under the lower flange of the RSJ allowed for the wall to step out by enough to allow for plasterboard fireproofing to the beam. The shelf is softwood, painted as per the wall.

Fig. 2 Shelf detail to top of wall on left of image.

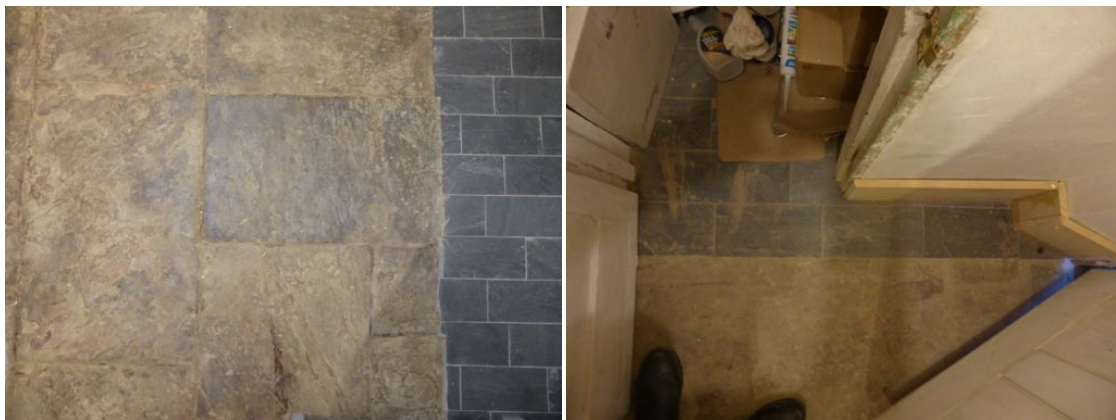
The flooring layout submitted and approved in the previous amendments was drawn prior to a full clean of the York flagstones. Following the cleaning it was discovered that a small section on the WC threshold and Vault threshold were concrete and not flags, so the extent of the slate tiling extended to accommodate this (Fig.4). Drawing GC 321C documents the minor alteration in the tiling design as built.

Fig. 3 York stone flags meeting the slate tiling, cut carefully to suit the stone profile.

Fig. 4 York stone flags in the corridor with slates extending to meet them from the WC

Fig. 4 also shows the plastered wall/WC doorframe junction that, together with the Vault door was without an architrave. The re-plastering of the walls following removal of impermeable gypsum plaster requires the junctions to be dealt with. As service rooms the use of mouldings elsewhere in the house would be inappropriate as the joinery was pared down, evidenced by the basement stair and understair doorframe. With no precedent to follow, a simple thin softwood section detailed in drawing GC 302C detail E covers the frame/plaster junction. A crude cut-out to the Vault door made when a gas boiler was installed in 1969 is retained for enhanced airflow, timber slats create a grill as the original grille was missing.

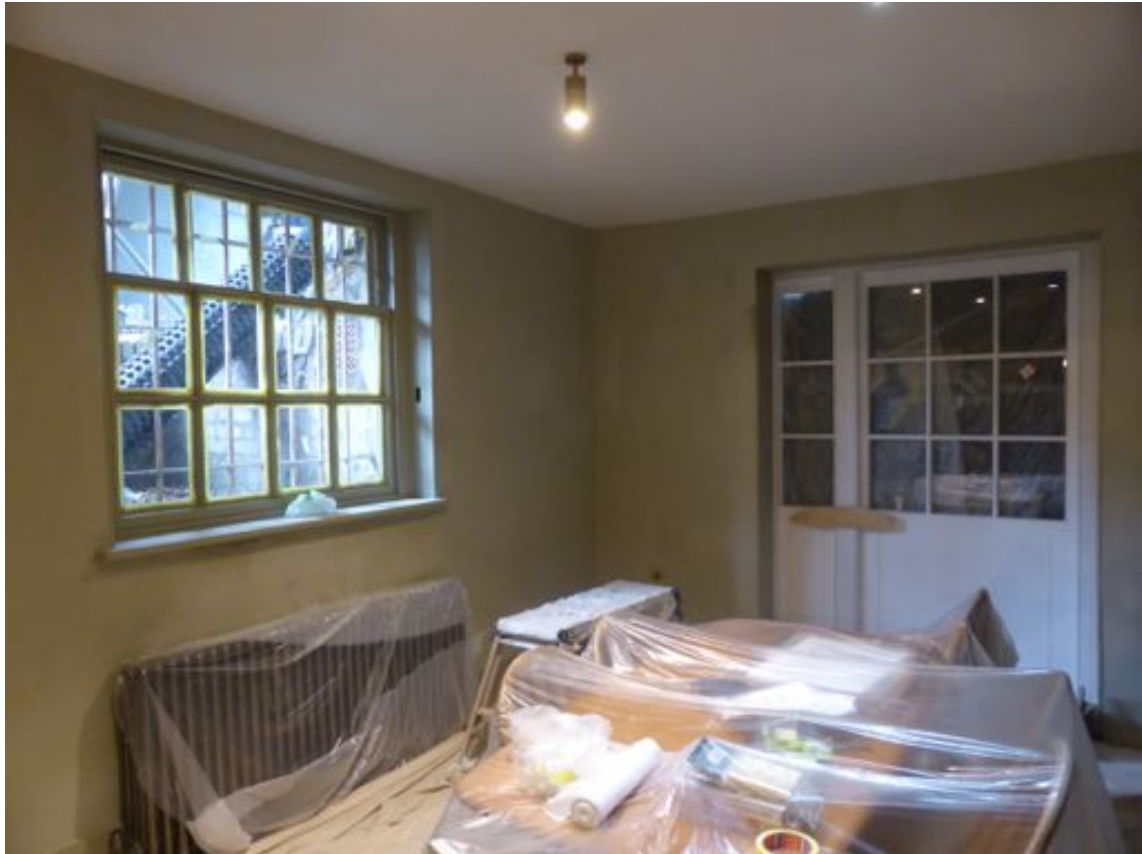
The new external dining room door (which utilises the structural opening made in 1969) is detailed as per the consented drawing GC 315, however GC 315B shows the revised alteration to the overall height of the glazed section of the door. Following the opening up of the wall the area it was felt that proportioning the glass panes according to the upper level blind window directly above this door on the First Floor was a mistake. This elongated pane dimension was felt to jar with the squatter sash window proportions within the basement service floor. The pane heights were therefore reduced to work in sympathy with the original basement sashes.

Fig. 5 North door re-proportioned to suit the original sash windows.

The lateral dimensions still follow the lateral divisions of the blind window above. Blocking to the Roman cement render around the door on the exterior is adjusted to suit this new glazing proportion. Whilst present of the façade, and holding significance because of this, the use of vertical proportion to sustain the language of the service level whilst using the lateral dimensions to link to the geometry of the blind window above reconciled the formal and informal aspects of the house, rather than imposing the elevated proportions on the ground and piano nobile floors at basement level.

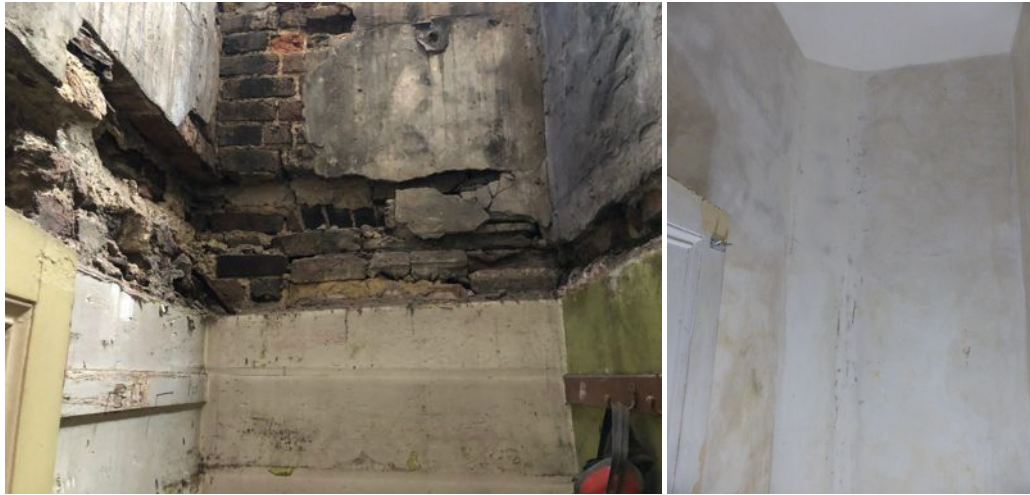
The consented removal of the redundant tank required the rotten wall plates, cut in when it was installed, to be removed. The masonry (Fig.6) was repaired in reclaimed brick and lime mortar.

Fig. 6 cloakroom walls prior to repair

Fig. 7 cloakroom walls after repair and plastering in lime, with corner boxed waste water pipe

The relocation of the waste water pipe from the first floor Master bathroom was required as the existing bath and basin were previously connected to the rainwater pipework on the middle of the West façade, which is non compliant. The renewal of the West elevation iron pipework meant that a simple rainwater pipe from the roof, in its original form, could be installed if the bathroom waste was relocated, so a more discrete way to drain the bath and basin was found. The cloakroom has limited significance and the presence of the waste pipework shown in Fig.7 behind a 45 degree plastered cover piece was considered to be less harmful than an iron SVP on the elevation.

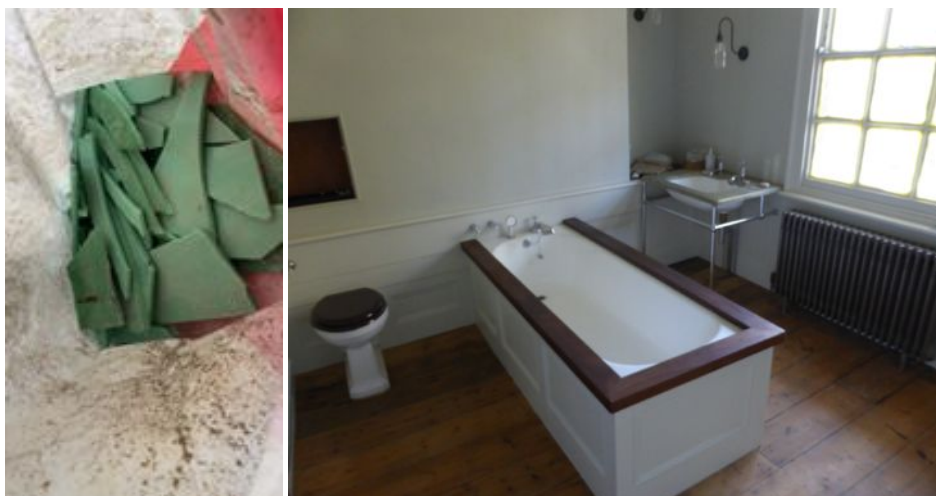
The breakage of the 'Vitrolite' glass splashback to the basin by the contractor was regrettable, it was shattered beyond repair. As this material in any colour is unavailable, a craft-made cast glass was sourced. A neutral grey-white was a suitable match for the basin marble given the inability to match the 'Vitrolite' – ref drawing GC 312B.

Fig. 8 shattered 'Vitrolite'.

Fig. 9 master bathroom showing alternative bracket wall lights.

The bracket wall light above the basin was considered unsafe by the Electrician, with no earth lug and an inability to re-fix the bulb holder to the bracket. A suitably IP rated bracket wall light was sourced to replace the 1969 fitting, which will be retained in the house in the bathroom storage cupboard (drawing GC 304C).

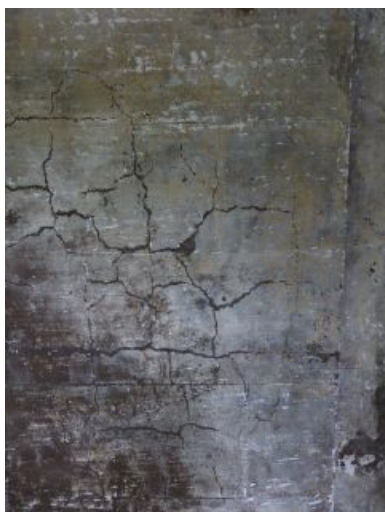
The consented removal of the modern paint layer using the Thermatech system revealed a deeply pitted surface (figs. 10,11). The heritage priority is to restore vapour permeability, therefore ruling out any form of contemporary filler that would be able to adequately deal with the fine fissures and pitting.

Fig. 10 surface fissures at first floor level

If the pitting was simply painted the façade would be able to retain water thereby increasing the potential for frost damage. The option to use a compatible vapour-open material such as Roman cement has technical constraints as it needs to be applied as a surface coating with a minimum 4mm depth. This coating has been applied to the degraded render as a like-for-like repair to sustain the requirement for vapour-open construction with the existing blocking reinstated precisely (Fig.12). The façade will be painted as per the existing consent.

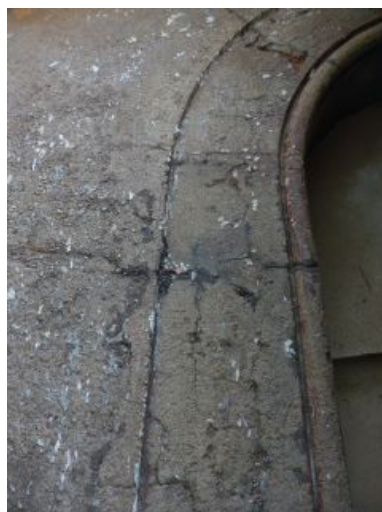
Fig. 11 deep pitting at the second floor level

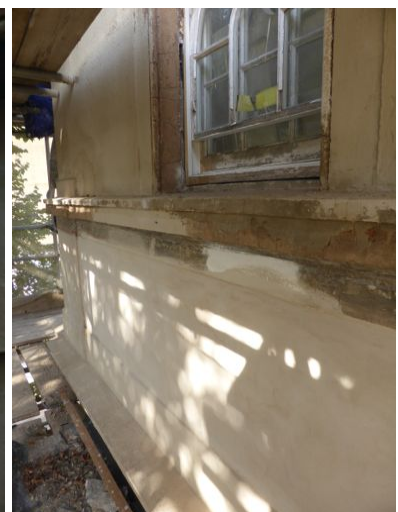
Fig. 12 re-coating the stucco with Roman cement.
