23 Gloucester Crescent

Design and Access Statement

Revised November 2021

This supporting statement forms part of a Listed Building Application seeking minor amendments to approval ref. 2021/2518/L (dated 06.08.2021) and is accompanied by the following documents:

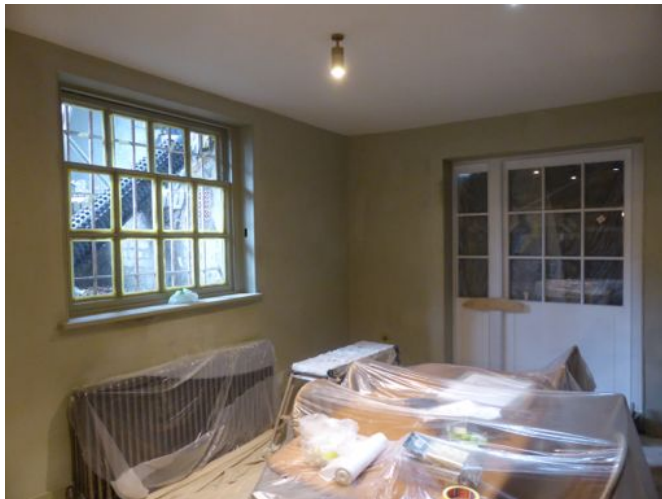
The North lightwell glazed door design has been adjusted in terms of its area of glazing. Following the opening up of the doorway originally formed in 1969, it was judged that the height of the glazing should reflect the existing proportions of the original basement sash windows, whilst at the same time lining vertically with the blind window above the door on the North Elevation as consented. This raising of the 'cill' height on the door with a more modest area of glass reflects its position in the service level of the house.

Fig. 1 Dining room interior showing revised glazed door proportioned to the original sash windows.

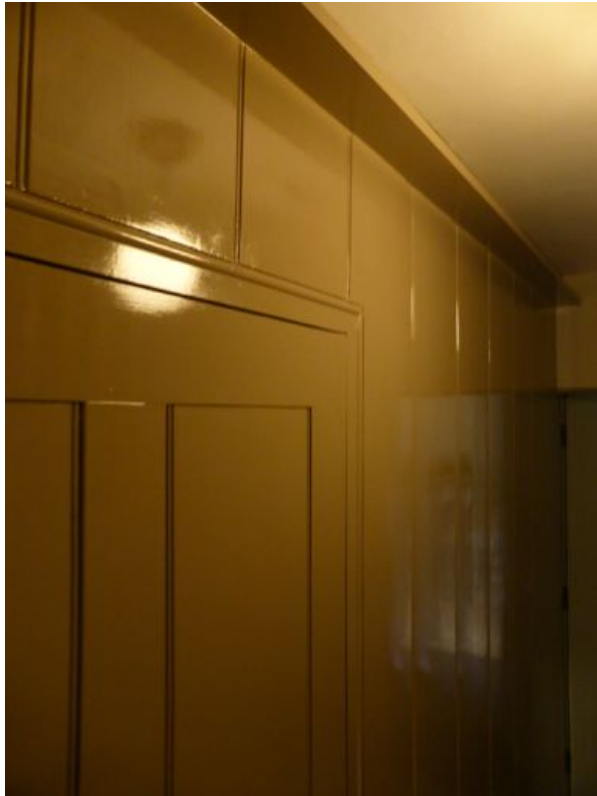
The threshold to the door needed to respond to the consented removal of the existing cement screed, requiring a 70mm step on the interior. A York stone bull-nose step was used to provide a robust surface when entering from the North lightwell. The details of the revised door are drawn on GC 315B. When installing the dividing wall between the kitchen and stairway the steel beam installed in 1969 was found to be misaligned. This meant that it slightly protruded beyond the line of the vertical timber paneling to the stair side. To ensure it was clad in plasterboard for fire protection, a small painted softwood shelf detail was installed to conceal the stepping out, visible in Fig.2 just below the ceiling. Refer to drawing GC 311A.

Fig. 2 Finished T&G paneling with shelf close to ceiling level.

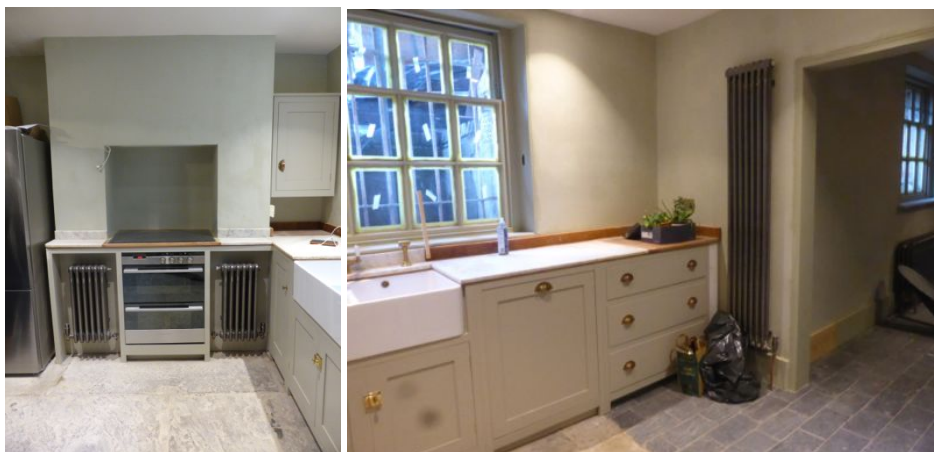
When the original mahogany and marble kitchen worktops were reworked, the areas of useable material were different to anticipated, requiring us to utilize more of the mahogany as there was less of the marble available a splashbacks. The marble was used adjacent to the hob and behind the sink, elsewhere the mahogany replaced marble that was detailed in the consented drawings.

Figs. 3,4 Finished kitchen units with mahogany splashbacks and revised radiator locations

The revised layout also incorporates an amended oven enclosure that accommodates two radiators, along with a tall third radiator re-sized to account for the revealed but unheated flagstone floor (Figs 3,4). The kitchen amendments are shown on GC 311A.

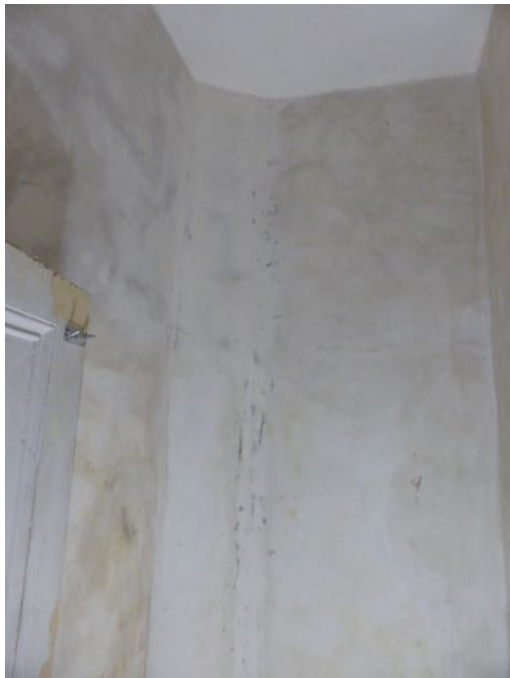
The bath and basin wastes from the First Floor were discovered to run under the floor to the centrally located rainwater goods on the West elevation. This was unacceptable from a building regulations perspective, and required connection to the internally routed SVP. The original SVP exits the duct and travels externally across the Hall roof, and the level of exit was above that of the bath/basin waste. The pipework therefore was run internally within the existing cloakroom, exiting at basement ceiling level to the South lightwell, where the pipework was set behind the existing SVP. This required 'boxing-in' to the corner of the cloakroom, executed with a panel a 45 degrees in the corner of the space to minimize visual impact, plastered and decorated as per the walls (Fig. 5), GC 303C.

Fig. 5 Boxed in waste pipe to cloakroom (plastered awaiting paint finish).

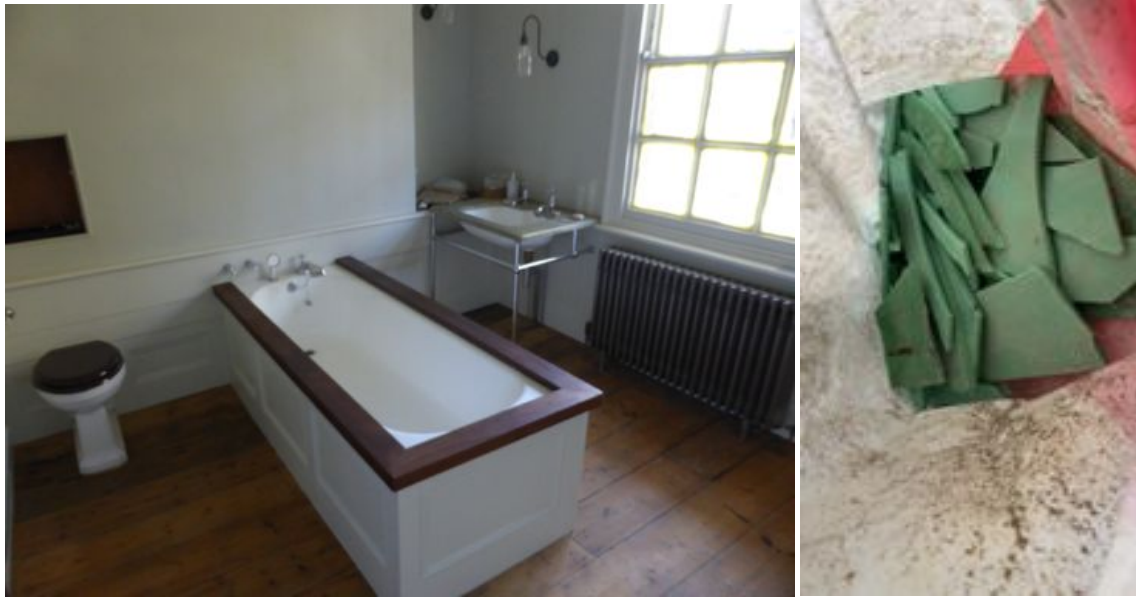
The consented scheme allows for the retention of the 'Vitrolite' panel acting as a splashback to the master bathroom basin, and the re-use of the bracket lamp above it. Fig. 6 shows the reinstated bath and sink minus the splashback, which prior to the redecoration of the room was broken by the contractors (Fig. 7). The 'Vitrolite' was likely a salvaged piece in 1969, and this material is no longer made. A source of cast glass which although thinner and without the ribbing to the rear, has been found and will provide the functionality required to protect the distemper finish to the lime plaster walls. The colours are limited and a grey-white that is available works with the replacement Shanks marble worktop and will be fitted in lieu of the lost original.

Figs. 6, 7 Master bathroom with shattered 'Vitrolite' splashback.

The bracket lamp above the basin in Fig.6 is a modern fitting as the original fitting was not safe when located so close to the basin. The bracket lamp (which was missing a shade) has been retained and stored within the bathroom cupboard.

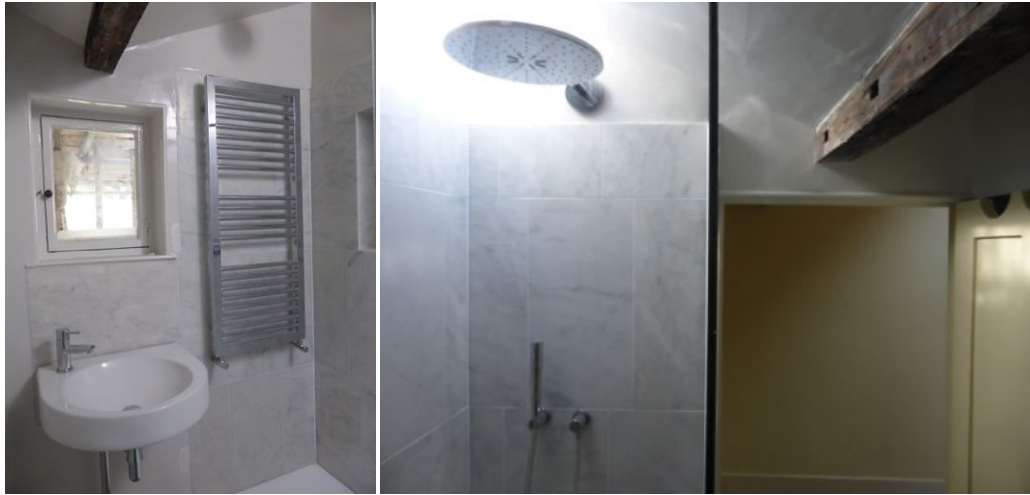
The shower room tiling was determined with the client and a thin marble tile was used to secure the water resistance of the shower enclosure – refer to drawing GC 324B, where final positions of lighting and a 110v socket were added to the space. Figs 8, 9 document the tiling and sanitaryware, the retained valley beam visible above the retained door with semicircular cutouts circa 1969.

Figs. 8, 9 Basin and towel rail, shower looking towards doorway with hall beyond the open original door

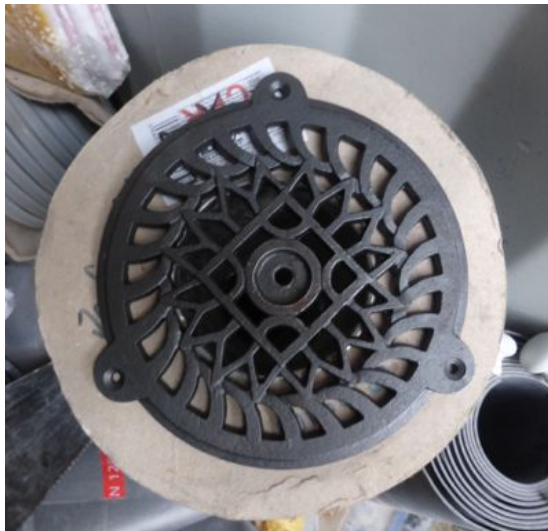
On drawing GC 310B South Elevation the Master Bathroom waste pipe is shown located adjacent/behind the existing cast iron SVP. The final location of the cast iron vents for the vault services space is also shown, with the vent chosen shown in Fig.10.

Fig. 10 cast iron grille prior to fitting, to be set flush to the Roman cement render, painted to match walls.

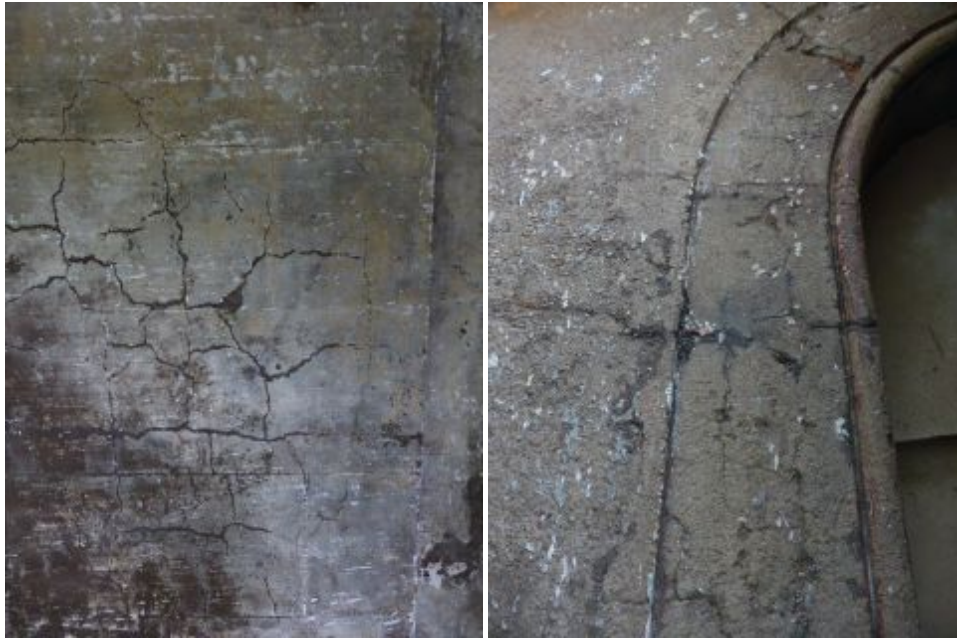
On all three exposed elevations the condition of the render under the impervious exterior masonry paint was poor, with extensive pitting revealed following the Thermatech paint removal (figs. 11,12). Pitting and fissures like this are difficult to fill using a traditional material, with admixtures to modern fillers creating impervious material that should not be extensively applied to a vapour open façade.

Figs. 11, 12 following Thermatech paint removal

As such the decision was taken to re-skim the flat areas of the façade in a lime-based Roman cement, suitable for the application of Keim mineral paint. Fig.13 shows the application of the Roman cement coating prior to painting.

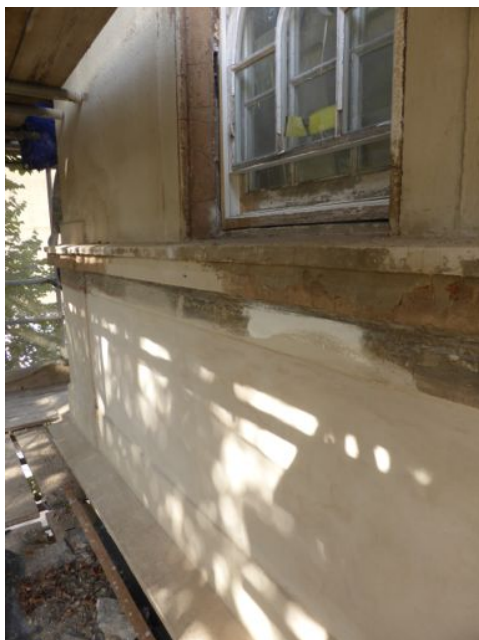
Fig. 13 skim coating in progress, mouldings retained as found.

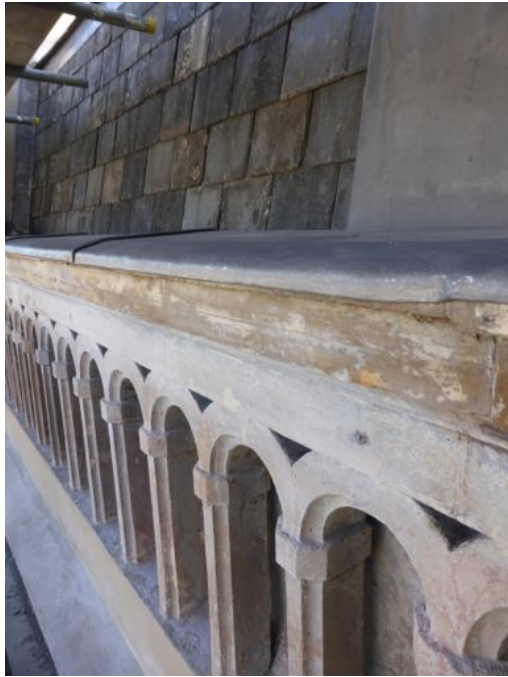
To the parapet detail on the North elevation extensive repair was required to the top of the parapet coping. This area of the building is inaccessible so the decision was made to apply a lead cloak to the top of the parapet to preserve its integrity, the edge detailed so that its presence is visually minimized – Fig. 14.

Fig. 14 lead cloak to parapet as installed
